# Boxford Culvert & Bridge Asset Management

Prepared for: **Boxford DPW**  
7B Spofford Road  
Boxford, MA 01921

Prepared by: **TEC, Inc.**  
146 Dascomb Road  
Andover, MA 01810

July 26, 2021

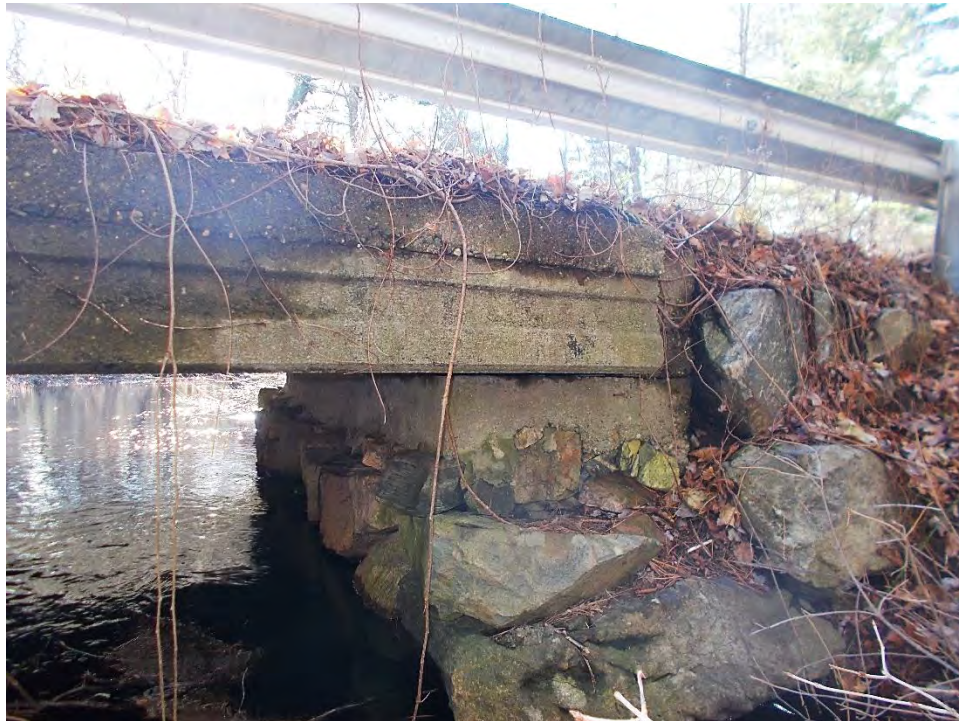
**Figure 2: Bearing at the southwest corner - B-19-001**

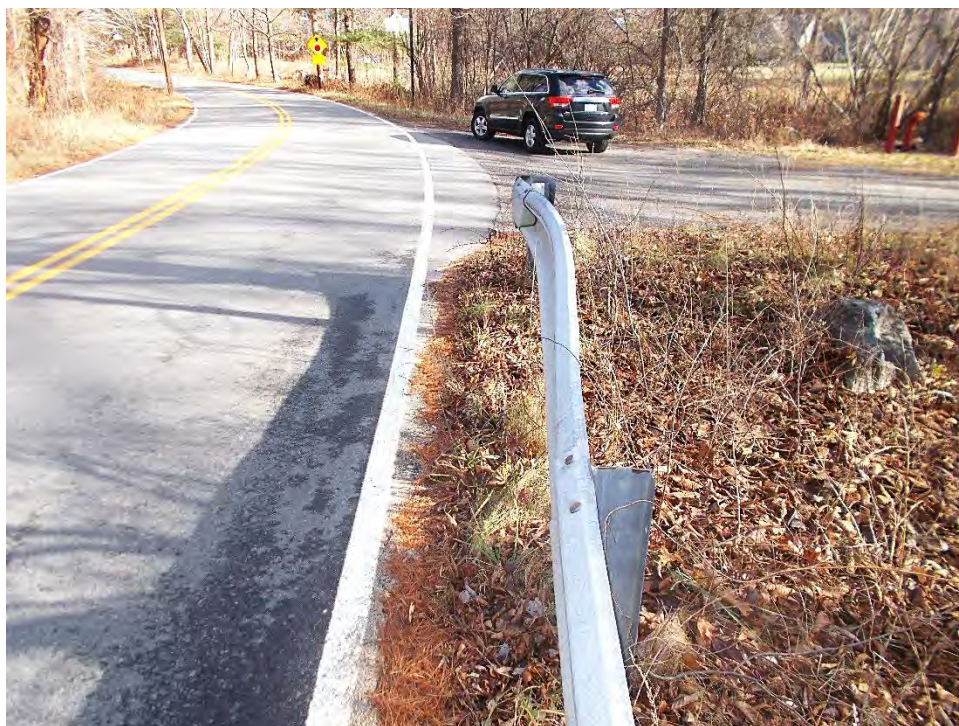
**Figure 3: Impact damage to guardrail at northeast corner - B-19-001**

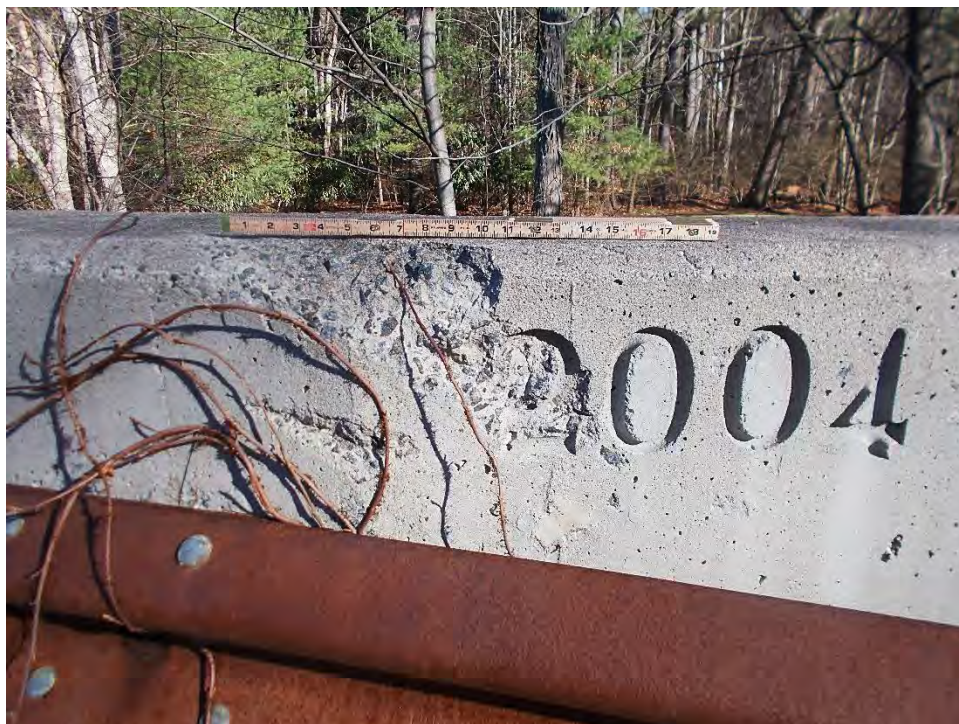
**Figure 10: Spalling on southeast concrete transition - B-19-002**

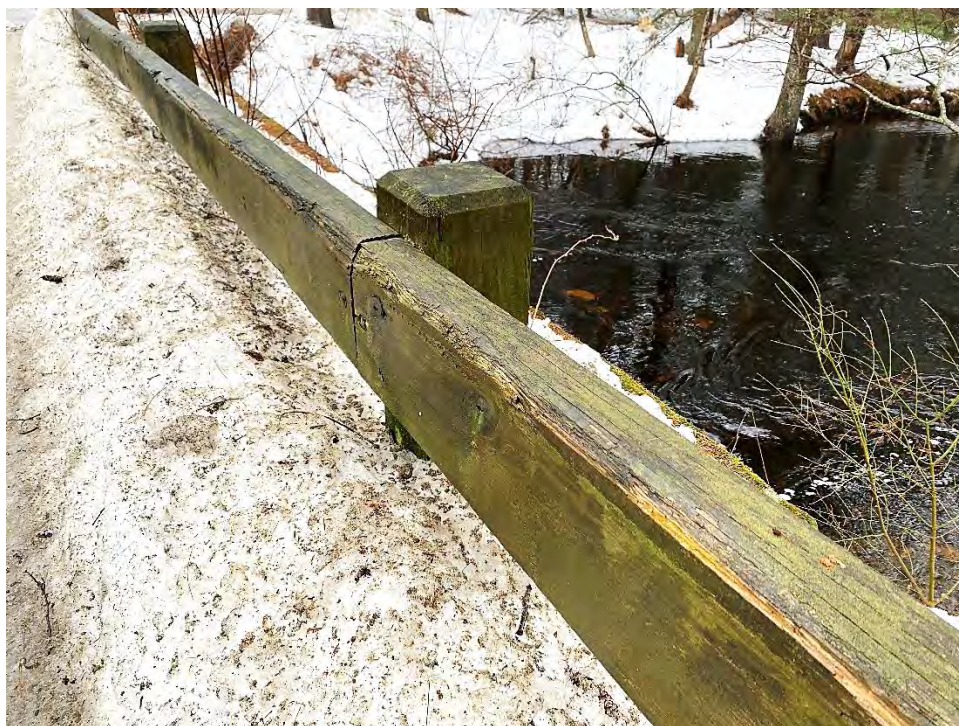
**Figure 13: Typical wood checking in timber bridge railing (looking south) - B-19-003**

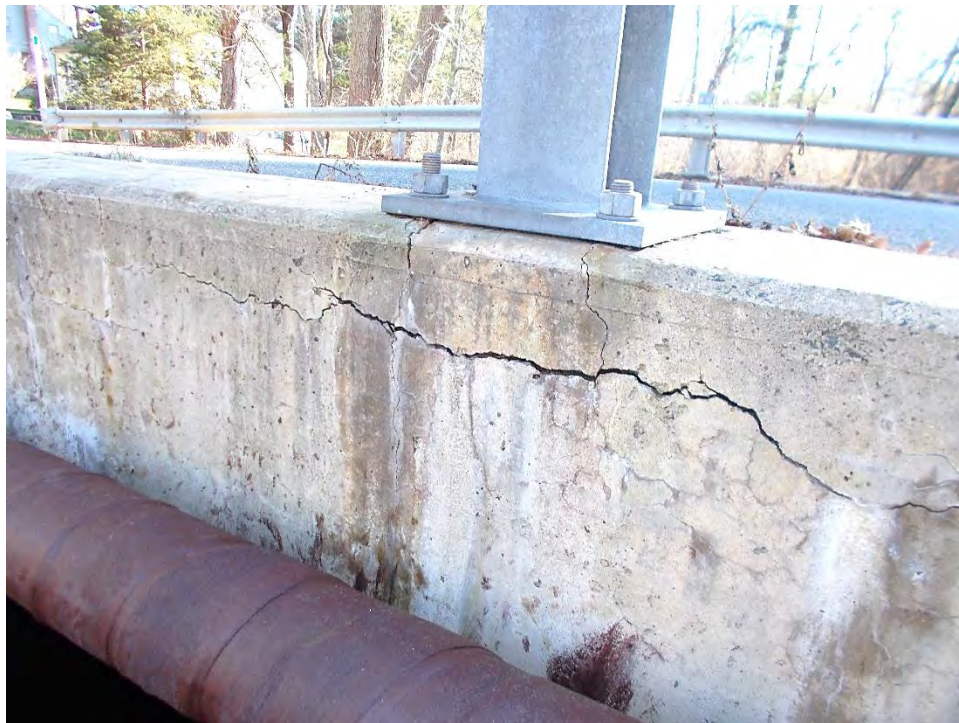
**Figure 20: Typical horizontal crack on headwall at guardrail baseplates – B-19-004**

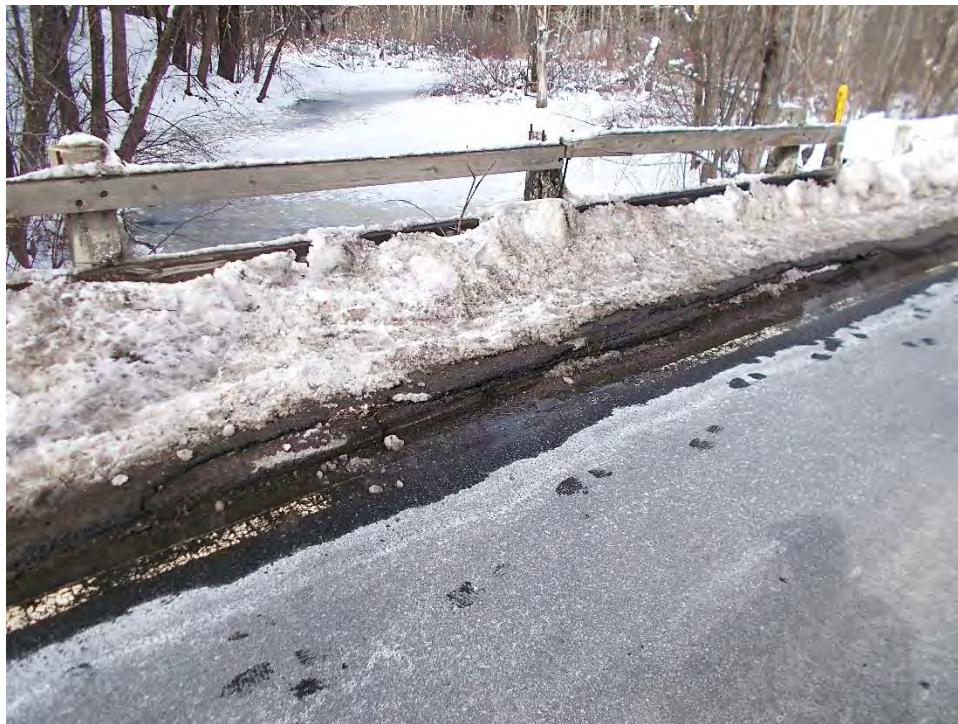
**Figure 22: Pavement condition along west gutter line – B-19-005**

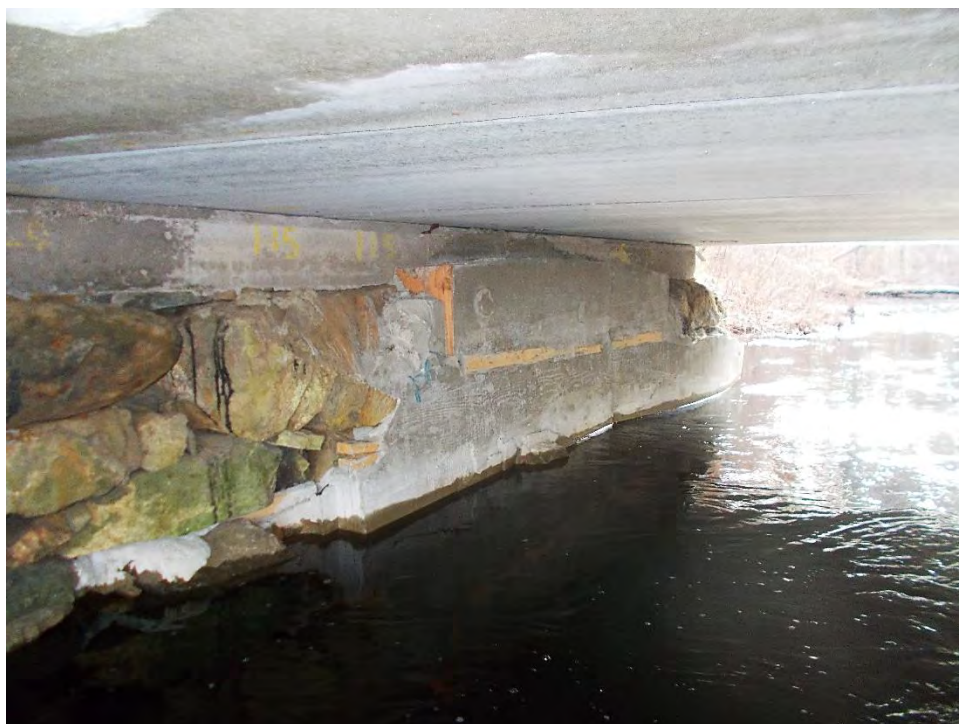
The special member inspections were required due to an undermining failure at the north and south breastwalls (Figures 30 & 31). These deficiencies were repaired shortly after the 2019 and 2020 special member inspections performed by MassDOT.

**Figure 31: Typical breastwall undermining repair – B-19-018**

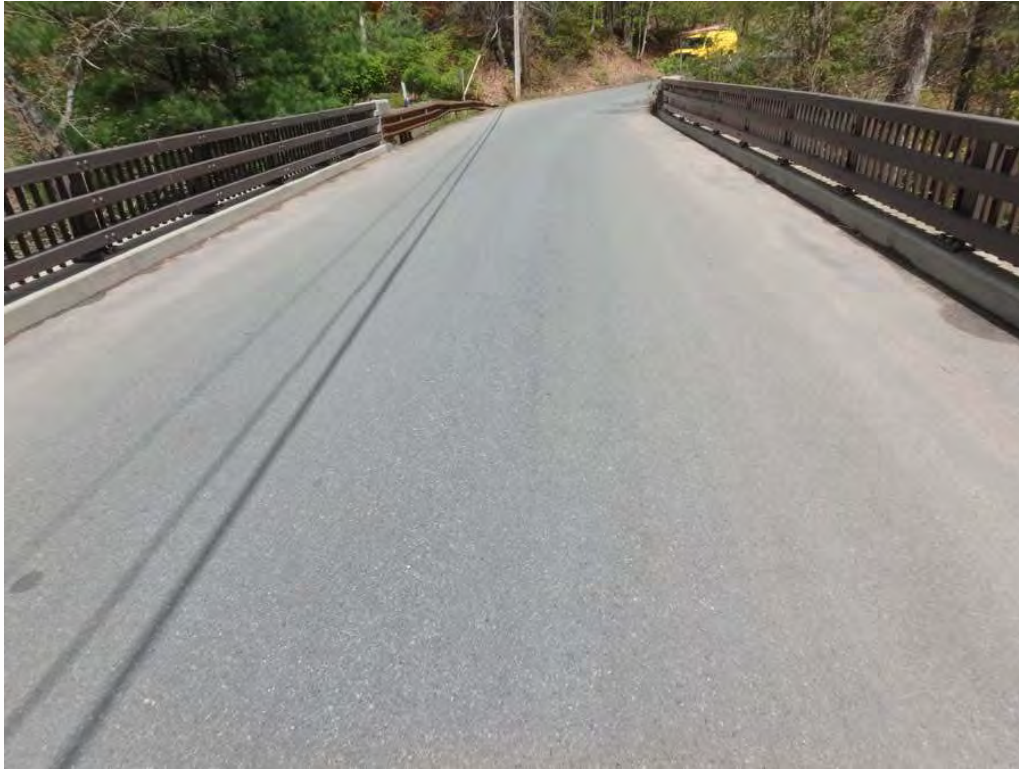
**Photo 1:     Wearing surface has hairline crack near mid-span at the crown of the roadway**

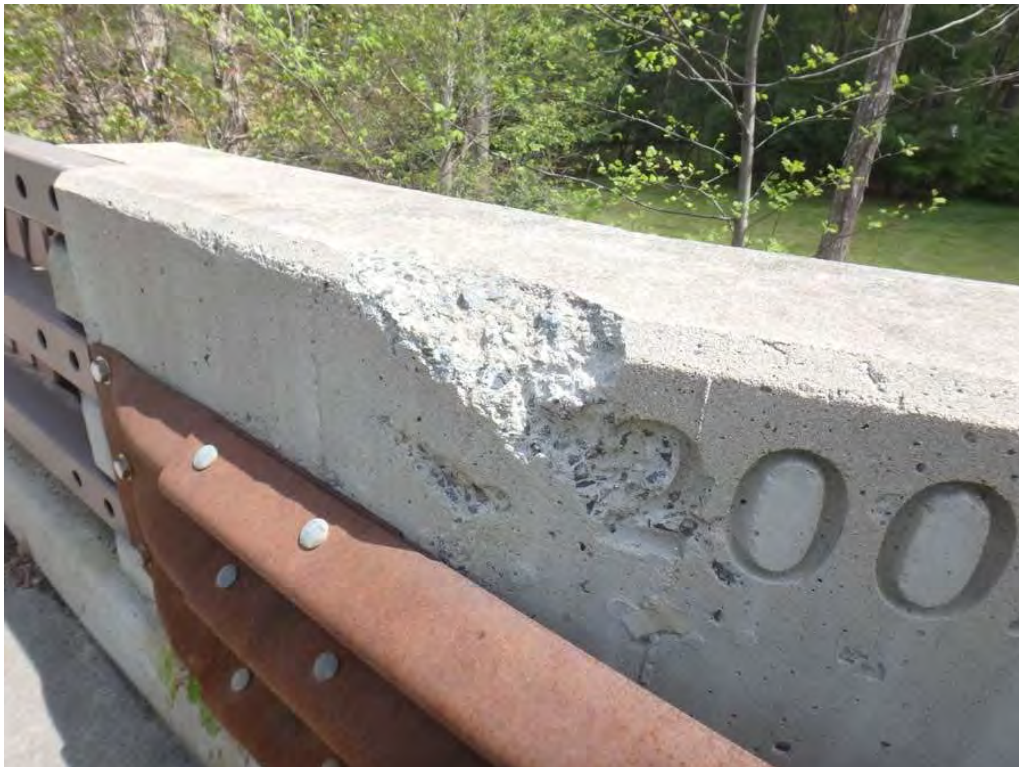
**Photo 2:     Southeast end-post has minor honeycombing or collision damage.**

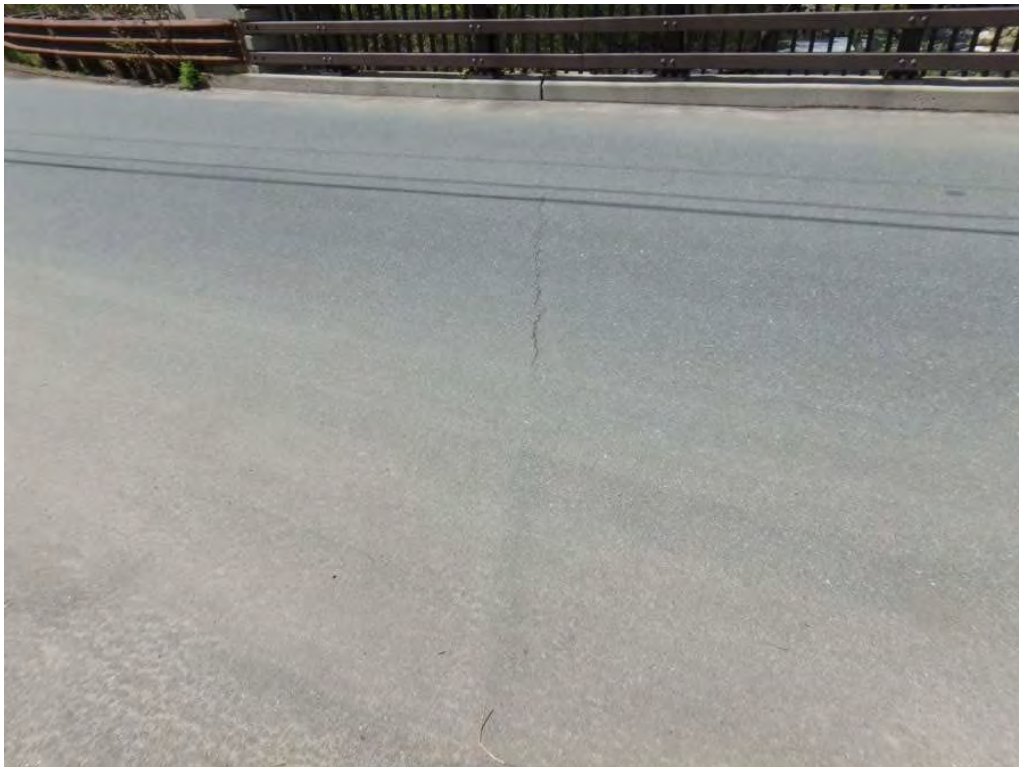
**Photo 4:** South deck end has a minor crack in the pavement at the joint.

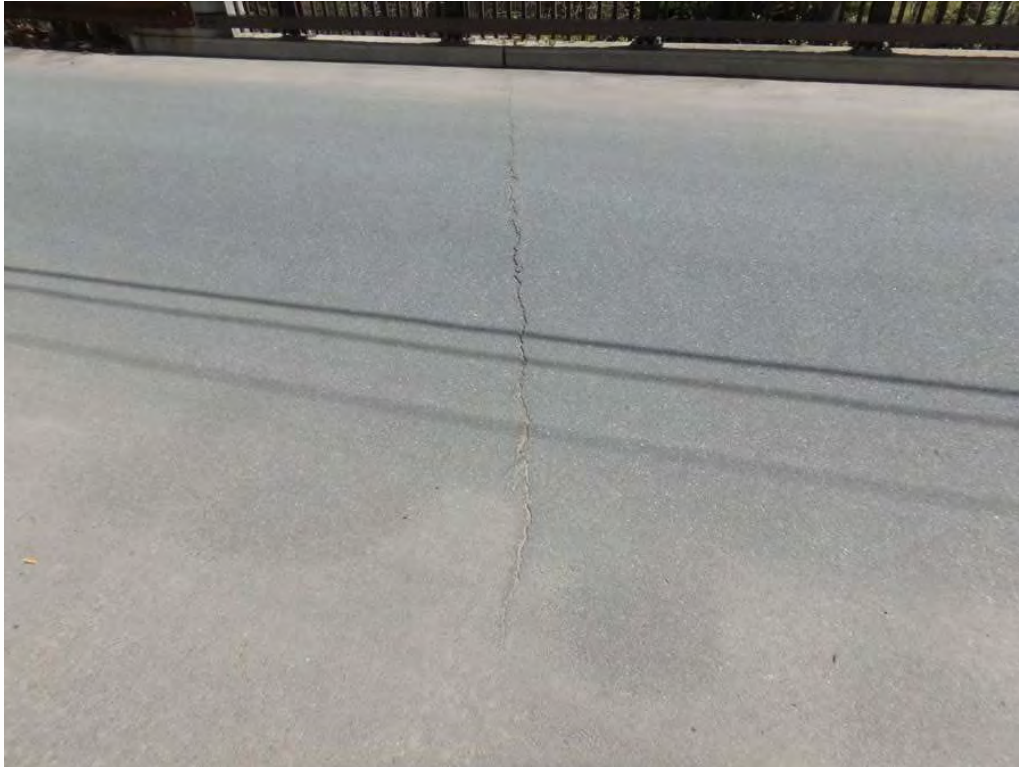
**Photo 5:** North deck end has a full length transverse crack, up to 3/4" wide.

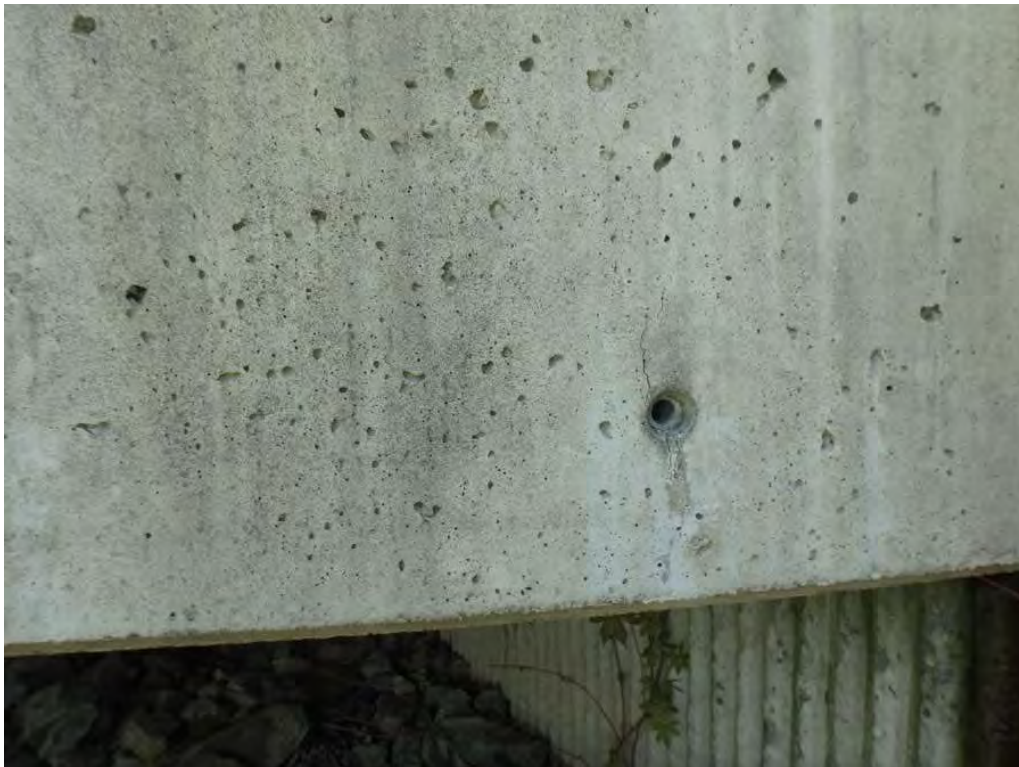
**Photo 6:** Beam 1, west face near the south abutment has a 12" vertical hairline crack.

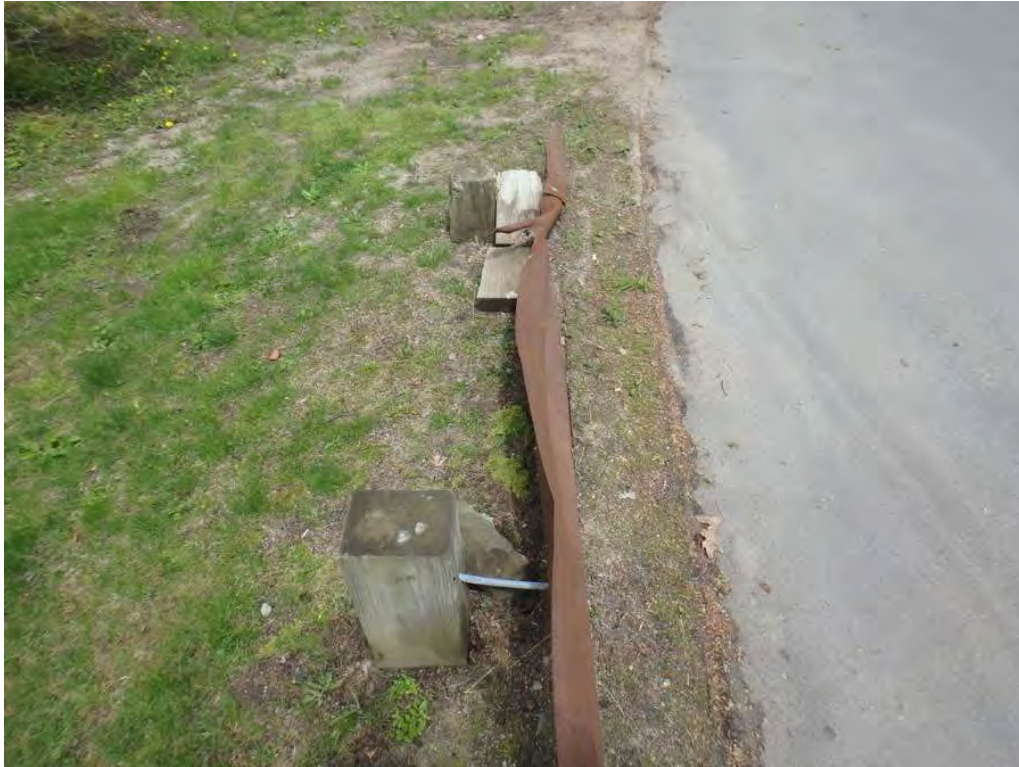
**Photo 7: Northwest approach guardrail has collision damage and displaced or missing spacer blocks.**

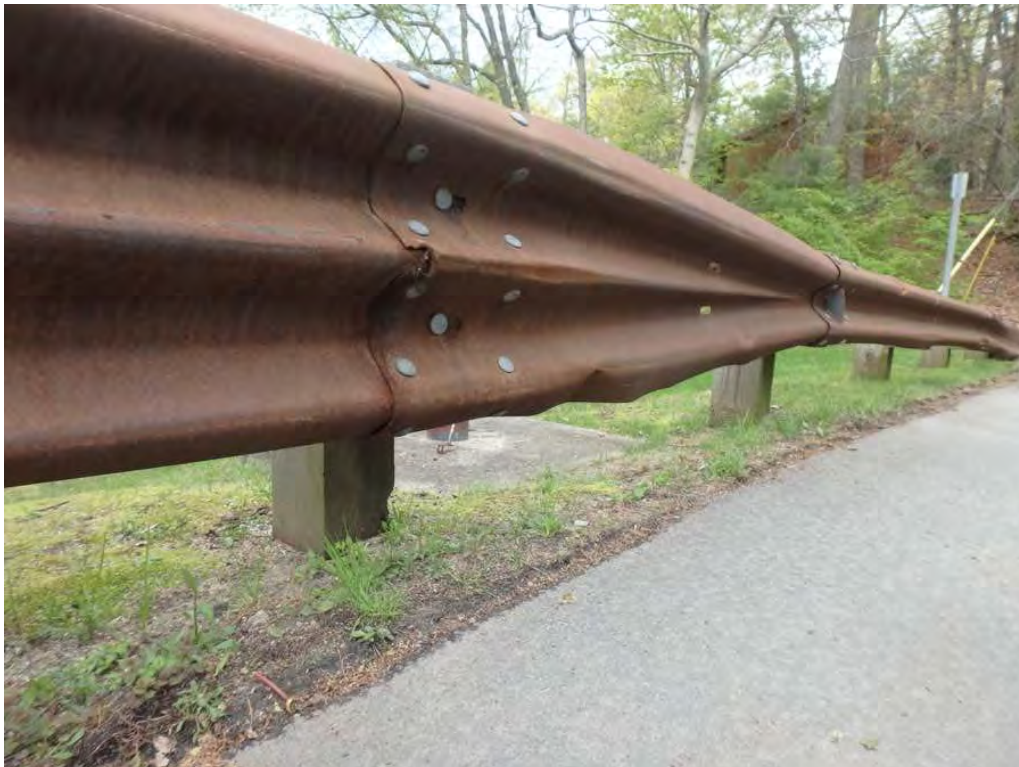
**Photo 8: Northwest approach guardrail-Minor collision damage.**

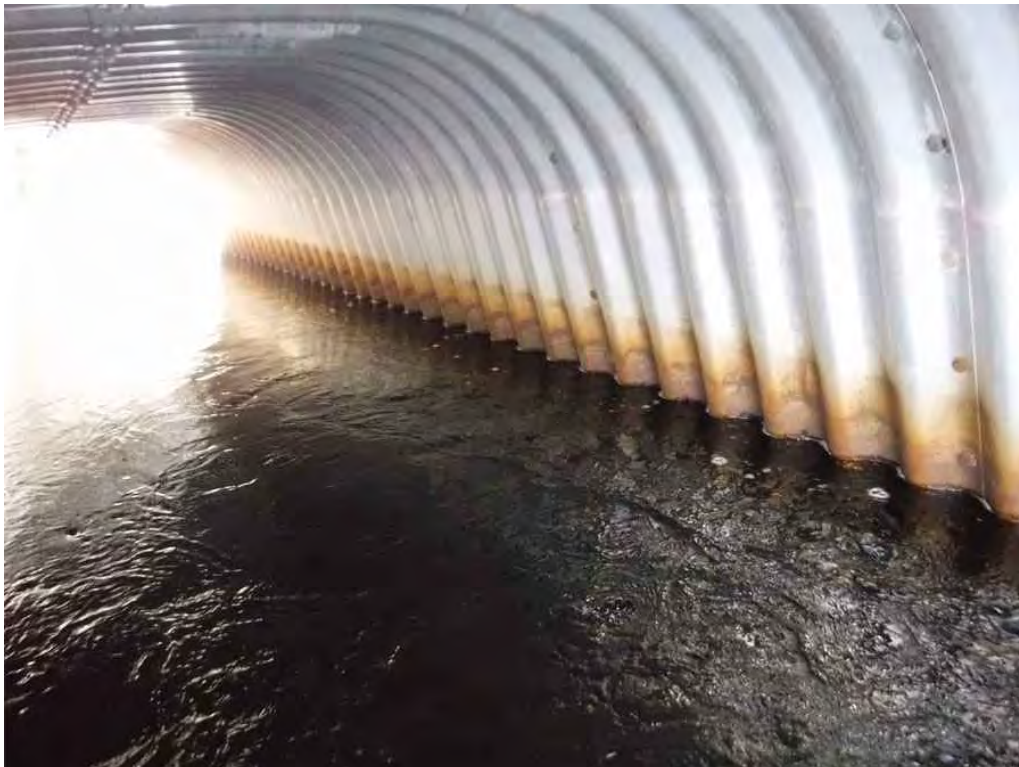
**Photo 8: Barrel 2, Typical Surface Corrosion along the Waterline**

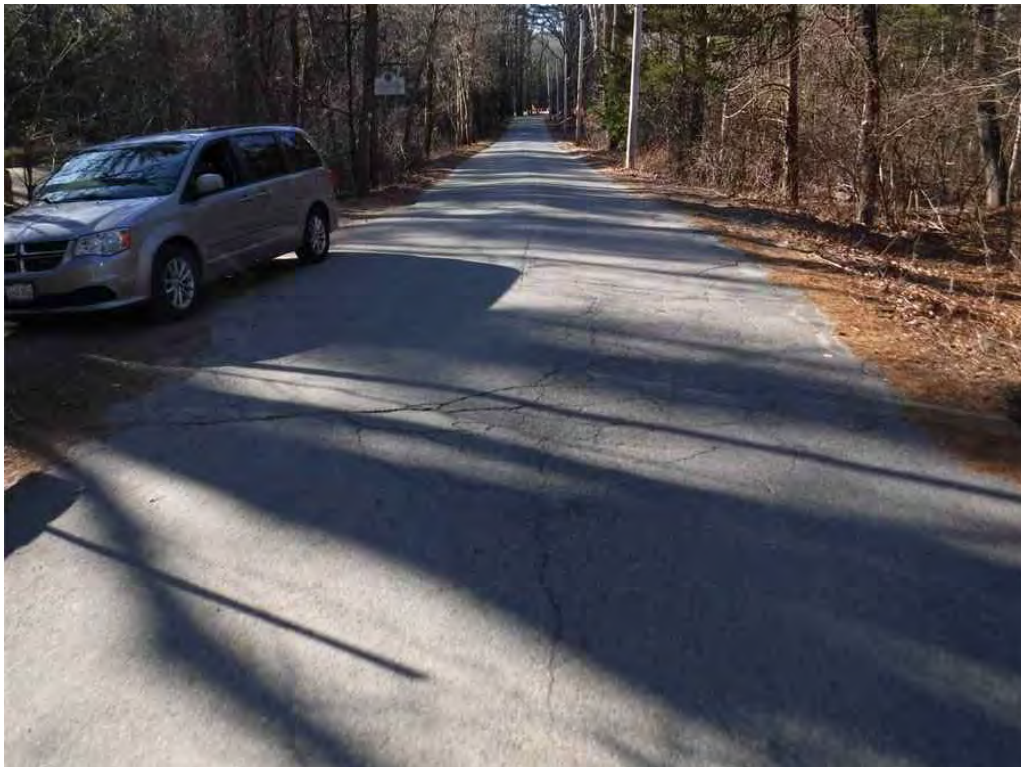
**Photo 12: Heavy Map Cracking in the Westbound (North) Lane at the West Approach**

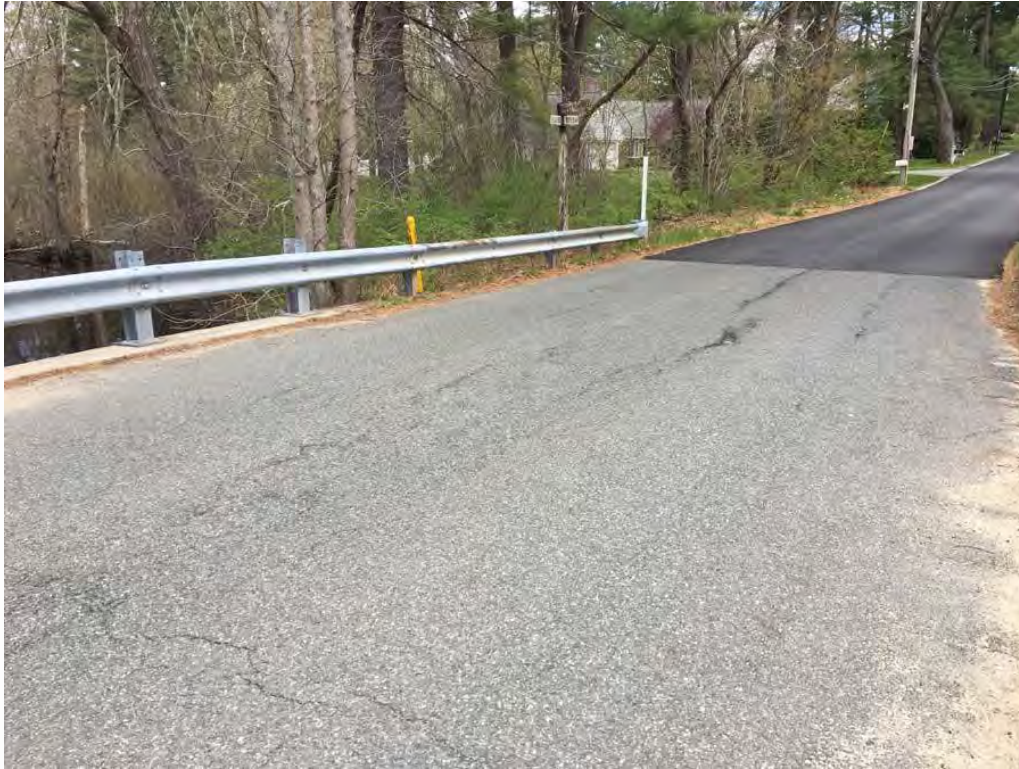
**Photo 1:** Longitudinal and transverse cracks, mostly on westbound travel lane and a pothole at the east end. At the west end, there is a full width transverse cracking.

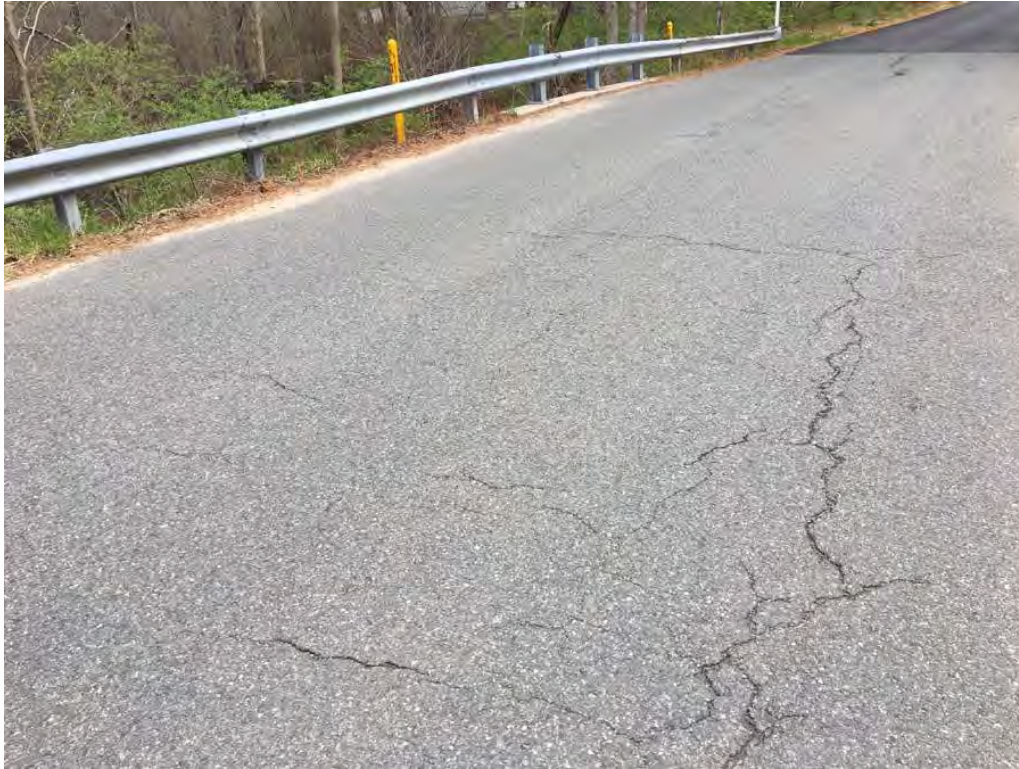
**Photo 3:** Longitudinal cracks on east bound travel lane and typical full width transverse cracking on the west approach. (Looking east)

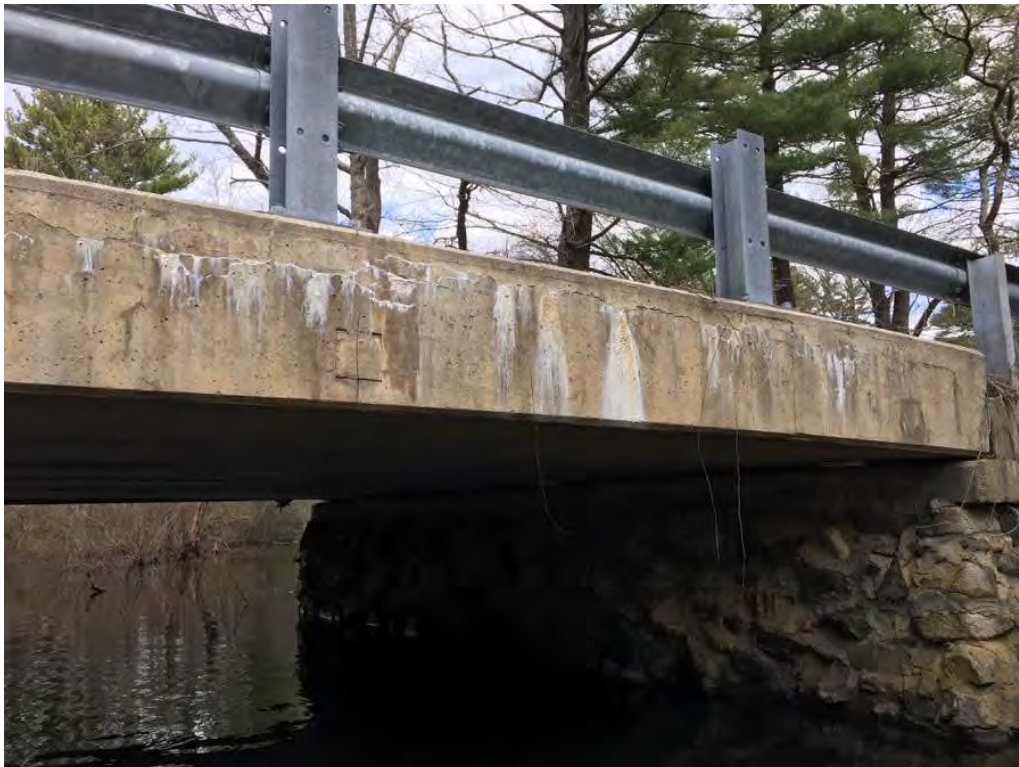
**Photo 4:** The South fascia (south side of of beam 1), up to 0.25" wide horizontal and map cracking, delamination and spalling with heavy efflorescence.

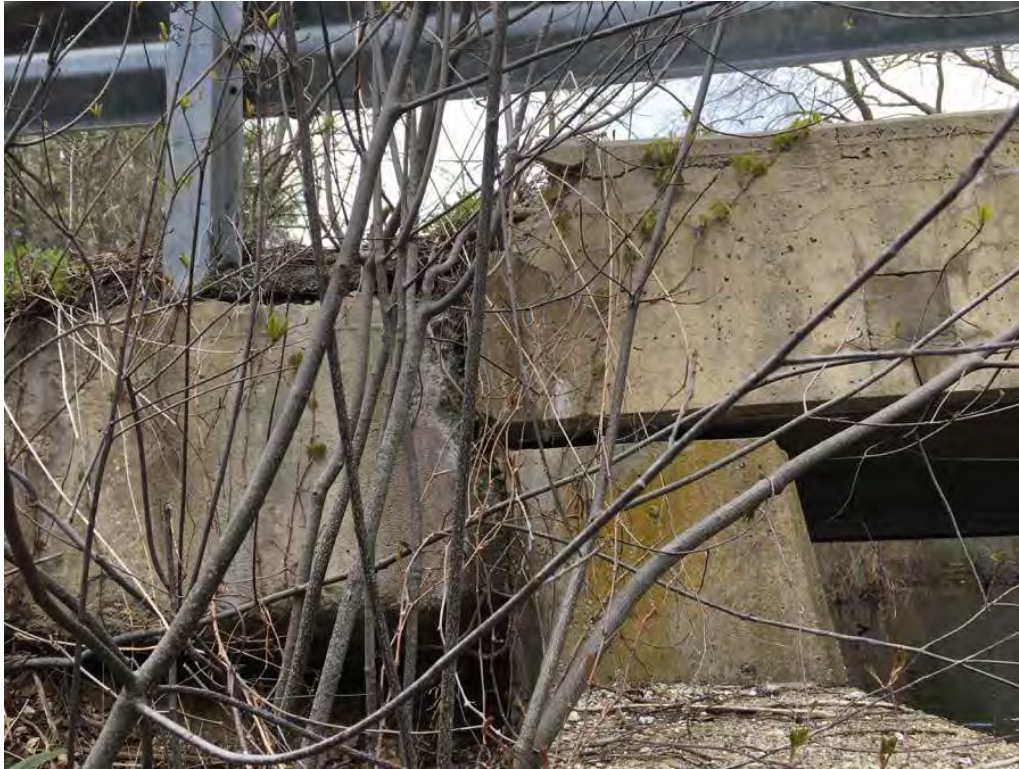
**Photo 5:** Spall up to 9" long x 1.5' deep x 1' high at the top corner at the west end of the beam (beam 1).

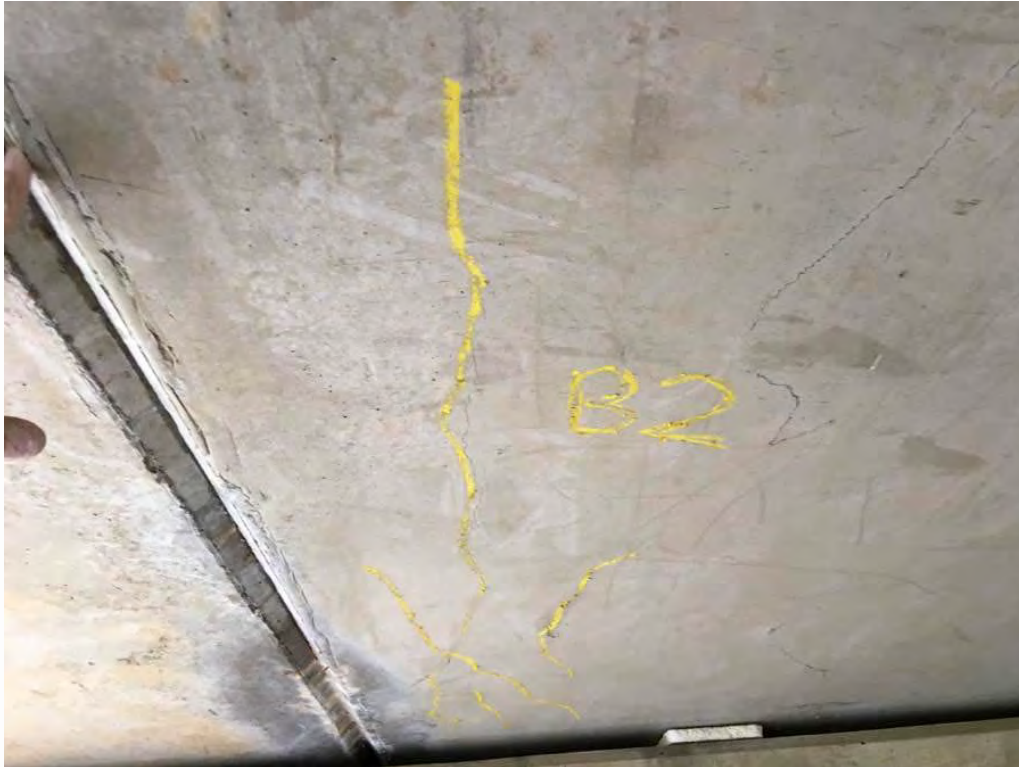
**Photo 7:** Beam 2 has hairline cracking at the west end at the south corner. (Looking west).

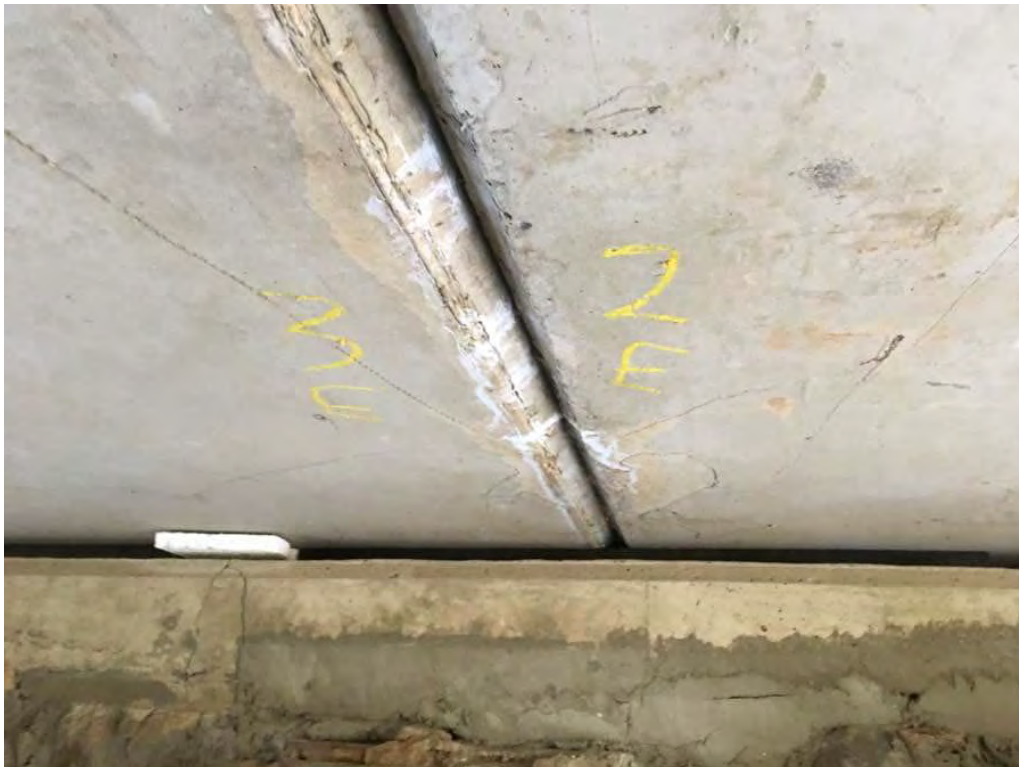
**Photo 8:** Water staining with efflorescence at the joint between beam 2 and beam 3 at the east end. (Looking east).

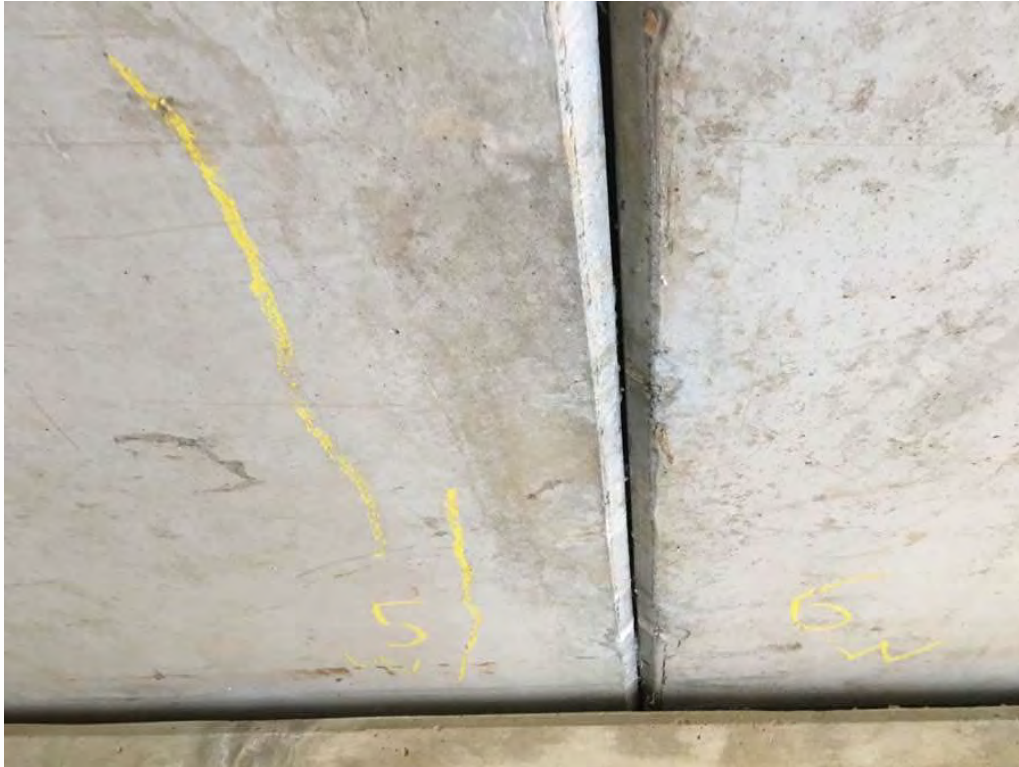
**Photo 9:** Hairline cracking at the west end of beam 5. (Looking west).

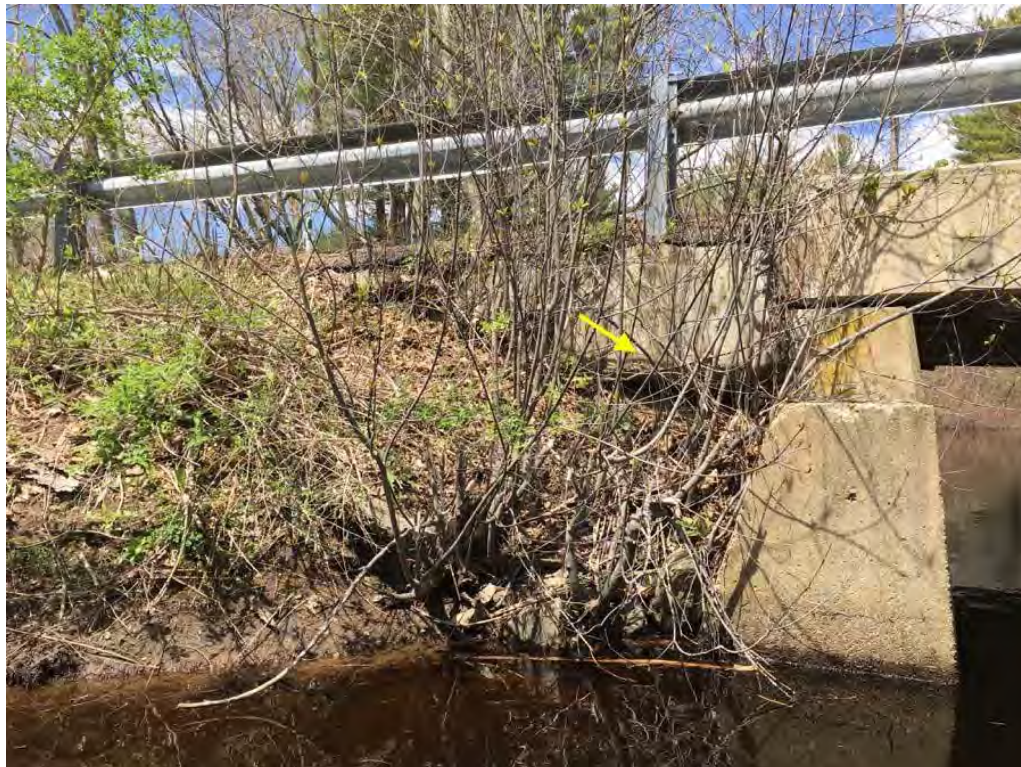
**Photo 18:** Southwest wingwall extension is undermined up to 1' long x 3' wide x 1' deep. Also note the moderate erosion at the embankment.

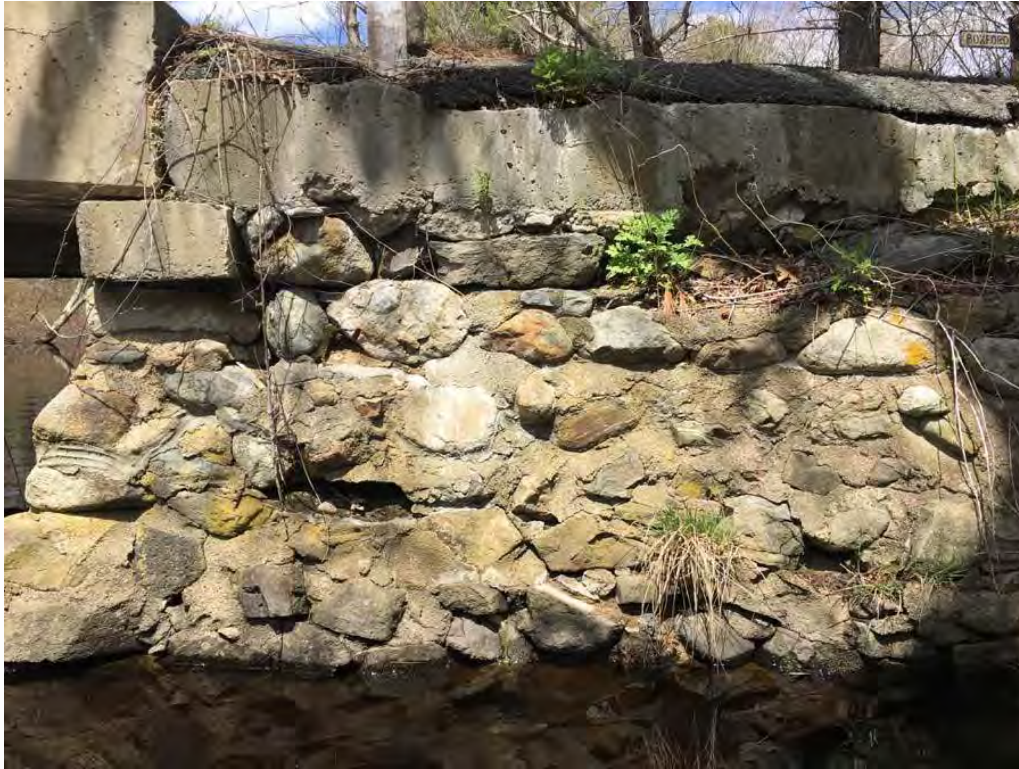
**Photo 19: Southeast masonry wingwall has cracking in mortar with voids and vegetation.**

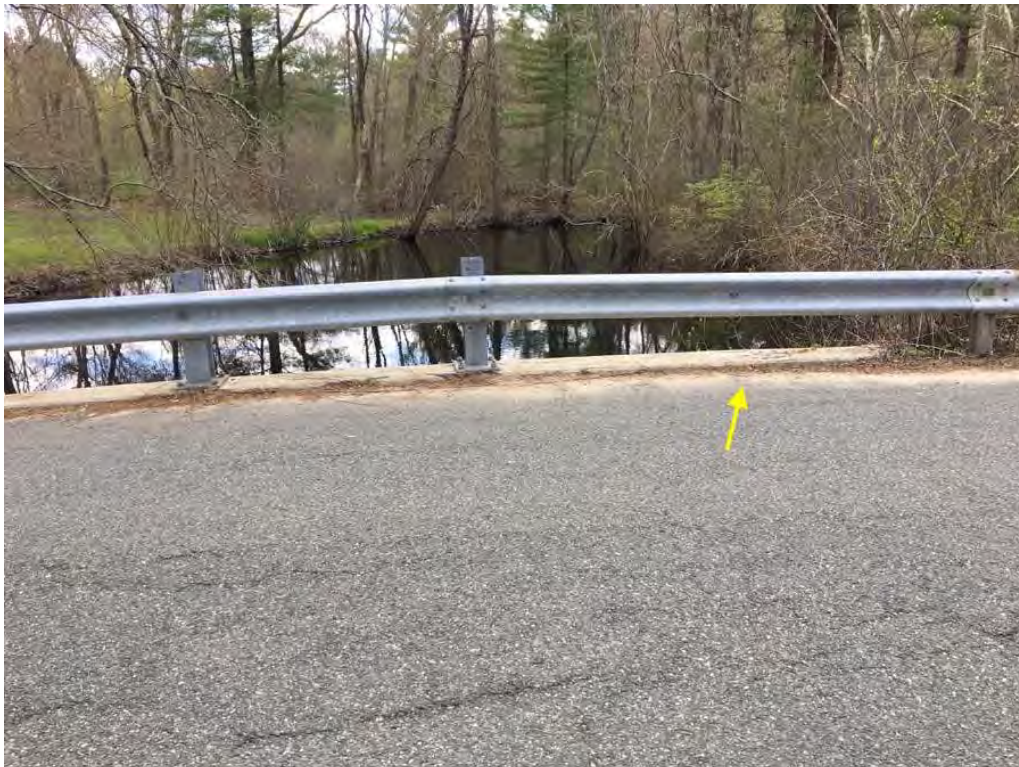
**Photo 20: The last post from west south bridge railing is missing.**

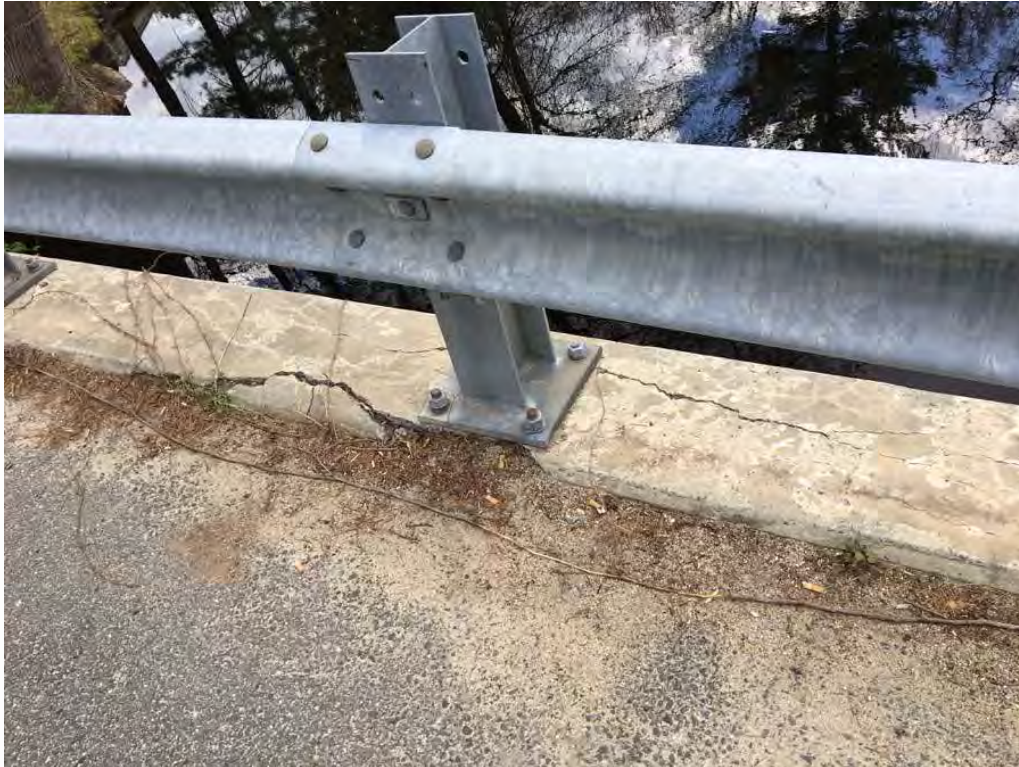
**Photo 21:** Both bridge railing concrete bases have typical areas of cracking, delamination and random areas of spalled concrete. (South bridge railing shown).

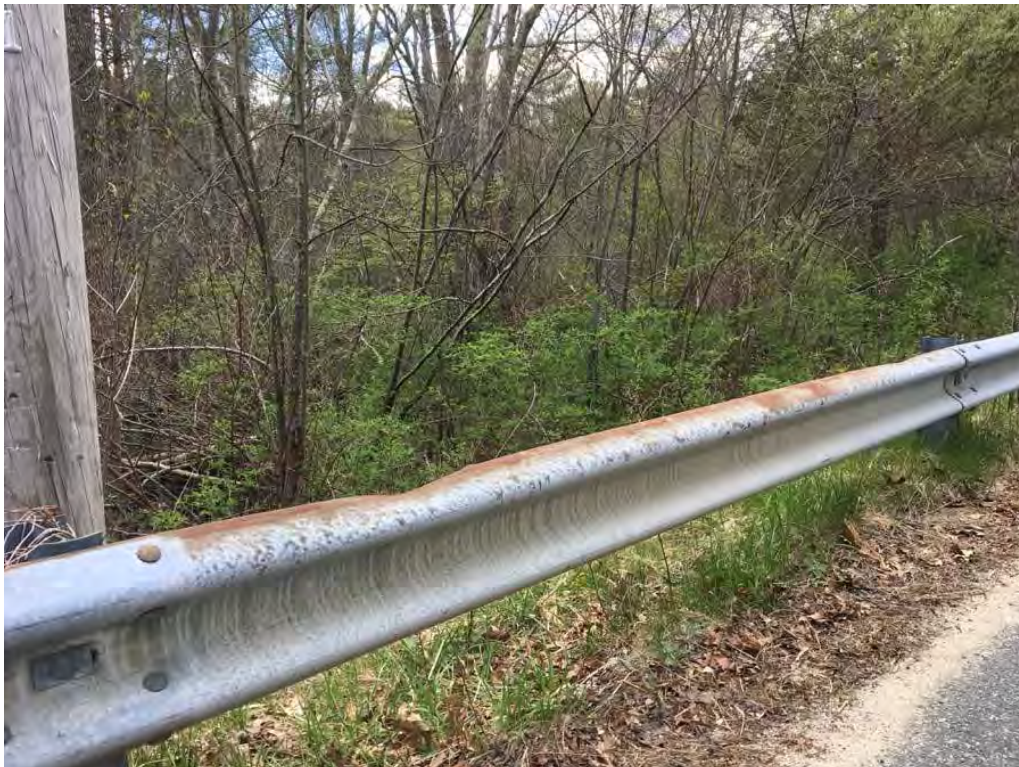
**Photo 22:** Minor impact damage and surface rust at the southwest approach guardrail.

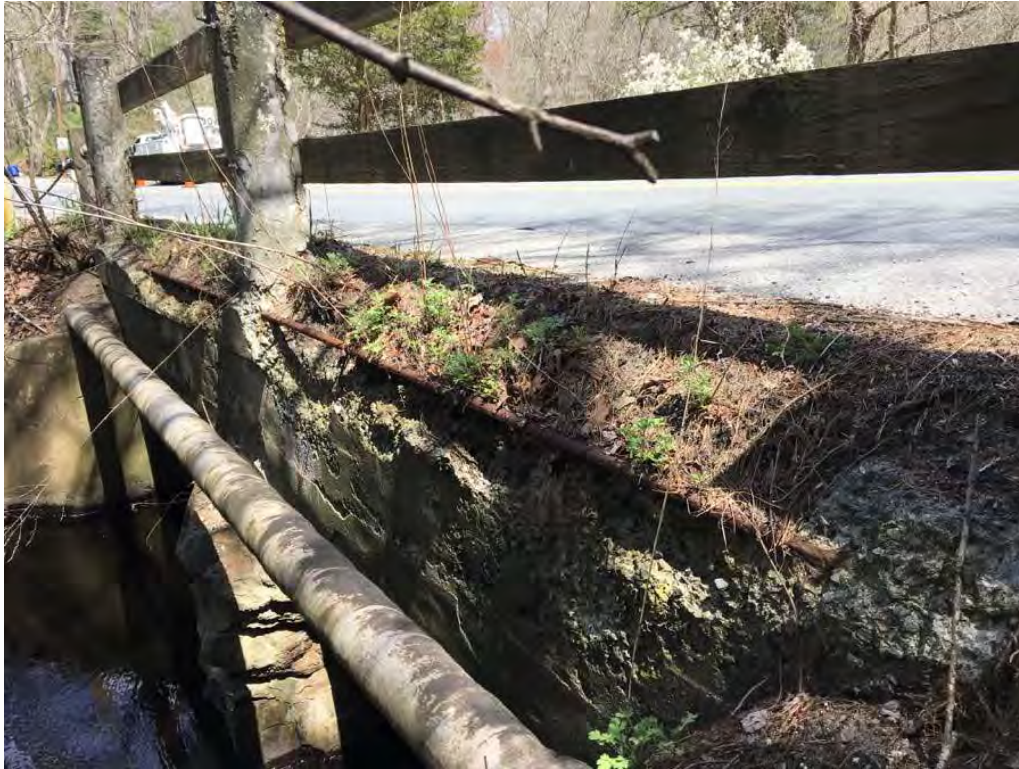
**Photo 1:** West fascia, areas of heavy and large spalls with exposed and rusted rebar.
