# Boxford Culvert & Bridge Asset Management

Prepared for: **Boxford DPW**  
7B Spofford Road  
Boxford, MA 01921

Prepared by: **TEC, Inc.**  
146 Dascomb Road  
Andover, MA 01810

July 26, 2021

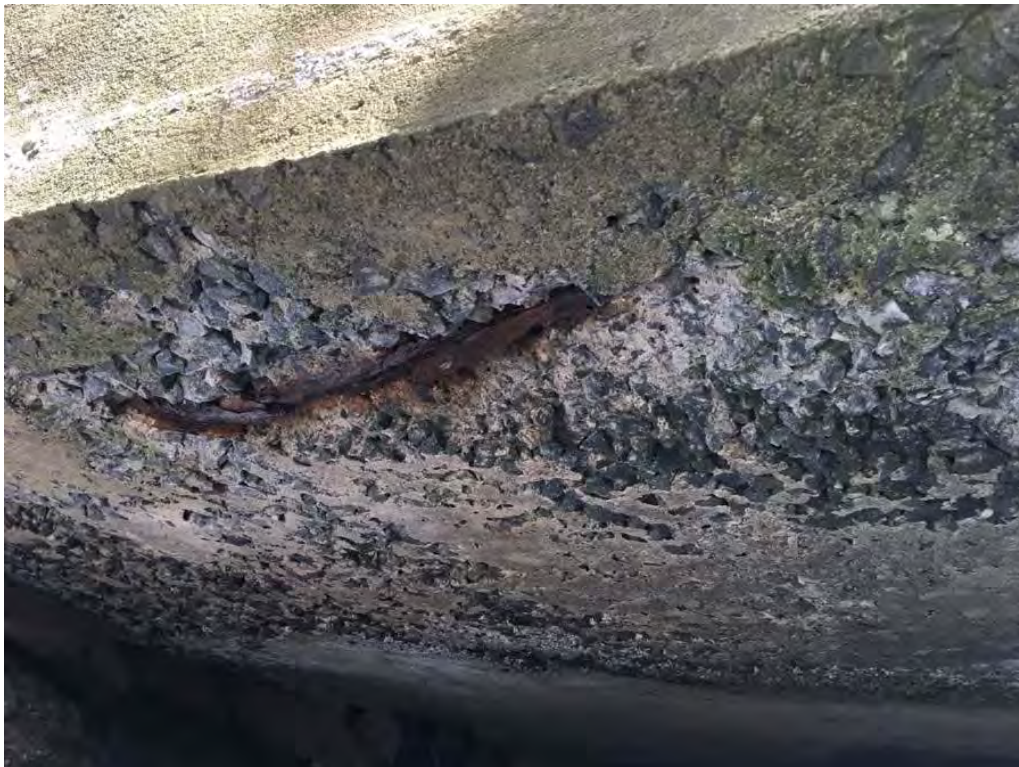
**Photo 2:** Span 1, near the west fascia, area of scaling, honeycombing and a spall at the concrete deck with exposed and rusted rebar.

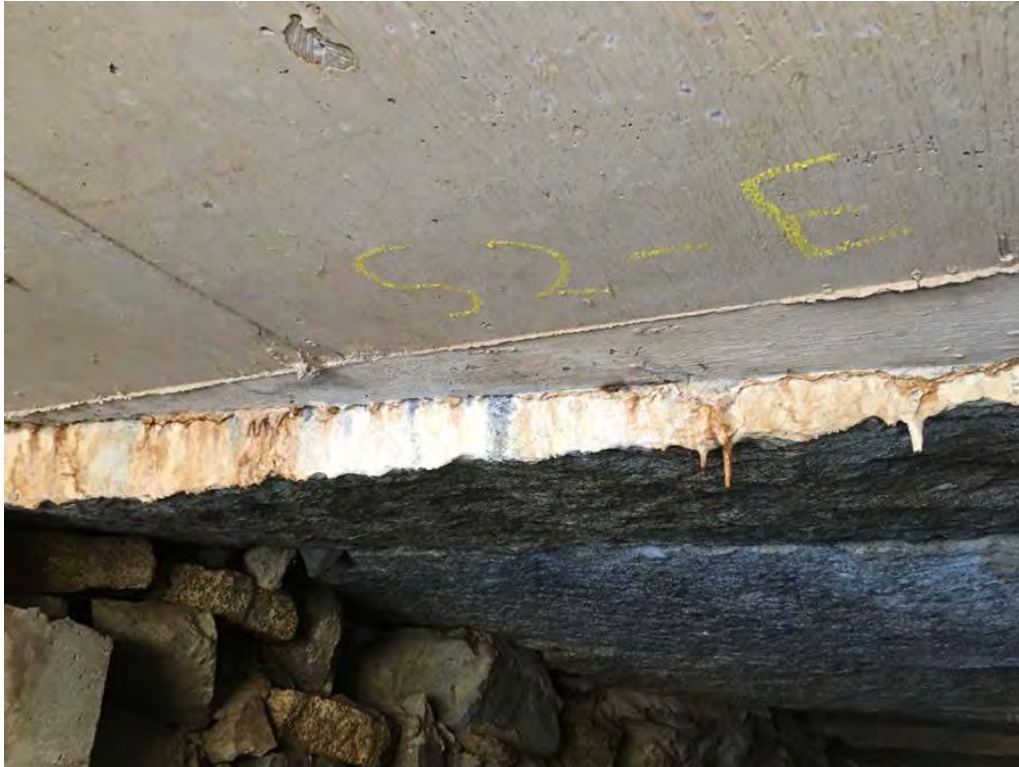
**Photo 3:** Active leakage with heavy efflorescence at the joint between the concrete slab and the first granite slab in span 2, near the east end.

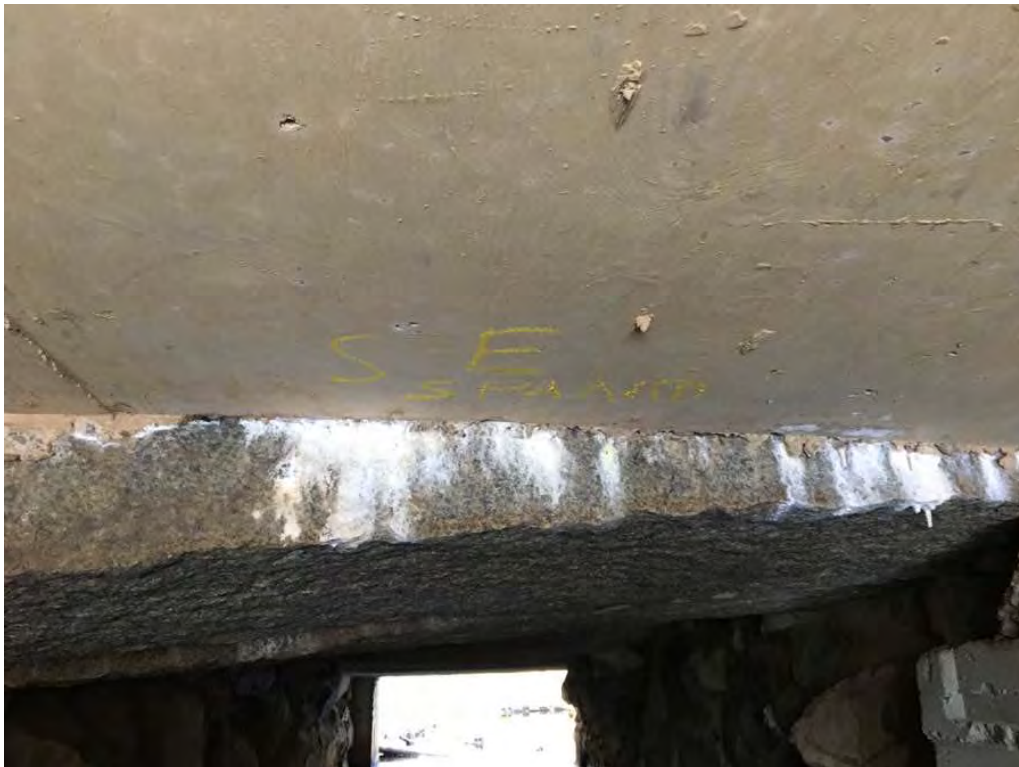
**Photo 4:** Active leakage with heavy efflorescence at the joint between the concrete slab and the first granite slab in span 1, near the east end.

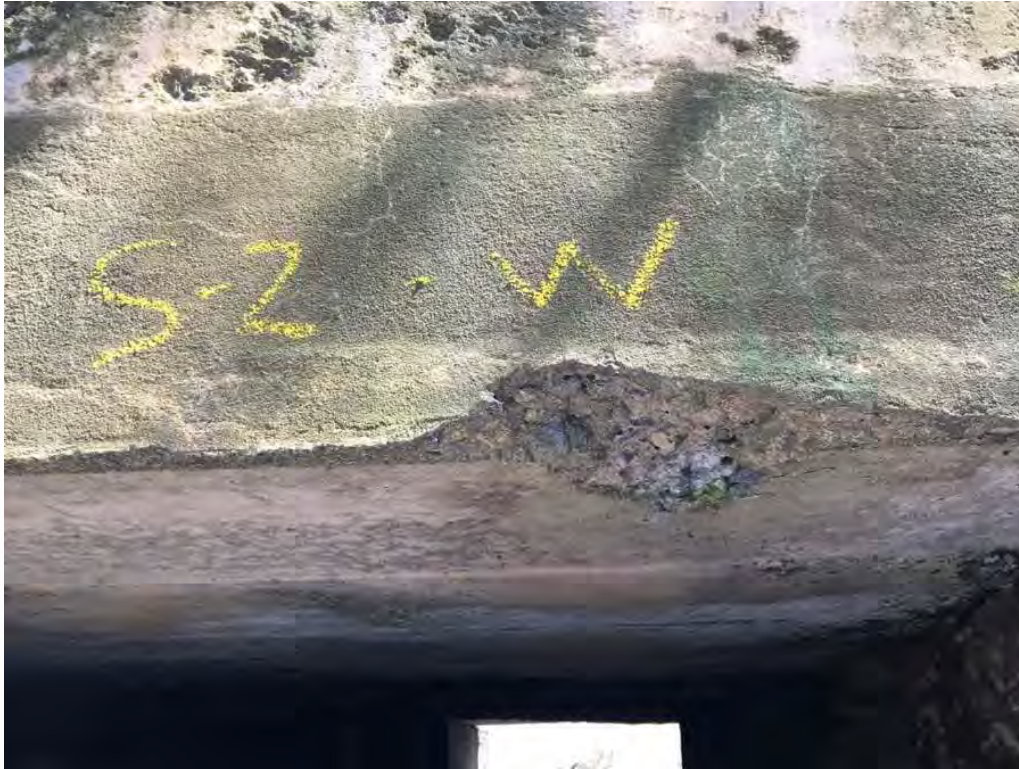
**Photo 5:** Span 2, spall up to 7" diameter at the edge of the west fascia.

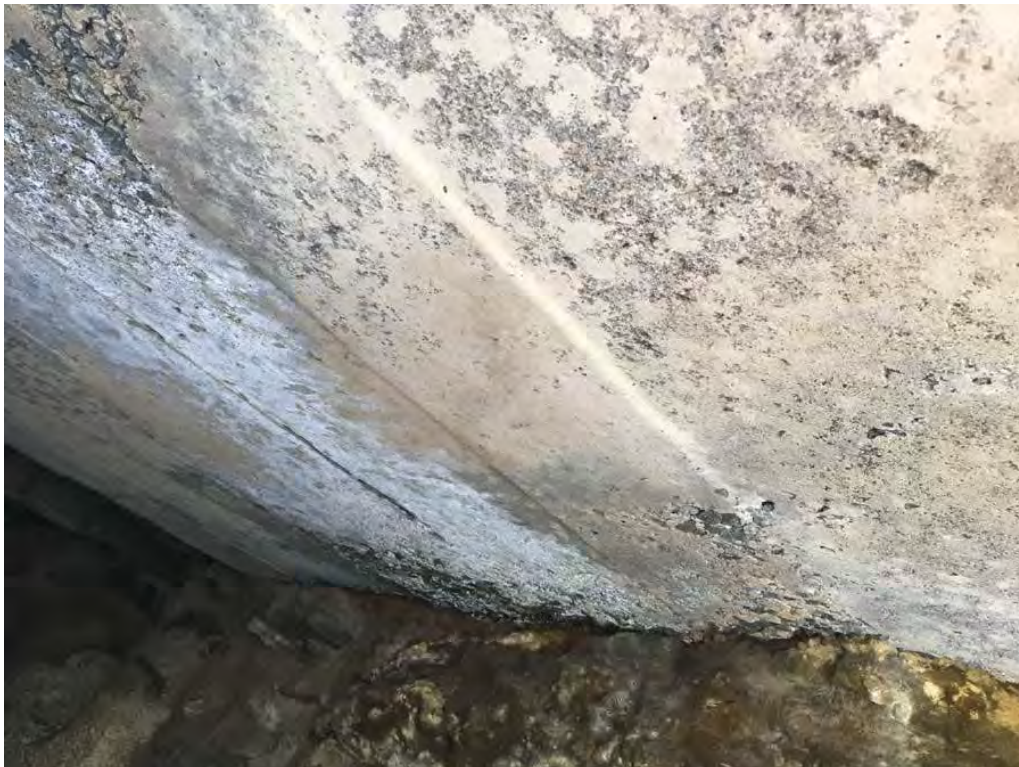
**Photo 6:** Span 2, west end, the underside of the concrete deck has full length x full width area of honeycombing/scaling with moderate efflorescence.

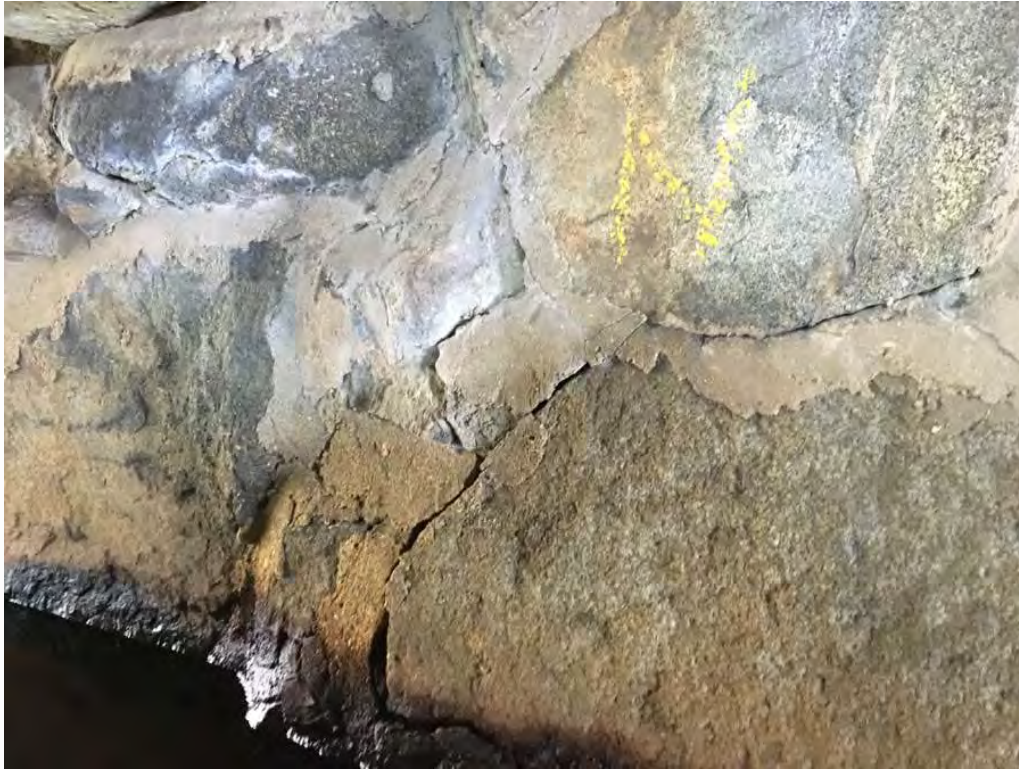
**Photo 7:** Typical cracking with efflorescence in the mortar between stones at all granite walls.

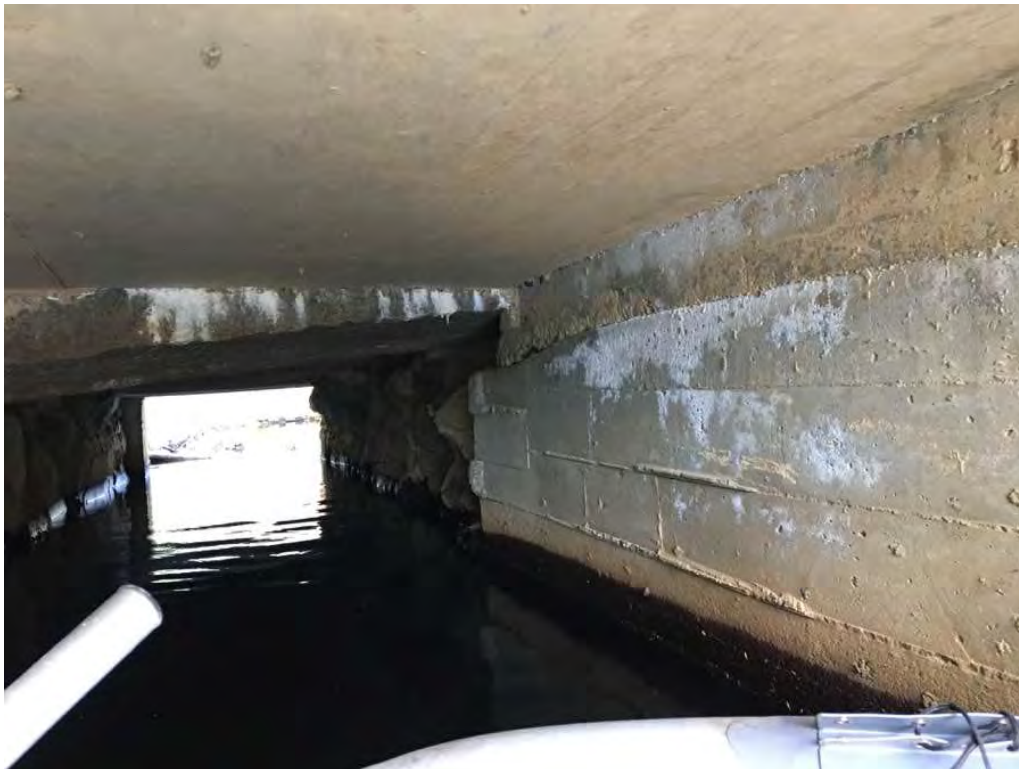
**Photo 8:** Typical abrasion along the water line and up to 2' high at the concrete walls. Also note the efflorescence at the east end of both north and south concrete walls. (Northeast wall shown).

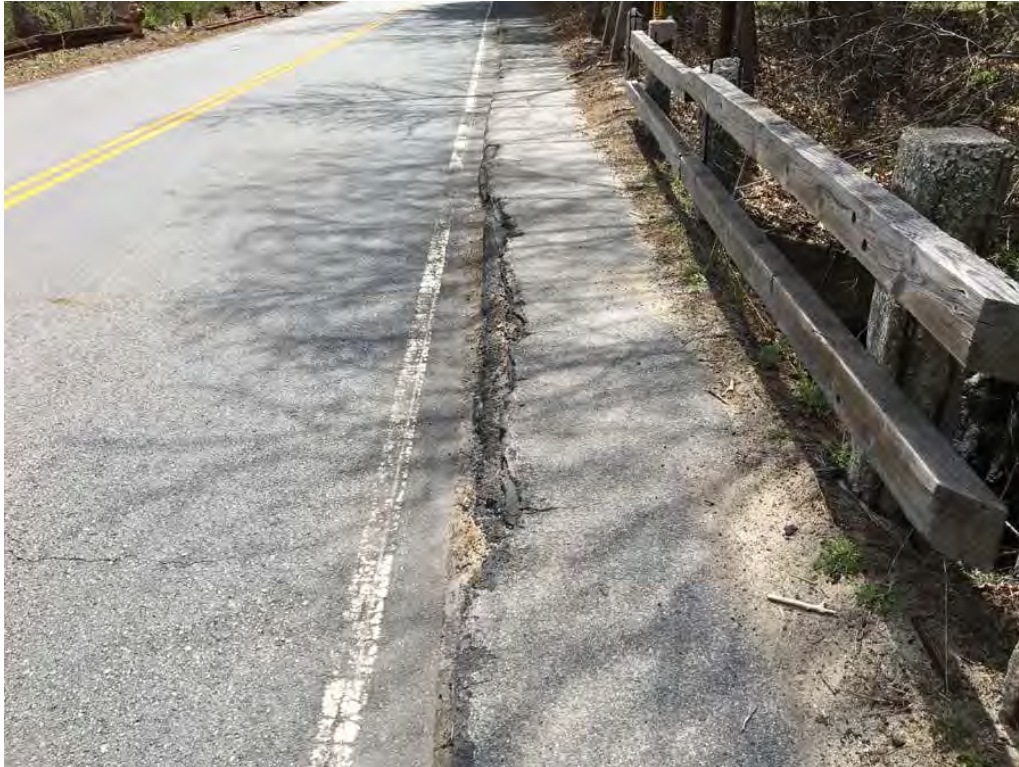
**Photo 9: West sidewalk, deterioration at the curb which is propagating into the sidewalk.**

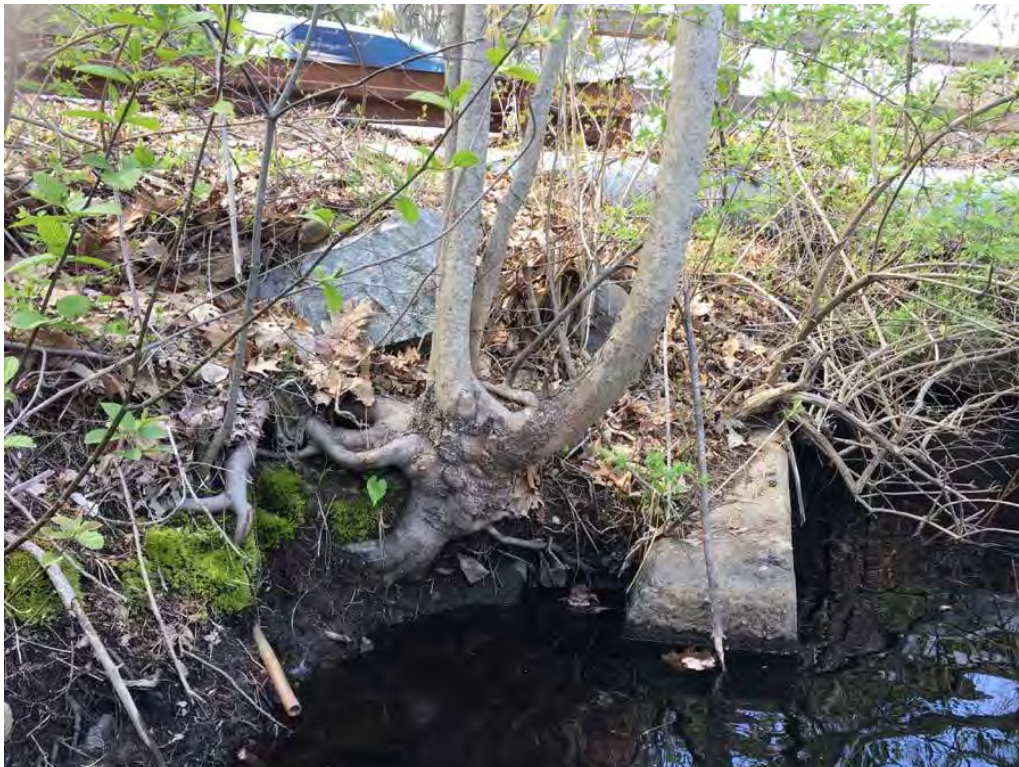
**Photo 10: Minor erosion behind the southeast wingwall.**

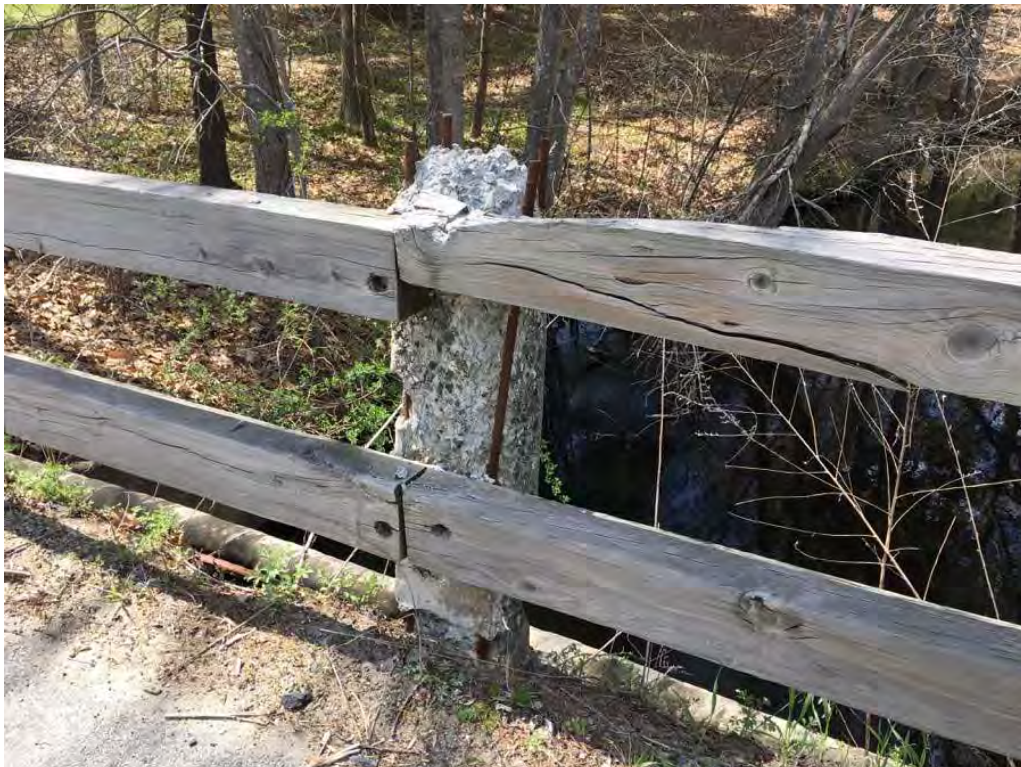
**Photo 12: West bridge rail, the top rail has split and is not attached to concrete post. Also note the concrete post has heavy spalls with exposed rebars for the full height.**

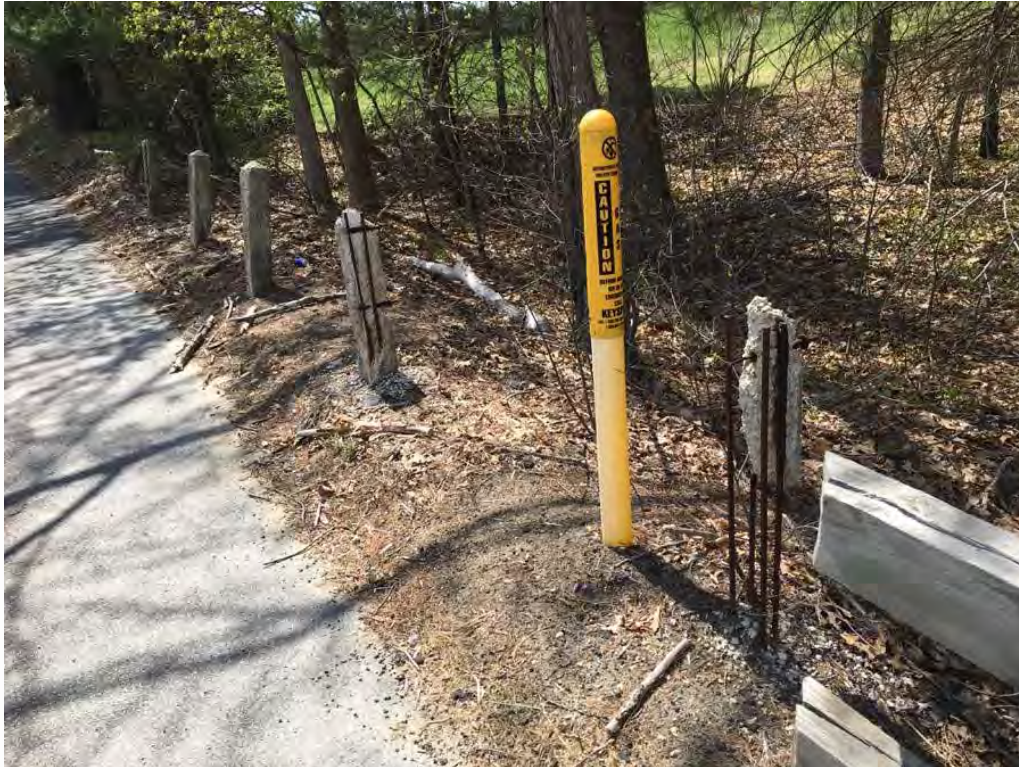
**Photo 13:** The southwest approach guardrail cables are missing, and the concrete posts heavily deteriorated and ineffective.

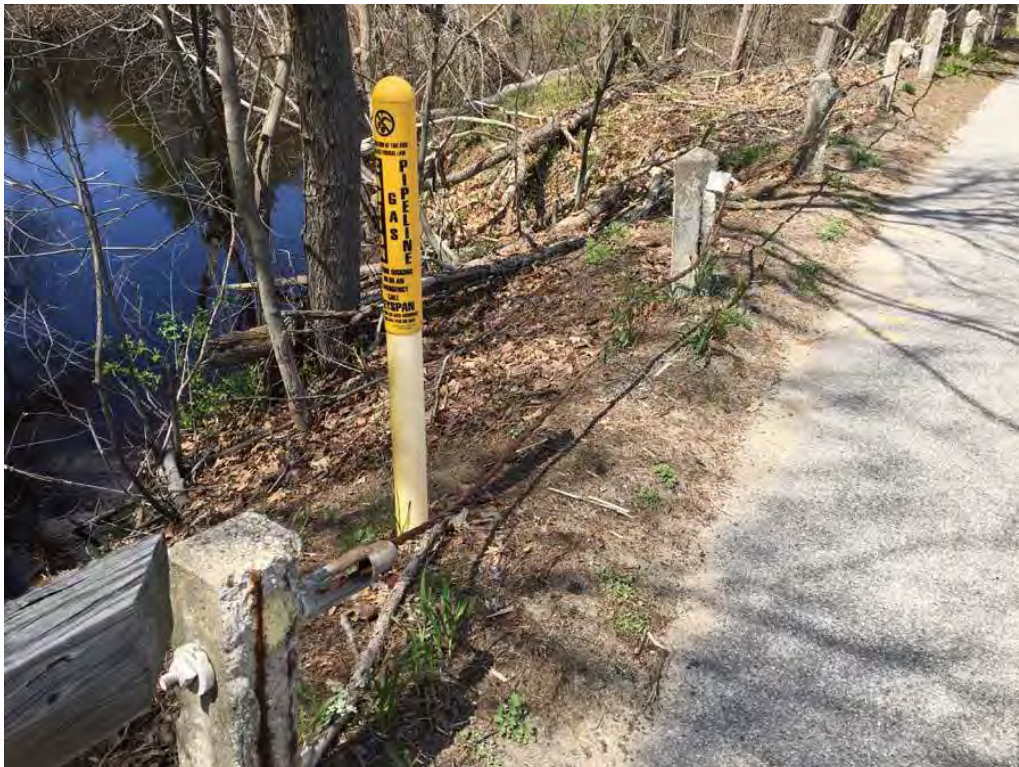
**Photo 14:** The northwest approach guardrail lower cable is missing, the upper cable is loose and ineffective and the concrete posts heavily deteriorated.

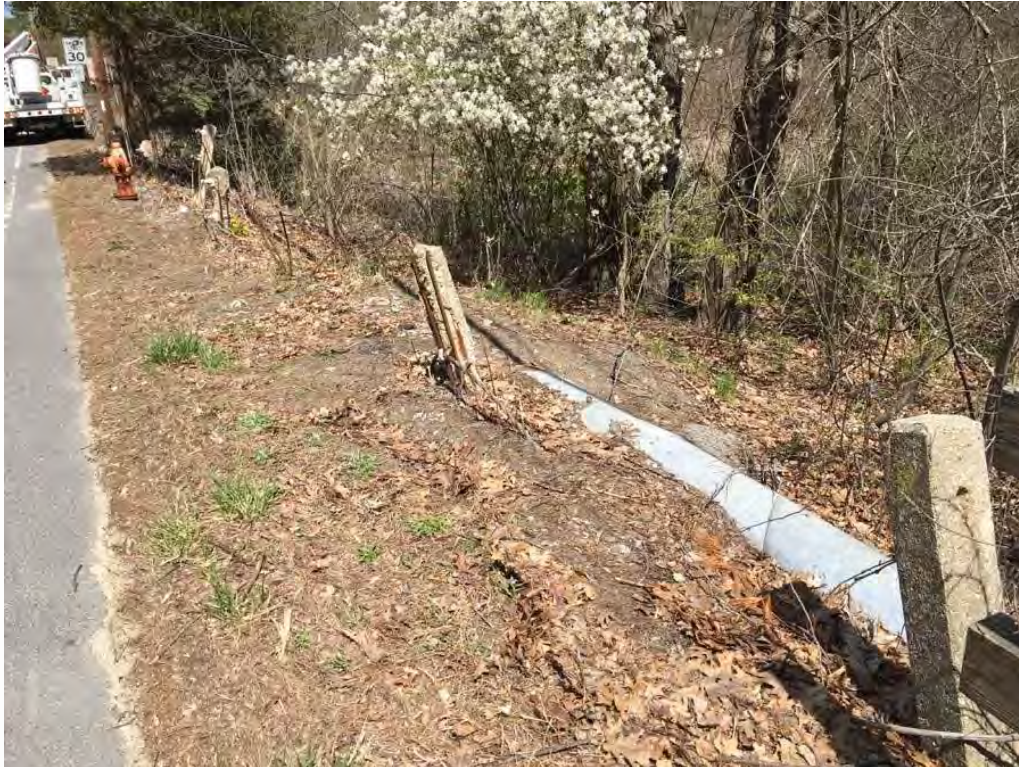
**Photo 15:** The northeast approach guardrail cables are missing, and the concrete posts heavily deteriorated and ineffective.

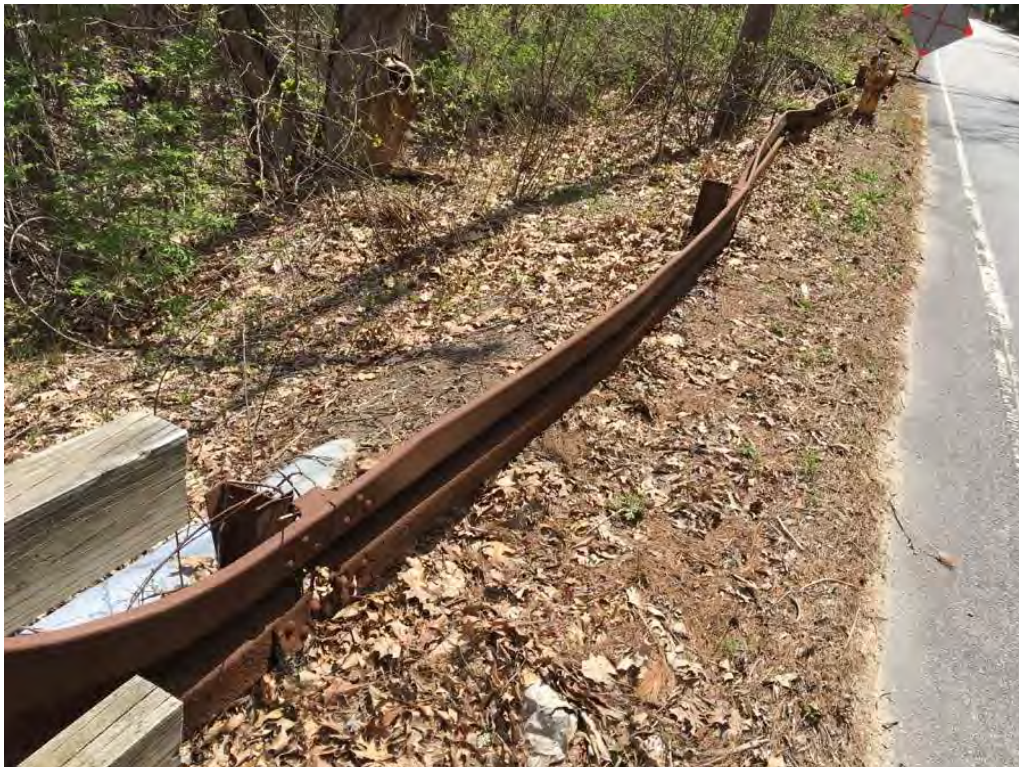
**Photo 16:** The southeast approach steel guardrail has 100% section loss, major impact damage and is ineffective.

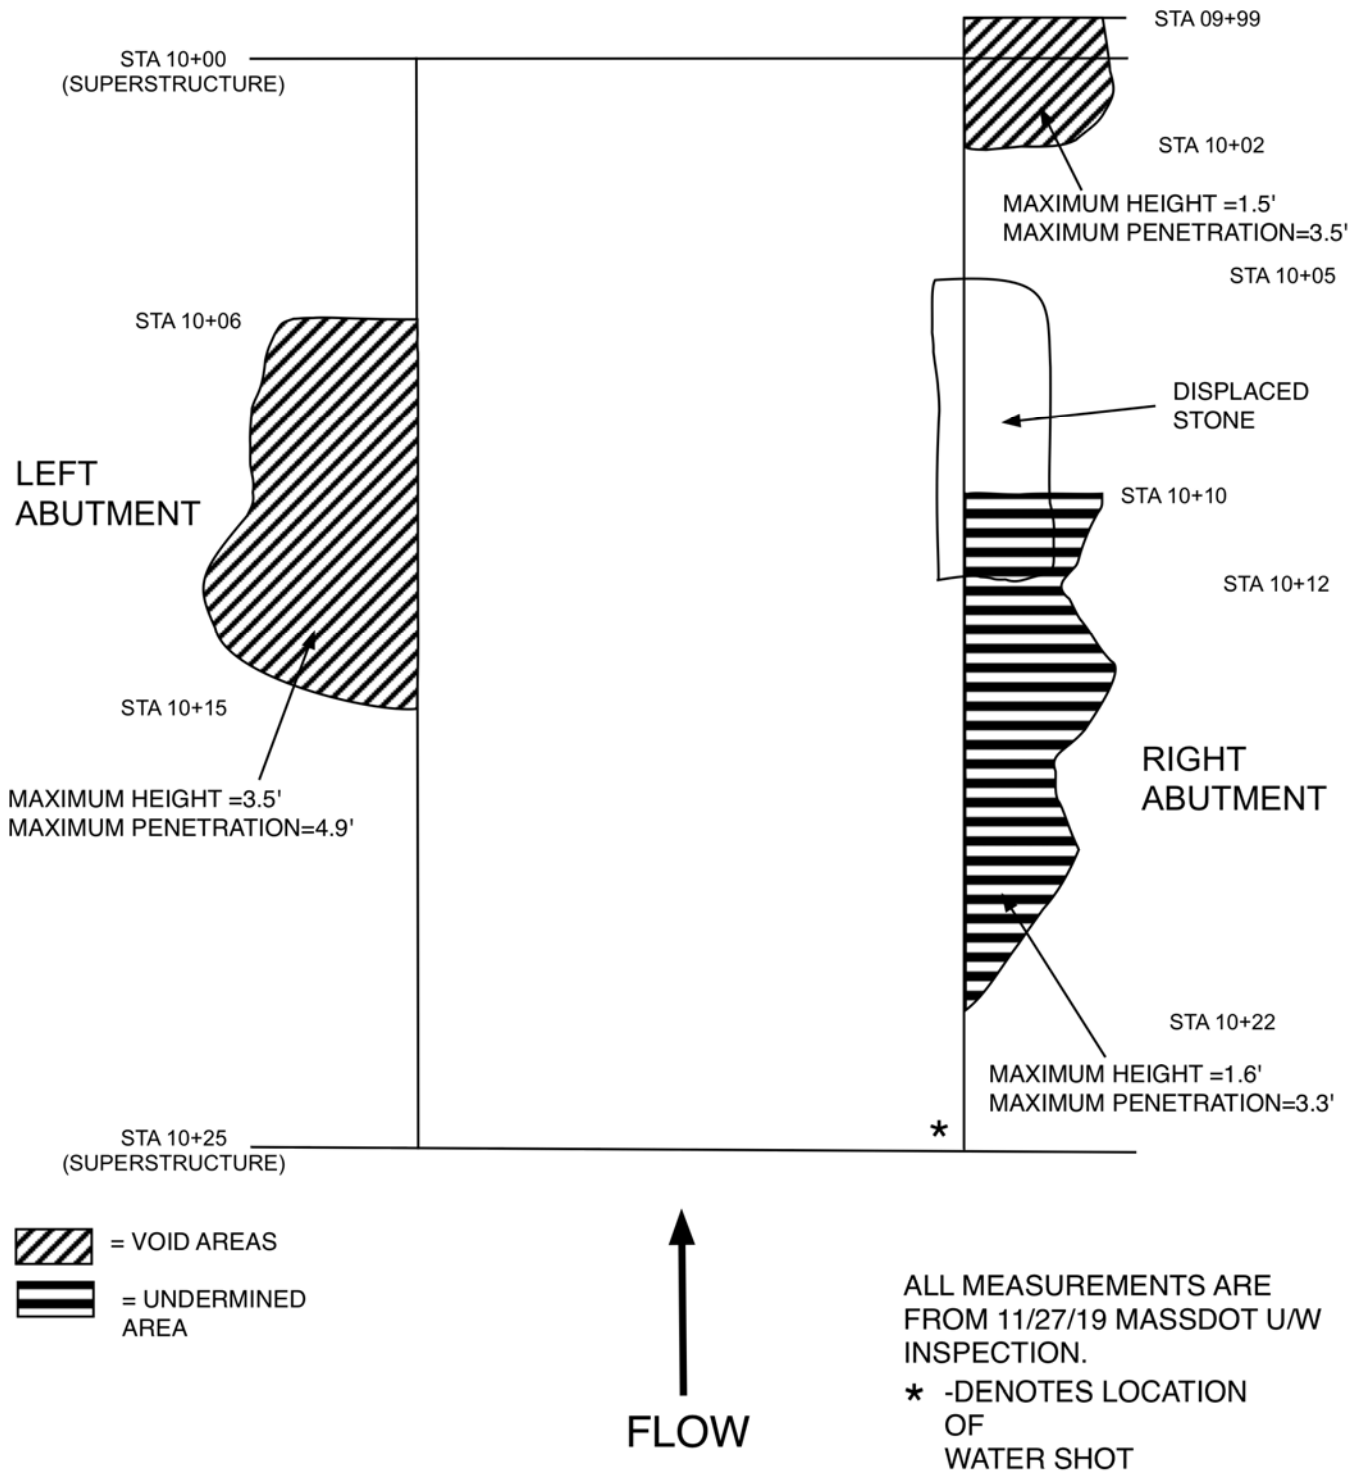
**Sketch 1: PLAN VIEW SHOWING UNDERMINING, VOIDS AND DISPLACED STONE PRIOR TO 2019 REPAIR**

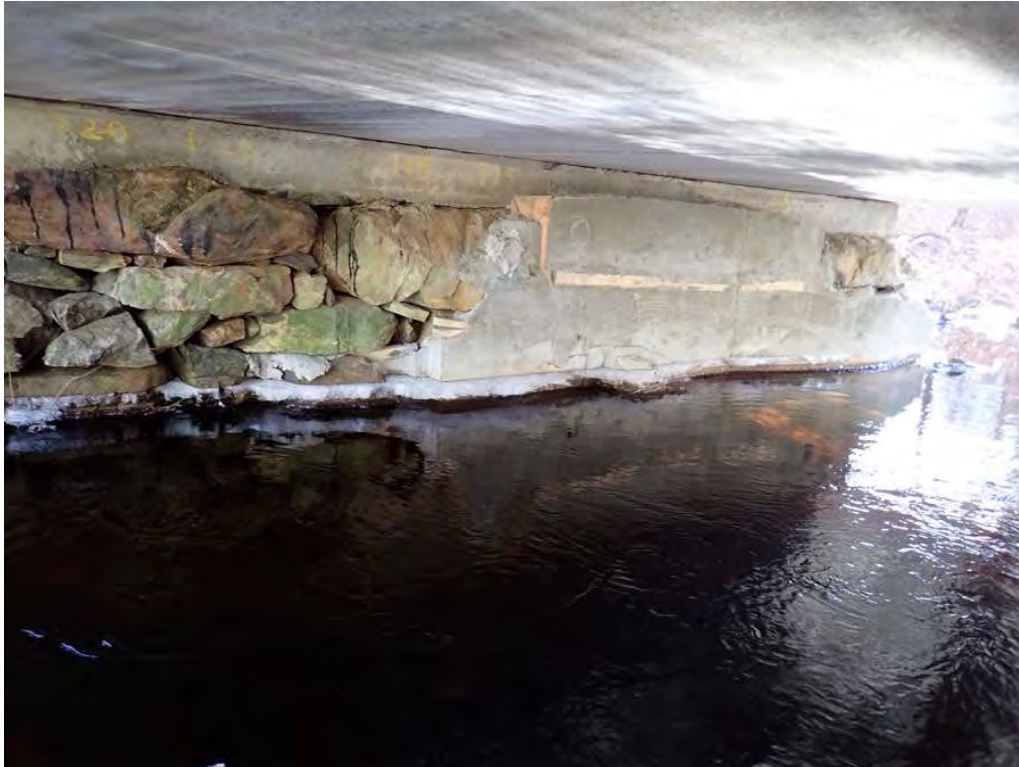
**Photo 1:** North breastwall, concrete repair throughout the east half.

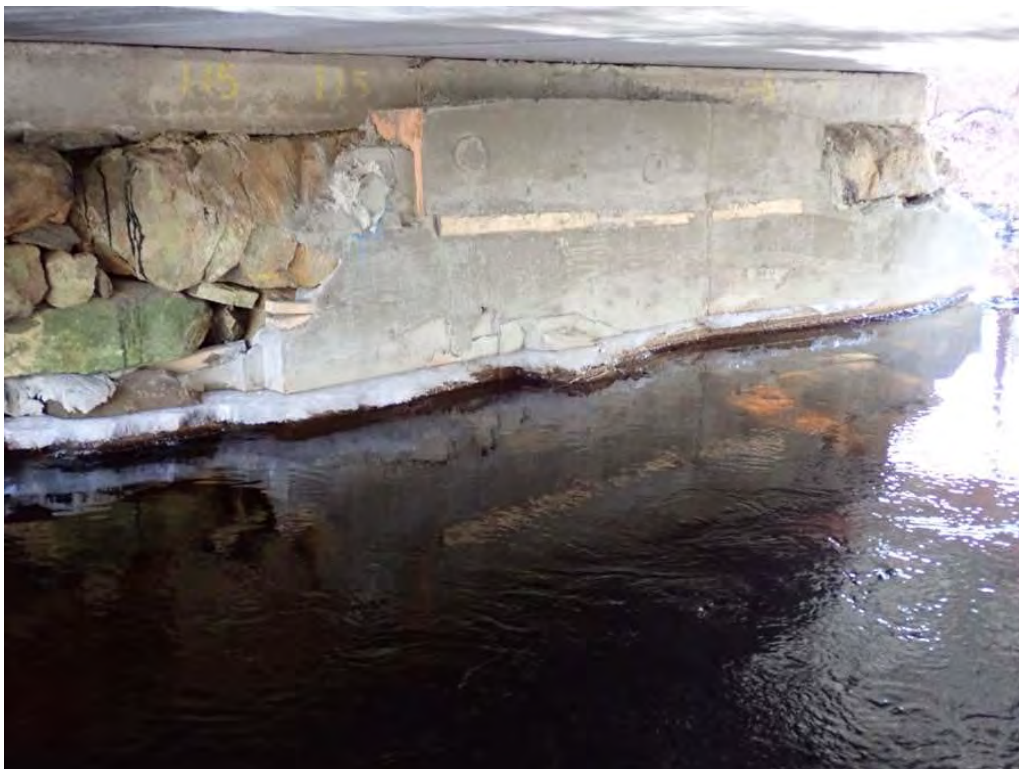
**Photo 2:** North breastwall, concrete repair starting at the east edge; alternate view.

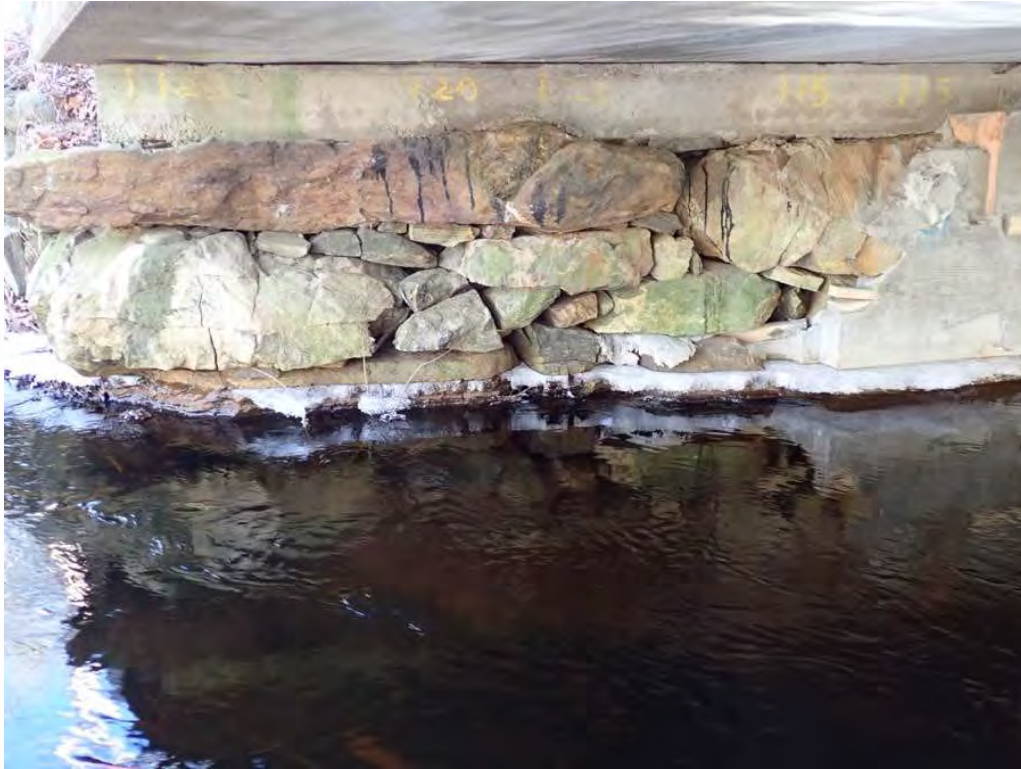
**Photo 3:** North breastwall, typical void areas throughout the remaining length past the repair.

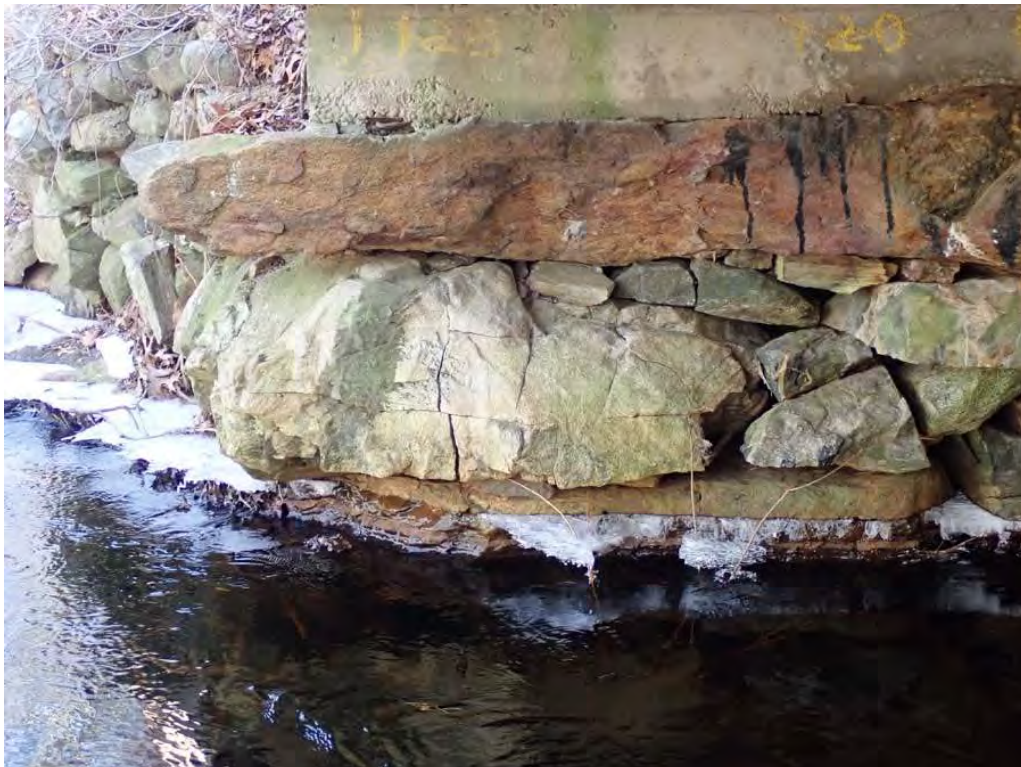
**Photo 4:** North breastwall, west edge stone with a full height crack.

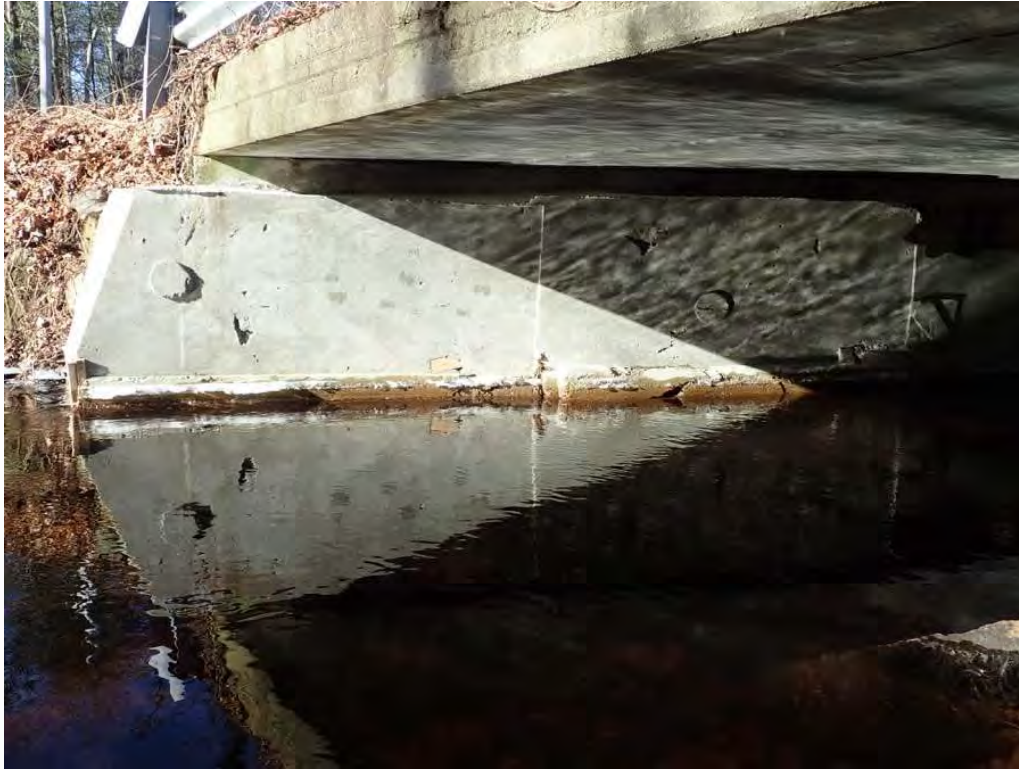
**Photo 5:** South breastwall, large concrete repair extending into the southeast wingwall corner.

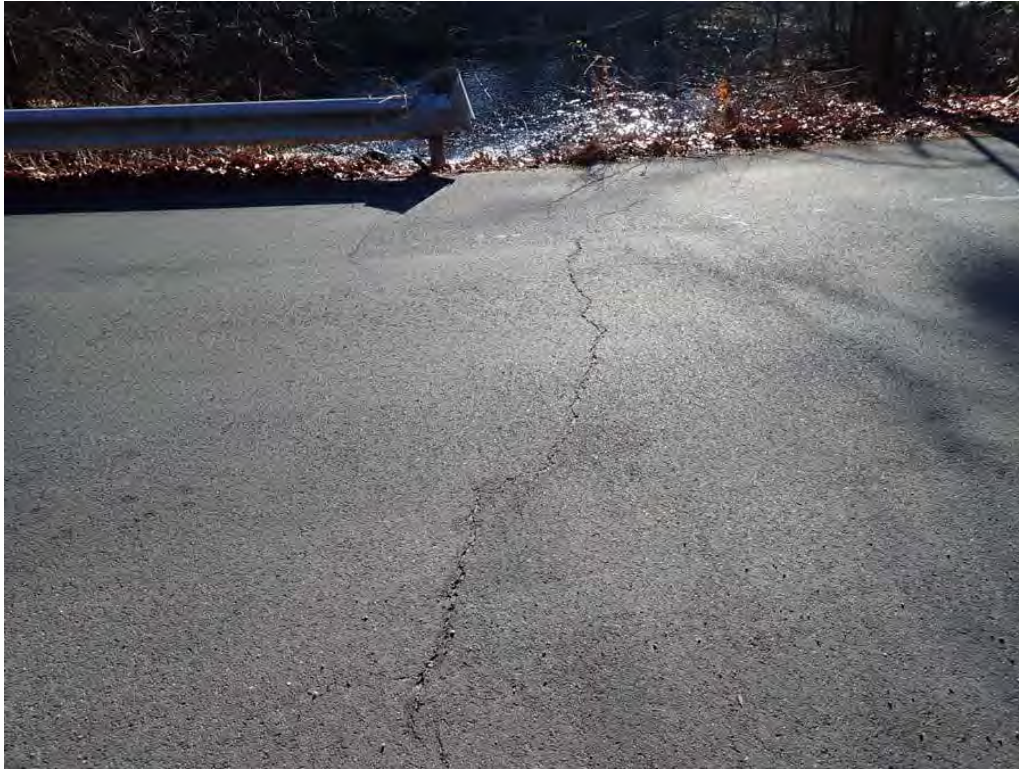
**Photo 1: South approach, transverse cracking near the south deck end.**

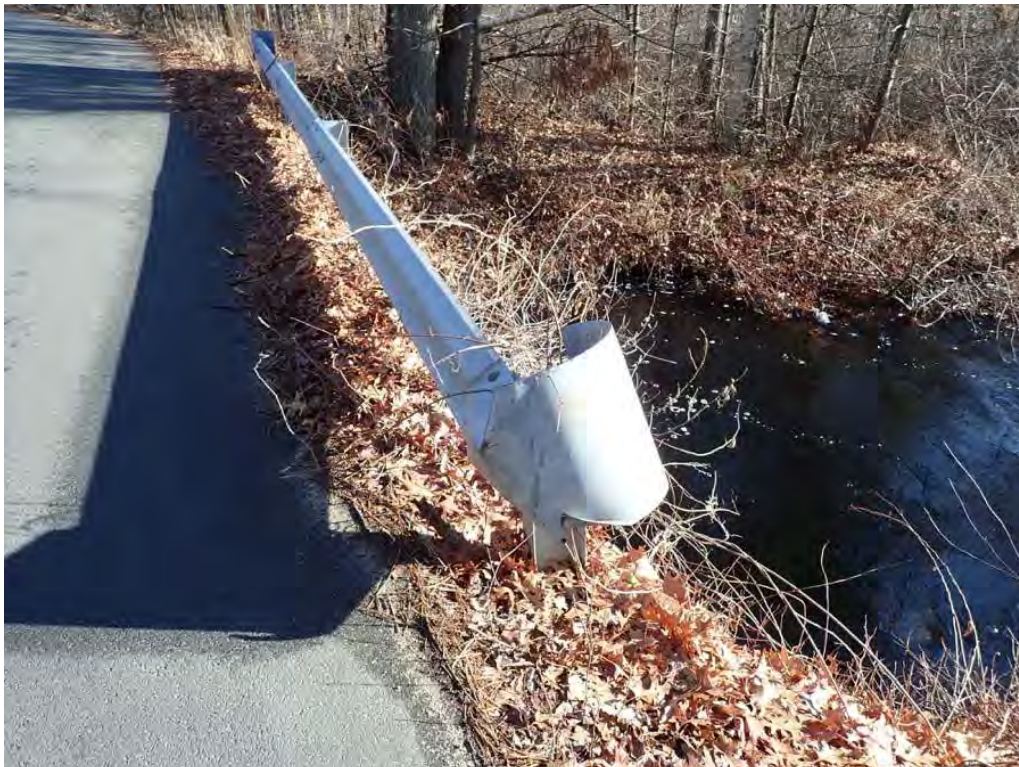
**Photo 2: East rail, south end damage and loose panel.**

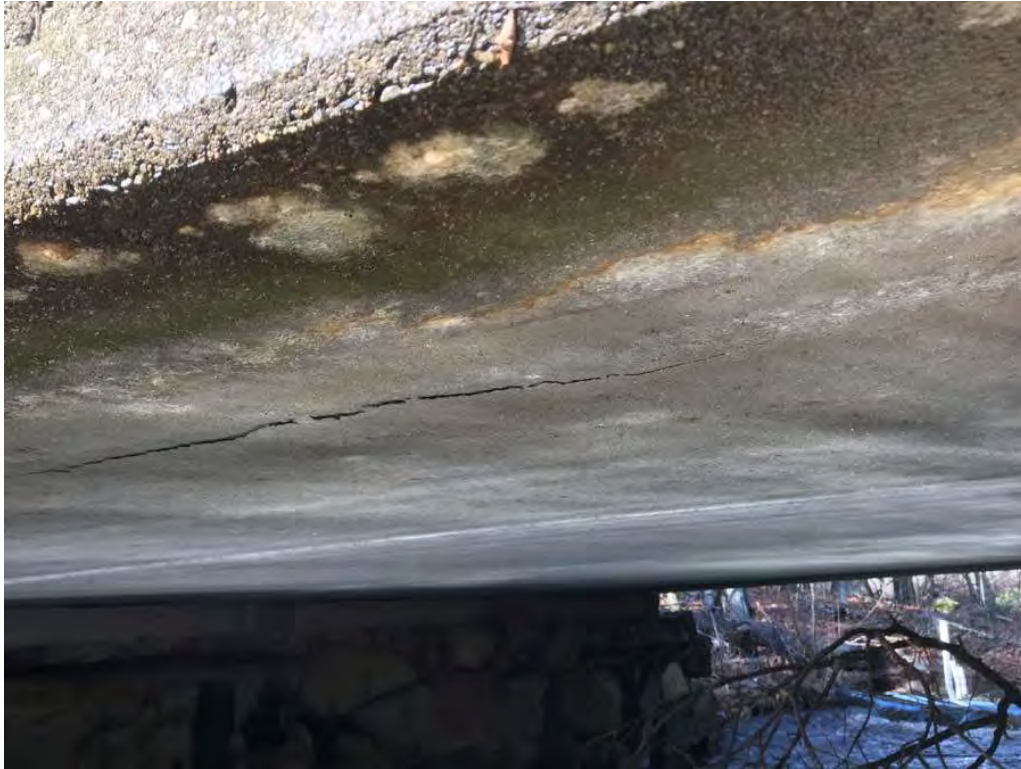
**Photo 3:** Slab, delamination/incipient spalling area near the northeast corner.

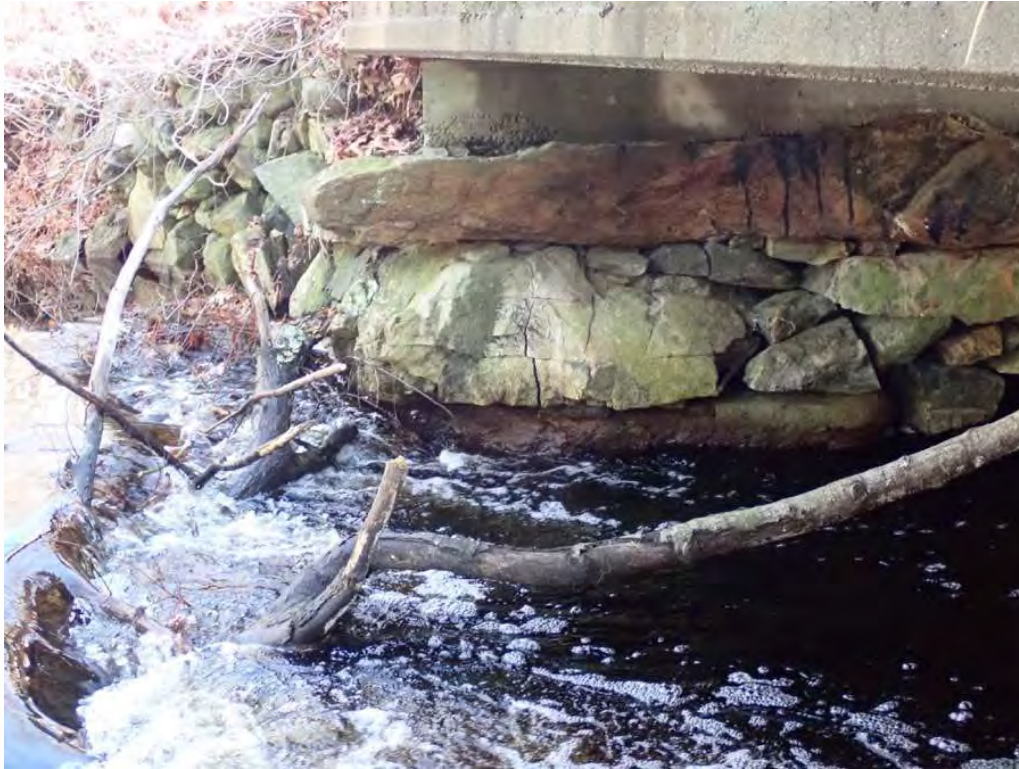
**Photo 7:** North breastwall, west edge stone, second layer from top, full height crack.

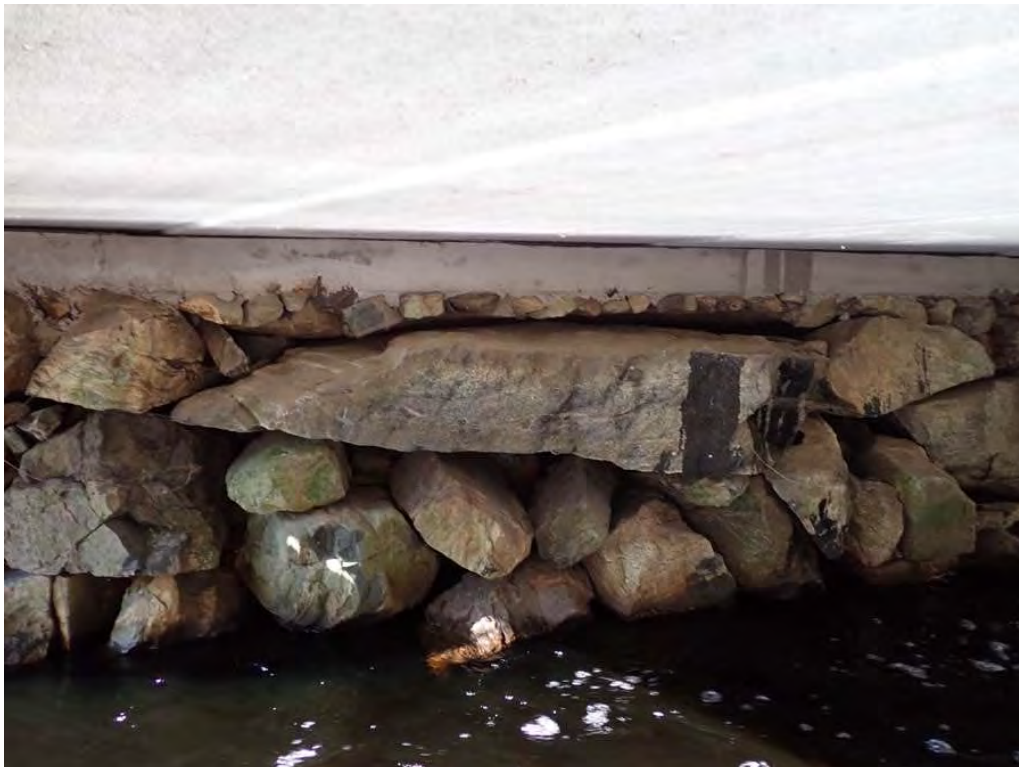
**Photo 8:** South breastwall, displaced stone starting at 5.5' from the east edge.
