**Field Report**

**Project: Boxford Community  
Senior Center  
10 Elm Street Boxford, MA 01921**

**Report No.:****022****GRLA Project No.:****2020120.01****Date of Site Visit:** 8 March, 2022

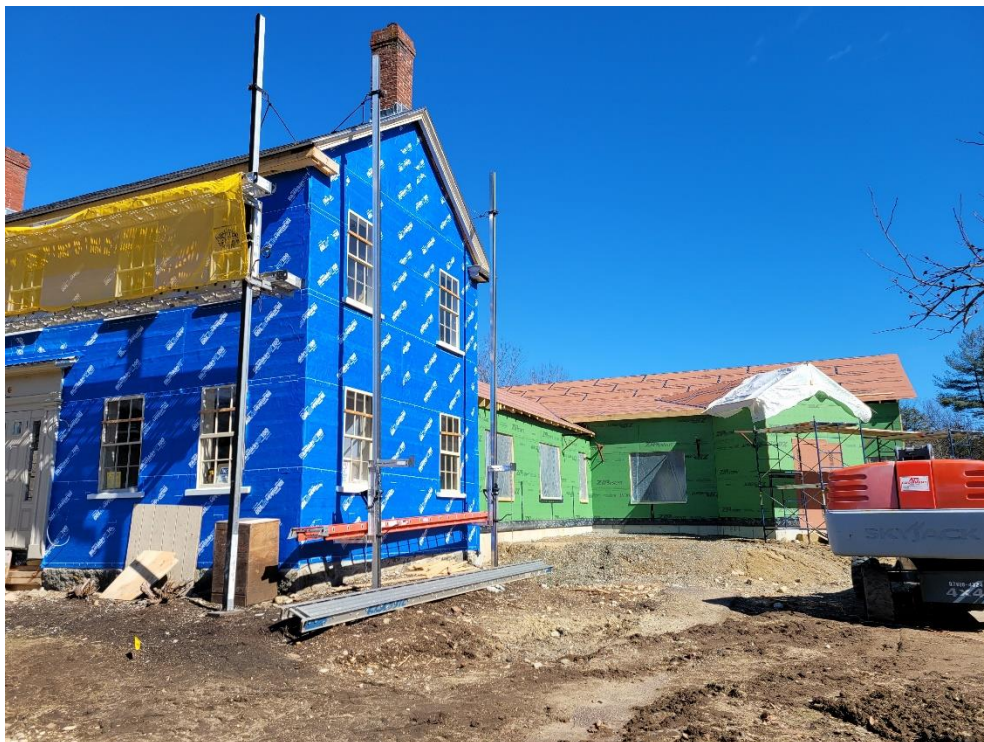
1. Progress view from southwest

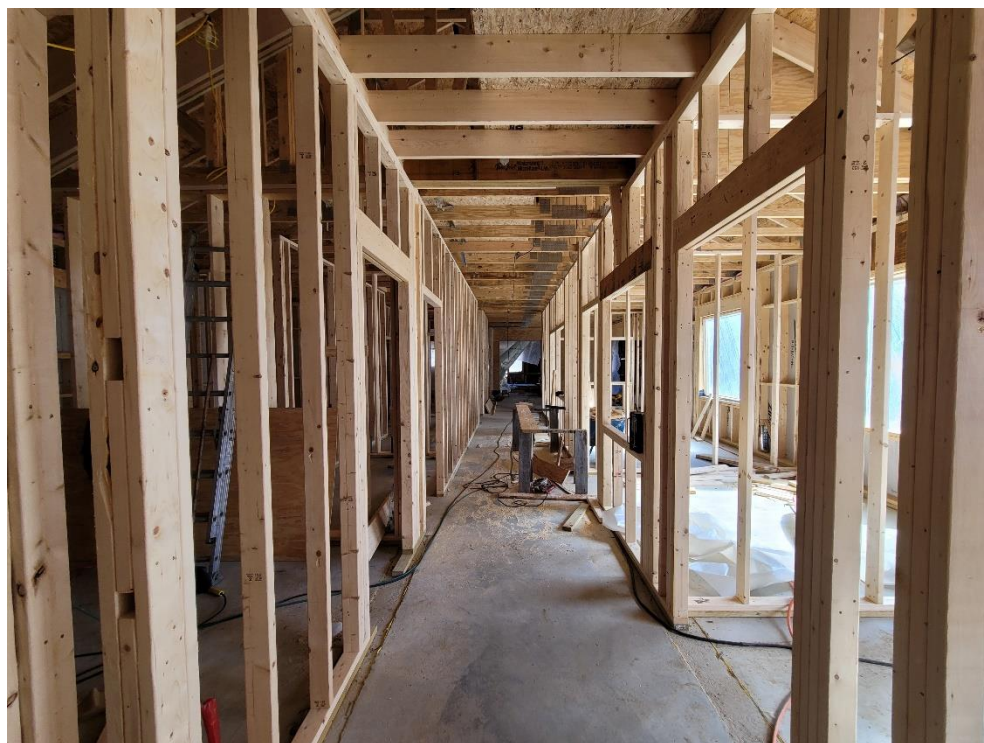
- a. Interior framing at both Office Wing and Multipurpose/ Kitchen Wing continues (photos 2,3,8,9).
- b. Stair from Water Room to 2<sup>nd</sup> Floor underway. Architect and Contractor reviewed headroom at top of stairs (photo 11).

2. Hallway outside door to Cummings House toward Lobby

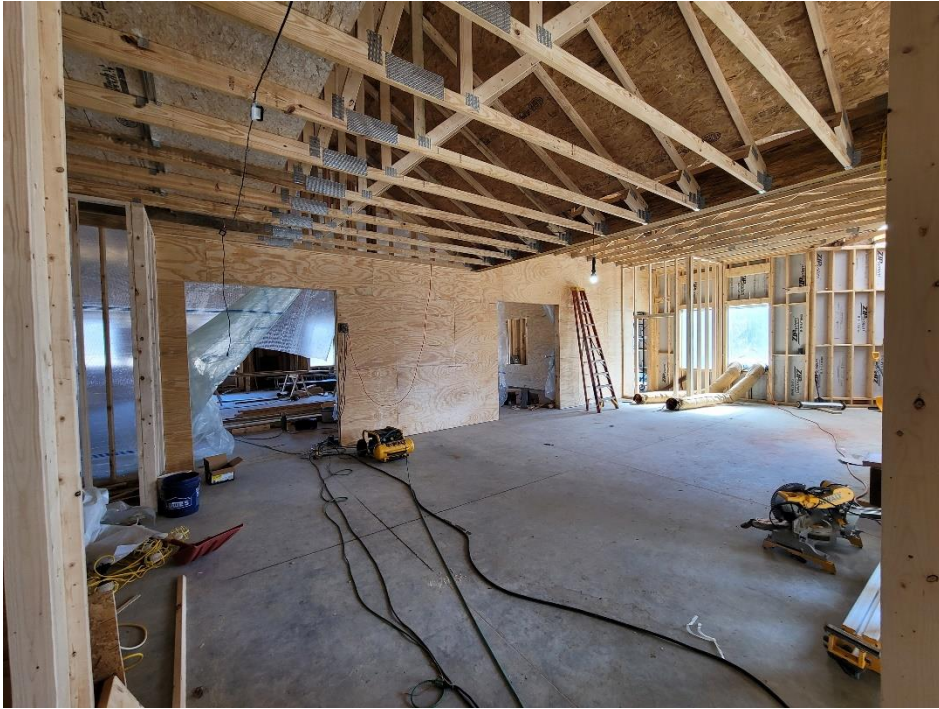
- a. Plywood sheathing of shear walls in progress (photos 3,4,5).
- b. ¾" Advantech wood panels installed at catwalks along both wings (photos 4,5,6,7,9).

3. Main Lobby with sheathing on shear wall at Multipurpose Room

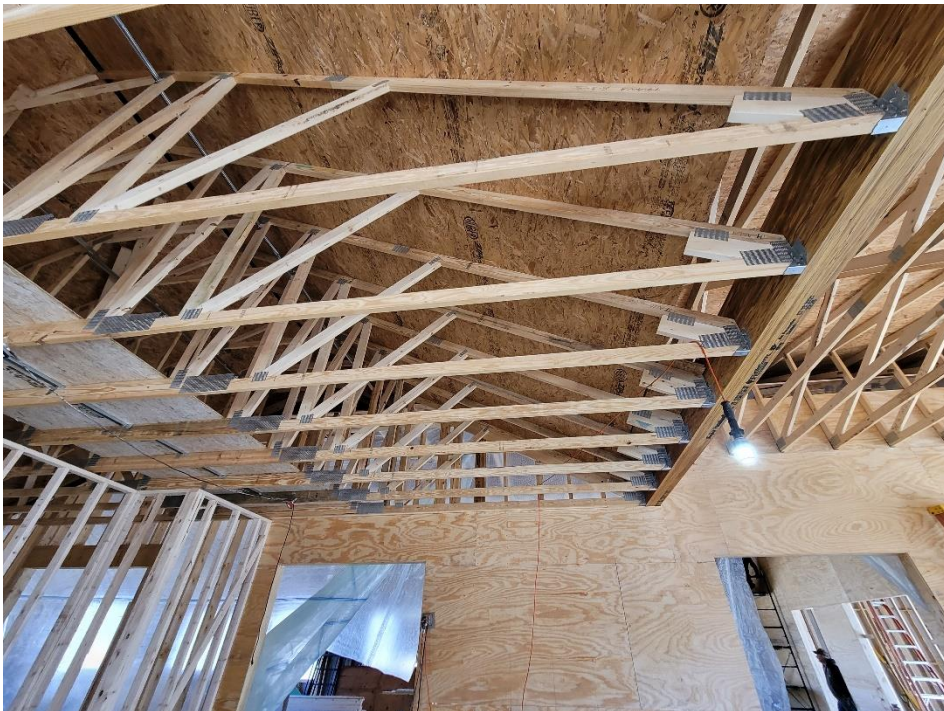
4. Trusses over east end of Office Wing (dropped beam at right)

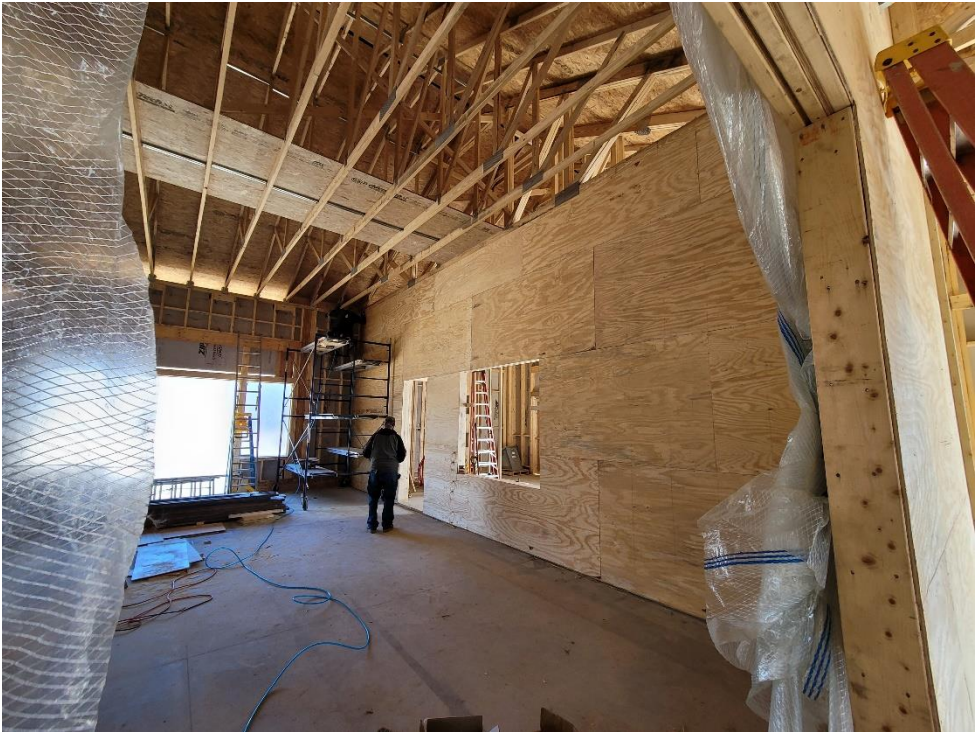
5. Sheathing on shear wall at Kitchen

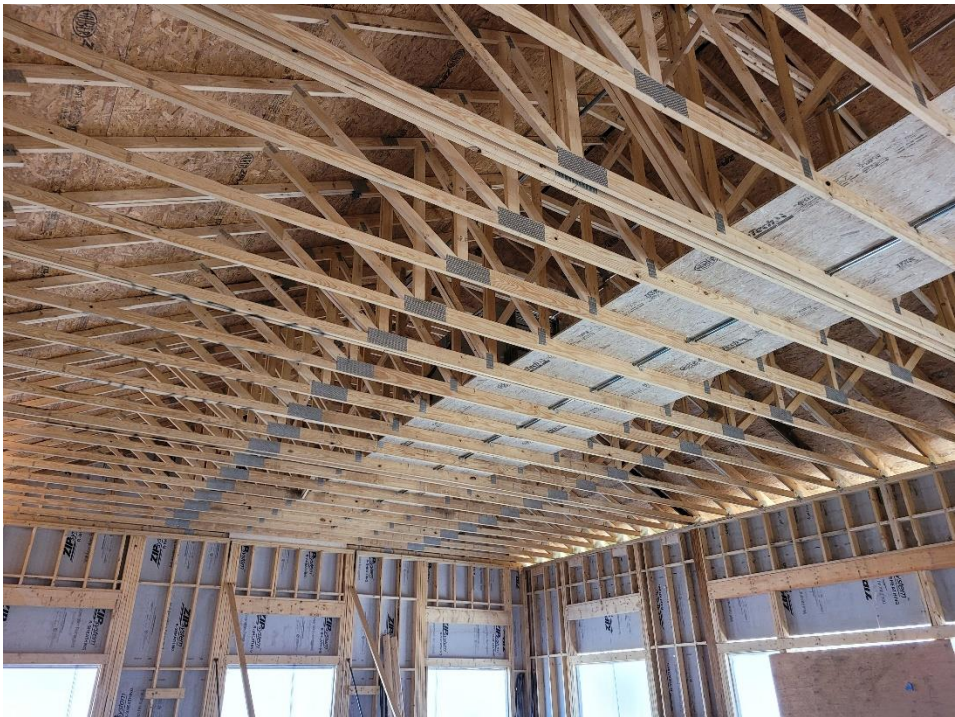
6. Catwalk along length of Multipurpose Room

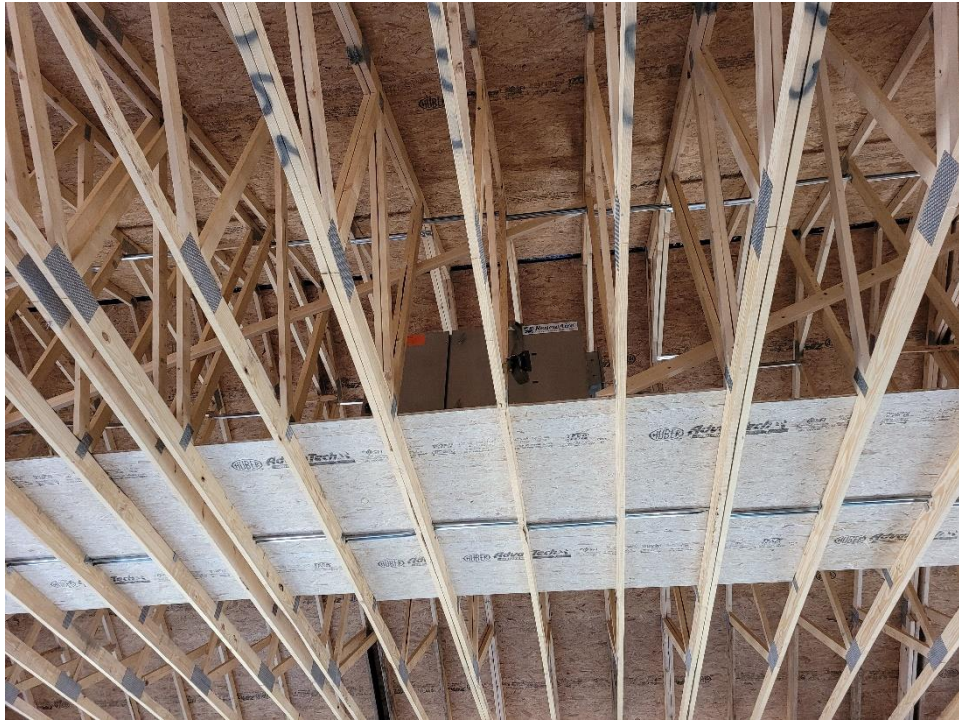
- a. ERV unit set on catwalk above Multipurpose Room; final install pending (photo 7).

7. ERV unit in place on catwalk above Multipurpose Room

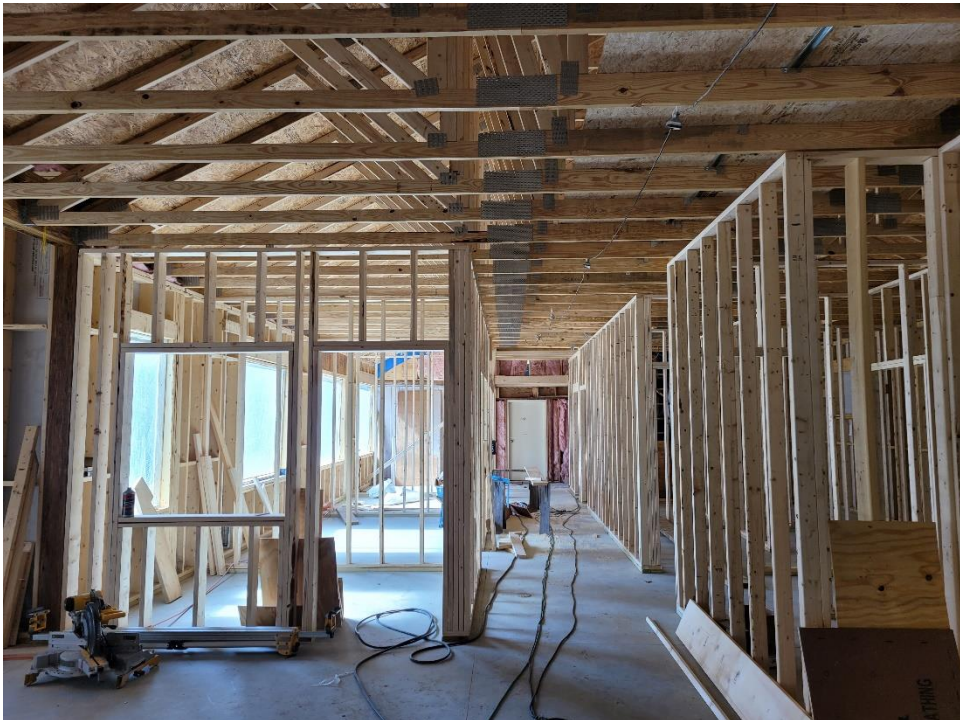
8. View down hallway toward Cummings House at far end

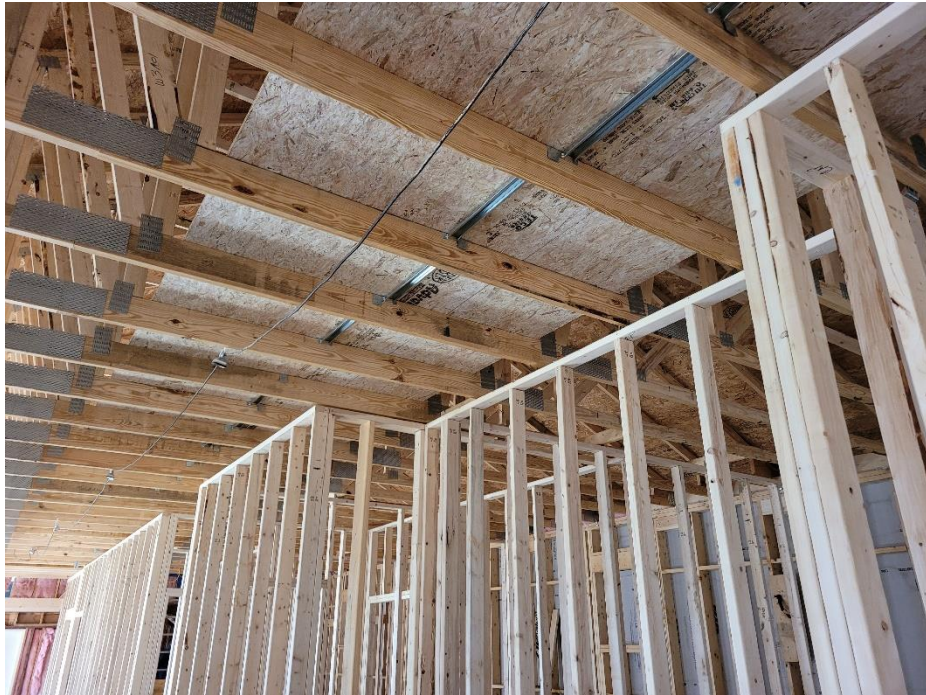
9. North end of Lobby at Coat Closet

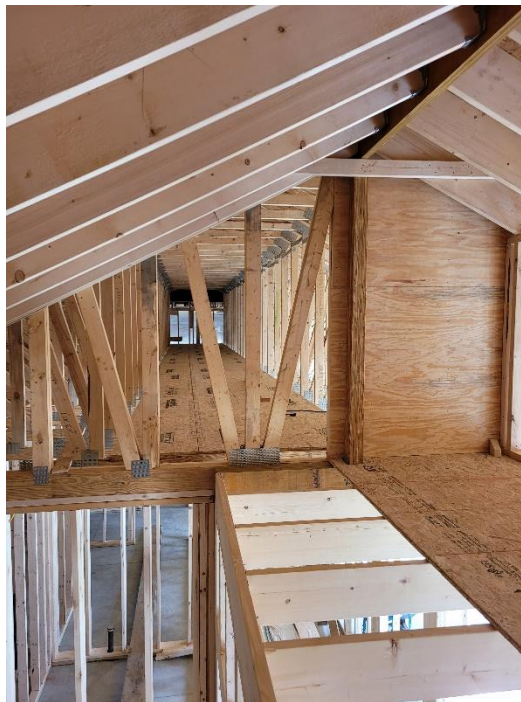
- a. End truss (GEO-1) at beginning of stick framed roof; partially sheathed; angled web member to be removed for access to catwalk (photo 10).

10. End truss (GEO-1) at beginning of stick framed roof; partially sheathed;  
angled web member to be removed for access to catwalk

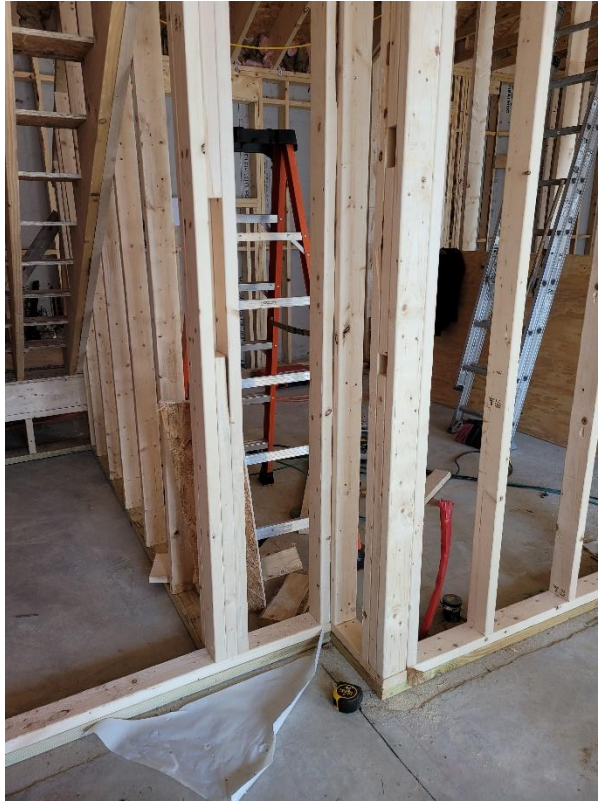
11. Recess at drinking fountain
