**Field Report****Project: Boxford Community****Senior Center****10 Elm Street Boxford, MA 01921****Report No.:****013****GRLA Project No.:****2020120.01****Date of Site Visit:** 7 December , 2021**Routed to:** Robert Aldenberg, Boxford Building Inspector  
Bob Hazelwood, PBC  
Mike Abraham, Classic Construction  
Bryan Gannon, Classic Construction  
Paul Kalous, Hill International  
Fred Scibelli, Hill International  
GRLA Files**Temperature:** 41 deg F**Weather:** Clear**Time:** 12:10 pm- 1:15 pm**PRESENT AT SITE:**

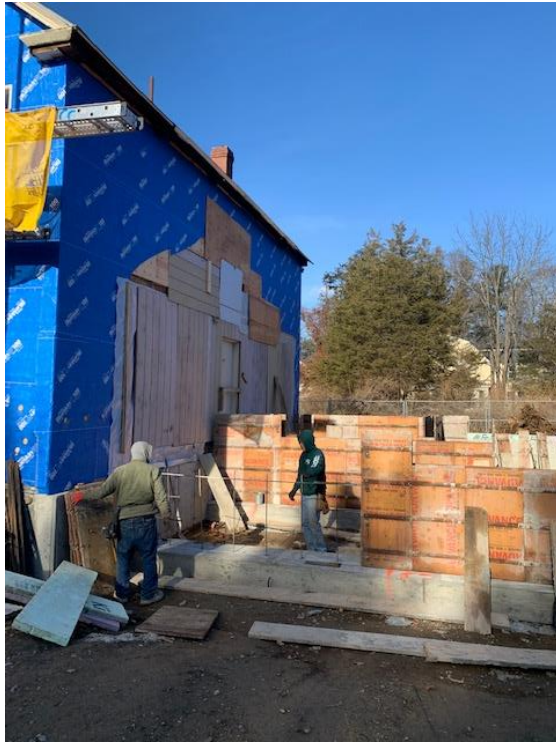
- a. Formwork for final sections of foundation wall extending to East Wall of Cummings House being erected (photos 1,2);
- b. Fill material being installed within the footprint of the new foundation and compacted (photo 6).

1. Formwork for final sections of foundation wall extending to East Wall of Cummings House being erected (view from south)

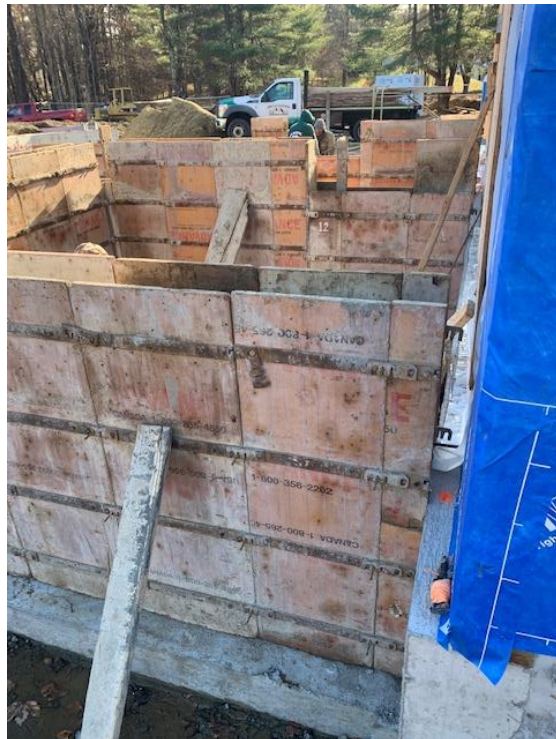
2 . Formwork for final sections of foundation wall extending to East Wall of Cummings House being erected (view from north)

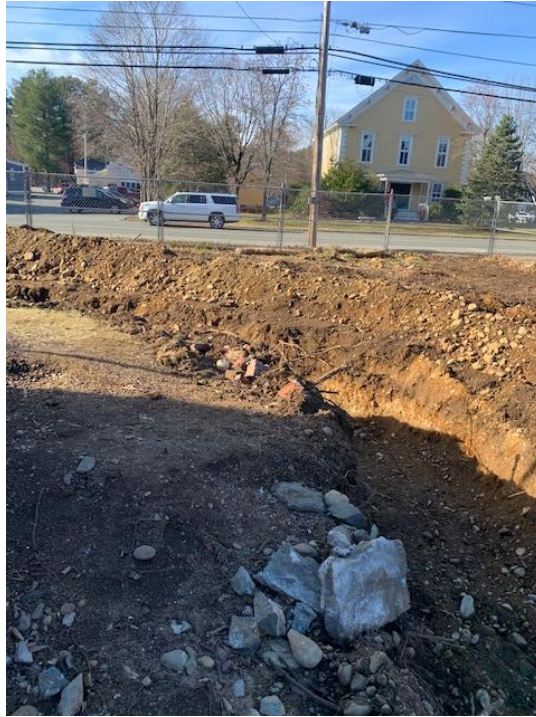
3. Trench for new water line to the well is excavated.

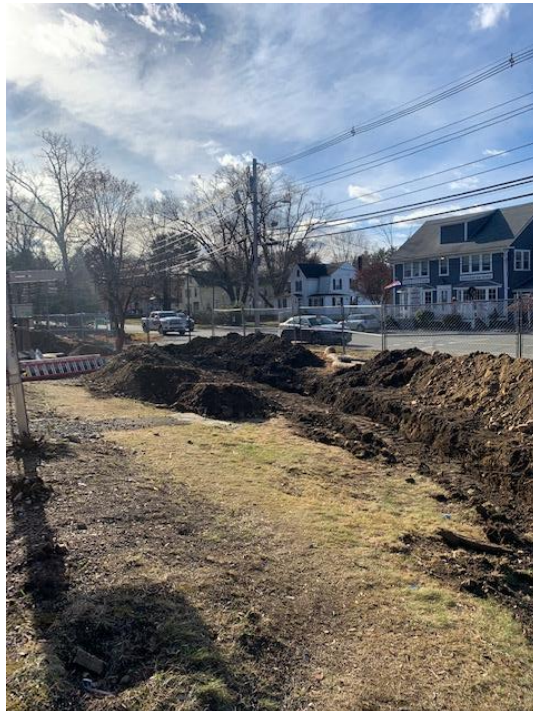
4. Trench for new water line to the well is excavated.

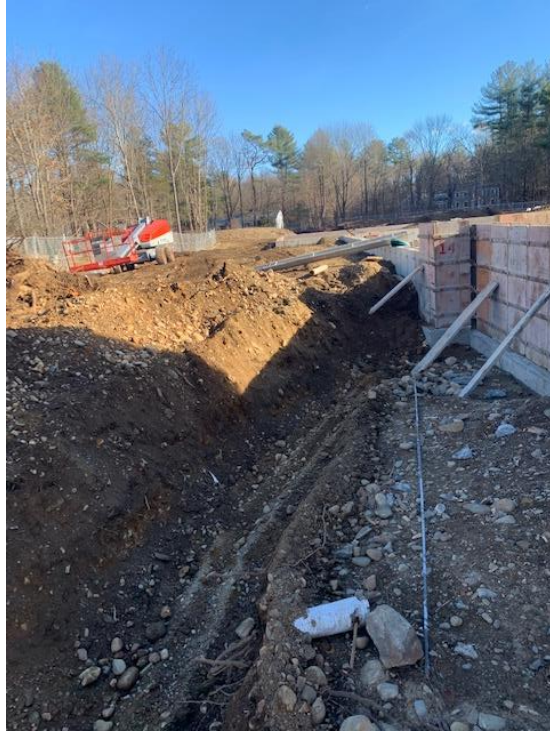
- a. Trench for new water line from the existing well to the south of the building and extending around the front (Elm St. side) and north sides of the Cummings House to the future Water room location has been excavated (photos 5,7,8,9).
- b. Pallet of rigid insulation arrived on site (photo 10).

5. Trench excavation for new well water line extending to Addition at north site (Water Room location)

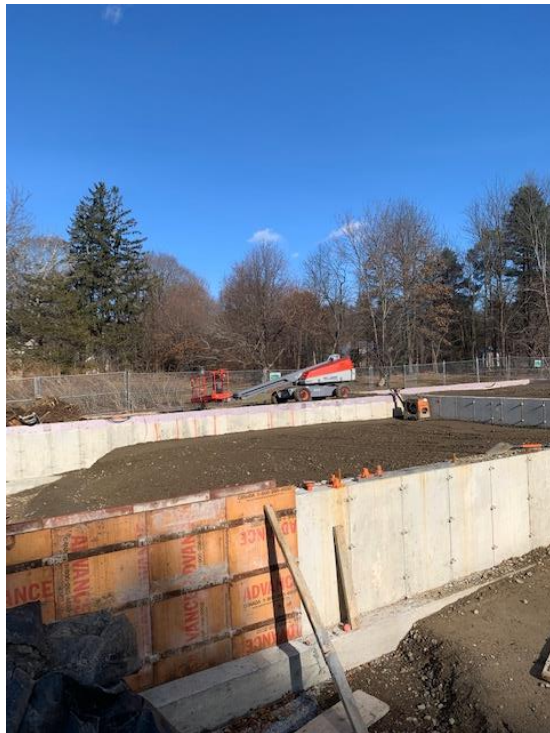
6. Fill material a new Addition installed and being compacted.

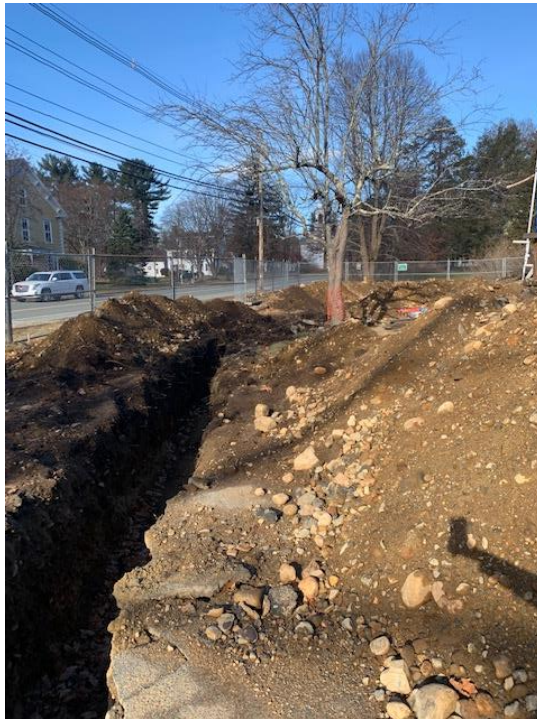
7. Water line trench along Elem Street

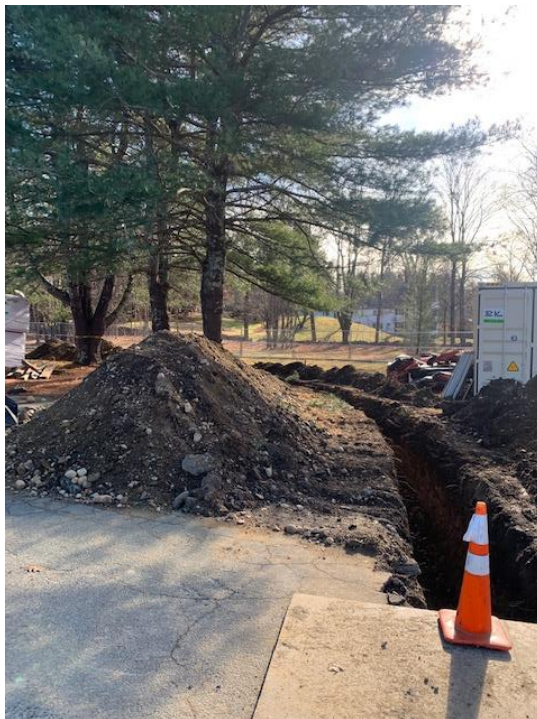
8. Well water line trench across driveway

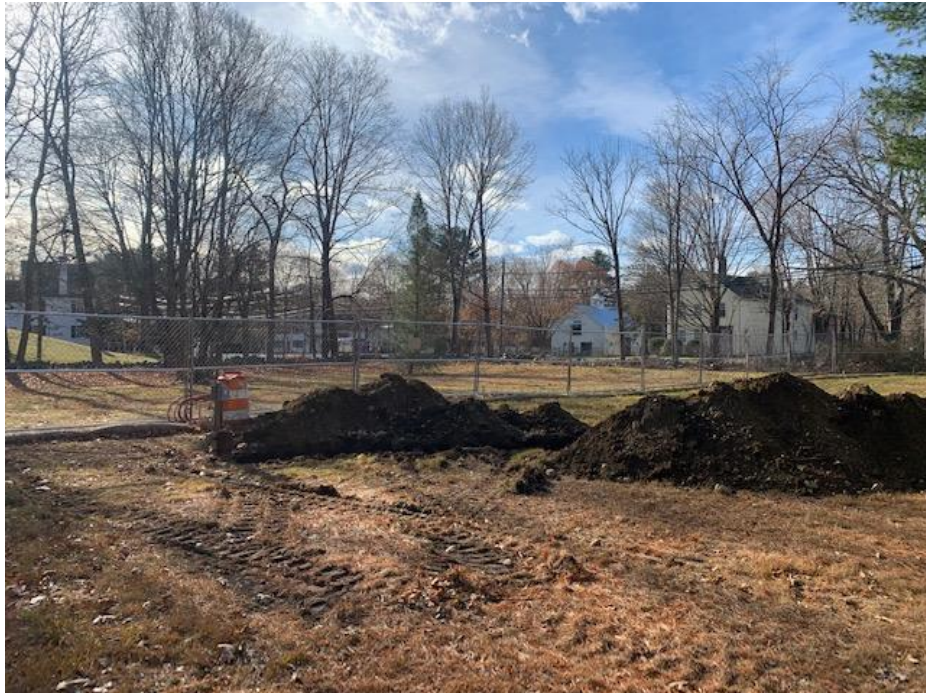
9. Trench for well water line terminating at well location

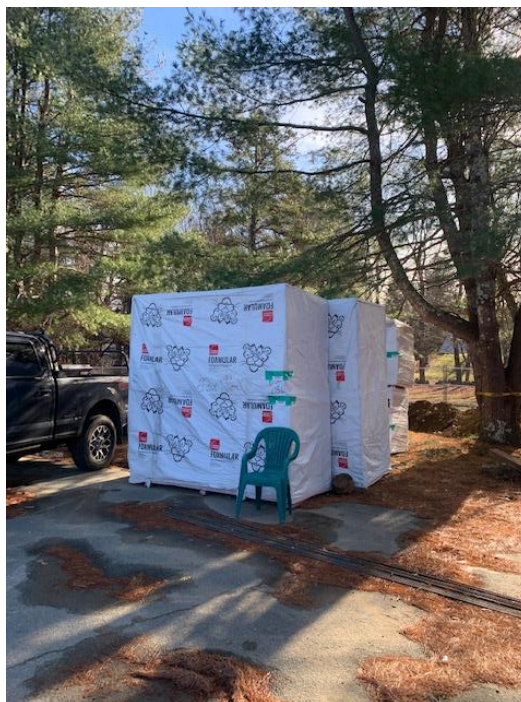
10. Pallets of rigid insulation for under slab arrived on site.

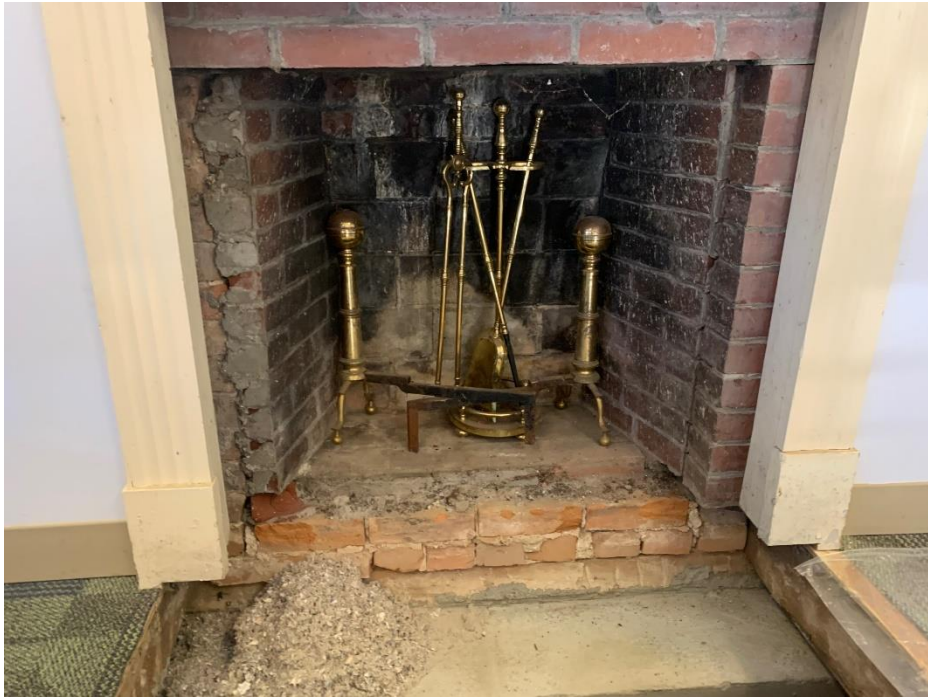
- i. Of the 2 existing fireplaces in the Cummings House, the north firebox and hearth will be restored and the south will remain with the brick infill. The north hearth will be finished with thin brick and the south will have no hearth (photos 11 through 14).

11. North firebox at Cummings house; hearth being prepared for new brick hearth finish.

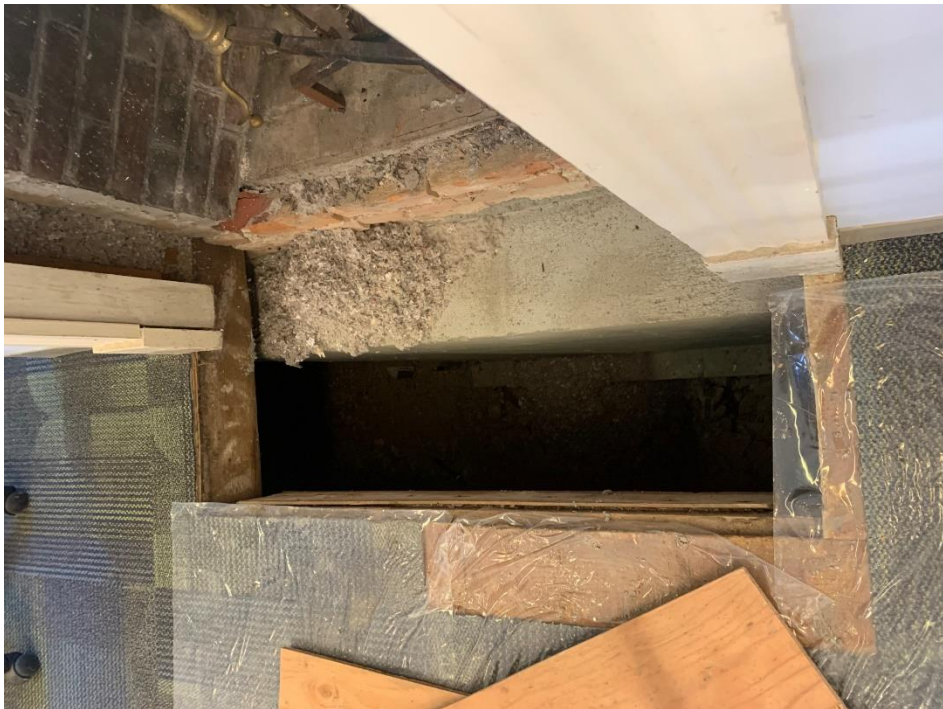
12. Hearth opening at north fireplace.

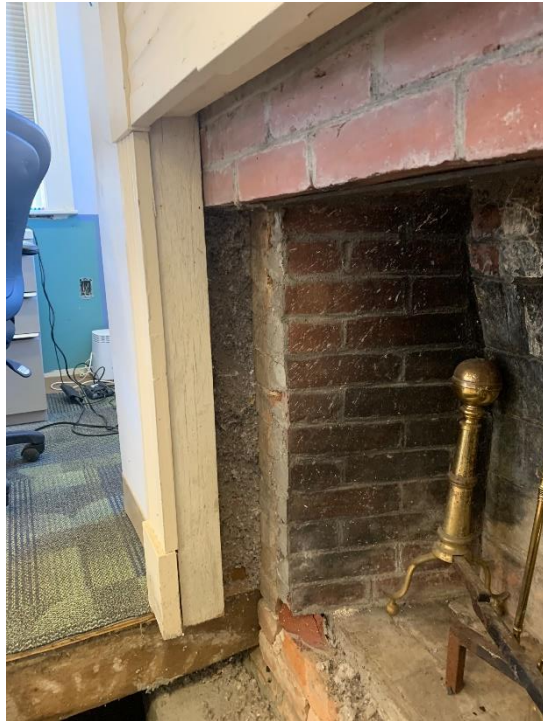
13. Left side of north firebox to be repaired.

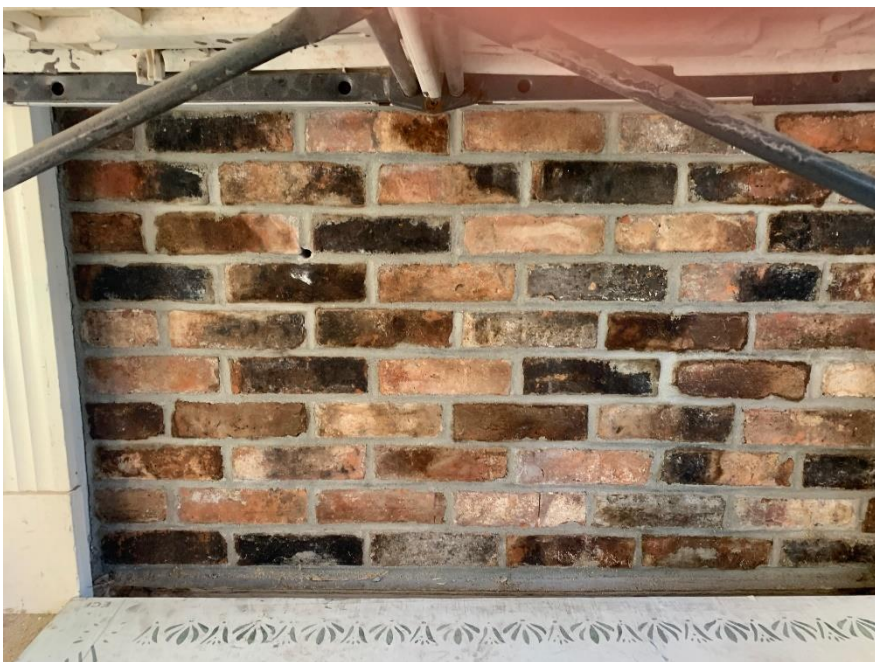
14. Brick infill at south firebox to remain.
