**Field Report**

**Project: Boxford Community  
Senior Center  
10 Elm Street Boxford, MA 01921**

**Report No.:****020****GRLA Project No.:****2020120.01****Date of Site Visit:** 15 February, 2022

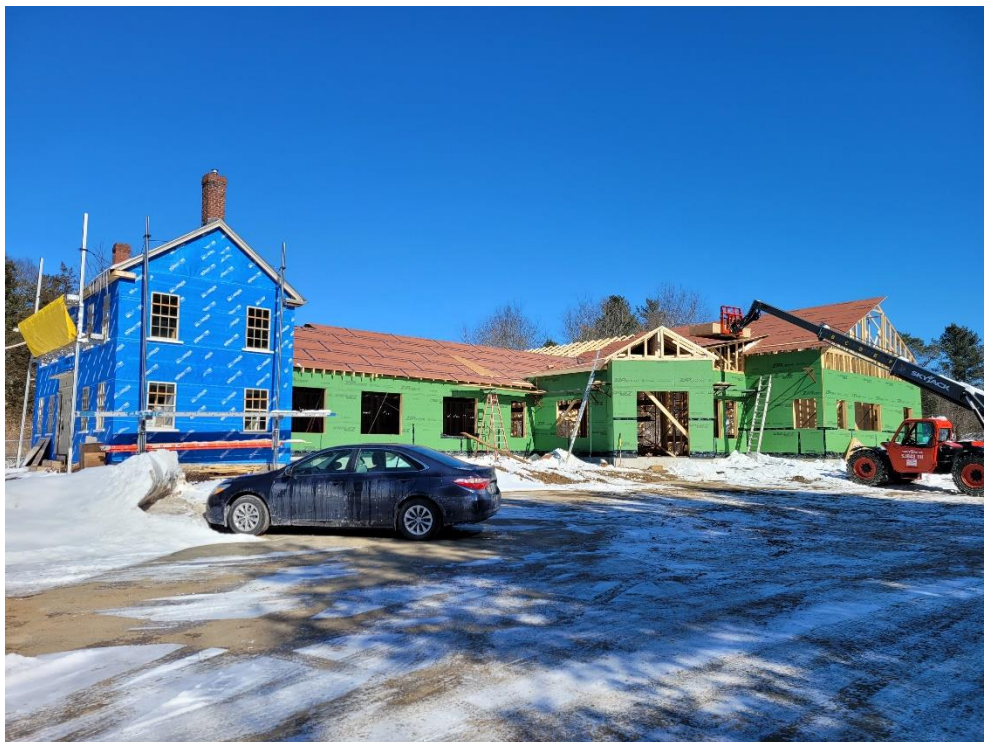
- a. Roof sheathing installed on Office Wing and in progress on Multipurpose/ Kitchen Wing (photos 1, 5, 6)
- b. End truss of Office Wing at junction with stick framed roof fitted with hanger for 14" LVL ridge for stick-framed rafters to Cummings House (photo 9); field modifications required to provide opening to catwalk and transfer drag load to shear wall below.
- c. Shear blocking between trusses above shear wall (north wall) installed between rafter ends above all exterior shear walls (photo 13).

1. Roof sheathing installed on Office Wing and in progress on Multipurpose/ Kitchen Wing

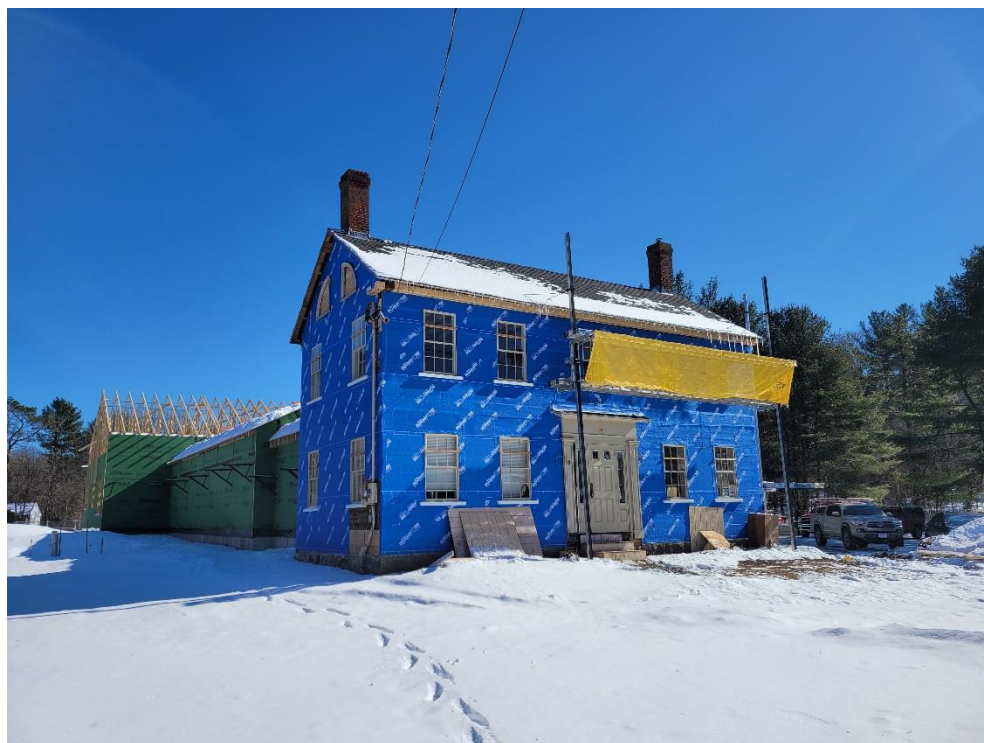
2. Progress view from the northwest

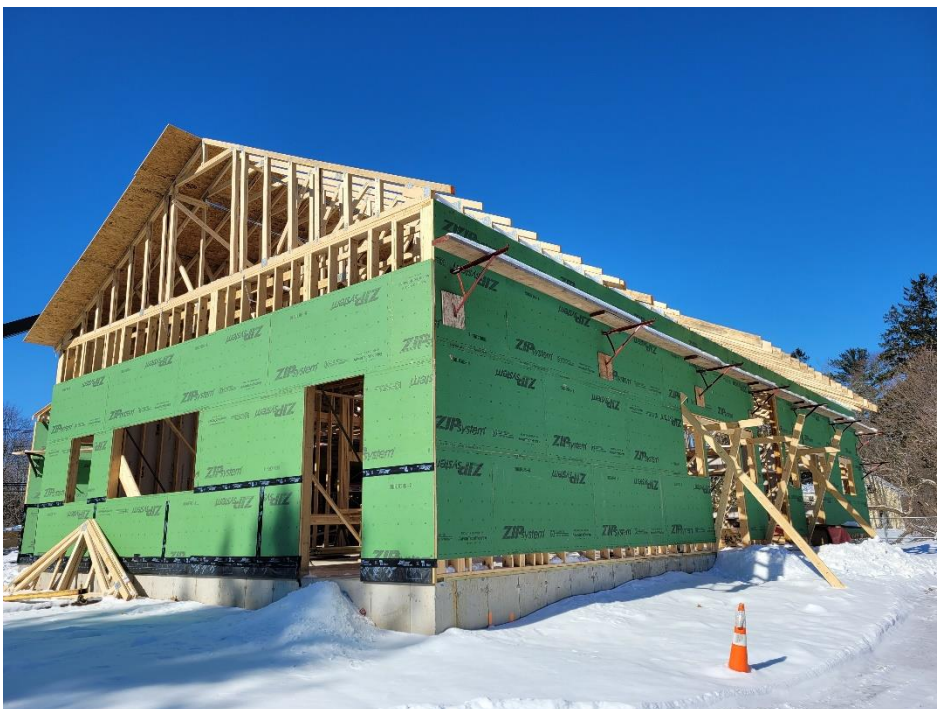
3. Multipurpose/ Kitchen Wing

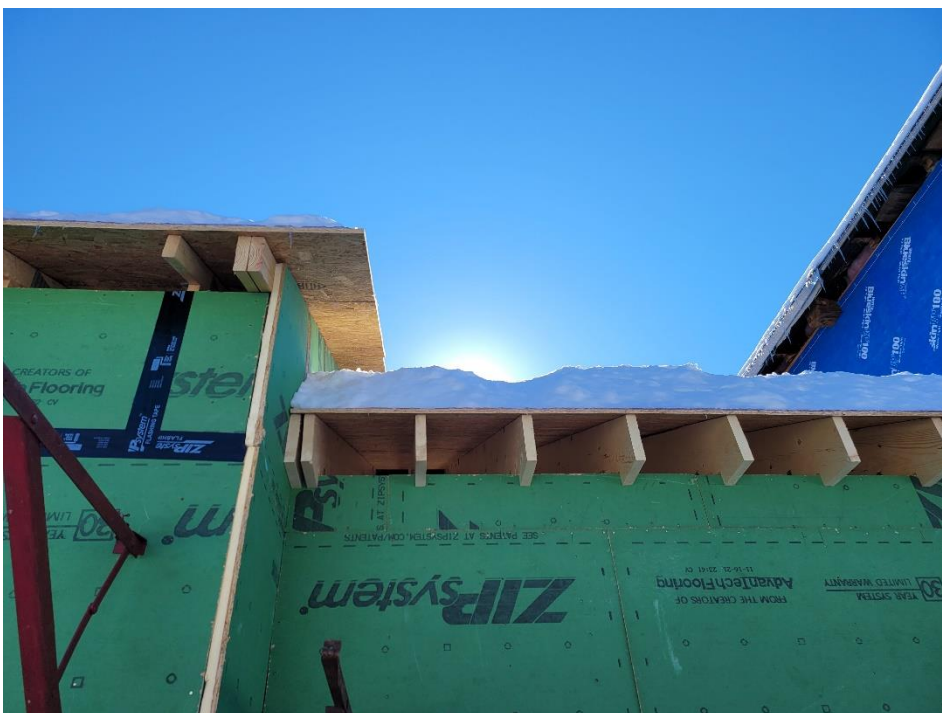
4. Transition from truss framed roof to stick (rafter) framed roof

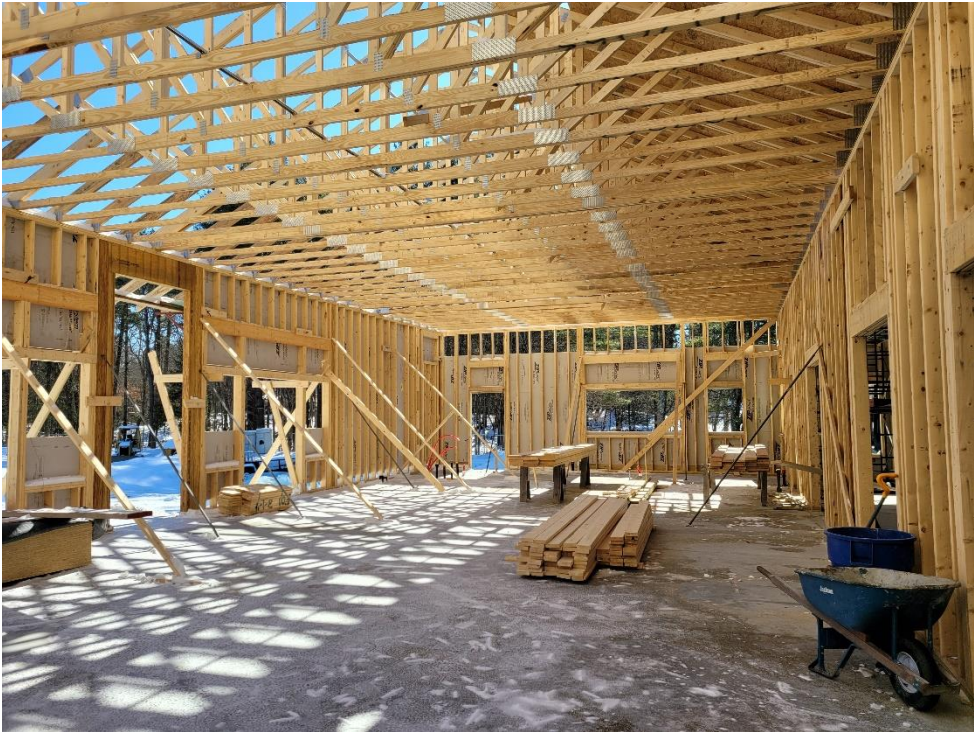
5. Interior view of Multipurpose/ Kitchen Wing looking toward the Kitchen (south) end

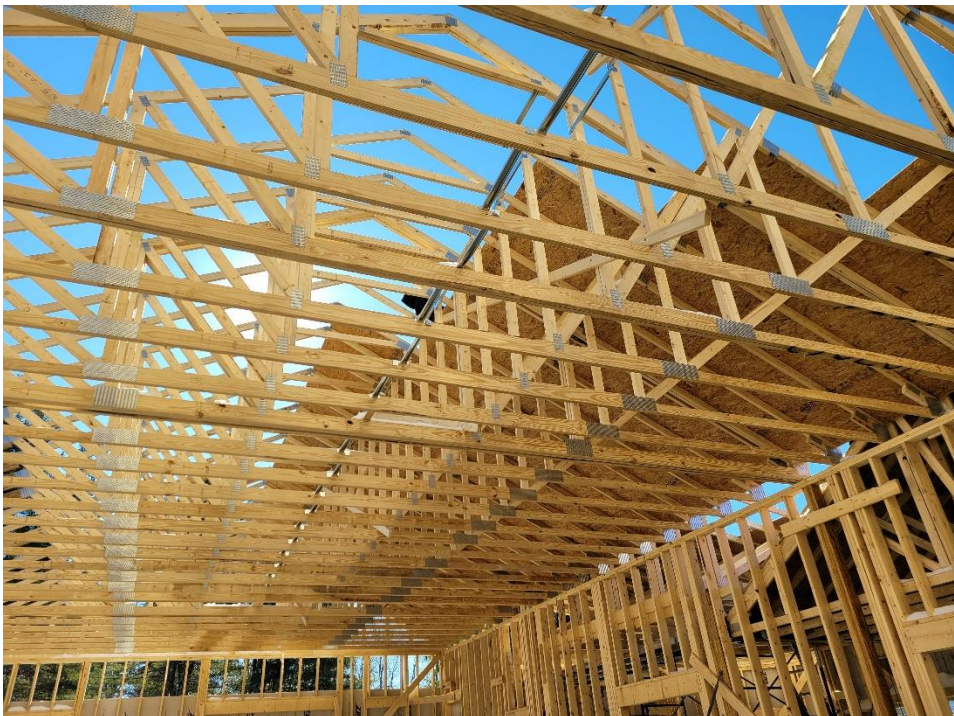
6. Roof trusses over Multipurpose/ Kitchen Wing with Lobby wall at right

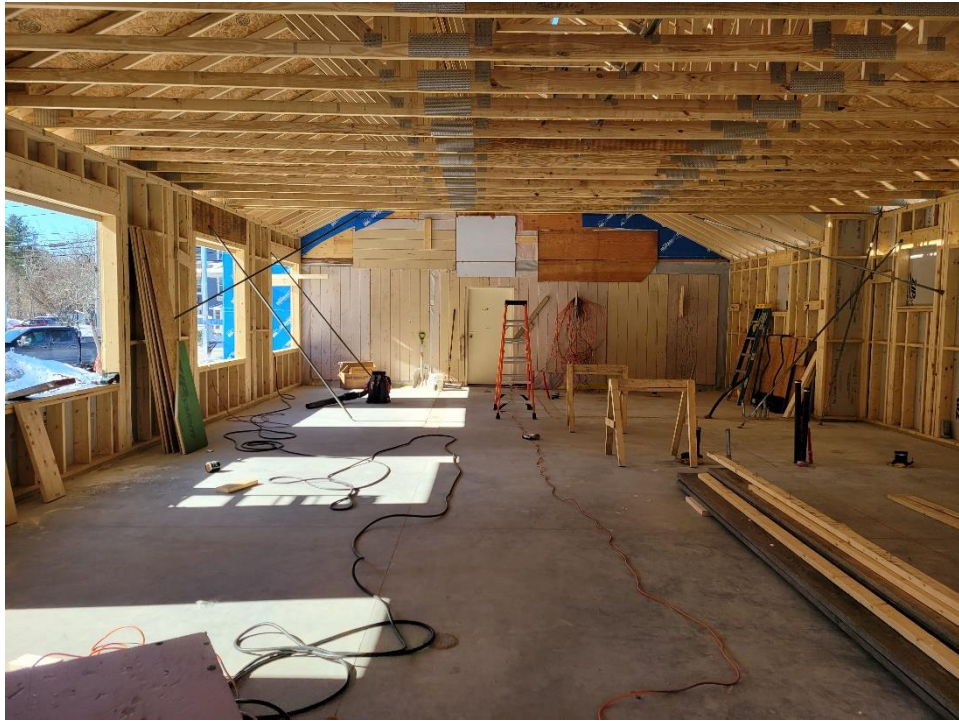
7. Interior of Office Wing toward Cummings House

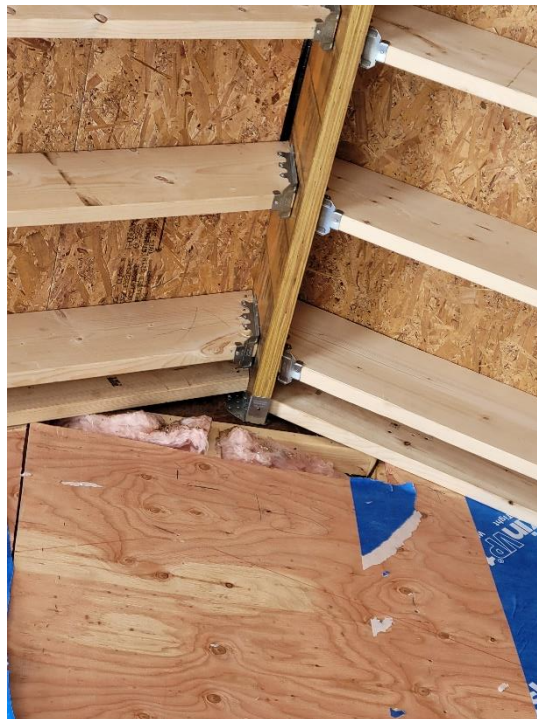
8. 14" deep LVL ridge beam at stick framed roof with connection to Cummings House

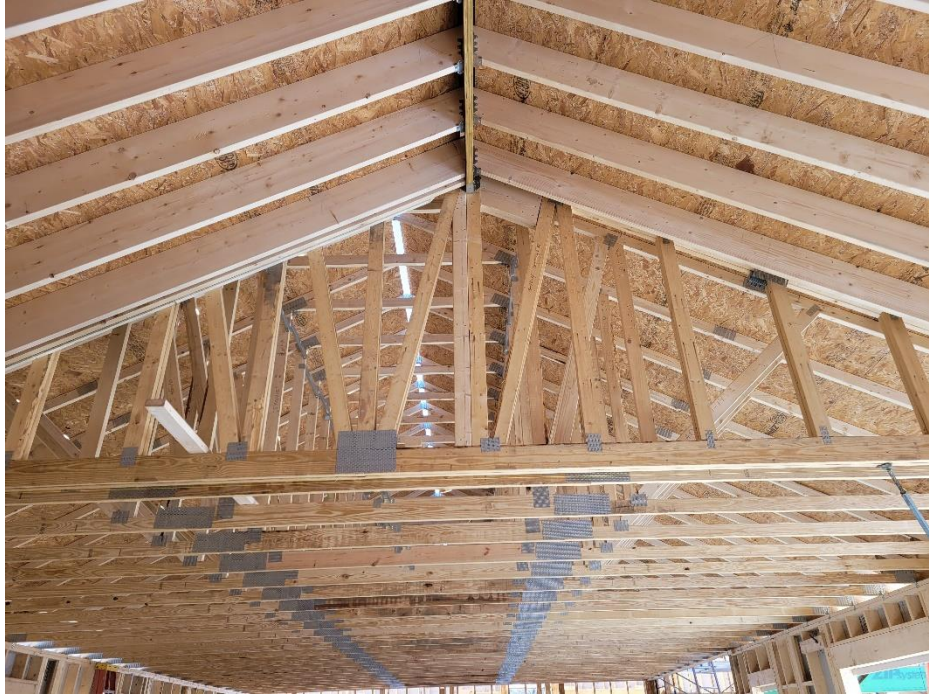
9. End truss at junction with stick framed roof

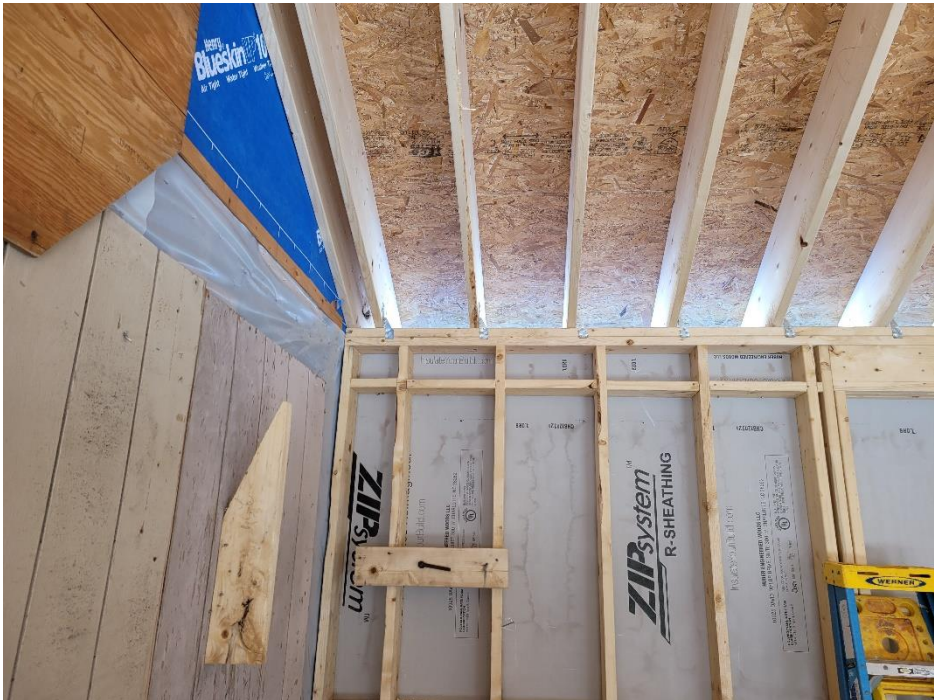
10. Rafter to plate connection at north wall

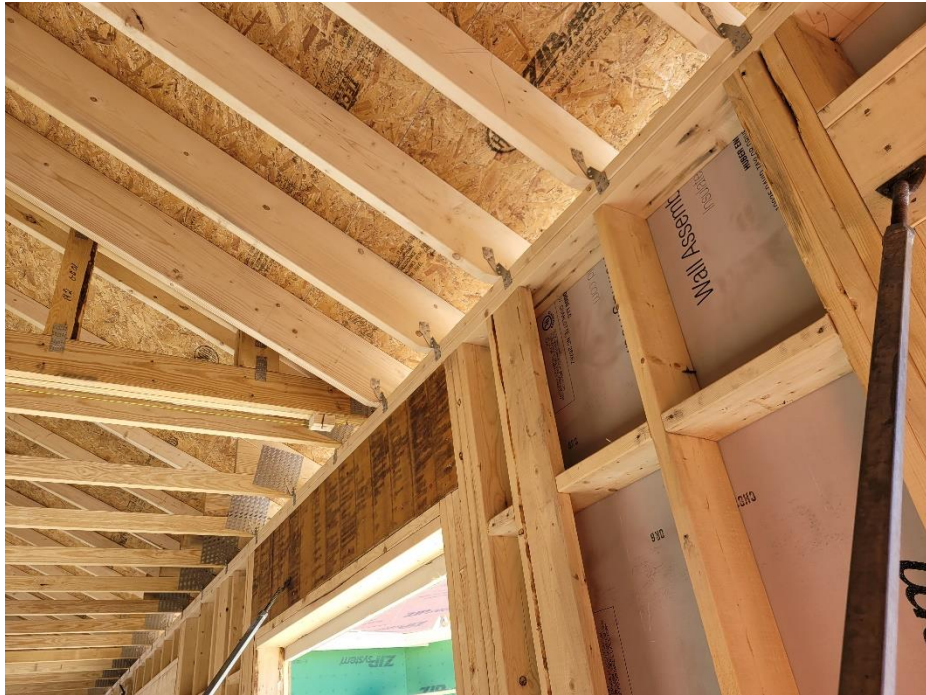
11. Rafter to plate connection at south wall

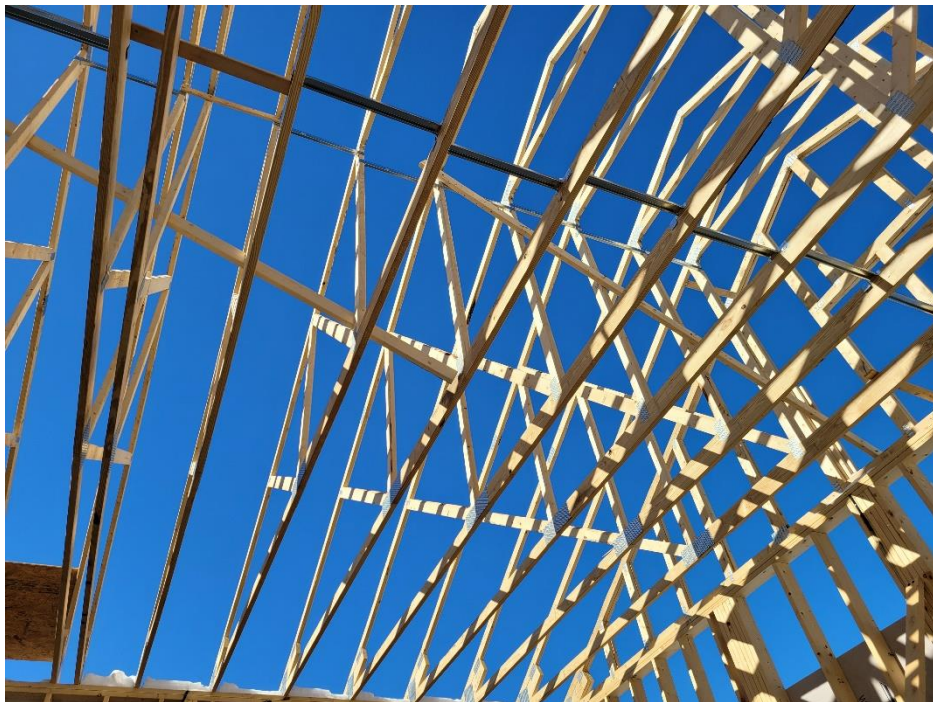
12. Roof trusses at Multipurpose/ Kitchen Wing prior to sheathing installation

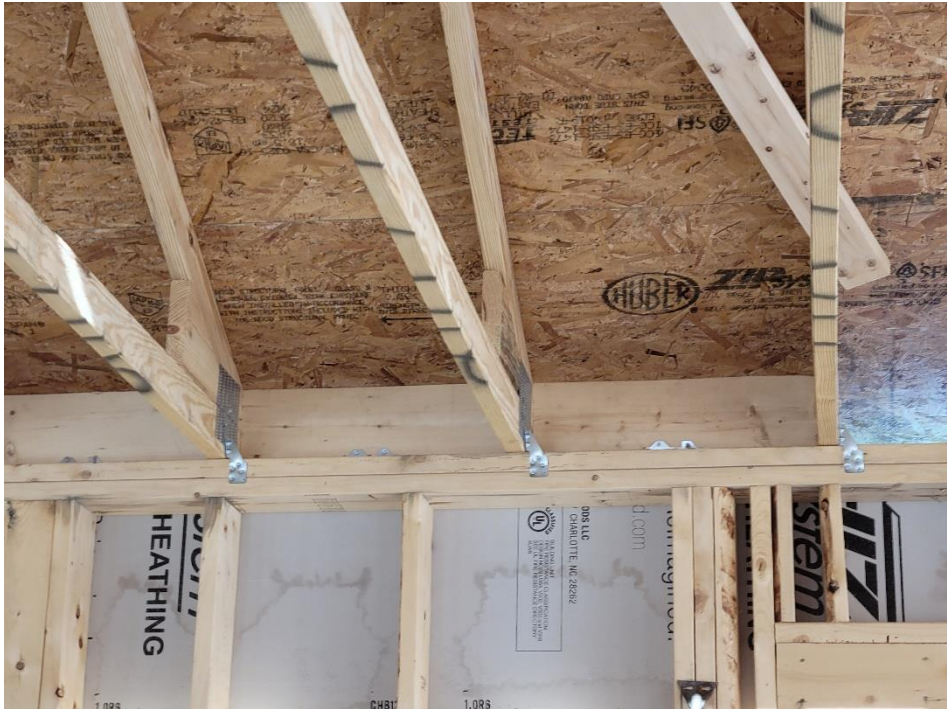
13. Shear blocking between trusses above shear wall (north wall)

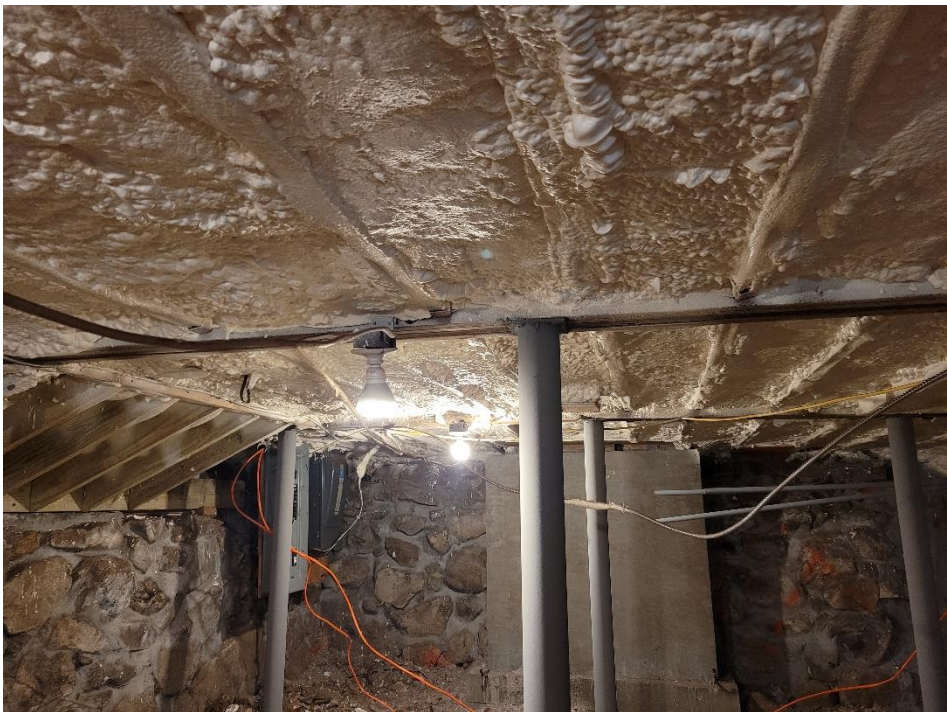
- a. Spray foam insulation installed at first floor framing overhead (photo 14, 16);
- b. Lally columns painted with zinc-ich paint (photo 15)

14. Spray foam insulation and painted columns at Cummings Basement

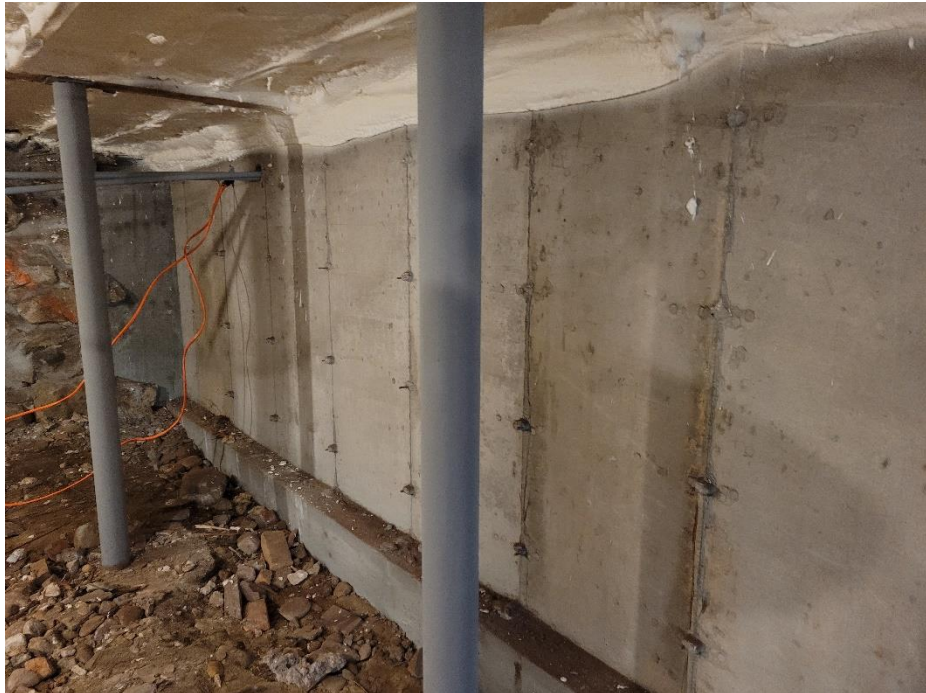
15. East wall of Cummings House at Basement

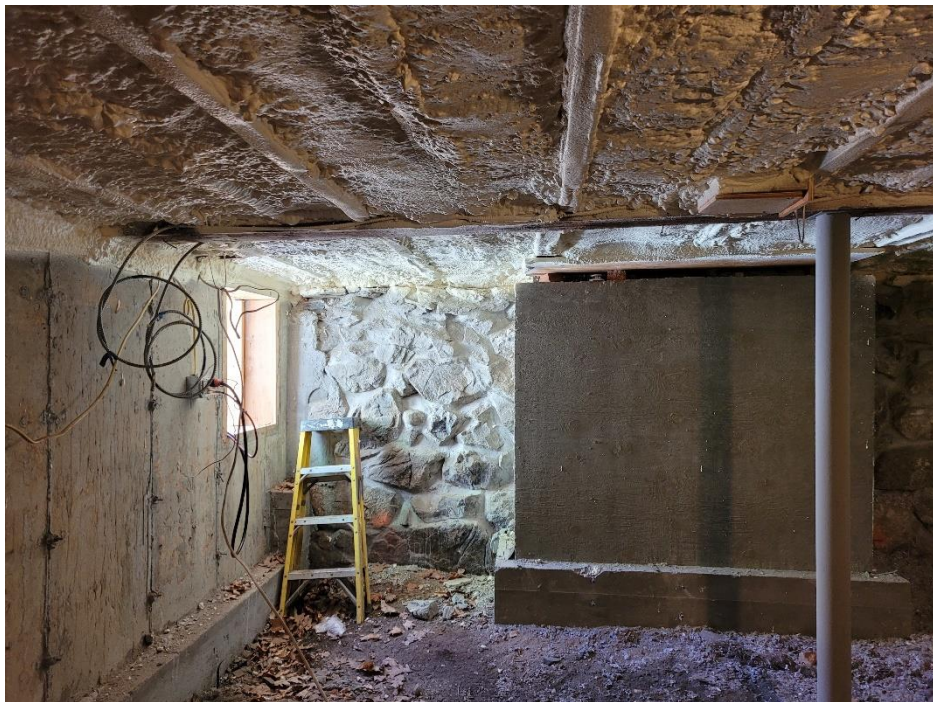
16. Basement of Cummings House toward access opening at the southeast corner

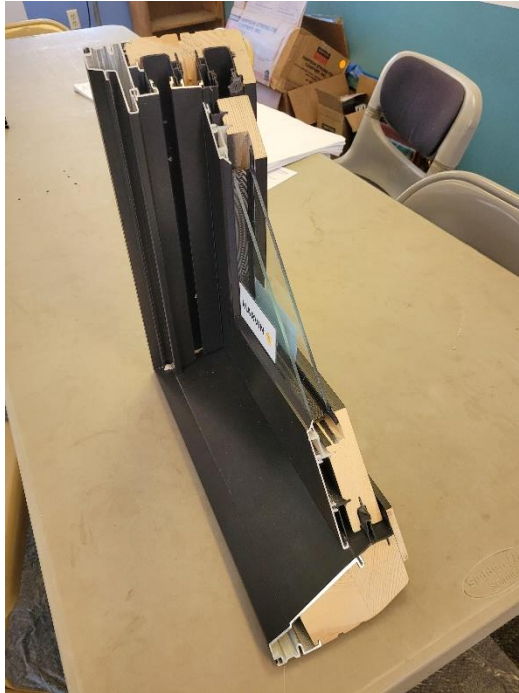
17. Sample cut of typical window at Addition- exterior aluminum cladding (sample only- final to be white)

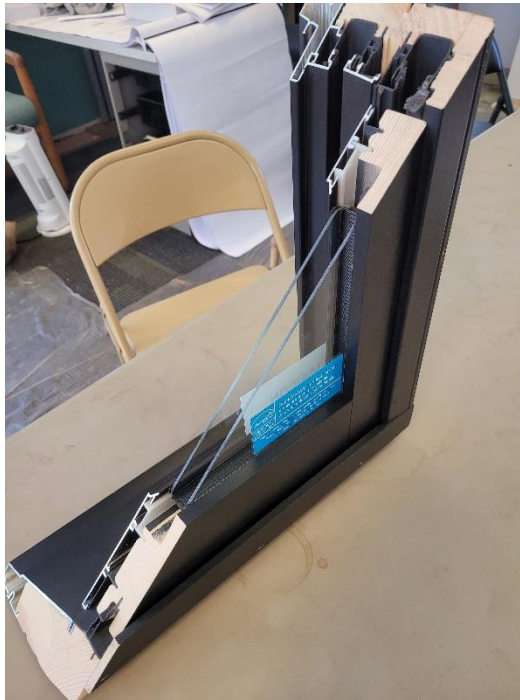
18. Interior view of Marvin window sample (final interior to be stained pine)
