Field Report

**Project: Boxford Community
Senior Center
10 Elm Street Boxford, MA 01921**

Report No.:**016****GRLA Project No.:****2020120.01****Date of Site Visit:** 18 January, 2022

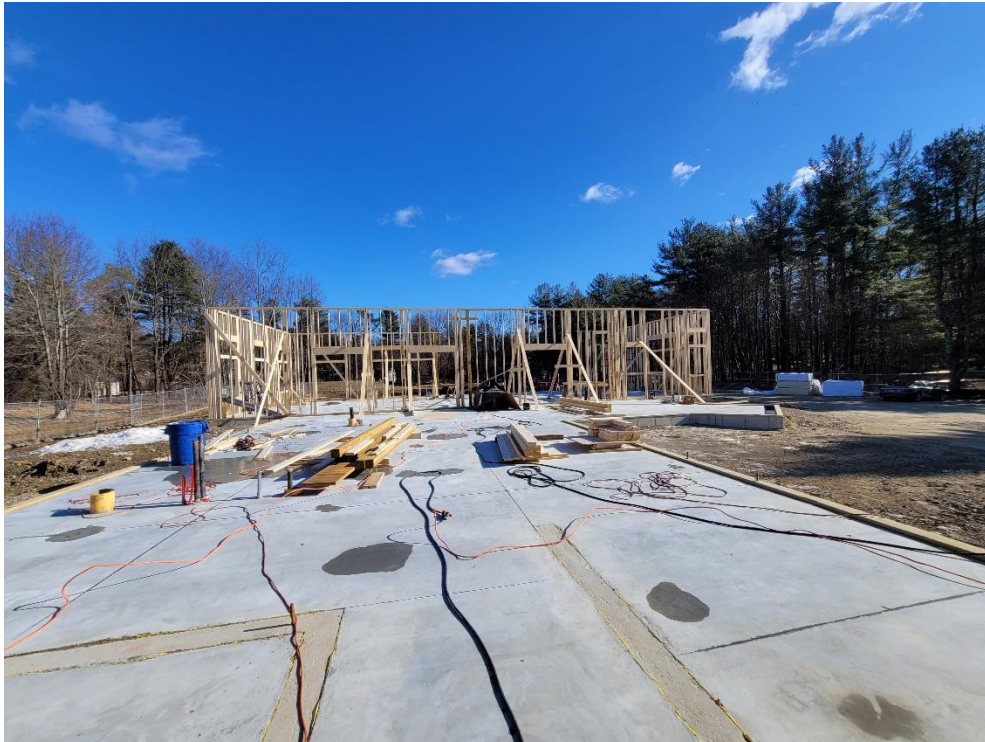
- a. All slabs are saw-cut, cured and ready for wood framing (photos 1,2,6,7,8,9).
- b. The new Addition slab is tied into the east wall of Cummings House.

1. View of new Office Wing Slab from Cummings House

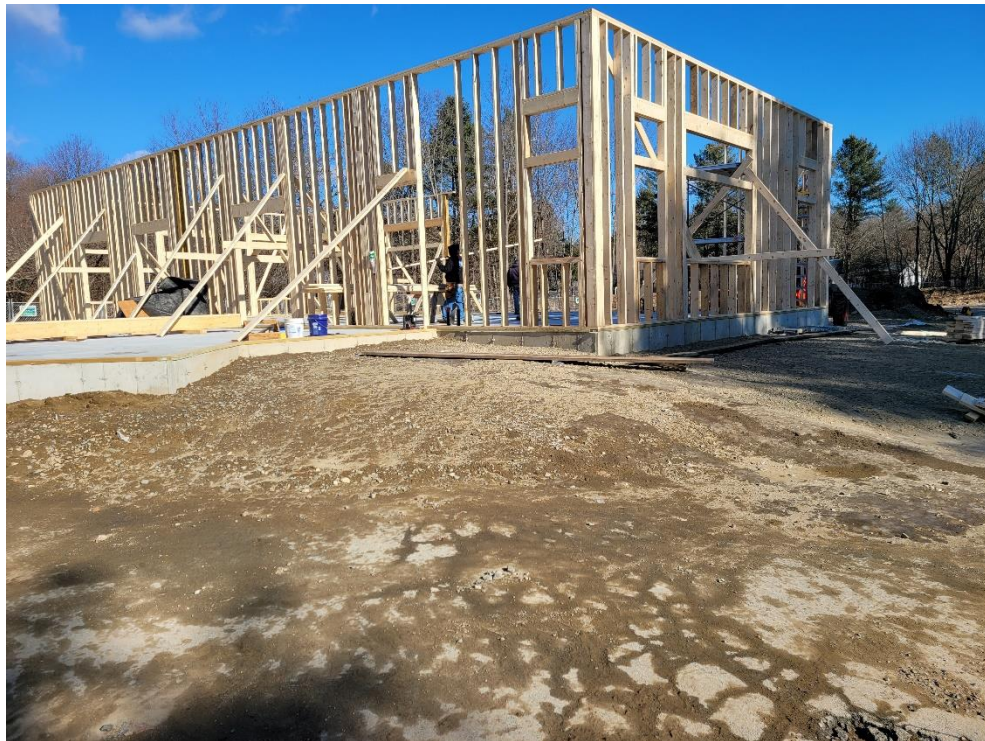
2. Exterior wall framing at Multipurpose/ Kitchen Wing

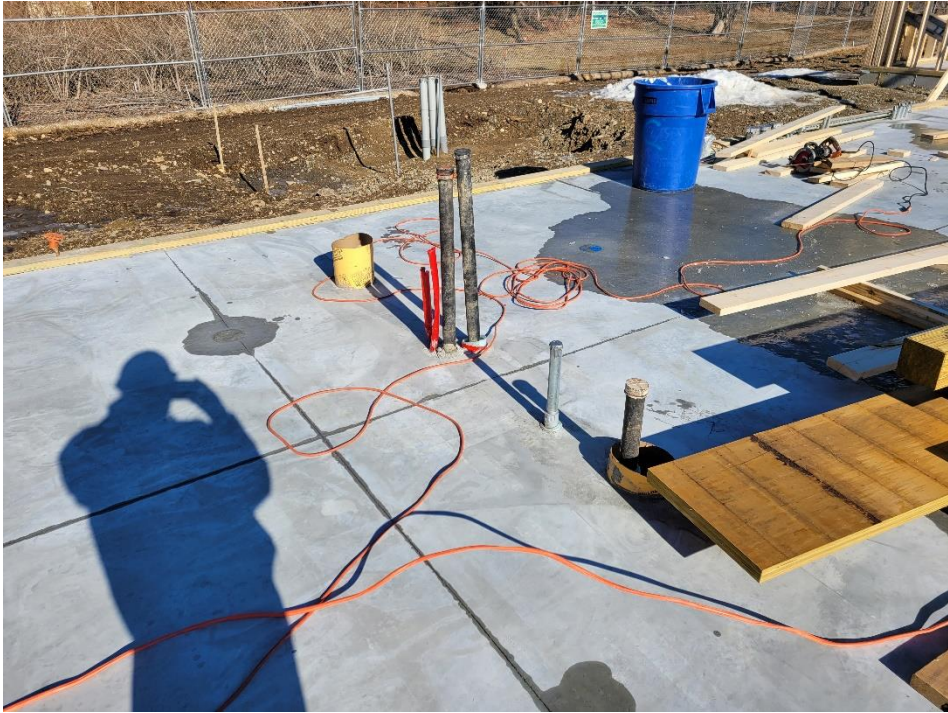
3. Plumbing at future toilet rooms

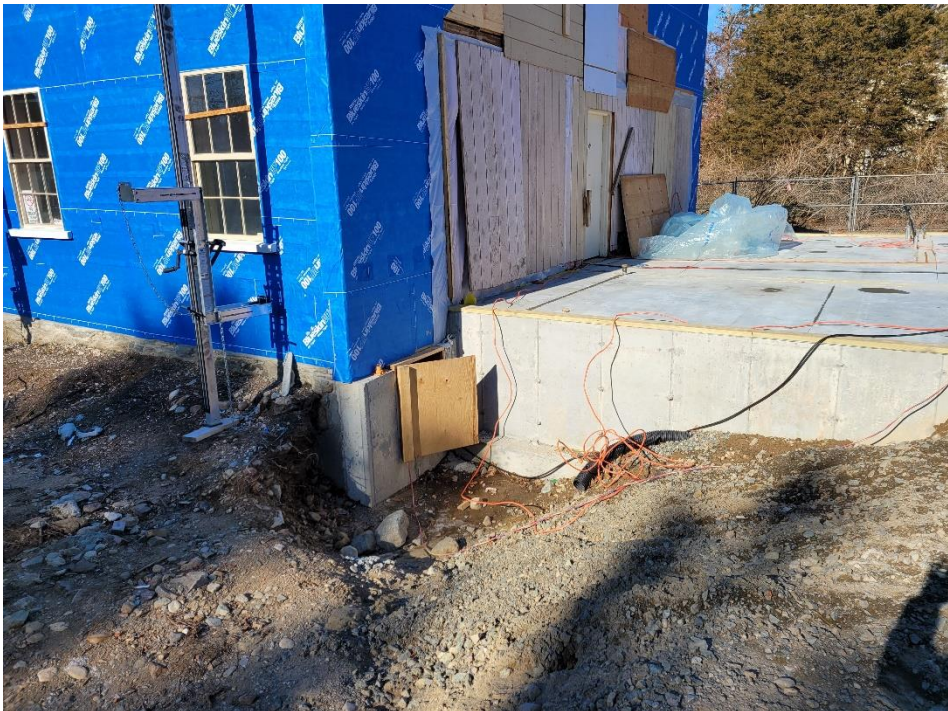
4. Tie-in to East Wall of Cummings House

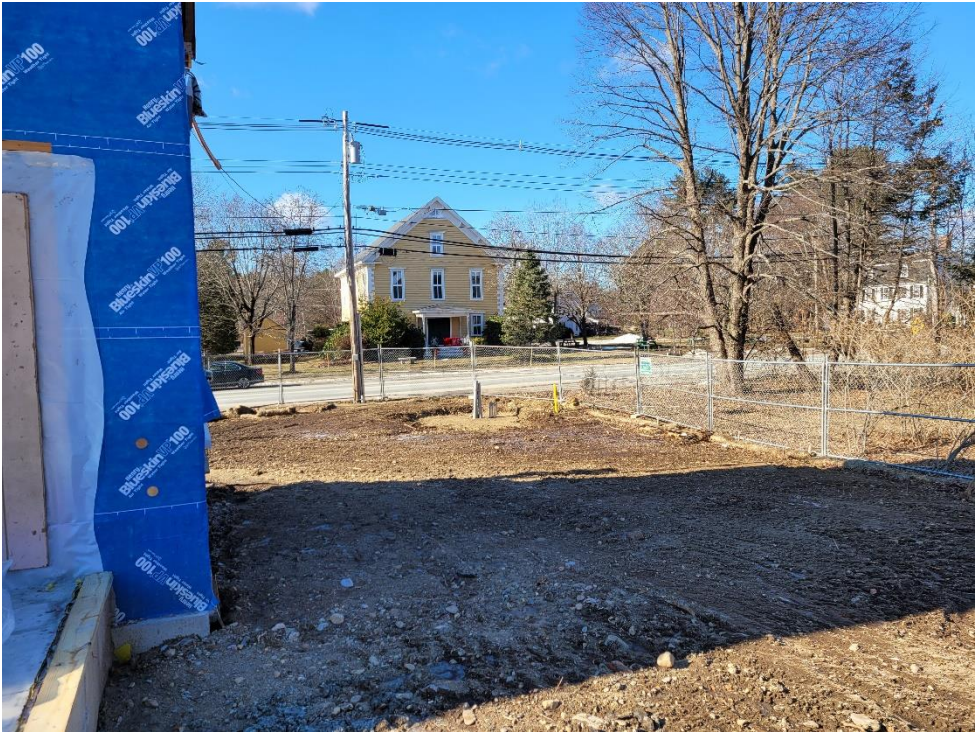
- a. Electrical ductbank has been in-filled;
- b. Clerk-of-the works, Fred Scibelli, recorded install of electrical warning tape above the ductbank per his daily report dated 01-06-2022.

5. Duct bank for new electrical and communications services has been backfilled

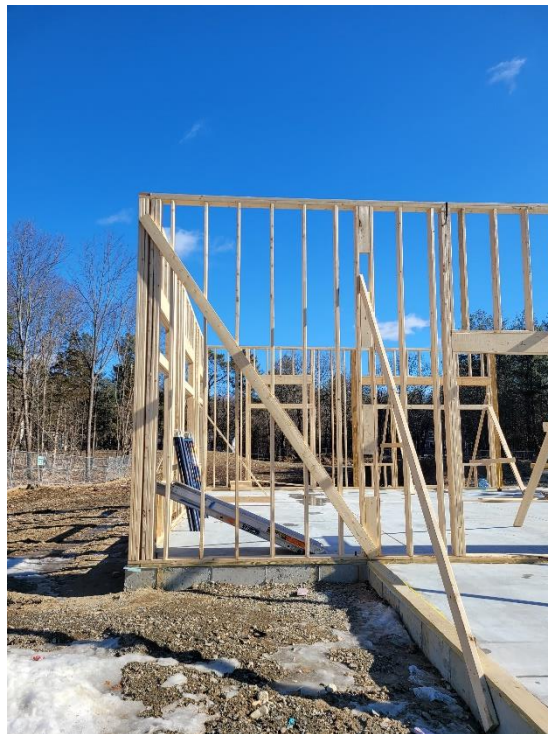
6. Northwest corner of Multipurpose Room

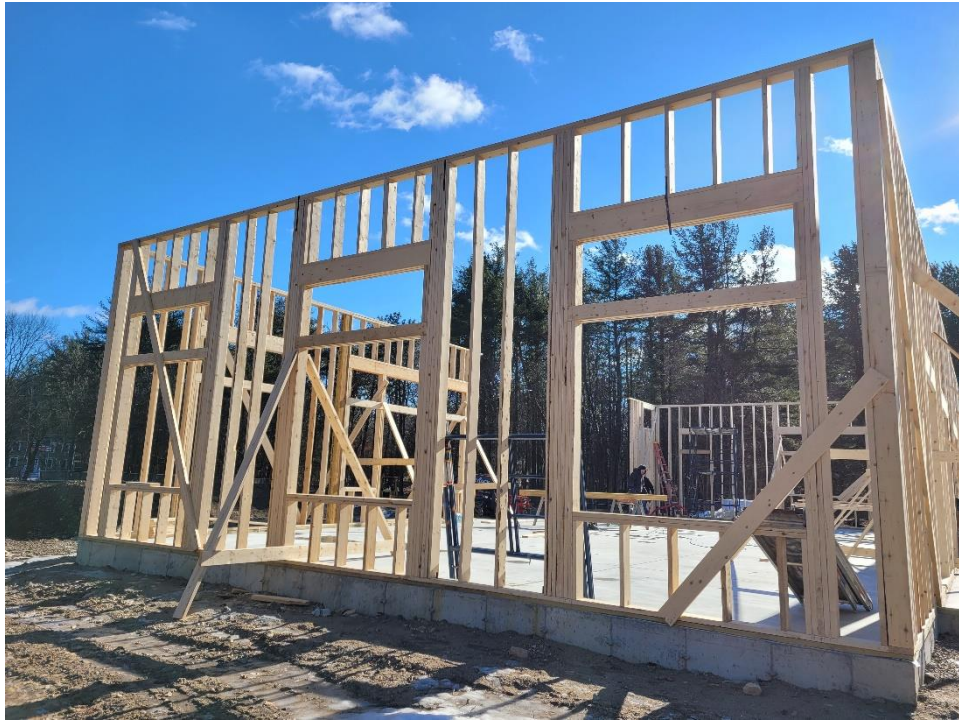
7. North wall of Multipurpose Room (14 feet high)

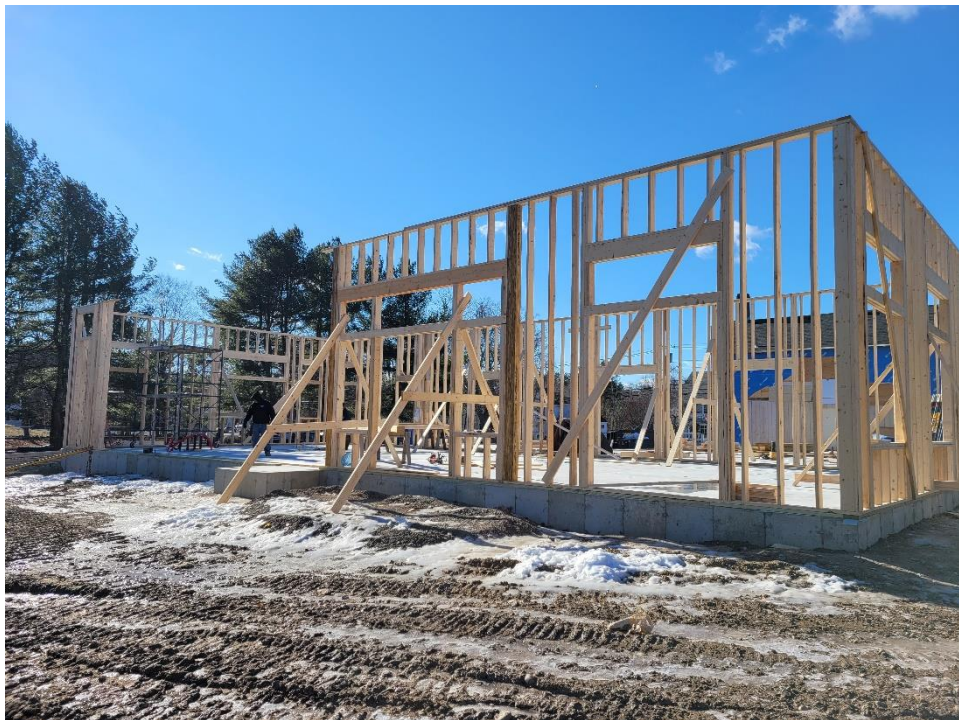
8. East Wall of Multipurpose/ Kitchen Wing

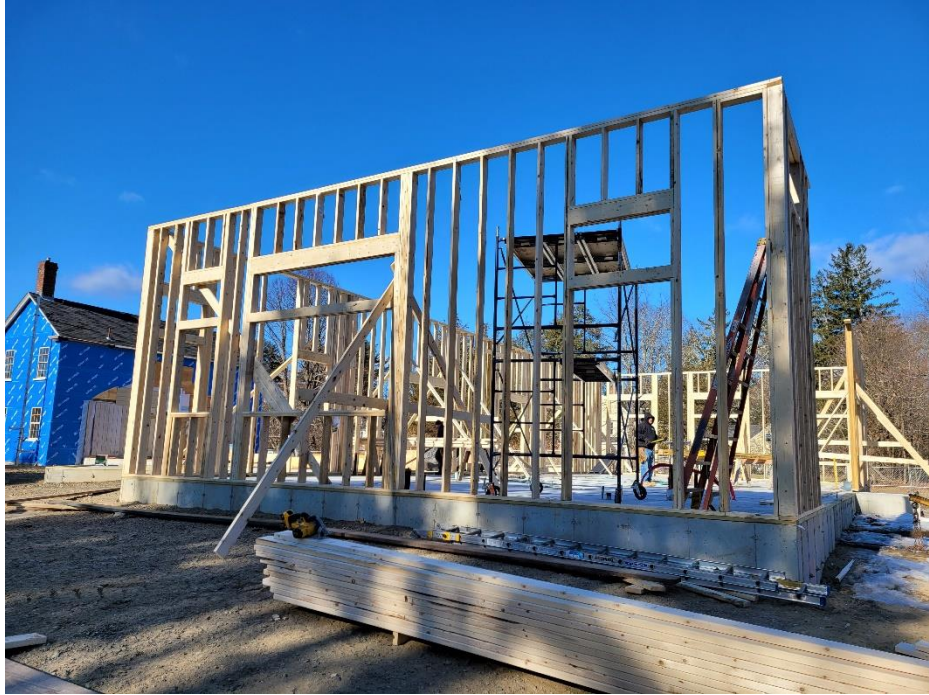
9. South wall of Kitchen

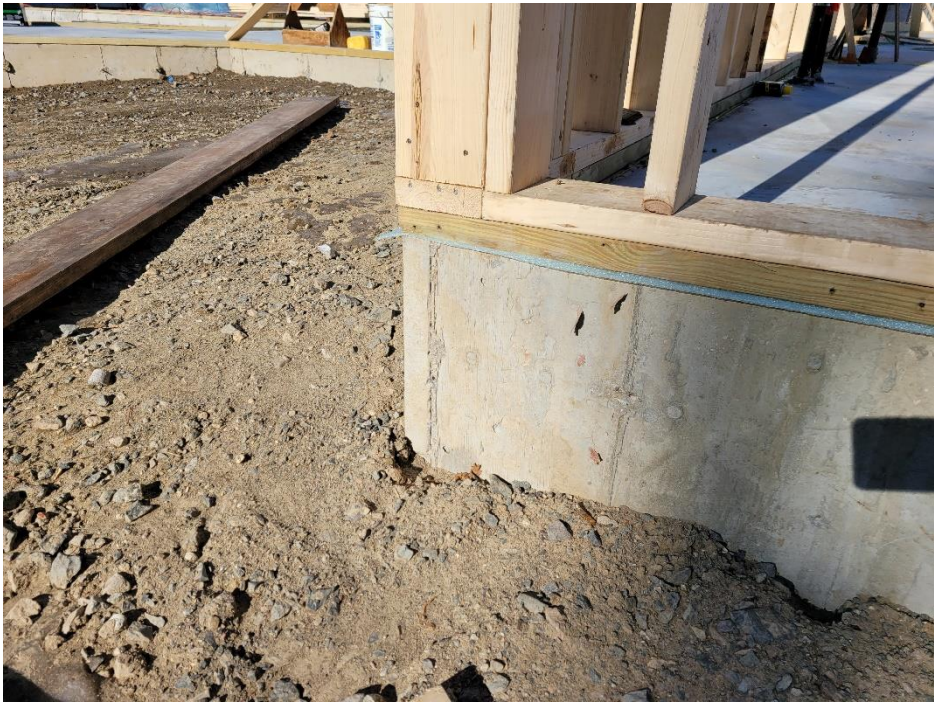
- a. Framing of walls at Multipurpose/ Kitchen Wing are at the 3rd day of framing.
- b. Closed cell sill sealer installed on top of concrete foundation wall under PT sill (photo 10).
- c. Classic has been pre-cutting studs and headers for framing effort.
- d. Temporary enclosure was constructed by Classic against the east side of the storage container to provide heated indoor space for pre-cutting framing members (photo 11).
- e.

10. Sill detail- typical at perimeter of new addition

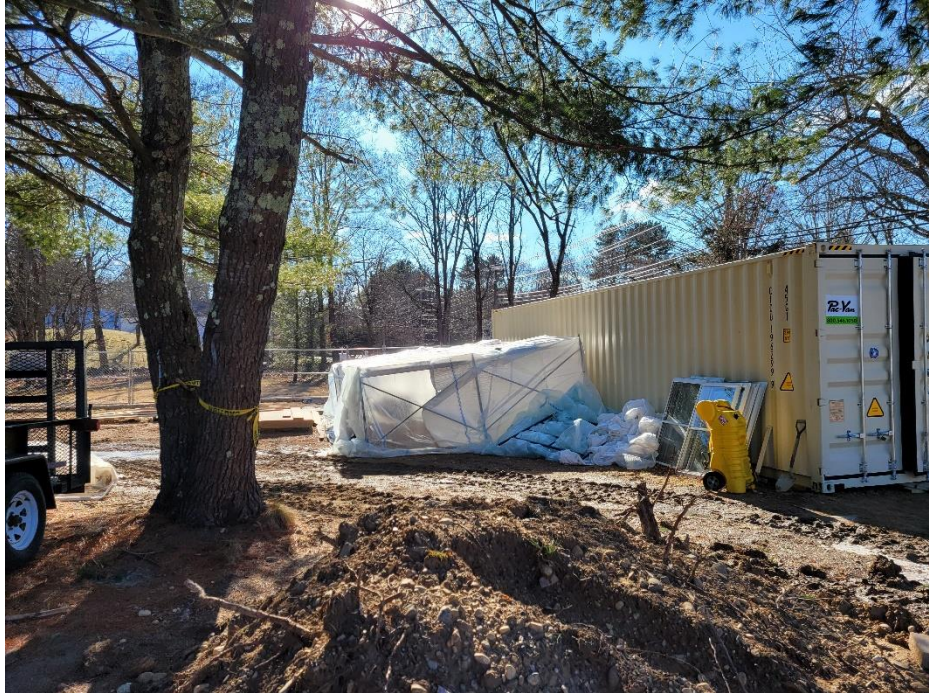
11. Temporary heated enclosure off storage unit

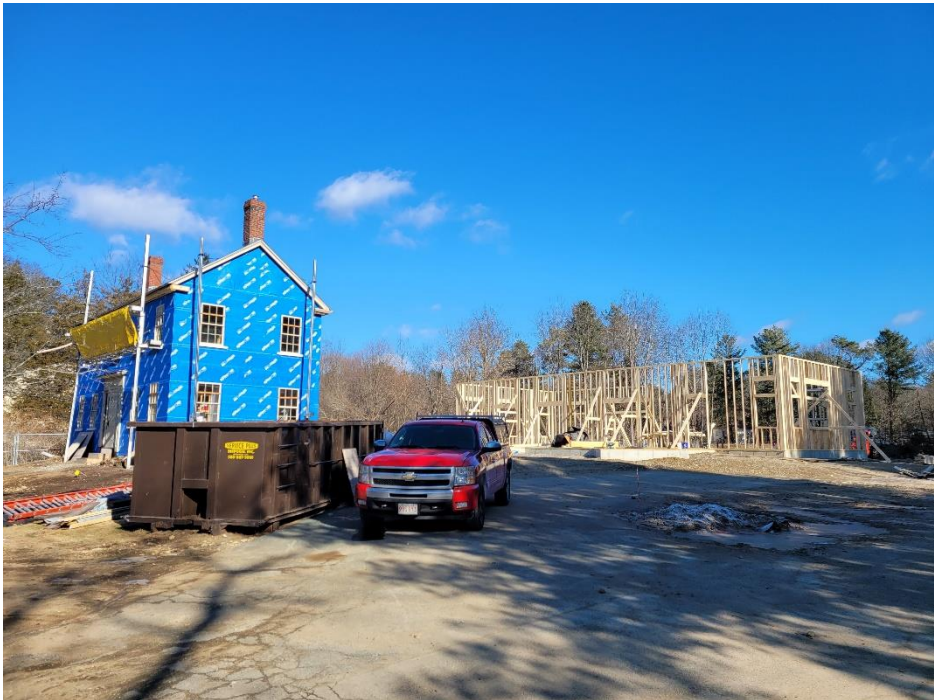
12. View of framing progress from southwest

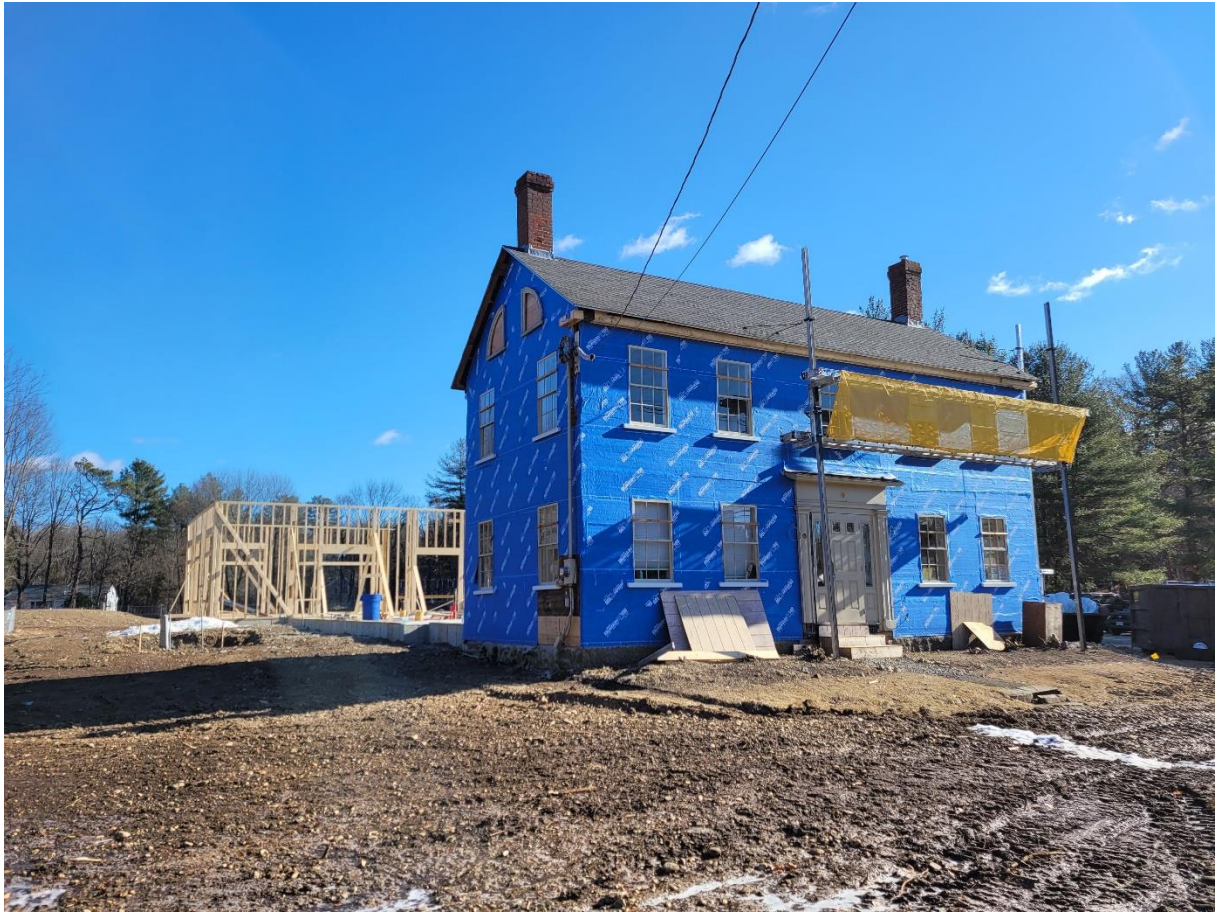
13. View from the northwest
