Field Report**Project: Boxford Community****Senior Center****10 Elm Street Boxford, MA 01921****Report No.:****017****GRLA Project No.:****2020120.01****Date of Site Visit:** 25 January, 2022**Routed to:** Peter Delaney, Boxford Building Inspector
Bob Hazelwood, PBC
Matthew Coogan, Town Administrator
Mike Abraham, Classic Construction
Bryan Gannon, Classic Construction
Paul Kalous, Hill International
Fred Scibelli, Hill International
GRLA Files**Temperature:** 36 deg F**Weather:** Cloudy**Time:** 11:40 am – 12:10 pm**PRESENT AT SITE:**

Field Report

Project: Boxford Community

Senior Center

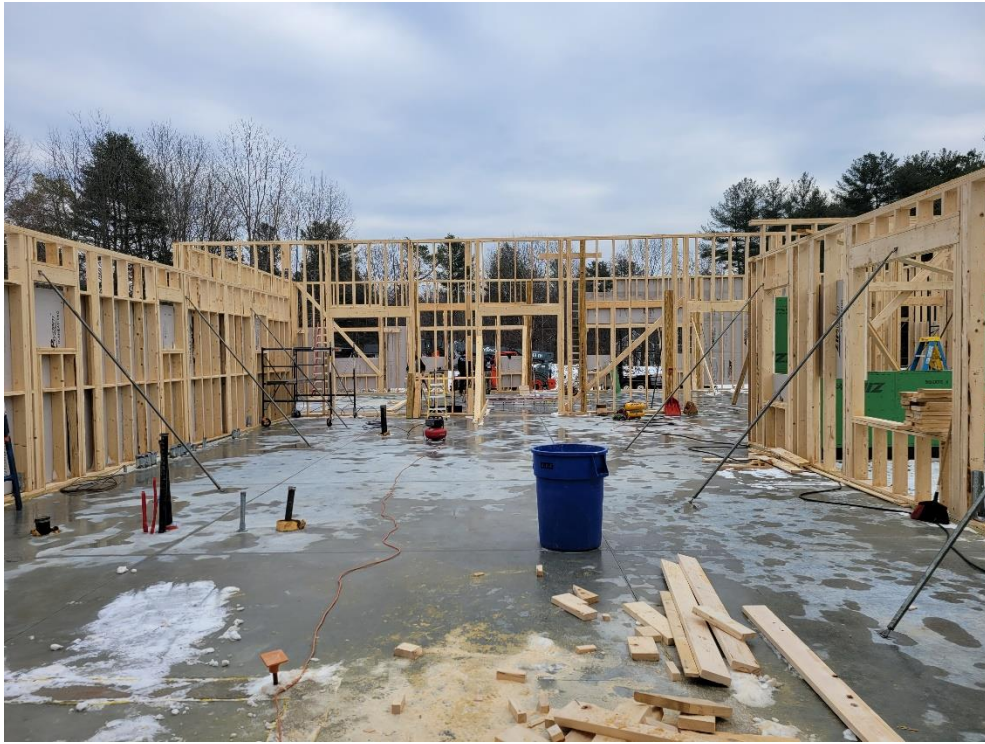
1. View of new Office Wing Wall Framing from Cummings House

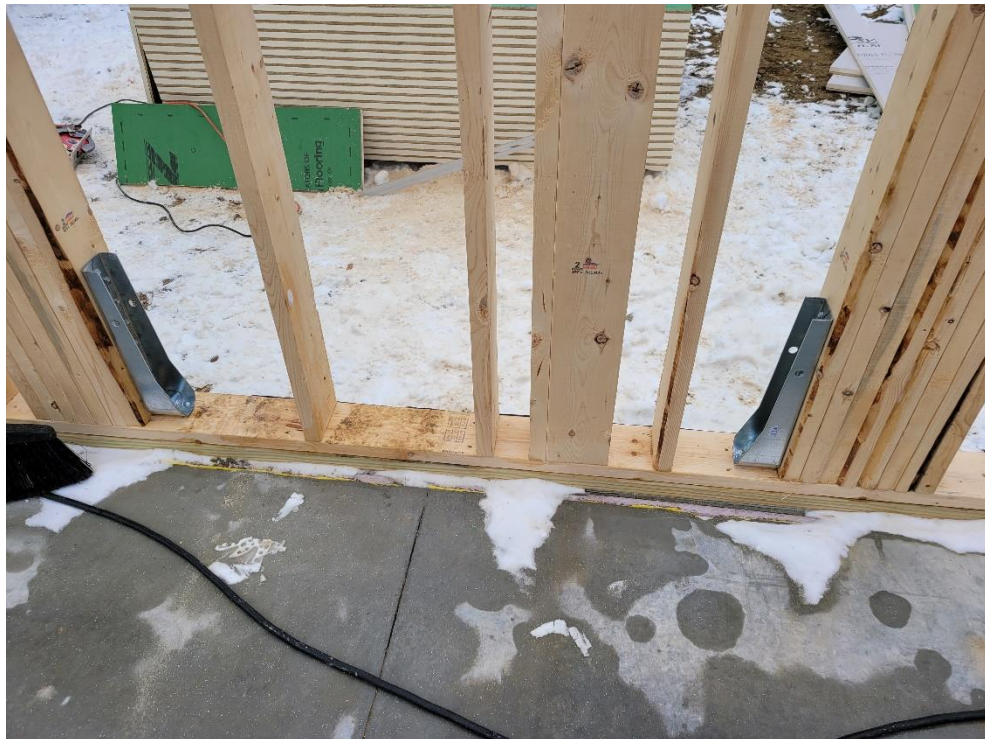
2. Detail of tie-downs at south wall of Office Wing

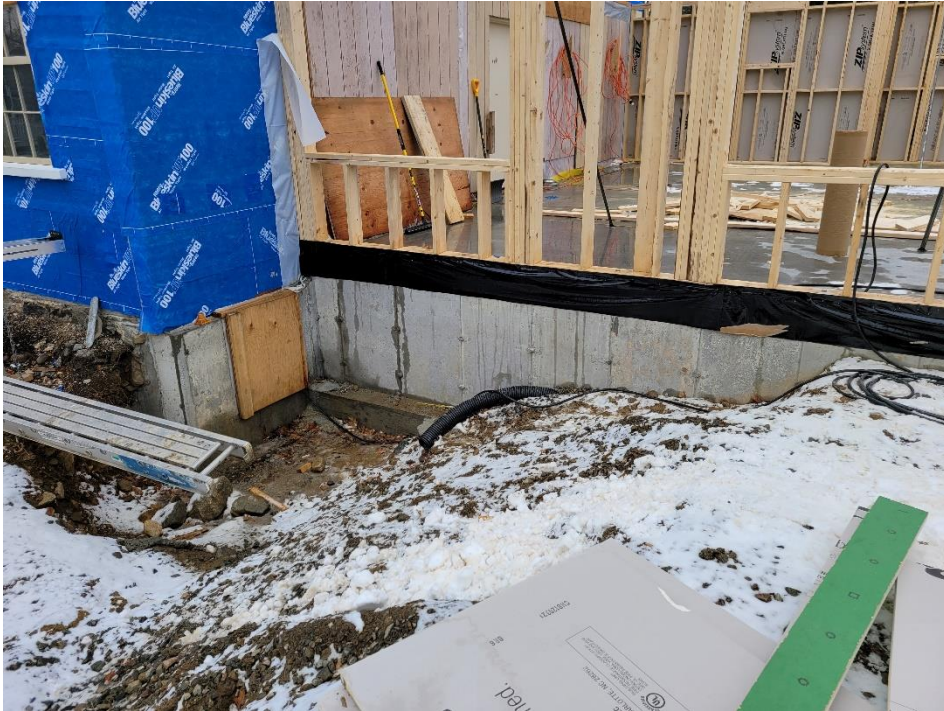
3. Connection of Office Wing to Cummings House- south side

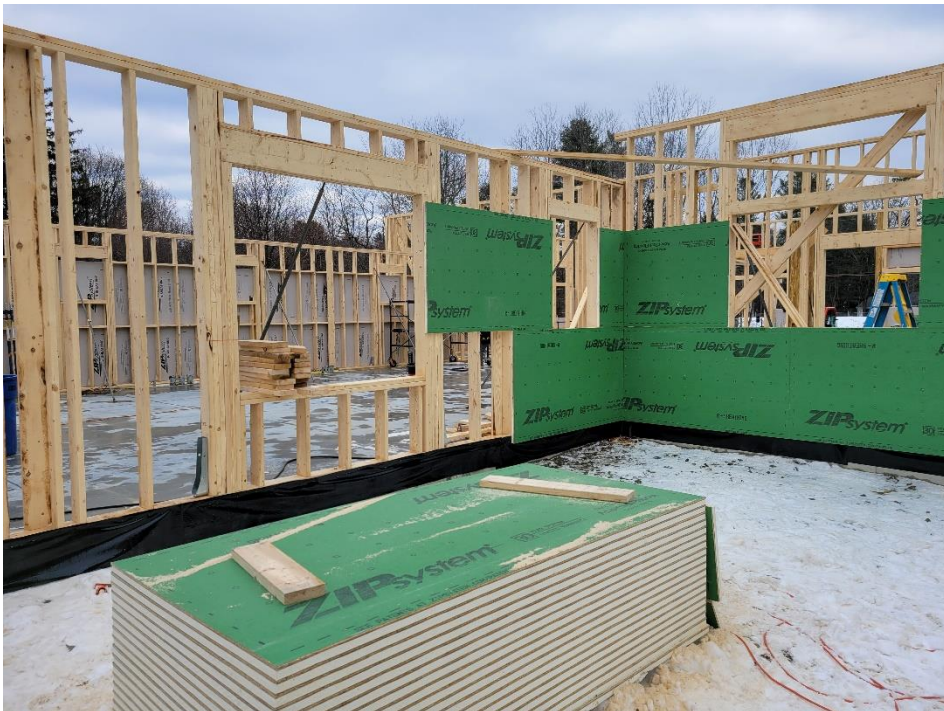
- a. Stud framing of all exterior walls at perimeter of addition and interior wall between Lobby and Multipurpose Room is in place and attached to east wall of Cummings House;
- b. Installation of Zip R-Sheathing (R-6) is in progress; horizontal blocking at panel edges being installed.
 - i. Ice & Water Shield membrane at base of wall installed as Zip wall is installed per SKA-12a and SKA 12b depending on grade elevation.
- c. Simpson tie downs noted at south wall.
- d. First bundle of roof trusses arrived on site; 2nd delivery expected Wednesday (1/26); installation with crane anticipated to occur next week.

4. Installation of Zip R-Sheathing (R-6) with strip of Ice & Water Shield membrane at base per SKA-12a

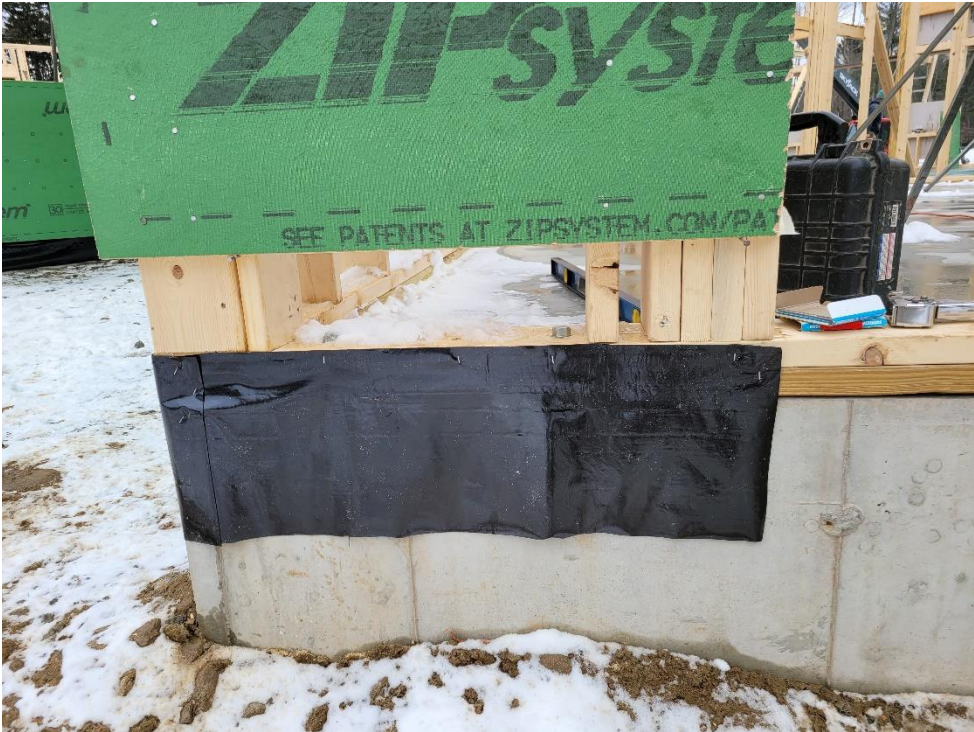
5. Detail of Ice & Water Shield at bottom plate- will wrap up face of P.T. blocking (not yet installed) per SKA-12b

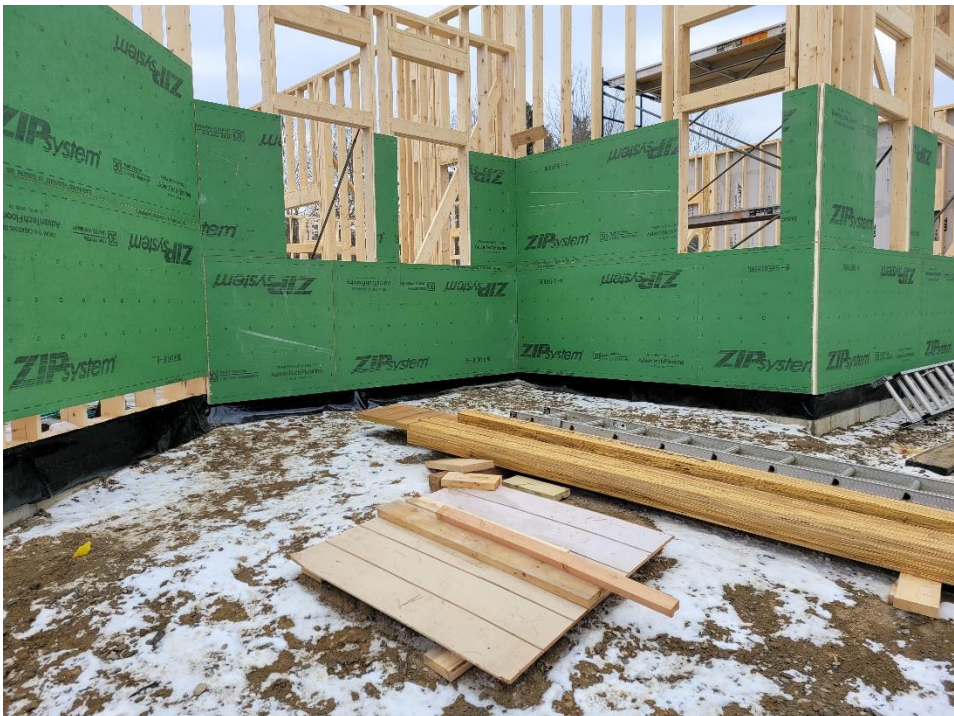
6. South Lobby wall between Main Entry Vestibule (left) and Kitchen Wing (right)

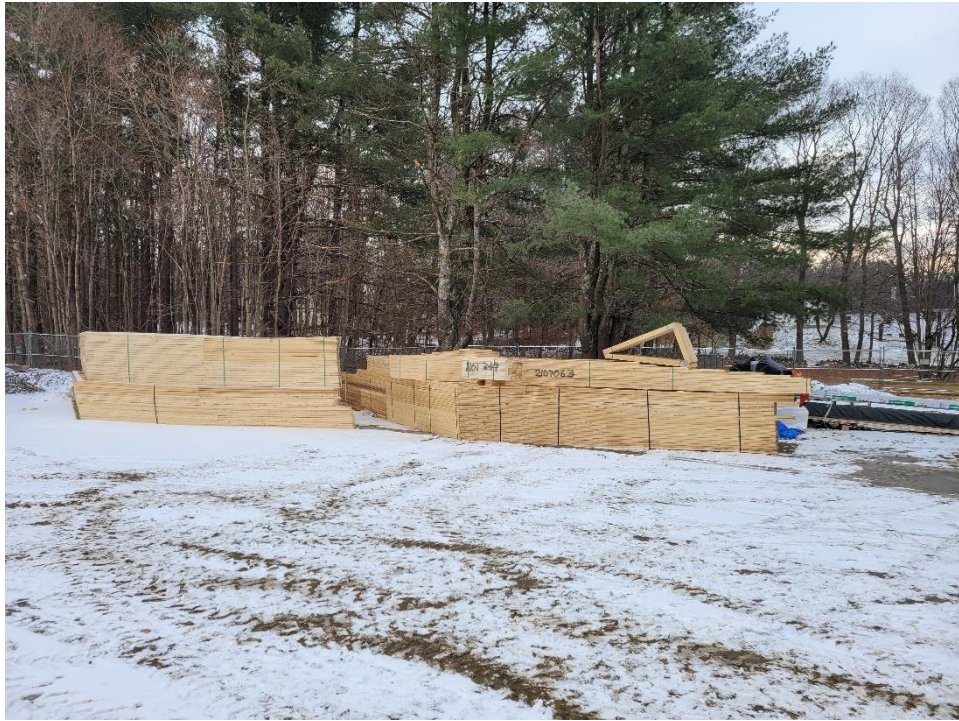
7. First delivery of roof trusses arrived on site

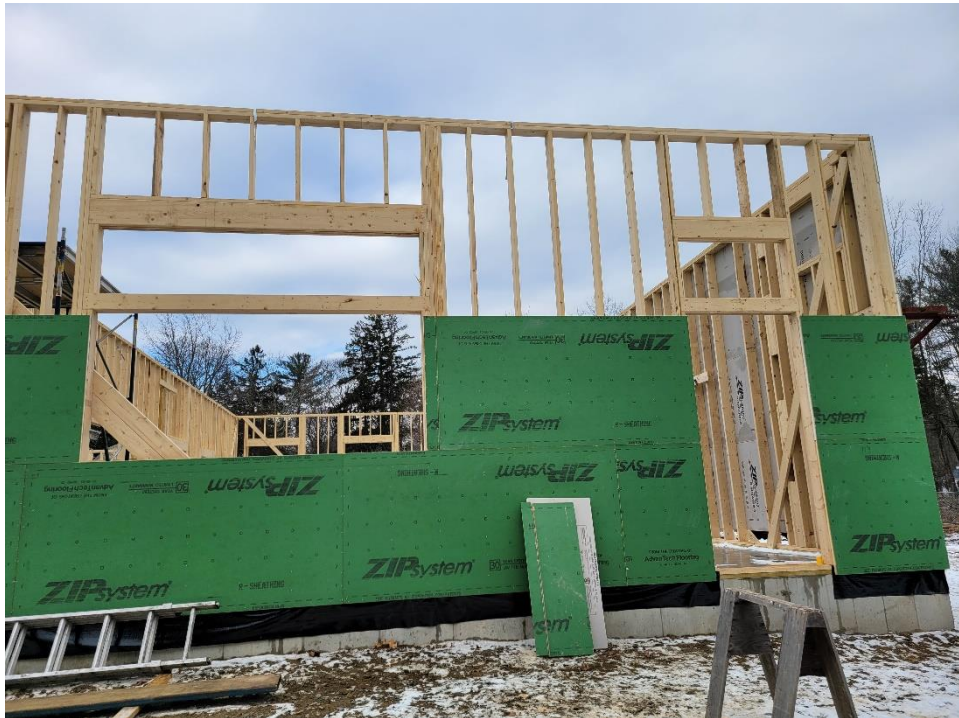
8. South wall of Kitchen Wing

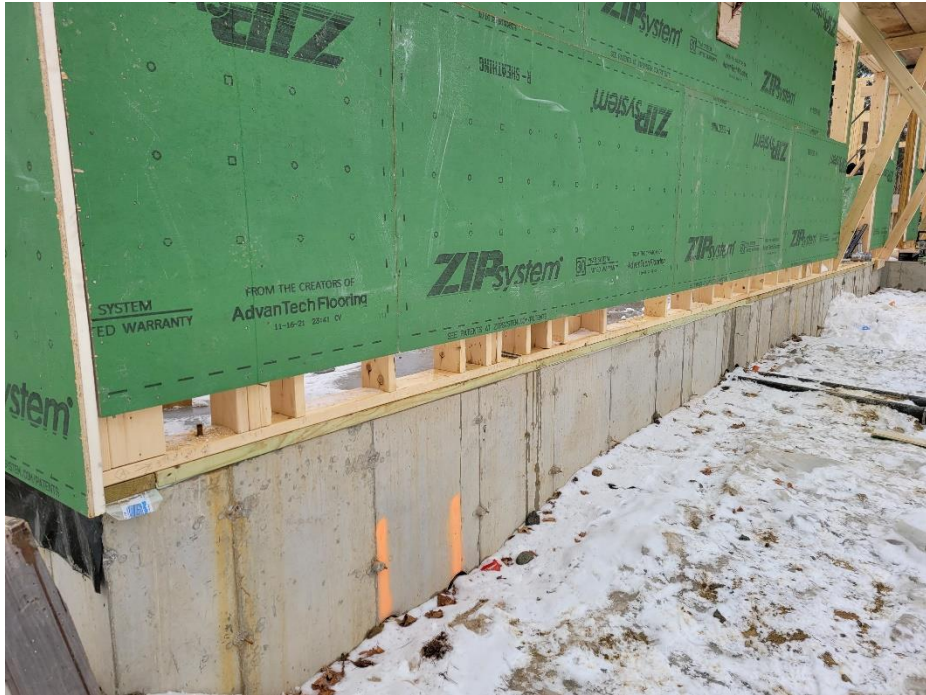
9. East Wall of Multipurpose Room with base detail per SKA-12b

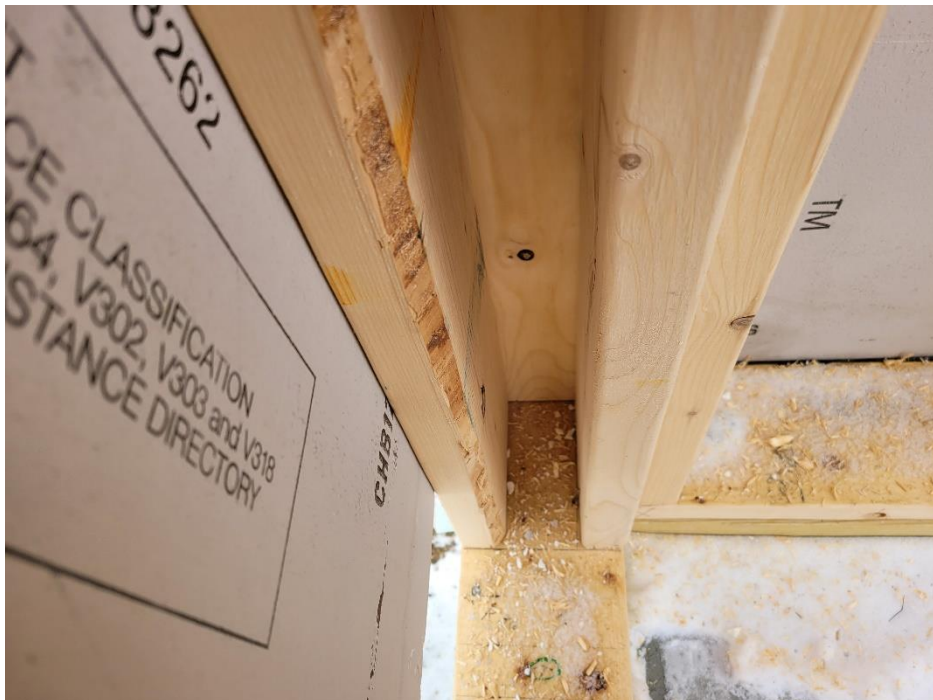
10. Corner framing detail at southeast corner of Kitchen Wing

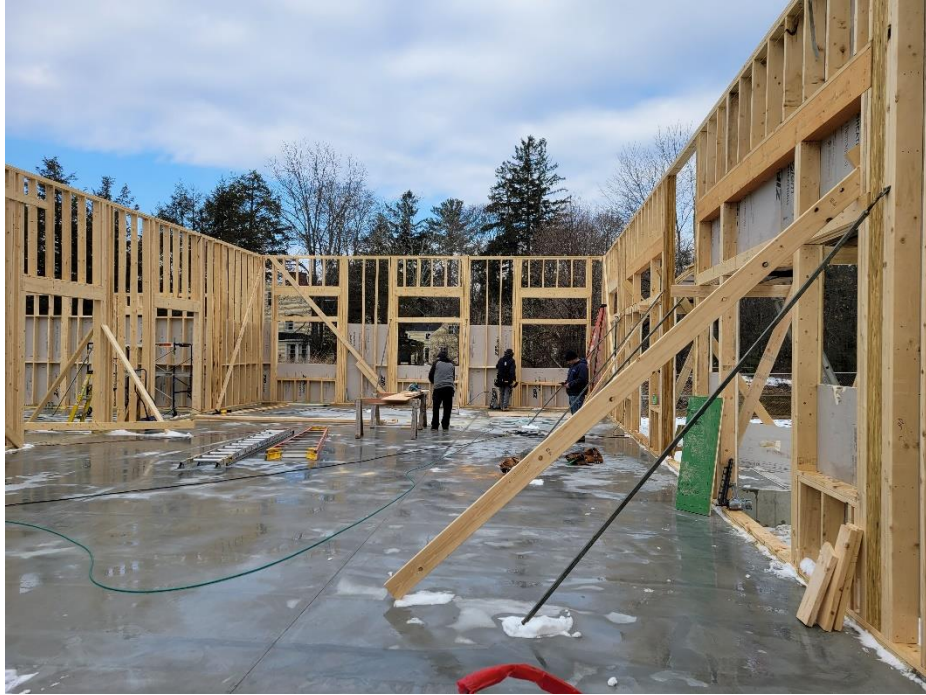
11. Classic carpenters installing blocking

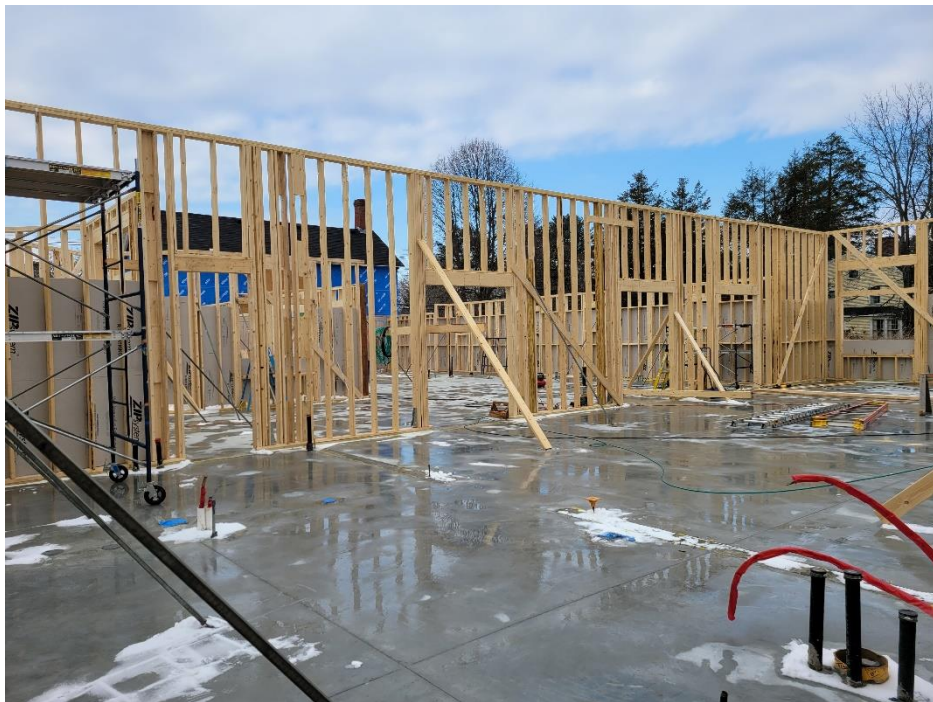
12. Wall between Multipurpose Room and Lobby

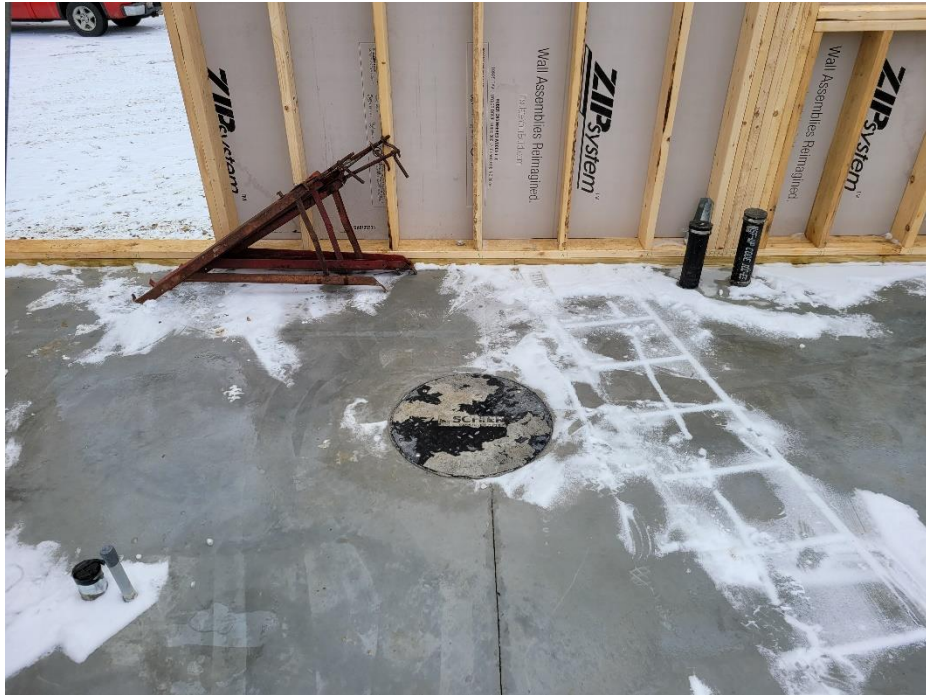
- a. Grease trap cover and floor drains at 3-bay sink location and island sink location noted.

13. Grease trap cover at Kitchen

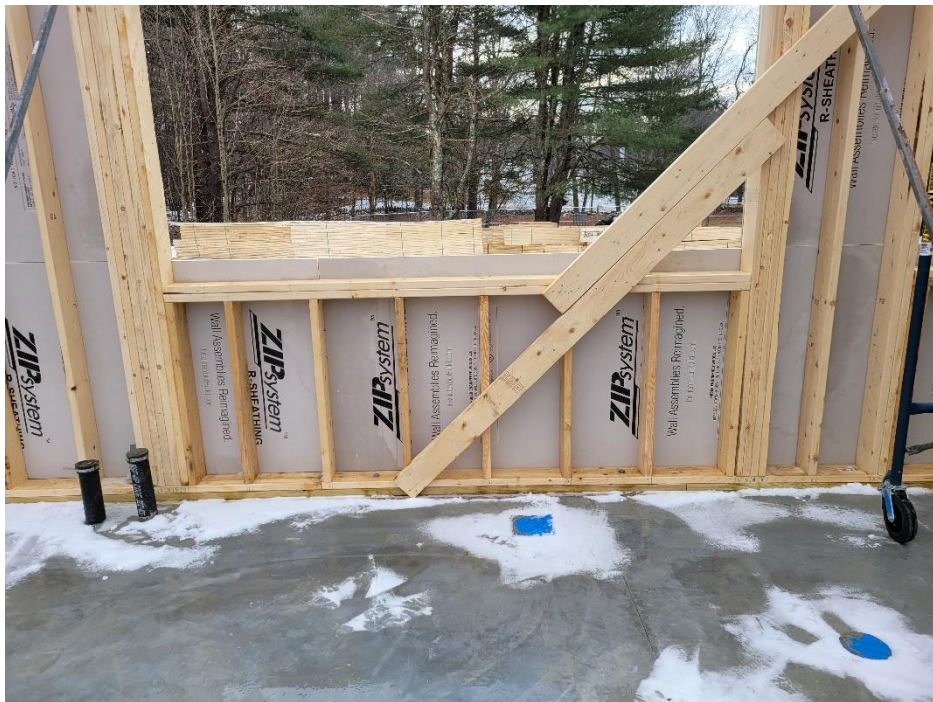
14. Floor drain (blue square) under 3-bay sink

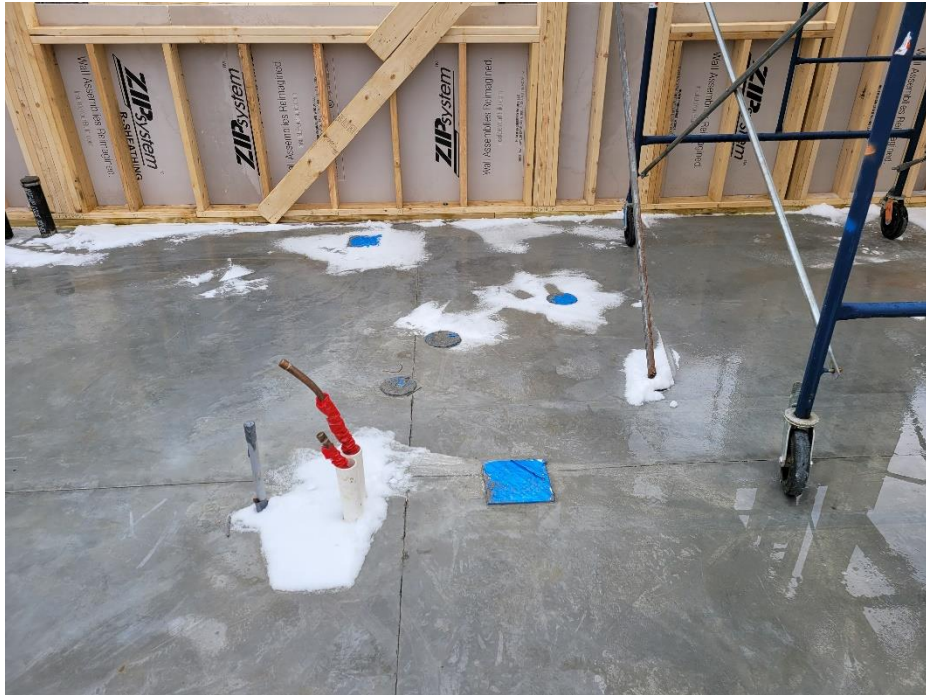
15. Floor drain (blue square) under island sink

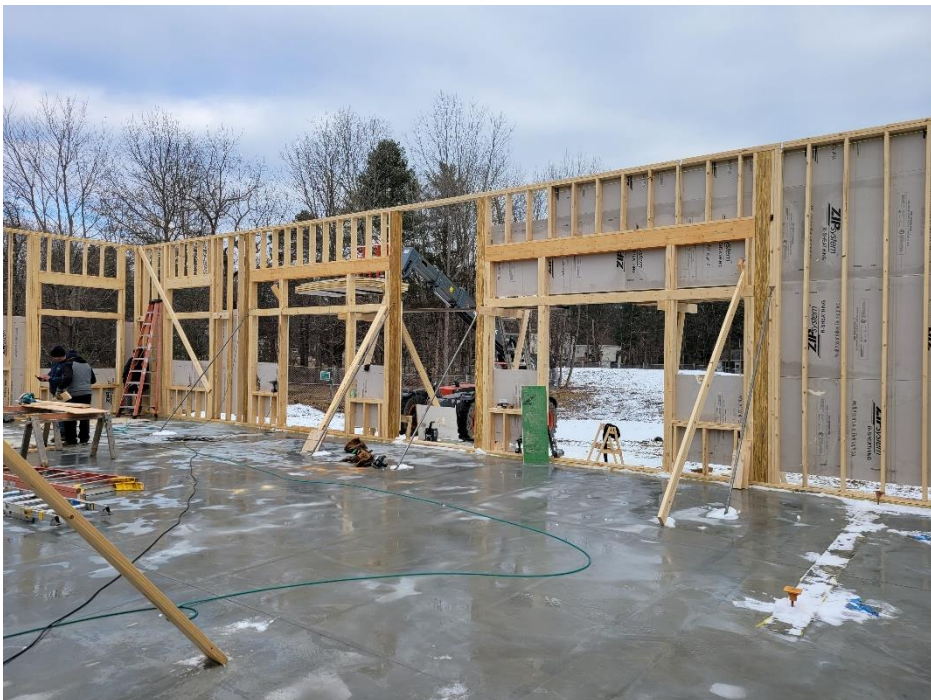
16. South wall of Multipurpose Room

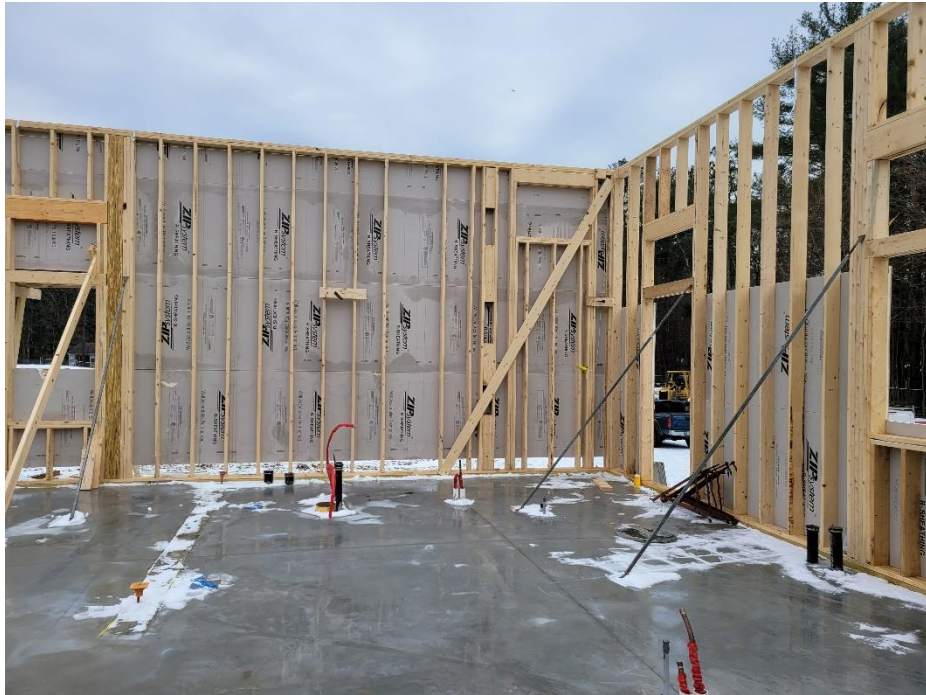
17. North wall of Multipurpose Room

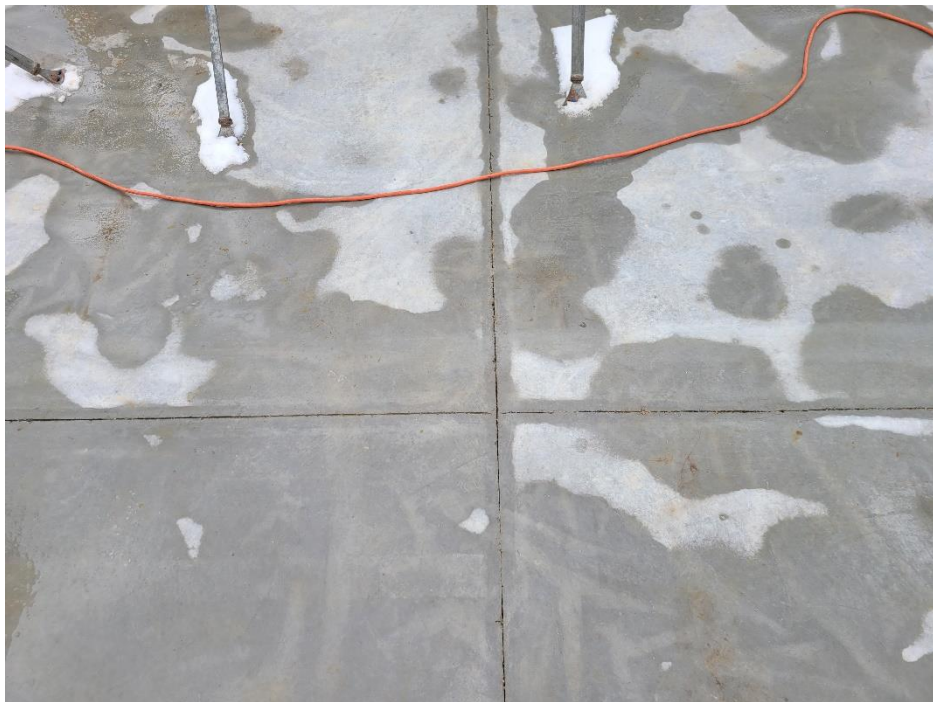
18. Saw cuts in slab

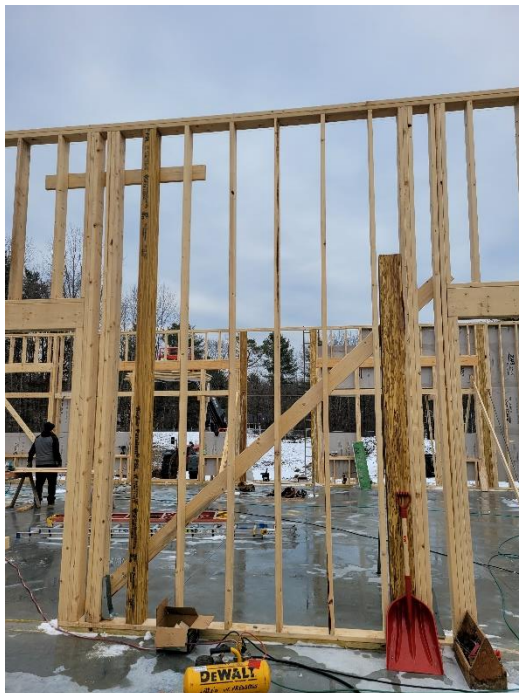
19. Parallam posts at interior wall to Multipurpose Room

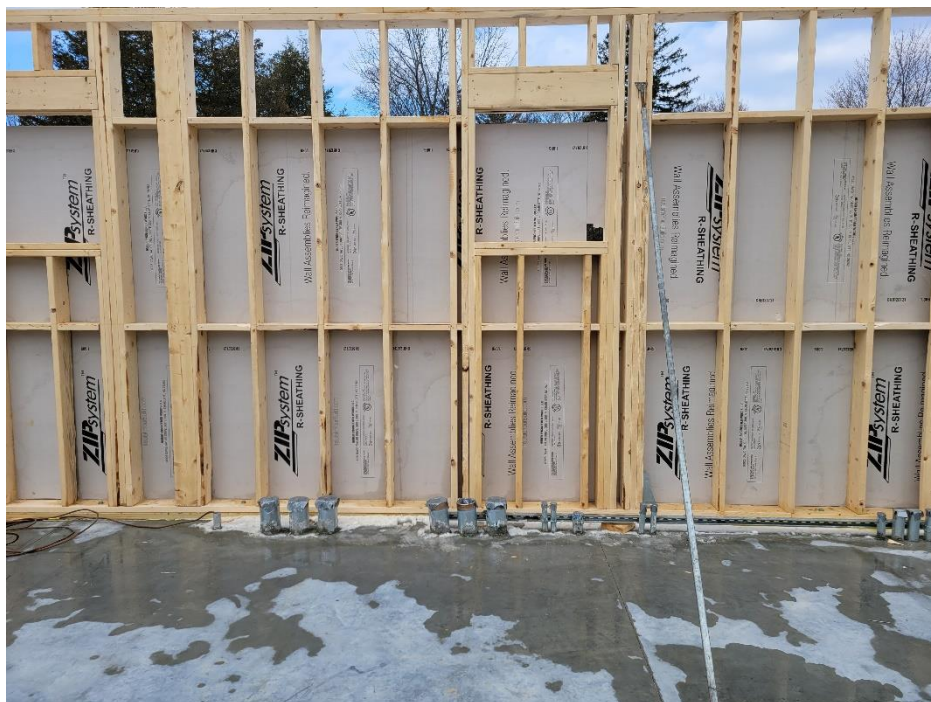
20. Window frame opening at Electrical Room

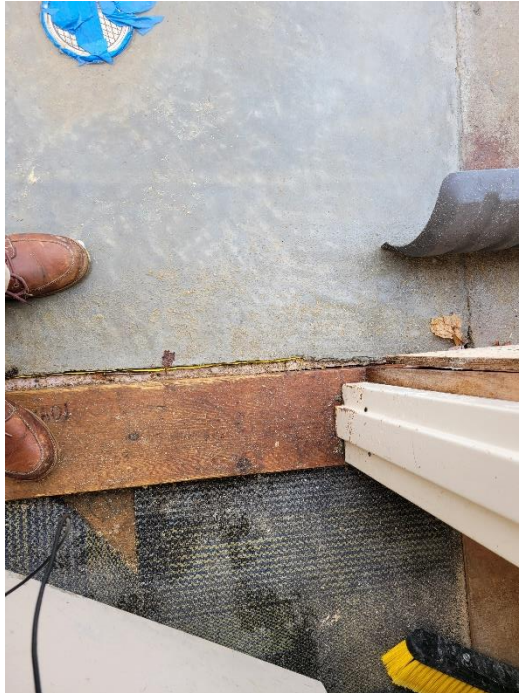
21. Meeting of Office Wing slab to Cummings first floor

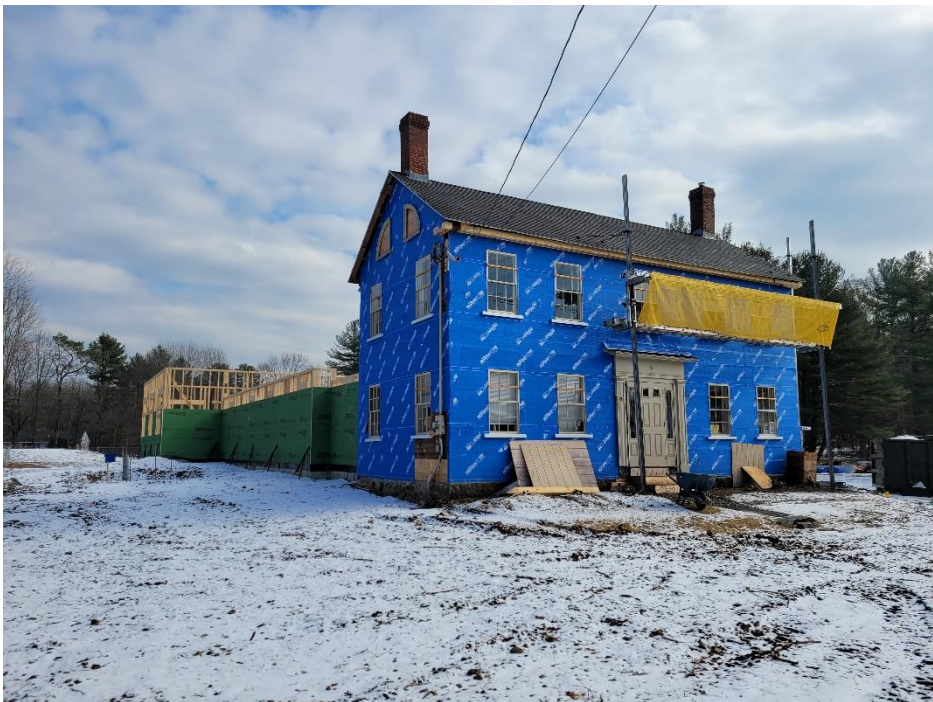
22. Progress view from the northwest

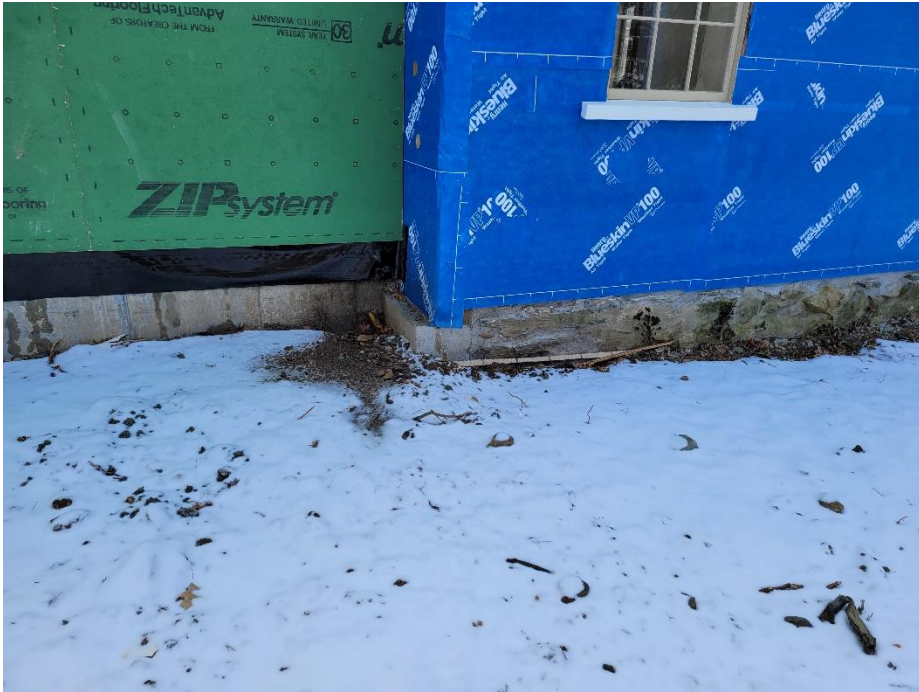
23. Foundation condition at connection between Office Wing and Cummings House

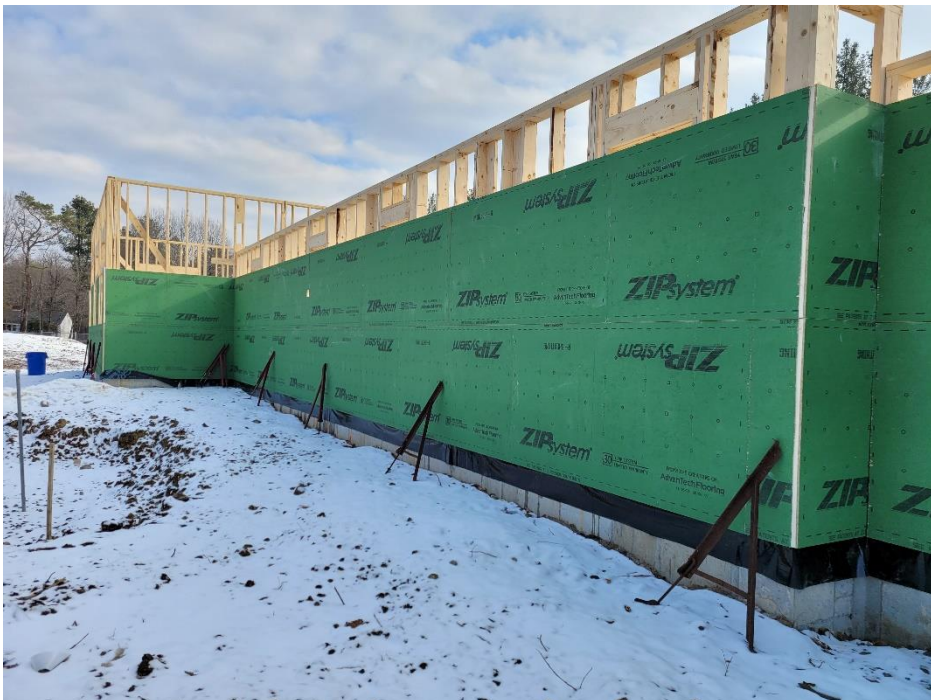
24. North wall of Office Wing with wall base detail per SKA-12a

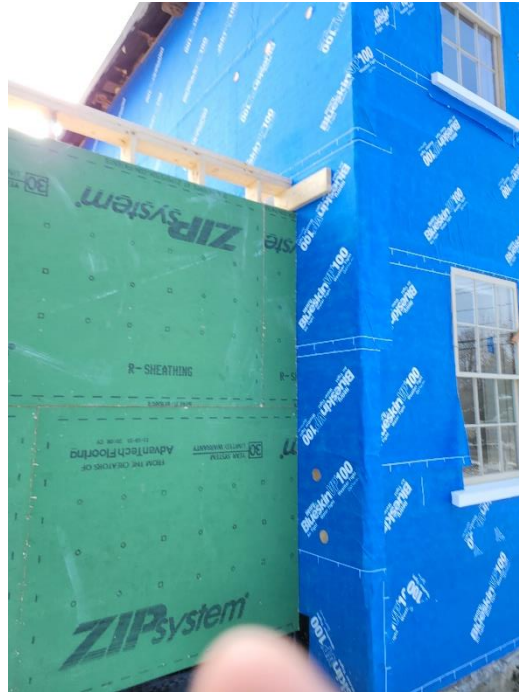
25. Connection of Office Wing to Cummings House at north side

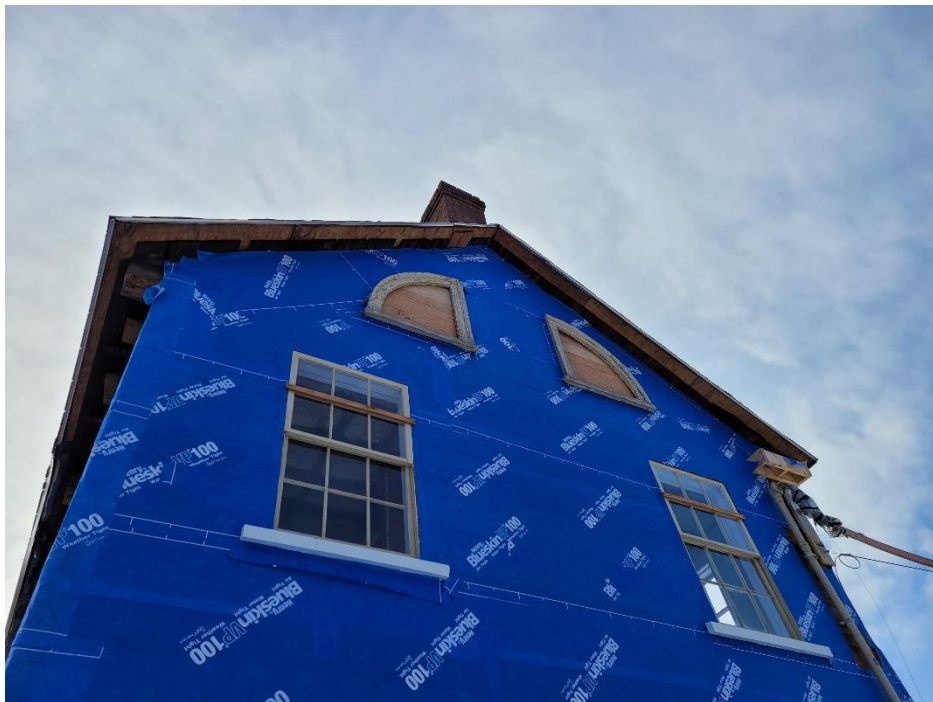
- a. Attic windows (frames and sash) from the south side and sash only from the north side have been removed and sent to the window restoration contractor (The Window Woman) for assessment and restoration.

26. Sash of north side attic windows removed to window restoration shop

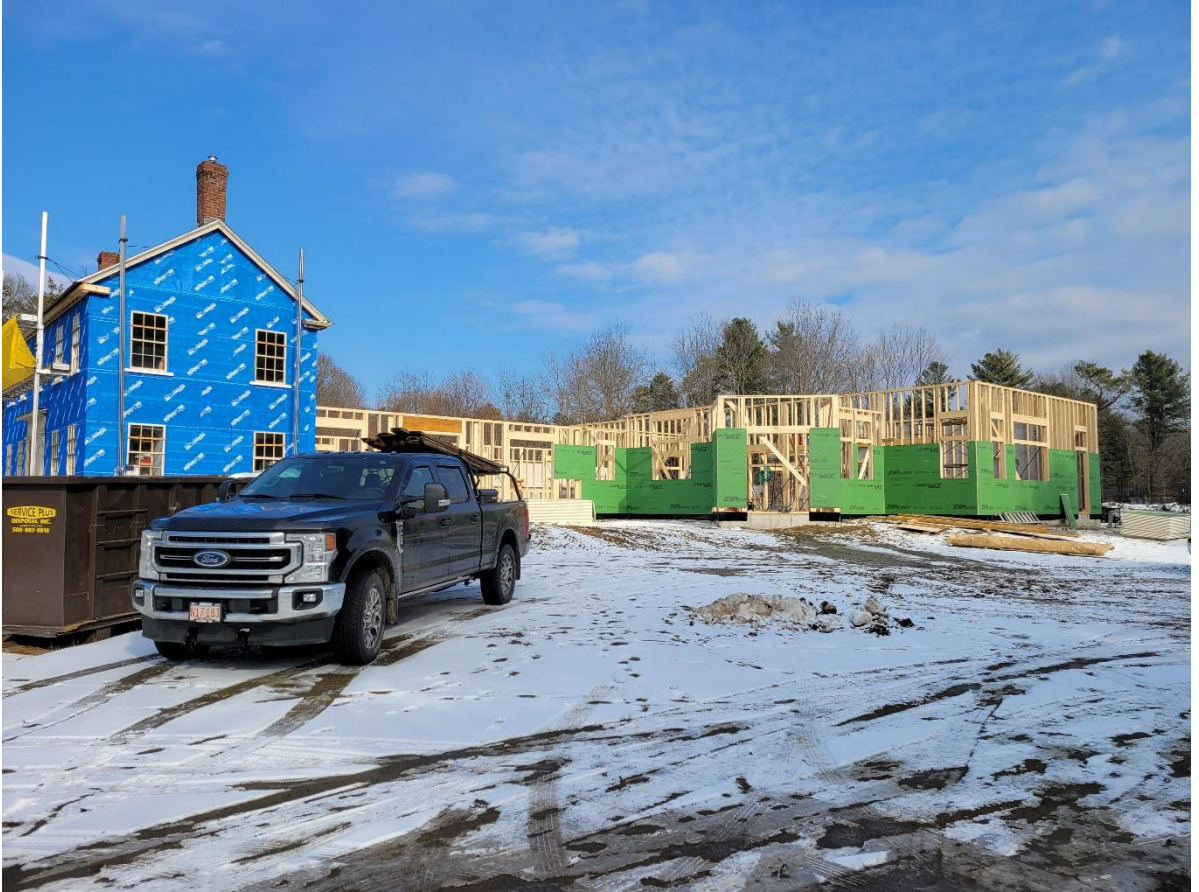
27. Progress view from southwest

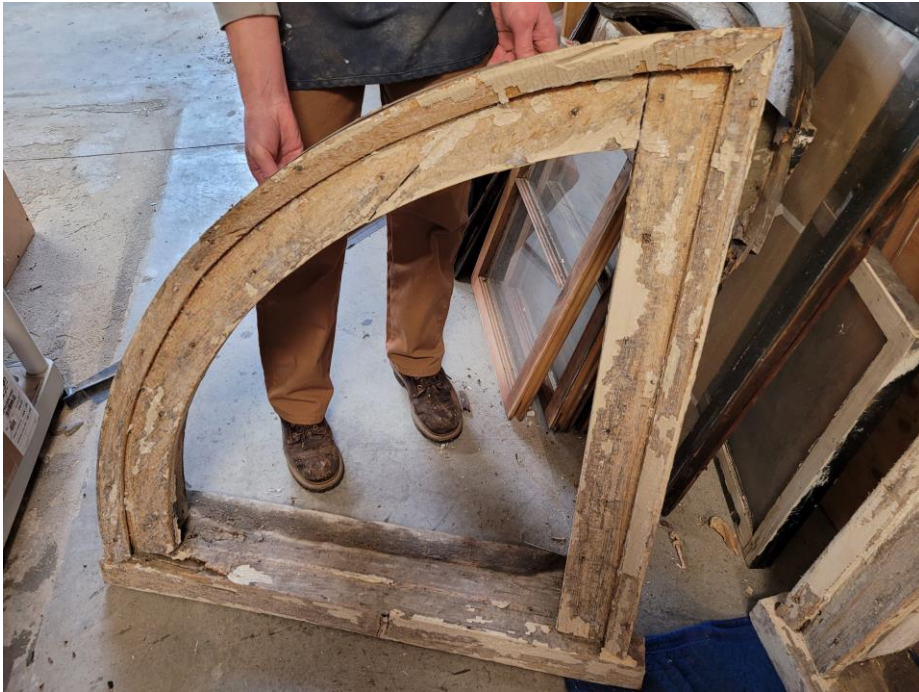
28. Attic window frame at restoration shop (The Window Woman)

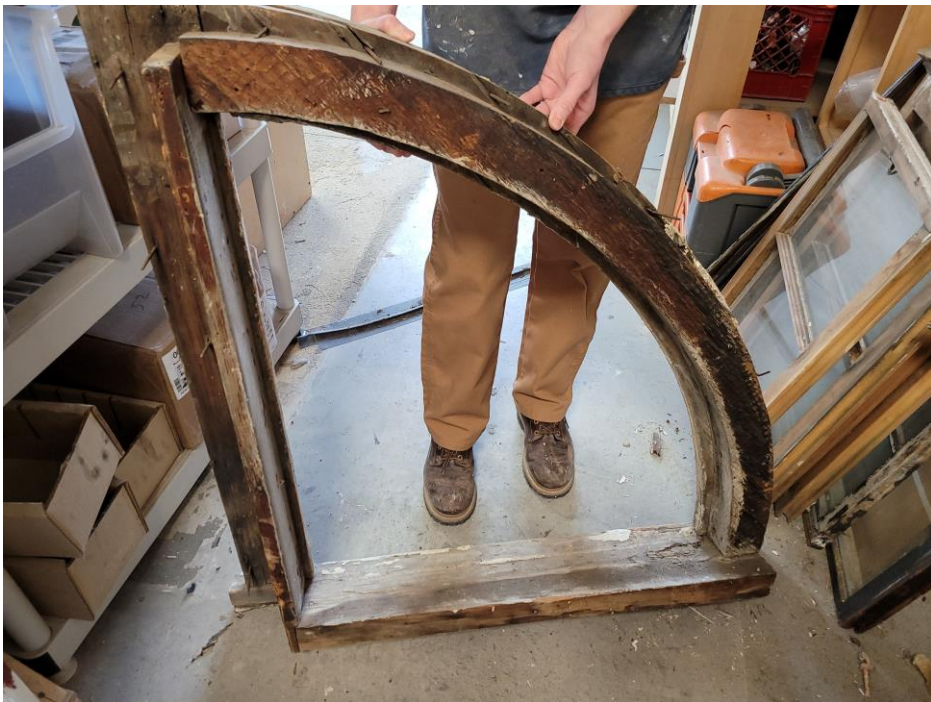
29. Backside (interior) of attic window frame at restoration shop

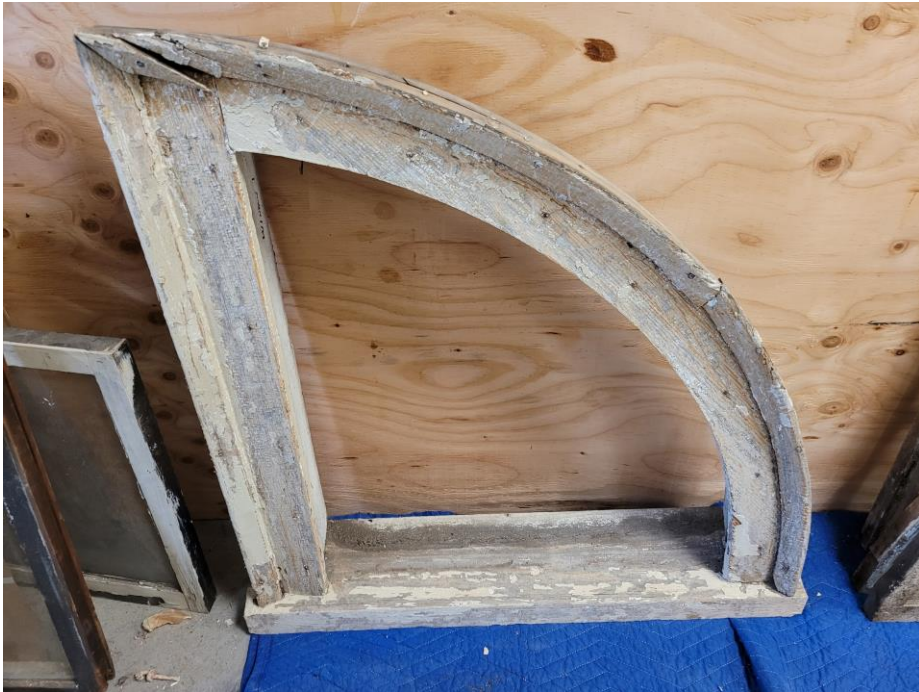
30. Attic window frame at restoration shop (The Window Woman)

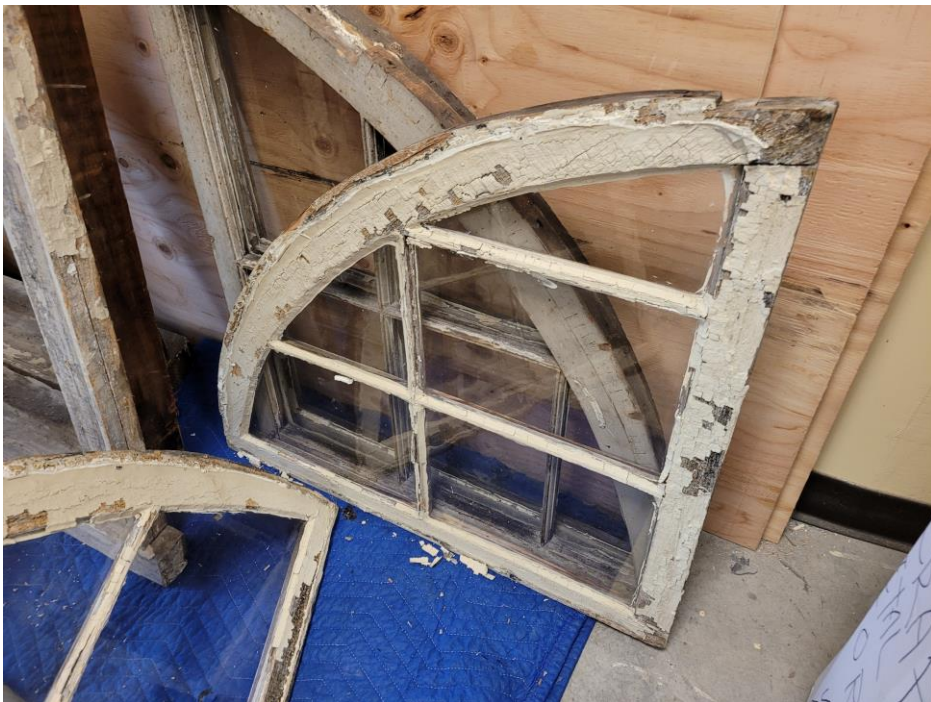
31. Attic window sash at restoration shop

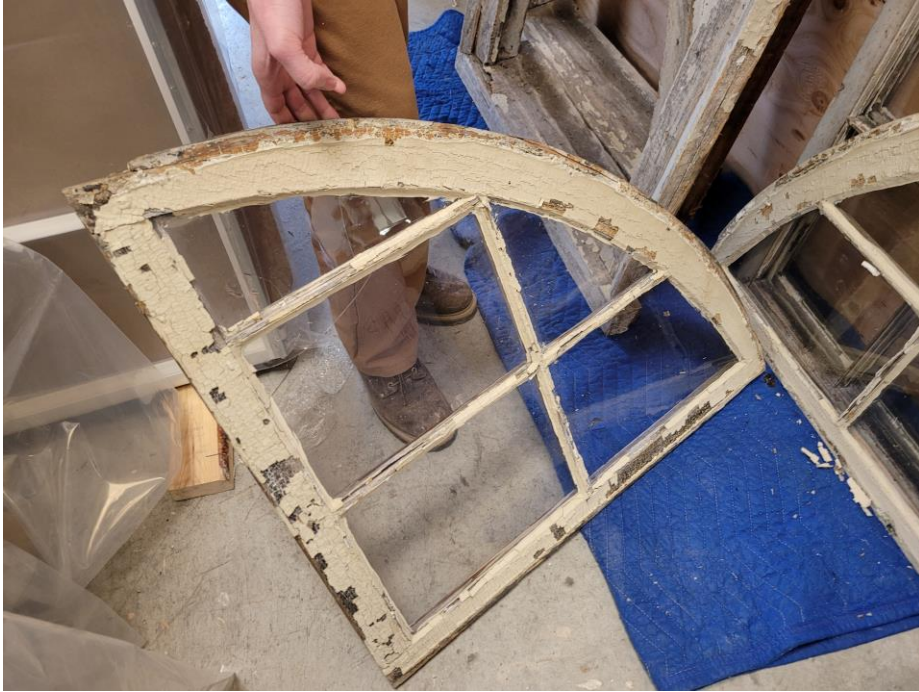
32. Attic window sash at restoration shop

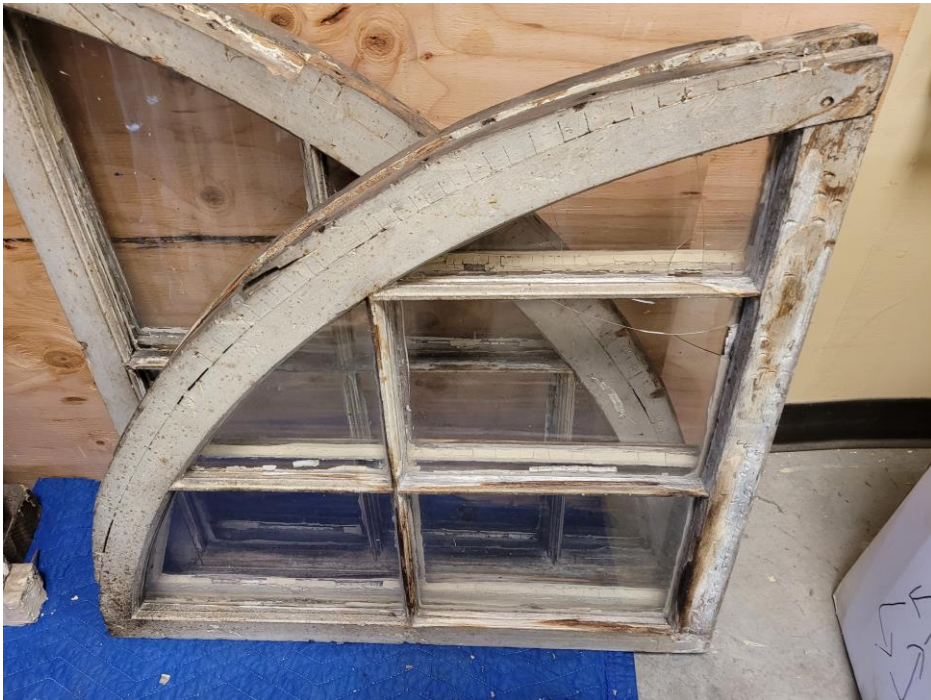
33. Attic window sash at restoration shop
