Field Report**Project: Boxford Community****Senior Center****10 Elm Street Boxford, MA 01921****Report No.:****015****GRLA Project No.:****2020120.01****Date of Site Visit:** 4 January, 2022

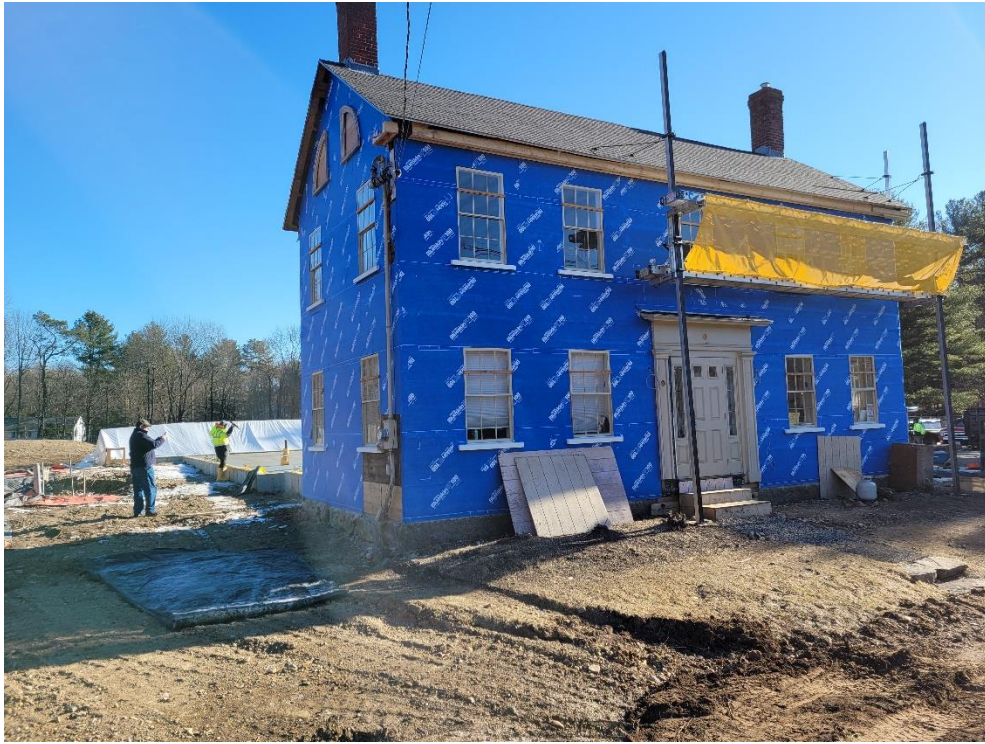
1. View from Northeast

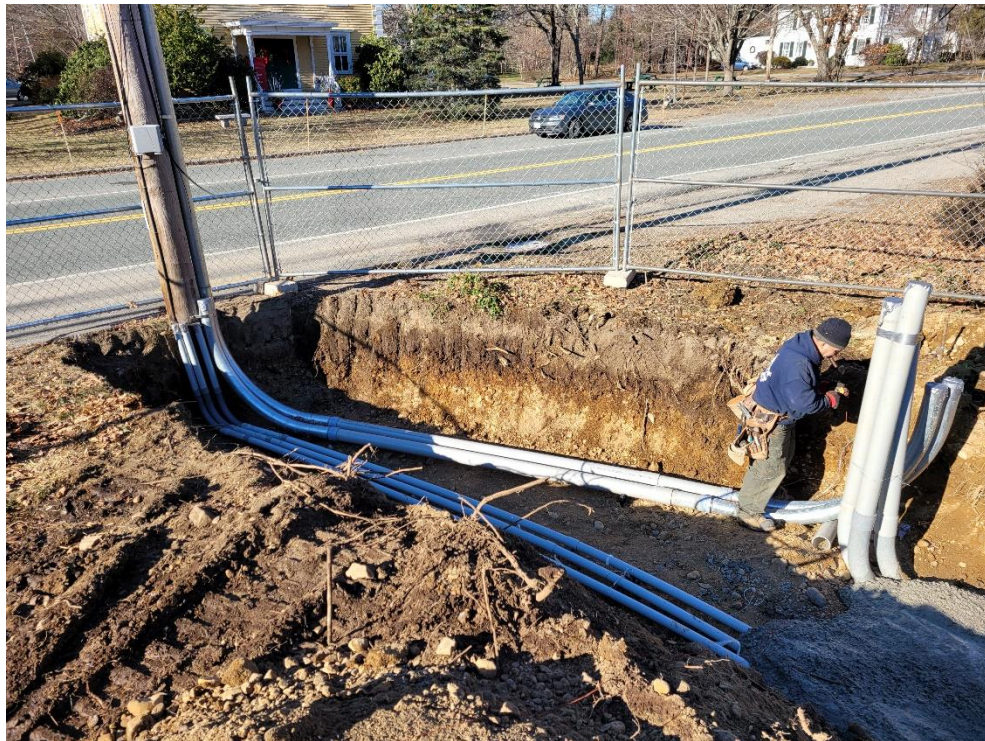
- a. Electrical ductbank (concrete encased) installed from the utility pole at the street to the location of the new Electrical Room in the Addition.
 - i. (2) primary electrical service risers extend from the utility pole to the transformer location (photo 2);
 - ii. conduit for secondary lines extend from the transformer location through the below-grade ductbank to the Addition via the concrete encased ductbank (photo 2,3,5)
 - iii. (3) 2" conduit extend as risers from the utility pole through the ductbank to the building (photo 2).
 - iv. Risers for the emergency generator located to the North of the future Electrical Room are in place (photo 5). A cast-in-place pad will be installed for the generator.
 - v. A precast concrete pad with cut-outs will be placed for the transformer per specifications by the utility (National Grid).

2. Electrical and Communication risers at base of existing pole;
transformer risers in foreground

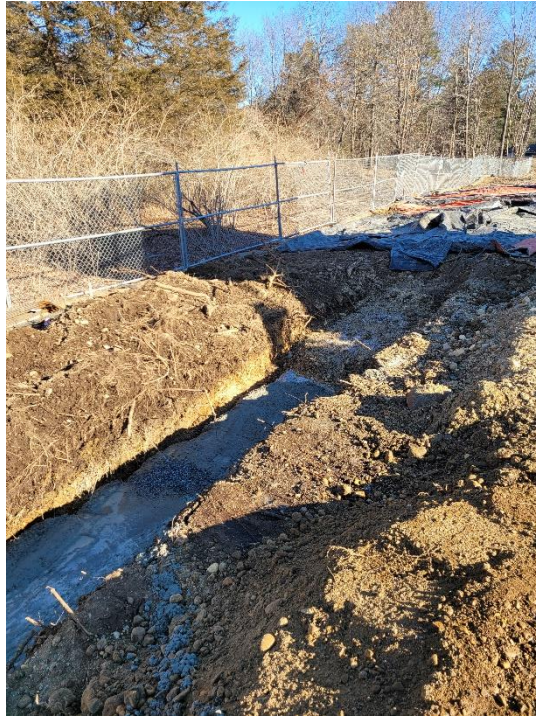
3. Electrical ductbank with concrete encasement

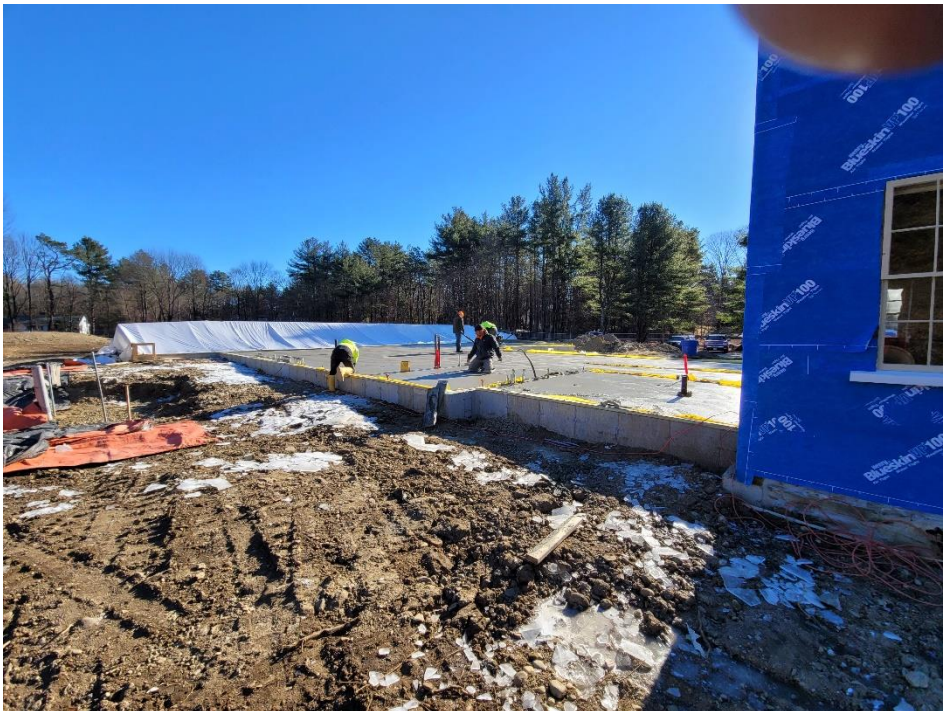
- a. Slab at office Wing poured this morning (1/4/22) and is being finished prior to set up, saw-cutting and tenting (photos 4, 6).
- b. As with the Multipurpose/ Kitchen Wing (7-day wet cure completed), this newly poured slab will be tented and heated and wet-cured for 7 days.
- c. Tent for Multipurpose/ Kitchen slab remains in place (photos 7, 8).

4. New concrete slab at Office wing, placed today, being finished in preparation for burning and tenting.

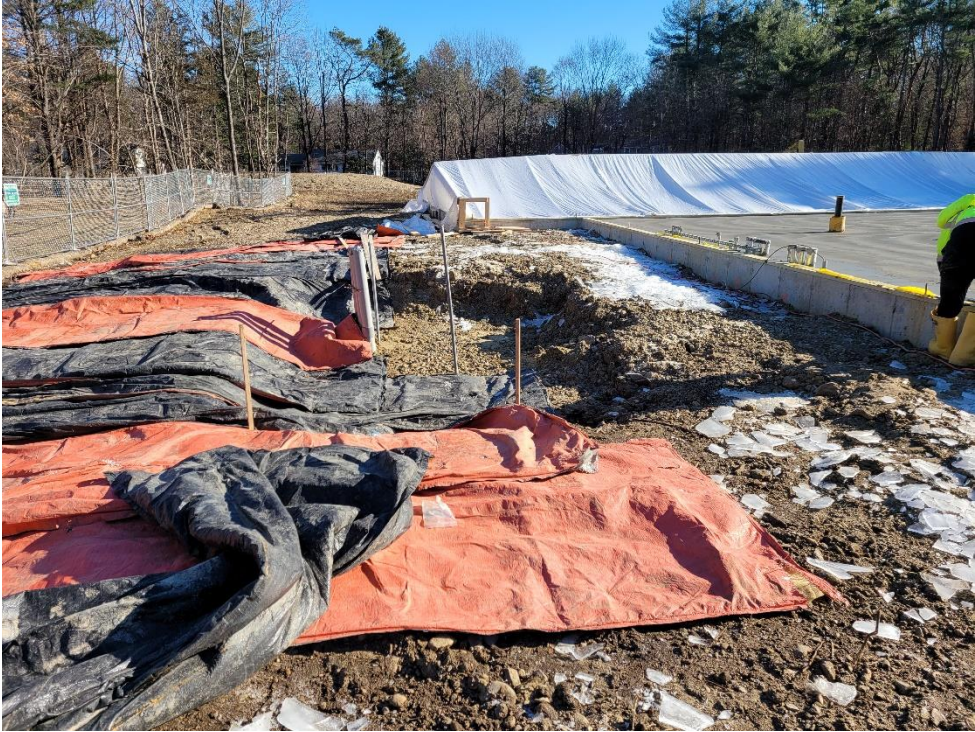
5. Risers for Emergency generator; tented Multipurpose/ Kitchen wing in background

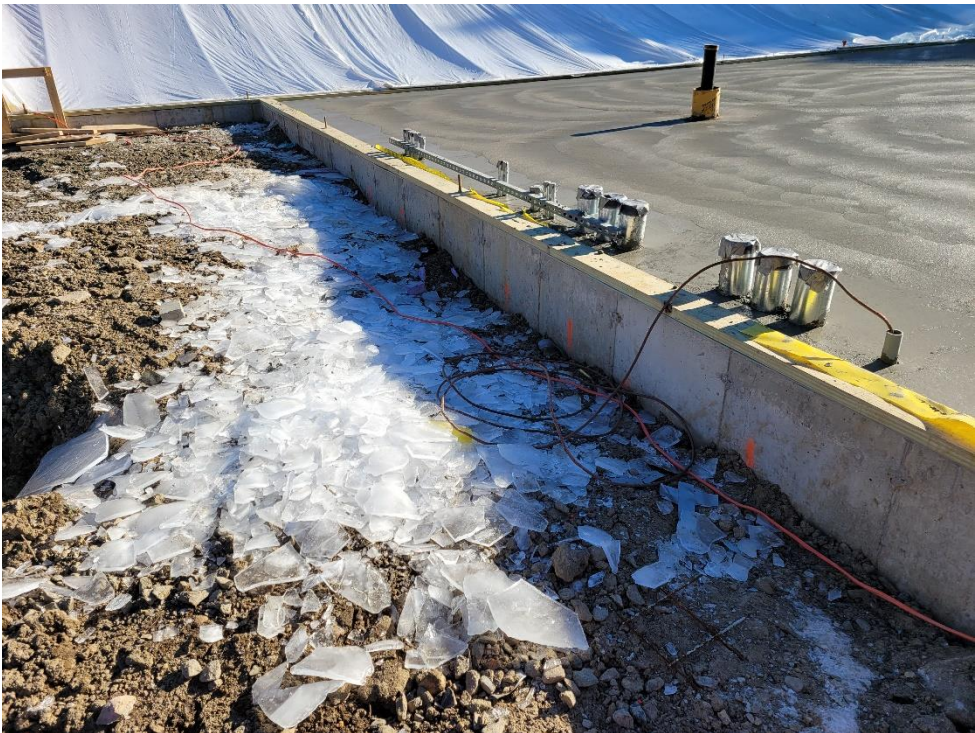
6. Stubs at Electrical Room and new slab in place

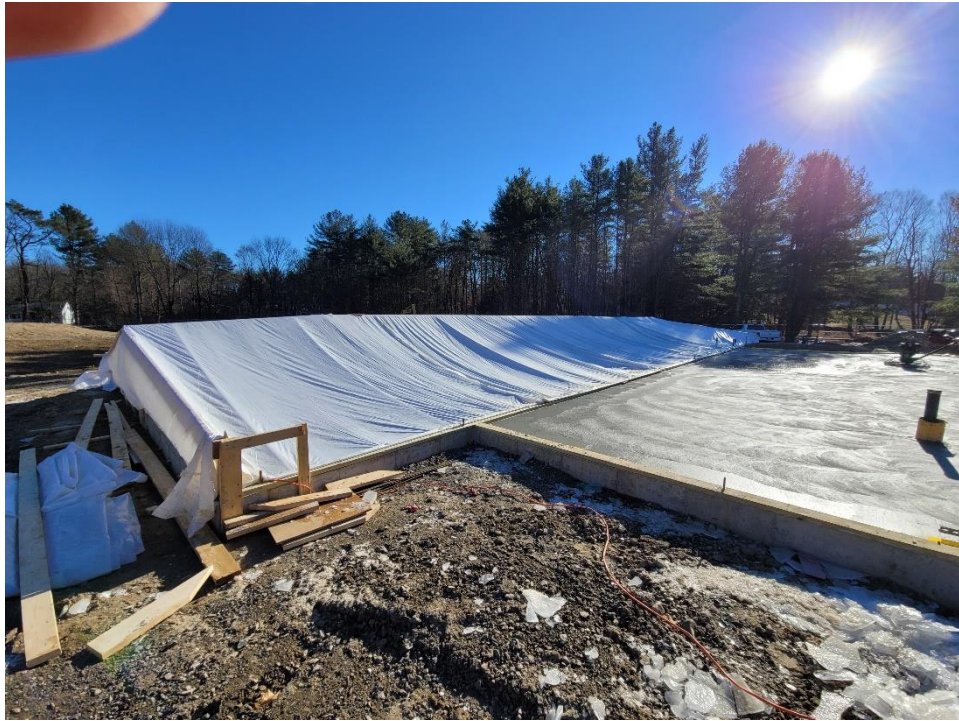
7. Tented Multipurpose/ Kitchen Wing slab; 7-day wet cure complete

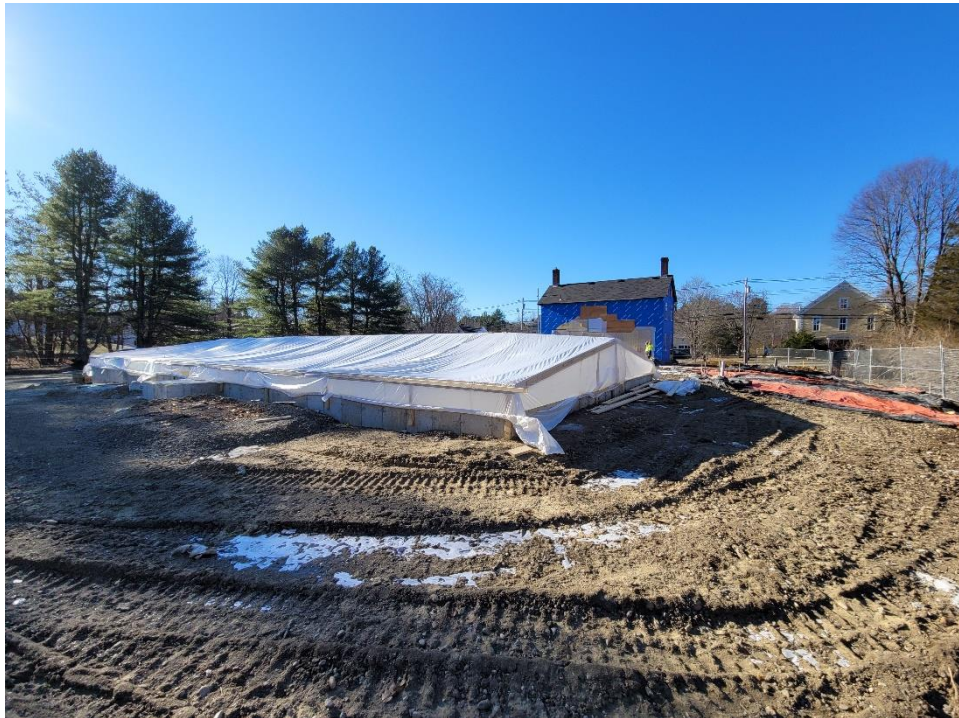
8. View from the west

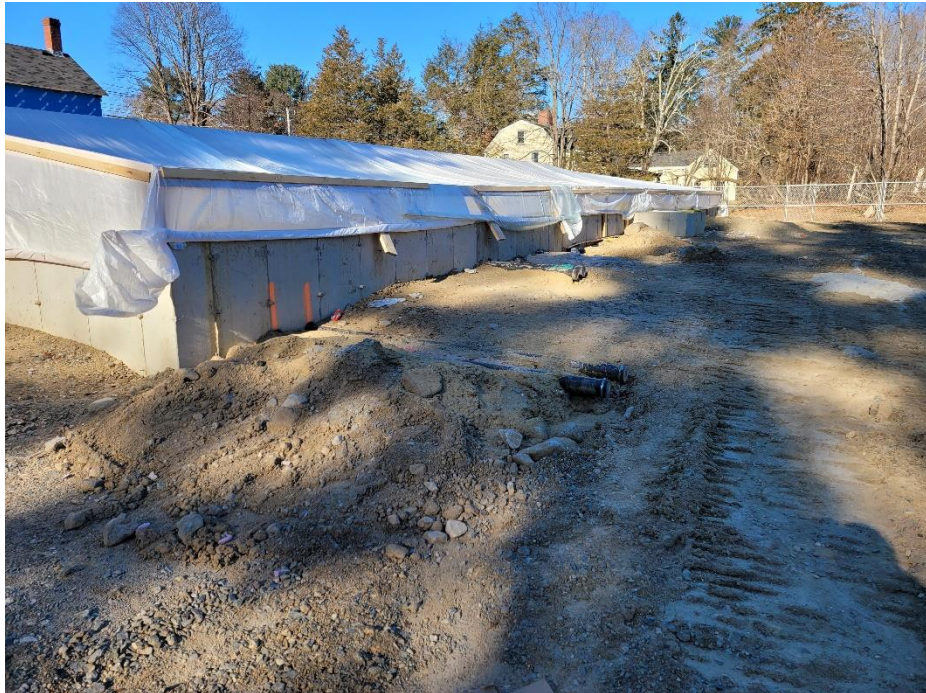
9. Sanitary and grease trap lines from east side of Kitchen wall

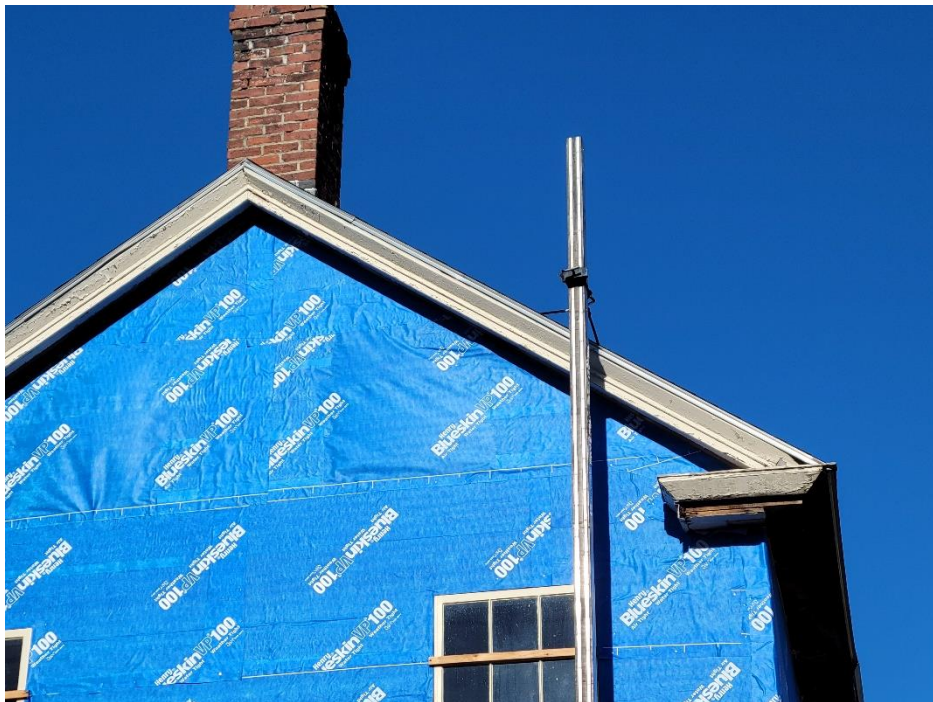
10. South rake still in place
