September 11, 2018

Cummings House Existing Conditions Assessment

Cummings House Boxford, Massachusetts

10 Elm Street, Boxford, MA

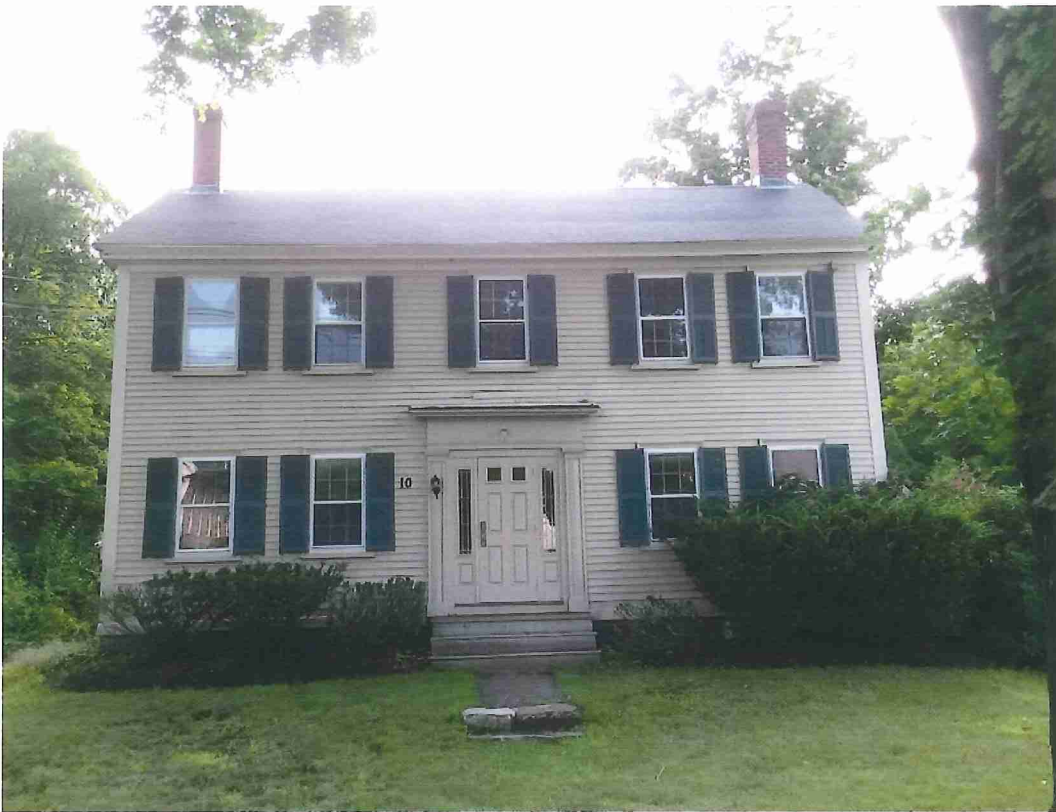
📍 10 Elm Street | Boxford, Massachusetts
📅 Aug 24, 2018 📷 Arron Sturgis

West Facade: Symmetrical window fenestration with front entry pediment and sidelights.

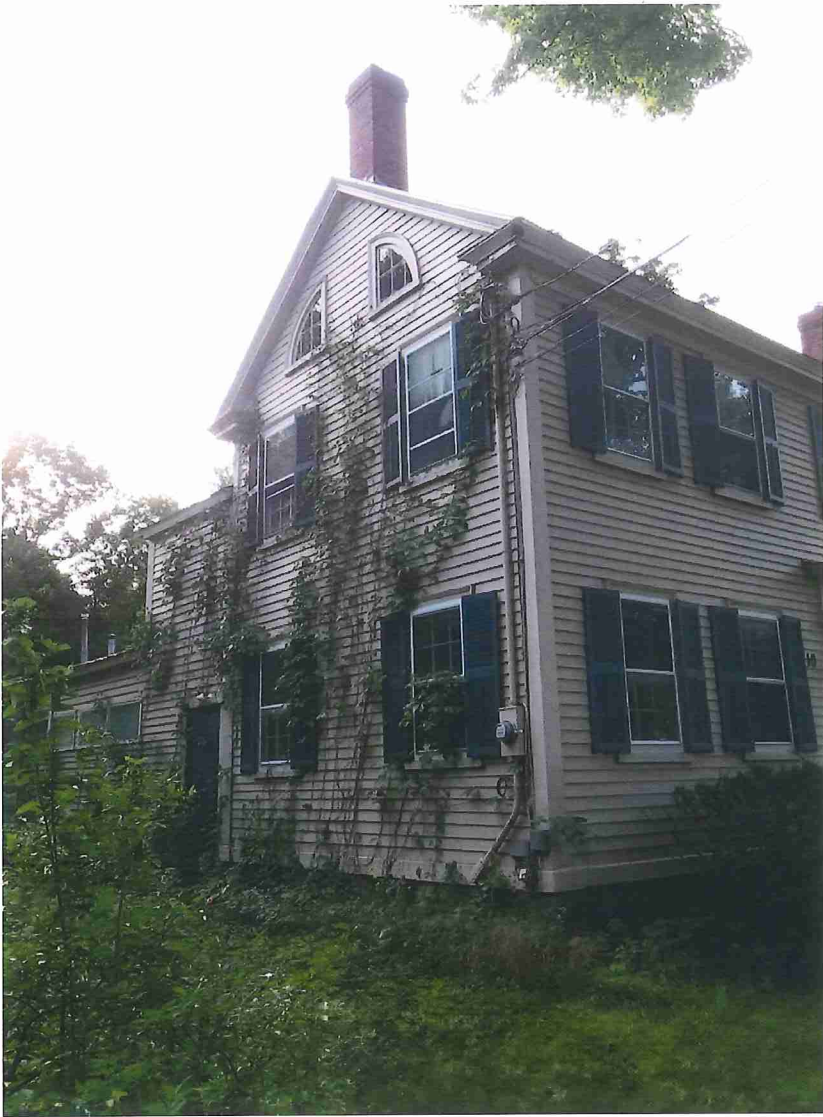
📍 10 Elm Street | Boxford, Massachusetts
📅 Aug 24, 2018 📷 Arron Sturgis

North Gable: Both gables host chimneys and radius windows on each side. Rakes and soffit with return creates small overhang at roof.

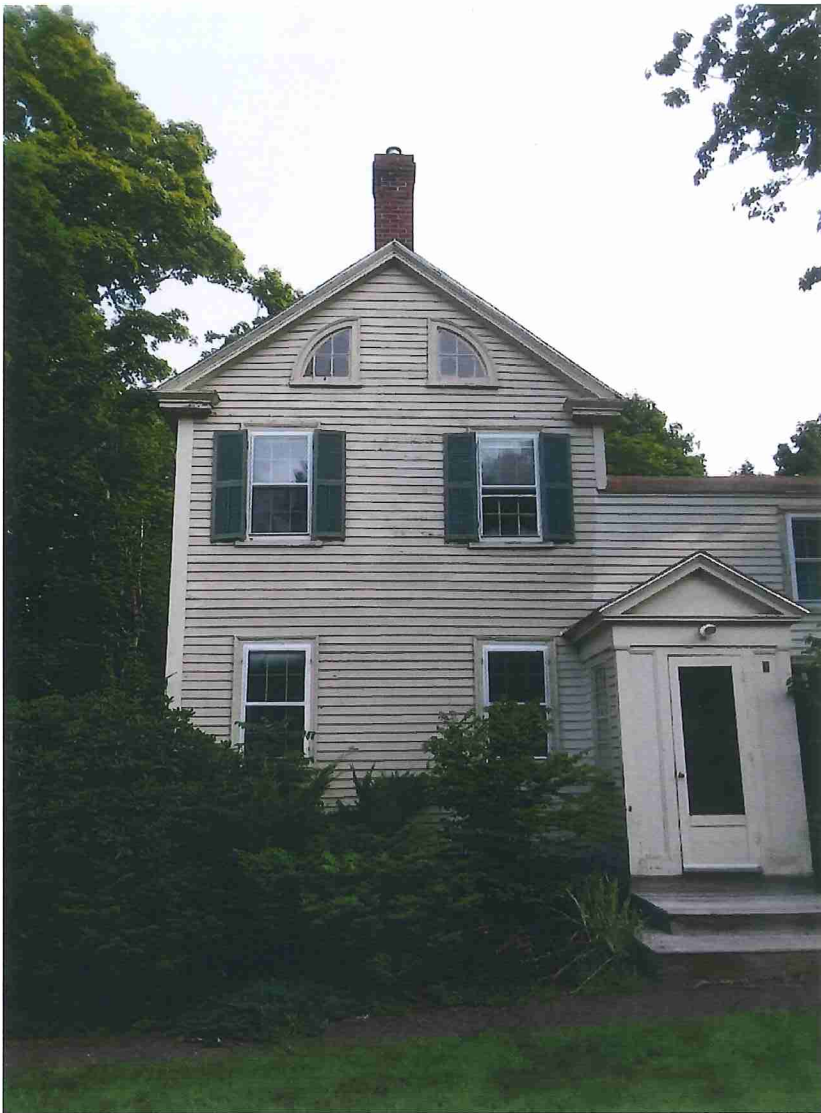
📍 10 Elm Street | Boxford, Massachusetts
📅 Aug 24, 2018 📷 Arron Sturgis

**South gable facade: Main House
with connecting ell and side
entrance portico**

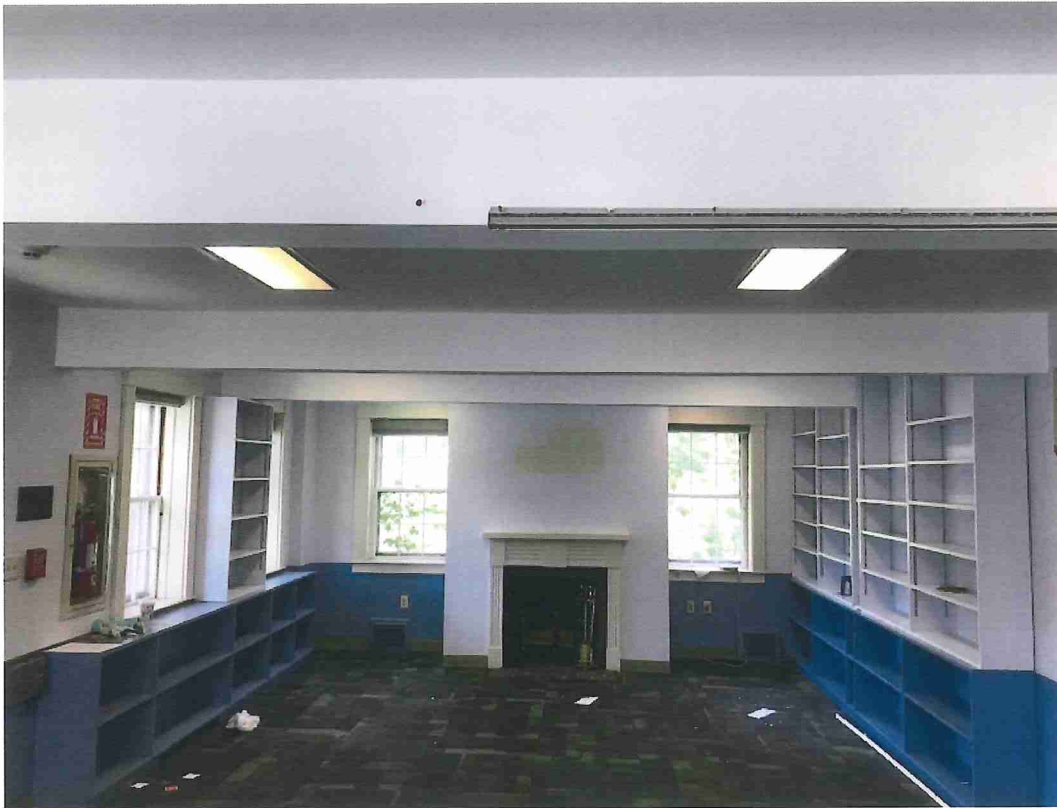
📍 10 Elm Street | Boxford, Massachusetts
📅 Aug 24, 2018 📷 Arron Sturgis

Main House: The first floor of the house has been opened up for library use. The chimneys and fireplace surrounds were retained. The interior window trim and sash have been carefully restored and retained as well. Note the ceiling bolster beams extending down into the room. They are in alignment with original timber floor beams and structural posts.

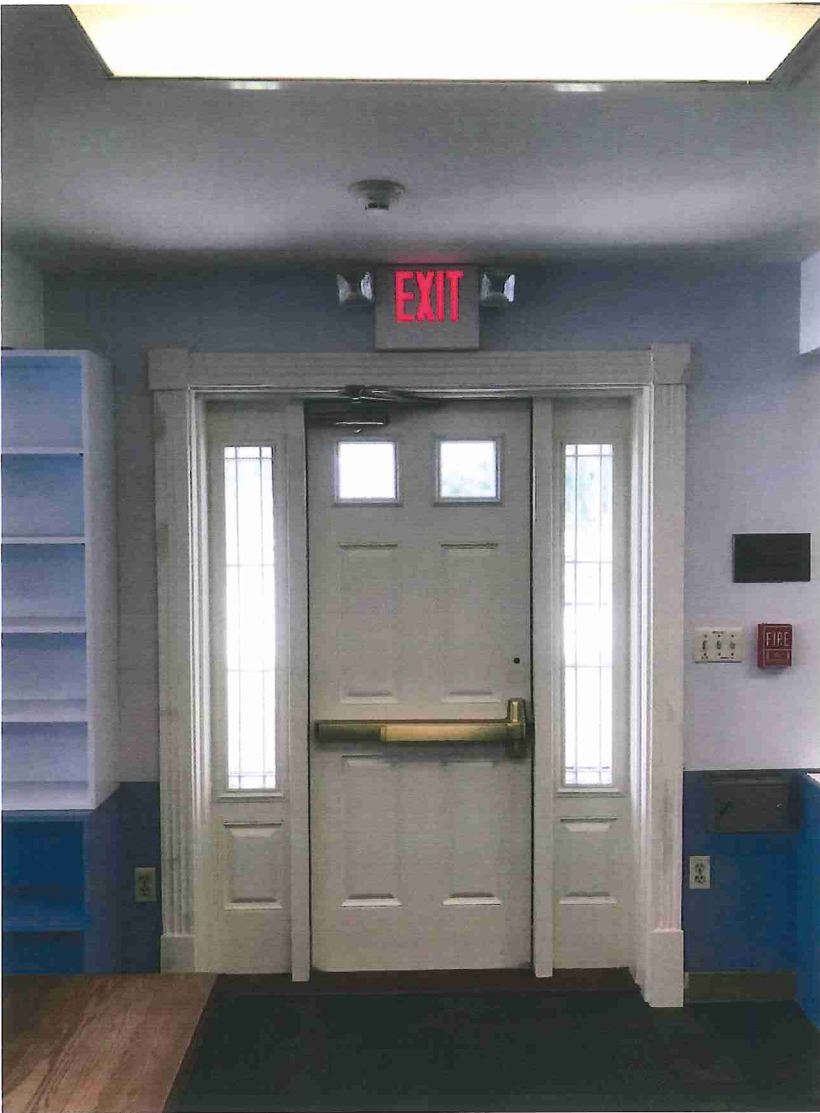
📍 10 Elm Street | Boxford, Massachusetts
📅 Aug 24, 2018 📷 Arron Sturgis

Main House: The front entry door is new but emulates the original house form. The trim is authentic and in keeping with the age of the home.

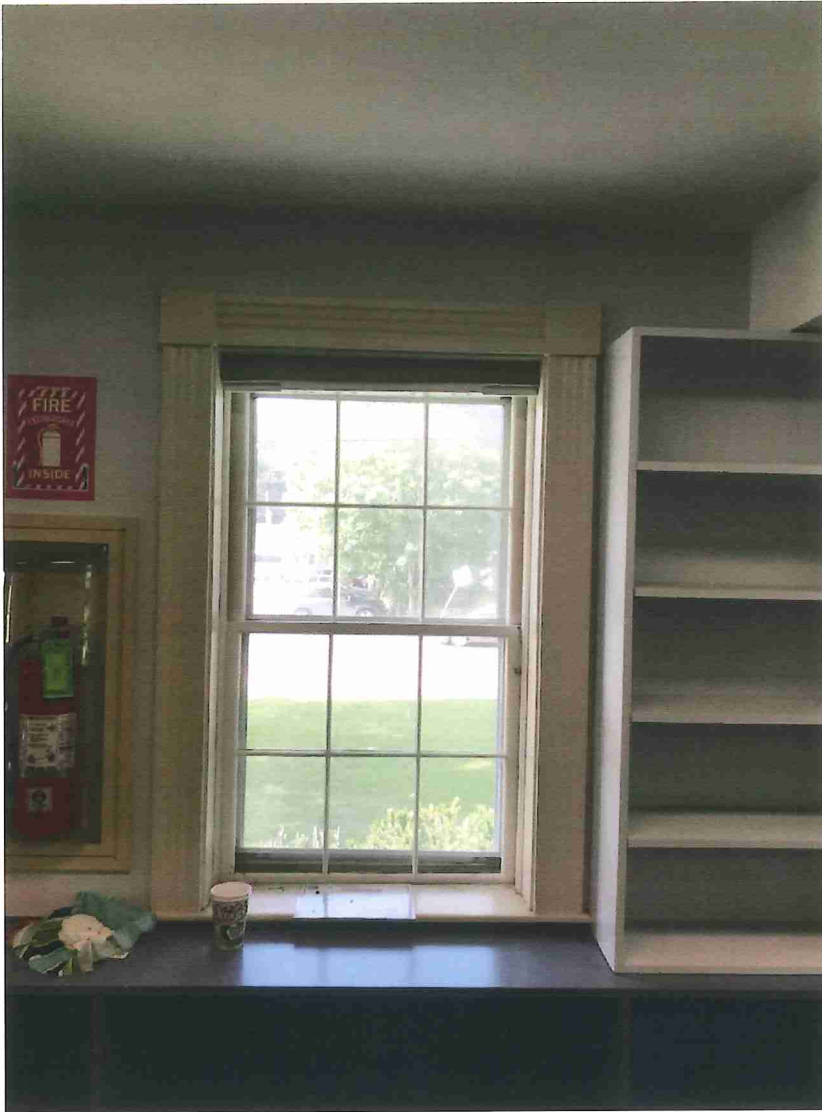
📍 10 Elm Street | Boxford, Massachusetts
📅 Aug 24, 2018 📷 Arron Sturgis

Window Sash: The main house windows are authentic and remain in their original locations. Windows like the one pictured have been removed from the East eave wall where the 1981 addition interrupts the main house and connecting ell.

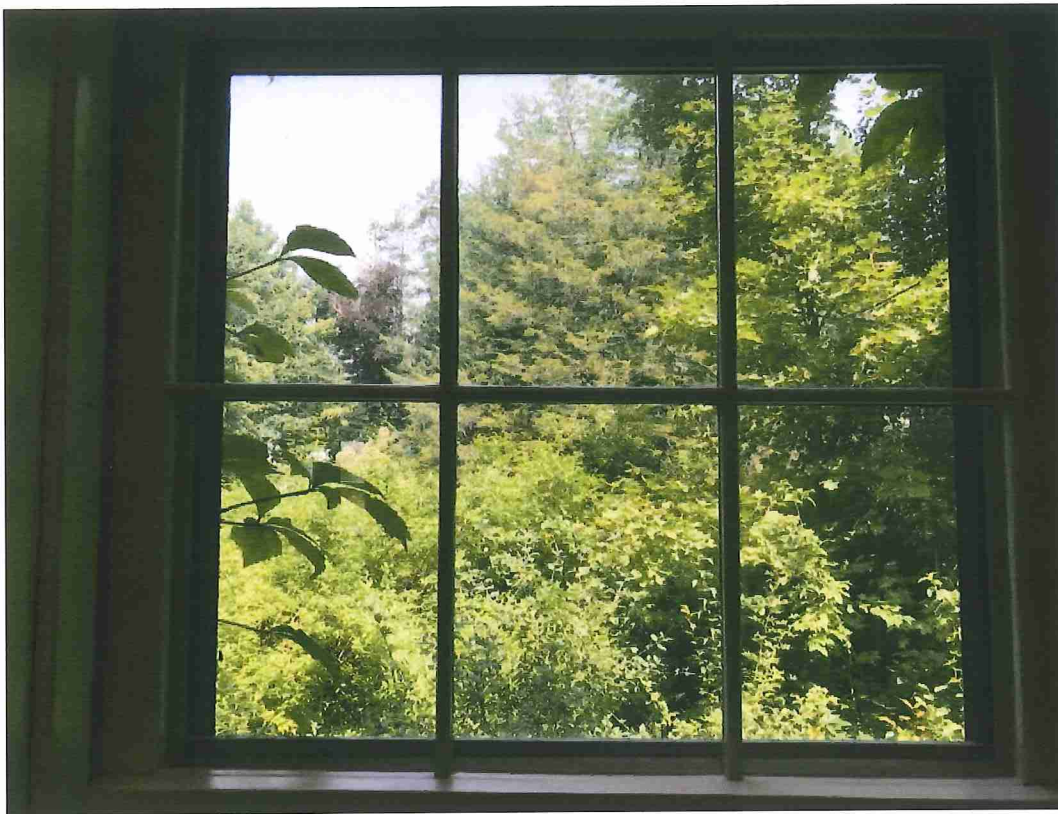
📍 10 Elm Street | Boxford, Massachusetts
📅 Aug 24, 2018 👤 Arron Sturgis

Window Sash: The six over six sash create a period look for the house. They are protected by aluminum storms to the exterior.

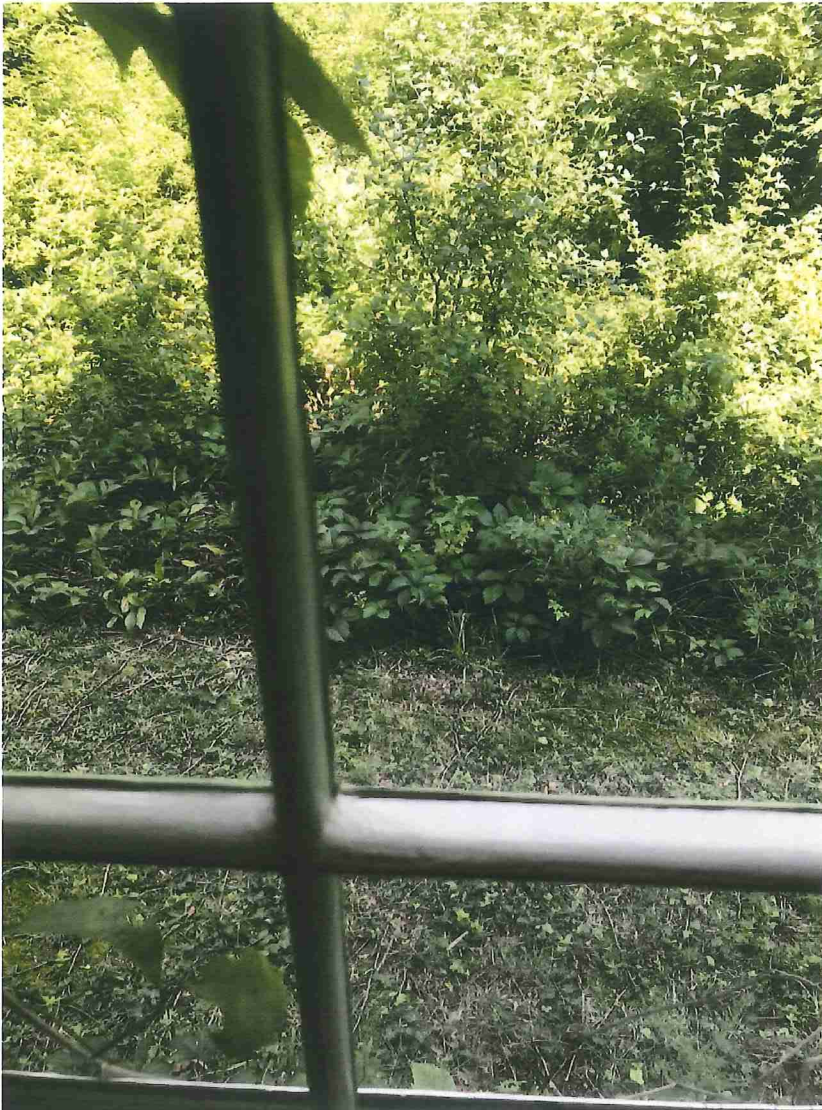
📍 10 Elm Street | Boxford, Massachusetts

Window Sash: The muntin profile appears to be early and is appropriate for the age of the house.

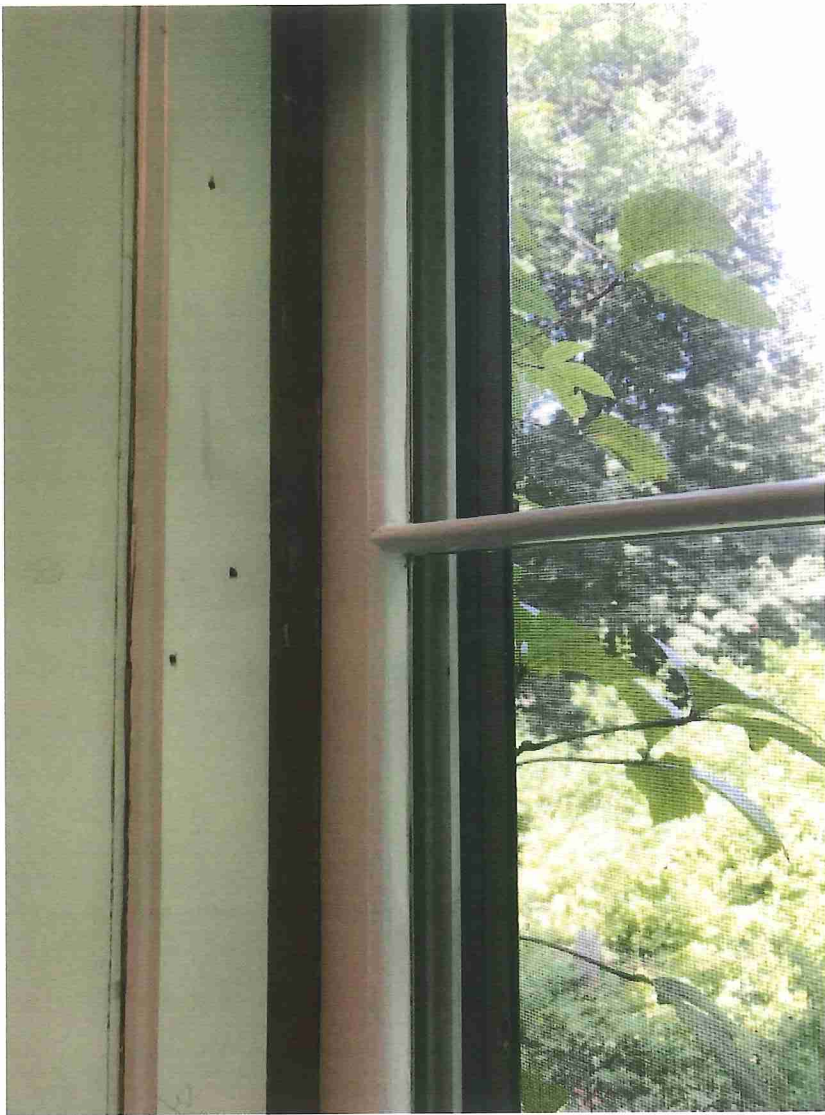
📍 10 Elm Street | Boxford, Massachusetts
📅 Aug 24, 2018 👤 Arron Sturgis

Window Sash: The windows are all fully operational in their window frames. Storms host screen and storm panels. There is also a unique spring loaded button that allows the windows to be safely opened with no fear of closing hard.

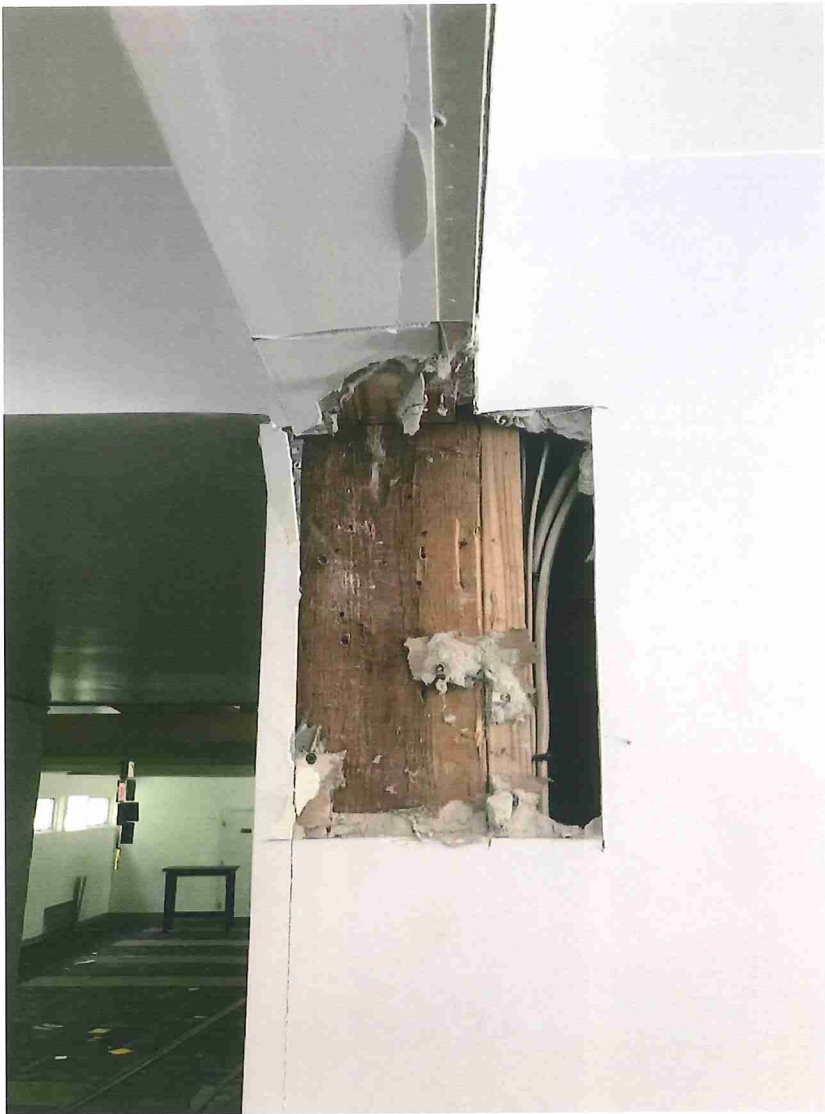
📍 10 Elm Street | Boxford, Massachusetts
📅 Aug 24, 2018 📷 Arron Sturgis

Main House: Original structural posts extend from sill to top plate and accept original floor beams and bolster beams at the second floor level. The original beams appear in very good shape.

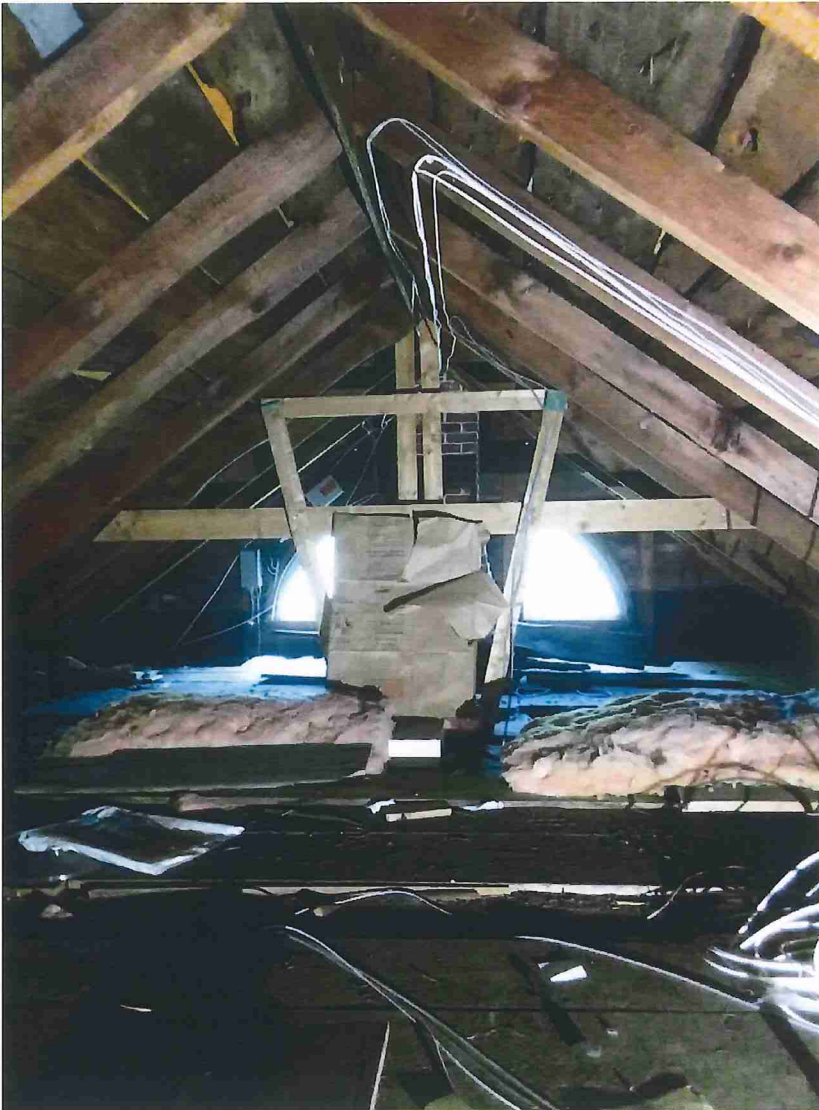
📍 10 Elm Street | Boxford, Massachusetts
📅 Aug 24, 2018 📷 Arron Sturgis

Main house attic space: Original rafters spaced about 29 inches on center with rough board sheathing. Some bolstering added to roof framing in 1981.

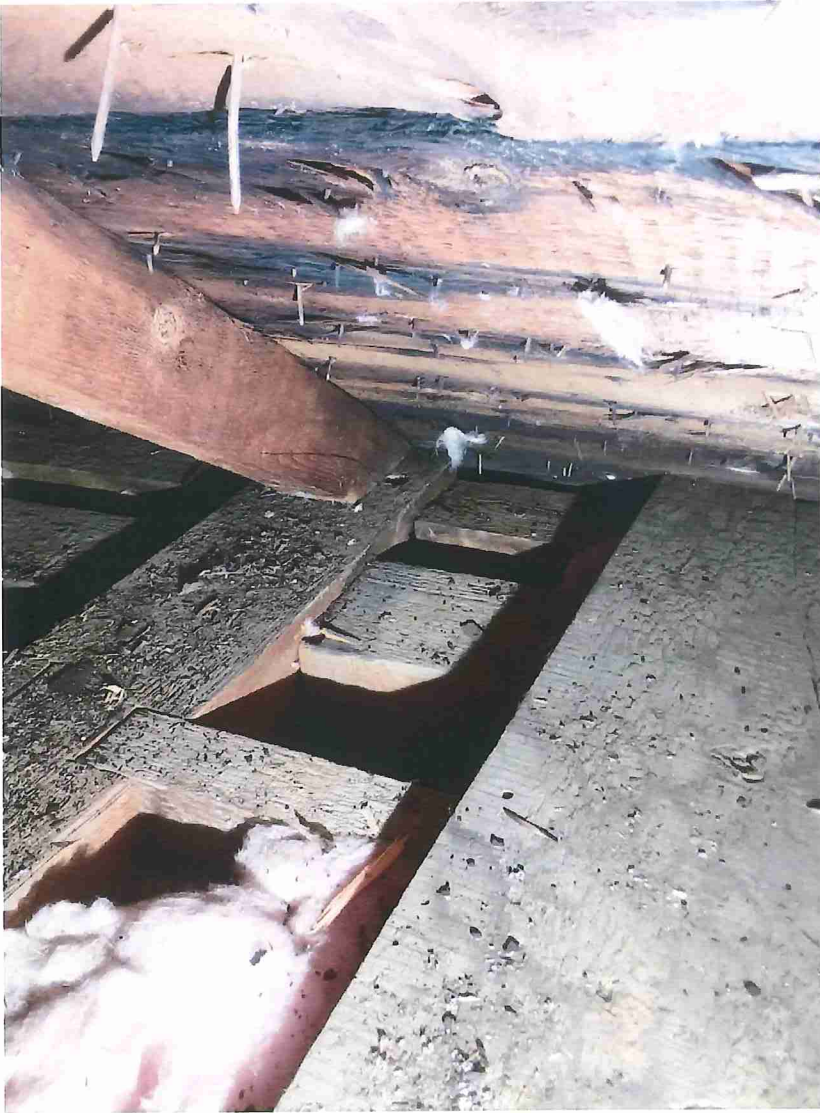
📍 10 Elm Street | Boxford, Massachusetts
📅 Aug 24, 2018 📷 Arron Sturgis

Main House: Roof system is created with common rafters sitting on the tie beams with a flying purlin overhang. Top plate is continuous along the length of the eave wall. Ceiling joists are notched into a continuous tie beam crossing from eave wall to eave wall.

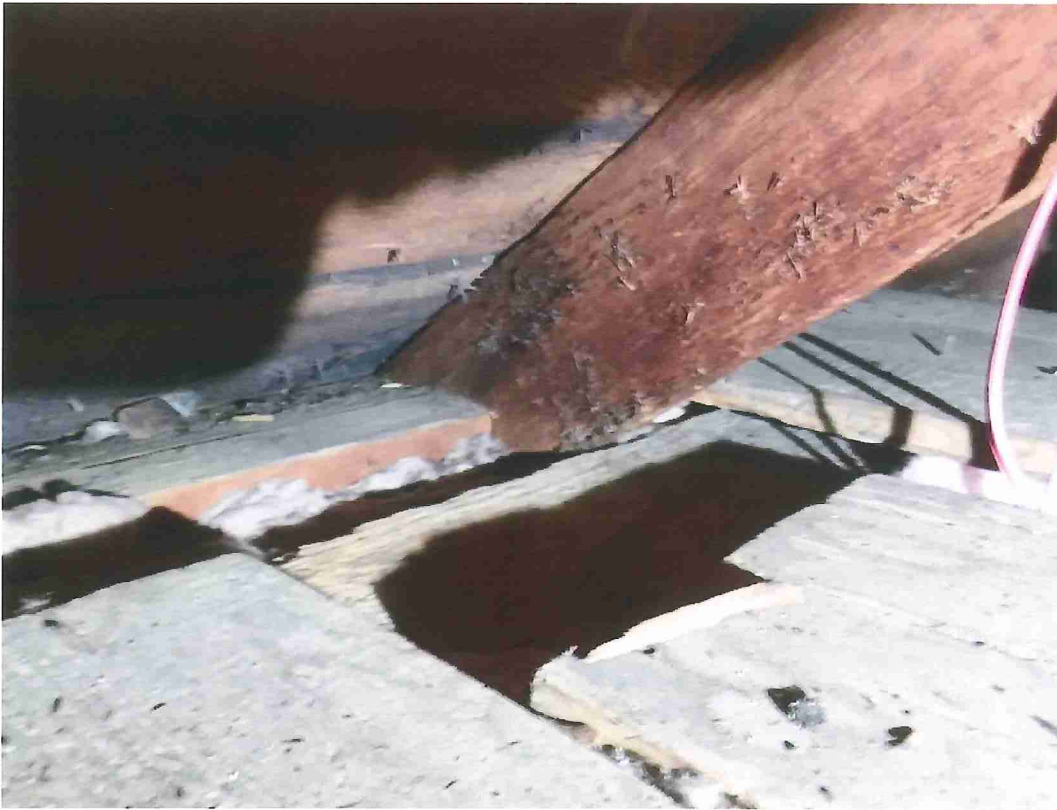
📍 10 Elm Street | Boxford, Massachusetts
📅 Aug 24, 2018 📷 Arron Sturgis

Main house attic: Common rafters also land on the flying purlin between tie beams. A birds mouth joint at the heel of the rafter is secured to the flying purlin with cut nails.

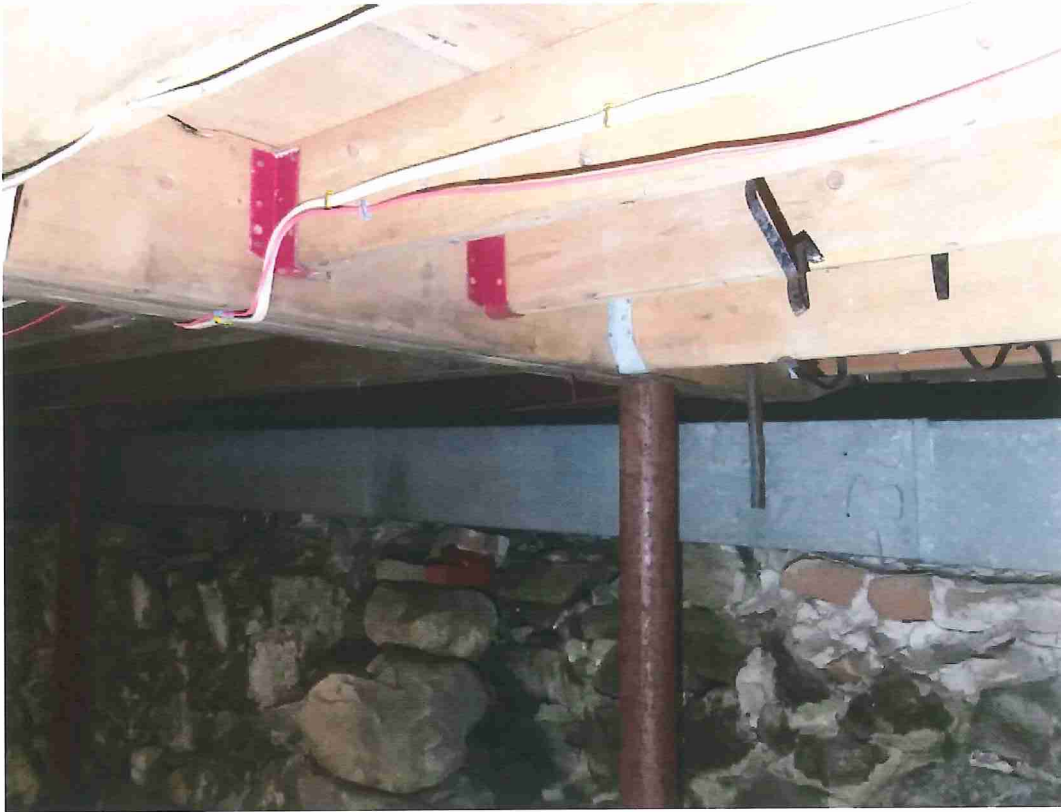
📍 10 Elm Street | Boxford, Massachusetts
📅 Aug 24, 2018 📷 Arron Sturgis

Main house cellar: Much of the first floor is bolstered with new joists and floor girts. Part of the cellar retains its original joists and girts with new joists added between the old.

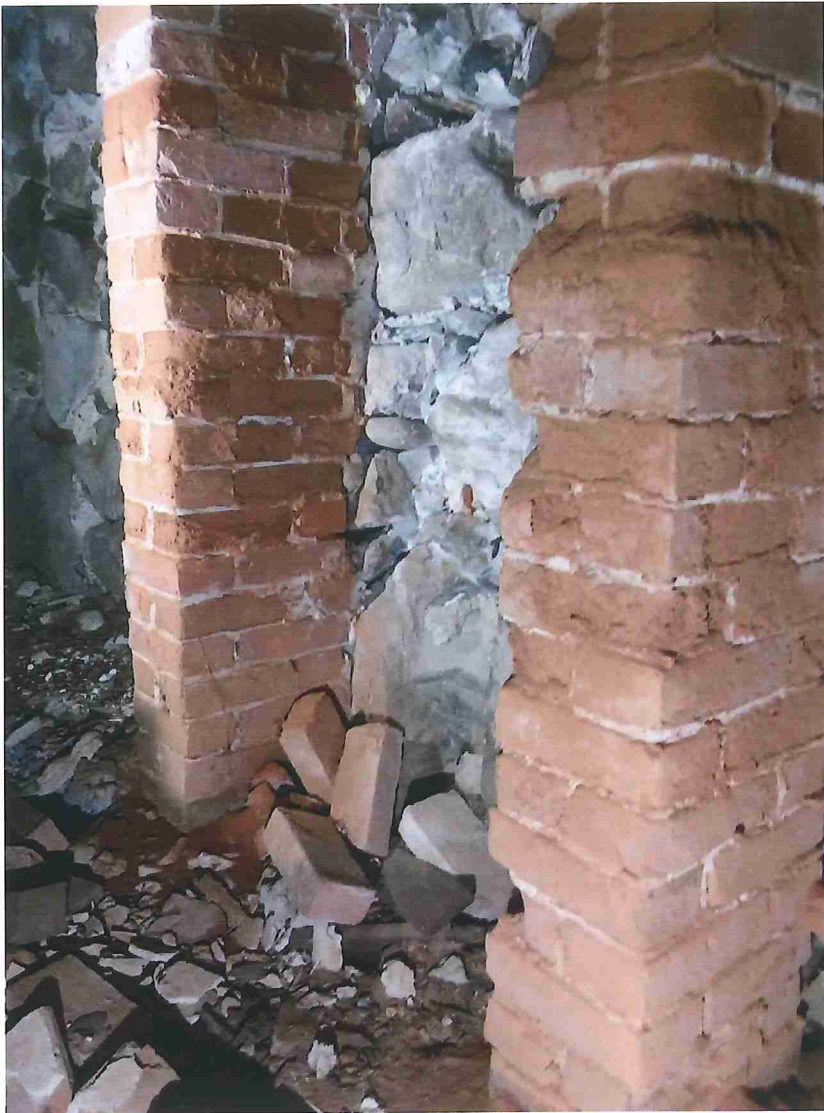
📍 10 Elm Street | Boxford, Massachusetts
📅 Aug 24, 2018 📷 Arron Sturgis

Main house cellar: Two simple brick piers integrate with perimeter gable rubble stone foundation to support the fireplaces above. Some spalling of the bricks is evident. The stone foundation under the main house is in very good condition.

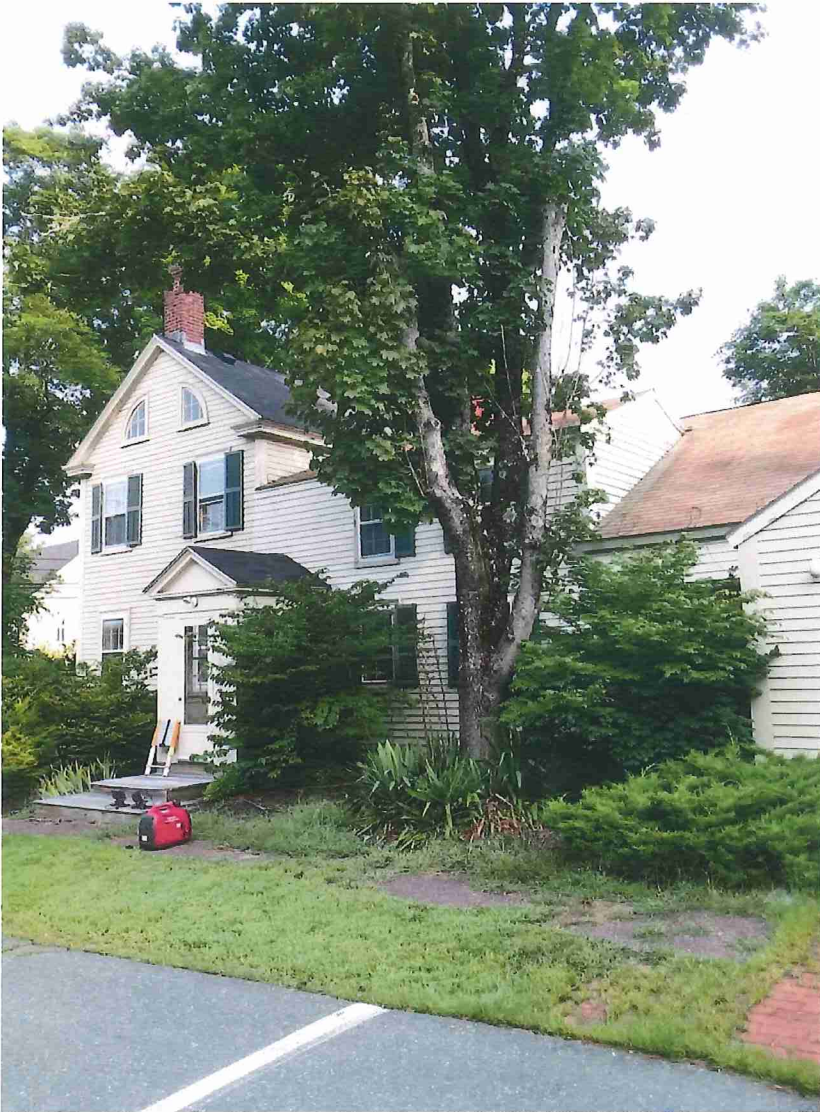
📍 10 Elm Street | Boxford, Massachusetts
📅 Aug 24, 2018 📷 Arron Sturgis

The addition is not the focus of this investigation. It is apparent that its construction is substandard and it is slated for removal. Its impact on the main house is not irreversible. Its impact on the connecting ell however, is significant rendering the ell largely unusable. It is possible to utilize the ell form with its portico as part of the restoration of the original frame. This would allow for code compliant stairs and egress to and from the original structure.

**South Gable: Connecting ell joins
with 1981 addition. Ell very
compromised by addition.**

The connected ell is fiercely damaged, but there is enough evidence to recreate it with code compliant stairways and perhaps an elevator should the need be determined. The original front entry along with the early portico entrance provides egress for code compliance. The windows are fully restored and fully operational. A connecting ell and portico is not included in this estimate. Careful design with adaptive use and accessibility in mind can be done to allow accurate pricing for its final destination.

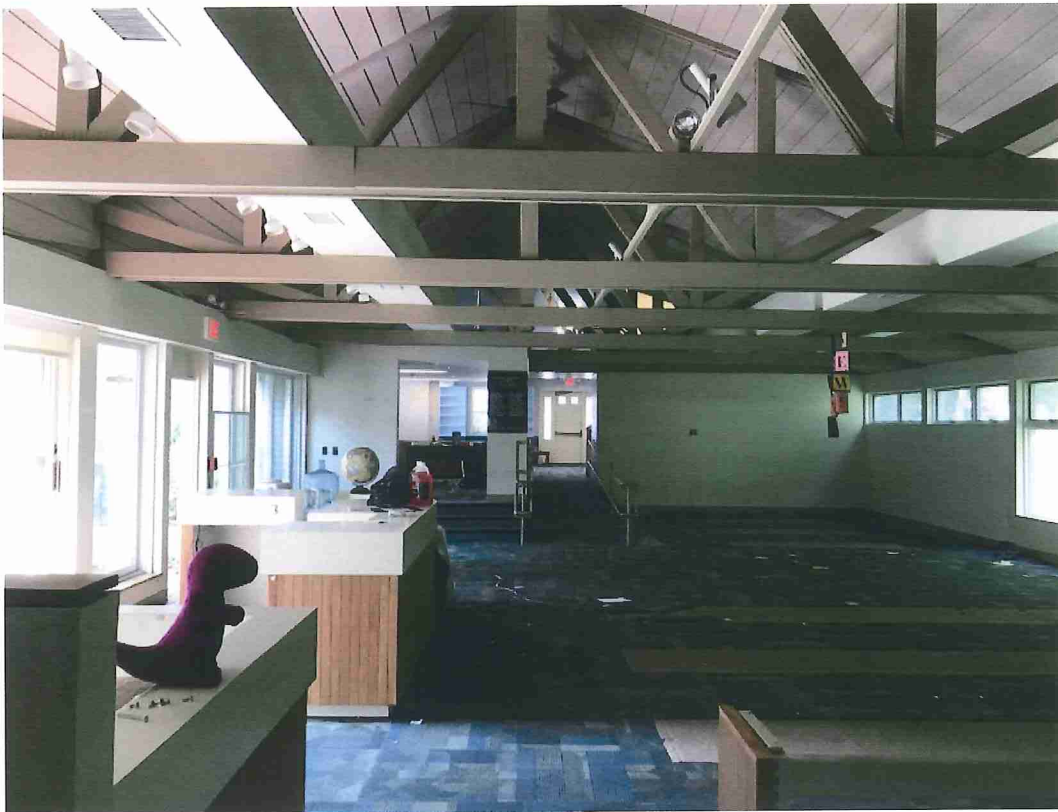
📍 10 Elm Street | Boxford, Massachusetts
📅 Aug 24, 2018 👤 Arron Sturgis

This investigation delves directly into the viability and structural integrity of the original home. It is known that the 1981 addition to the original house is dangerous due to poor construction methods and severe mold growth leaving the house in jeopardy.

1981 addition: A large open space with conventional trusses as interior finish. Mold pervasive throughout this structure.

The Cummings House cannot be used without removing the 1981 addition and connecting ell. The demolition of these structures will require numerous dumpsters for debris and a qualified excavation contractor with substantial machinery. The addition would need to be carefully severed from the main house and the East wall would have to be closed in after the 1981 addition is removed. Once removed, the house regains its cohesiveness and is ready for adaptive reuse. Knowing that the Town of Boxford is trying to find a new purpose for the Cummings House, it is important to understand that the original frame is both viable and worth preserving. It can become a part of a larger vision for the community or it can stand alone. It is a strong structure and can be moved intact anywhere within the immediate area. It is adaptable. It is beautiful. It was given freely to the town. It should not be destroyed.

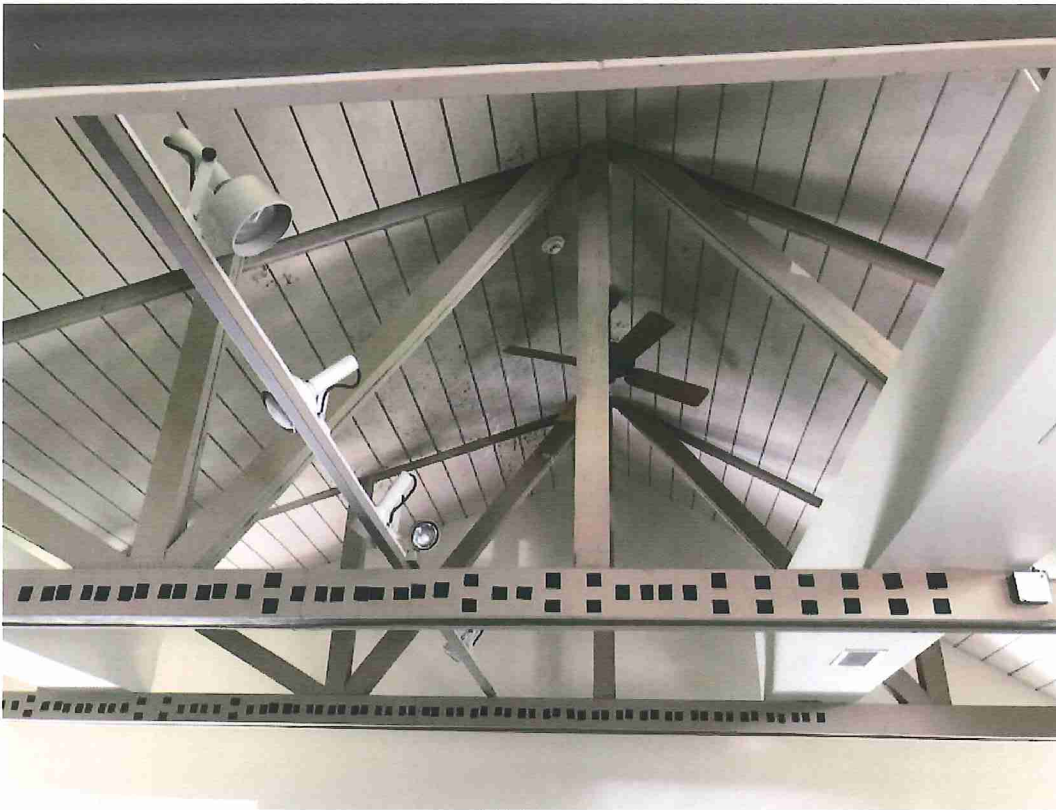
📍 10 Elm Street | Boxford, Massachusetts
📅 Aug 24, 2018 📷 Arron Sturgis

1981 addition: The truss is partially clad with flat trim boards. the ceiling is created with 6 inch tongue and groove boards. Mold is pervasive.

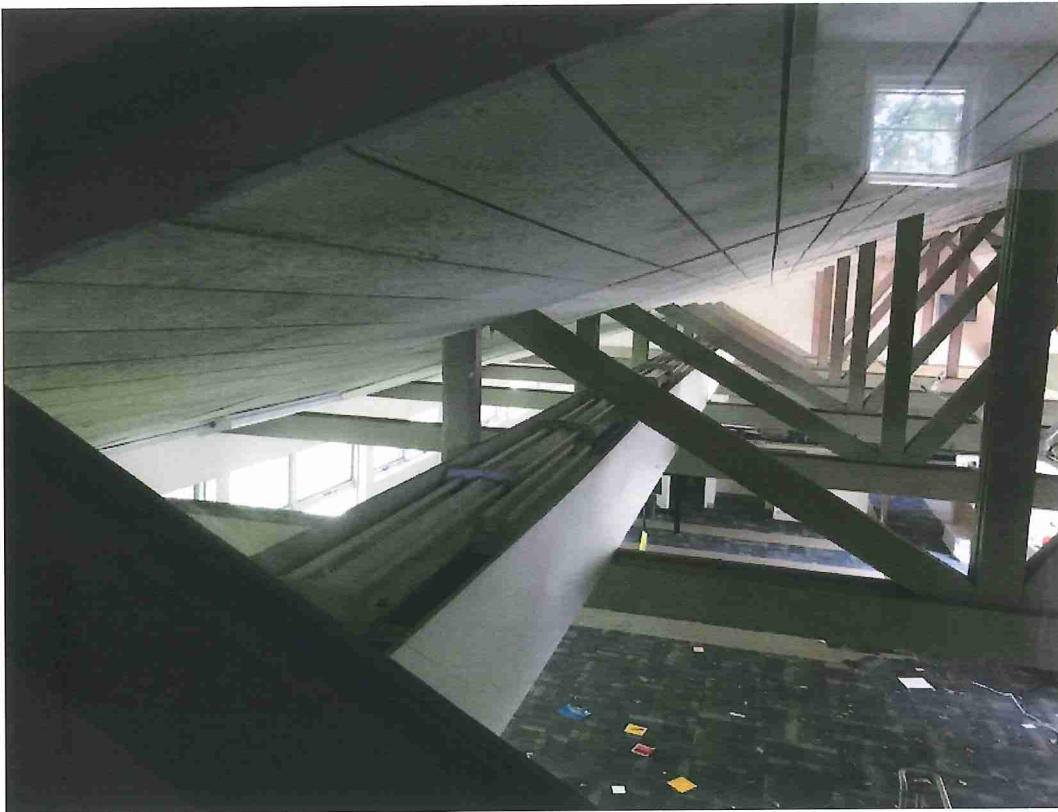
📍 10 Elm Street | Boxford, Massachusetts
📅 Aug 24, 2018 📷 Arron Sturgis

1981 addition: The lighting valence is open and clearly visible from the library stair well rising to the second floor of the main house. It appears sloppy and unfinished. Mold is pervasive.

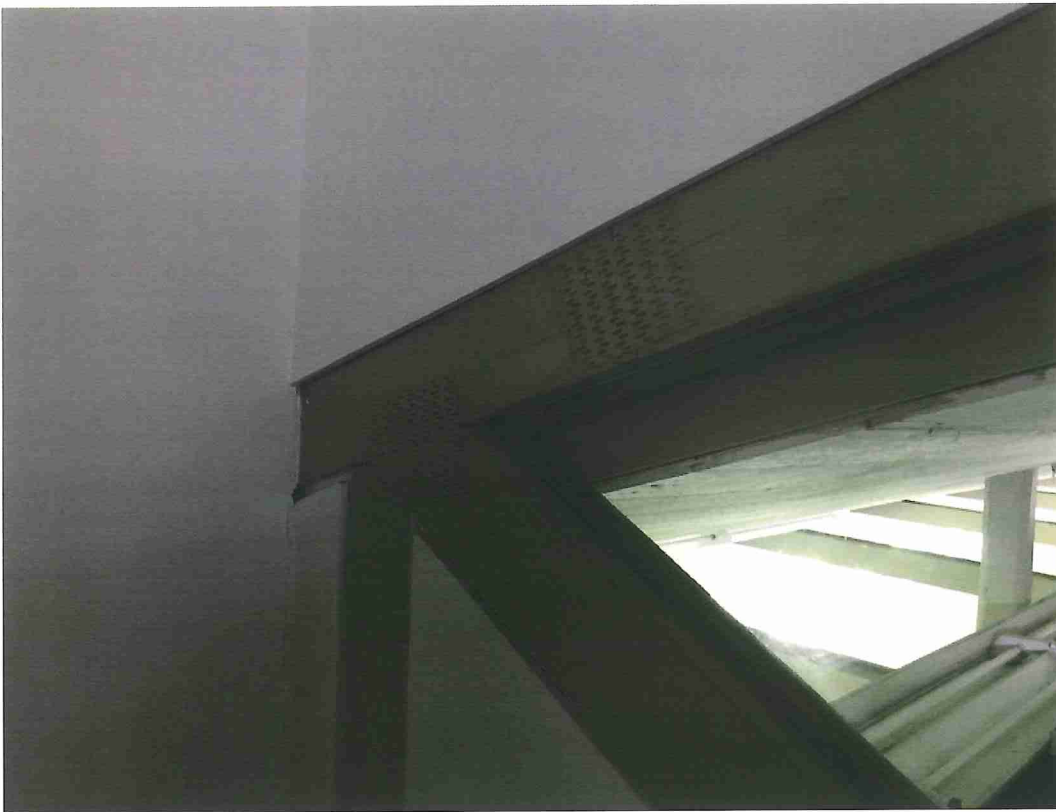
📍 10 Elm Street | Boxford, Massachusetts
📅 Aug 24, 2018 📷 Arron Sturgis

1981 addition: The gusset plates holding the conventional trusses together are clearly visible from the library stair well rising to the second floor of the main house. This is typically not a finish detail.

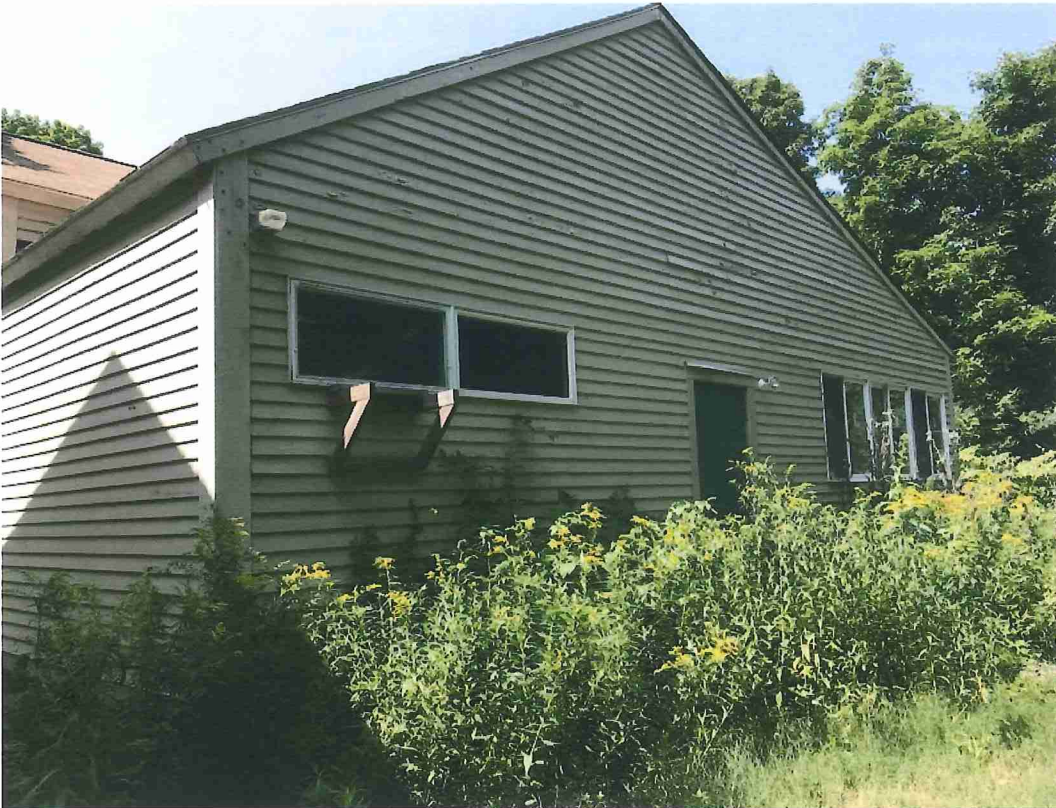
📍 10 Elm Street | Boxford, Massachusetts
📅 Aug 24, 2018 📷 Arron Sturgis

1981 addition: The East Gable of the addition is shrouded now with heavy vegetation. Windows and siding are rotting and the mold on the interior is unabated.

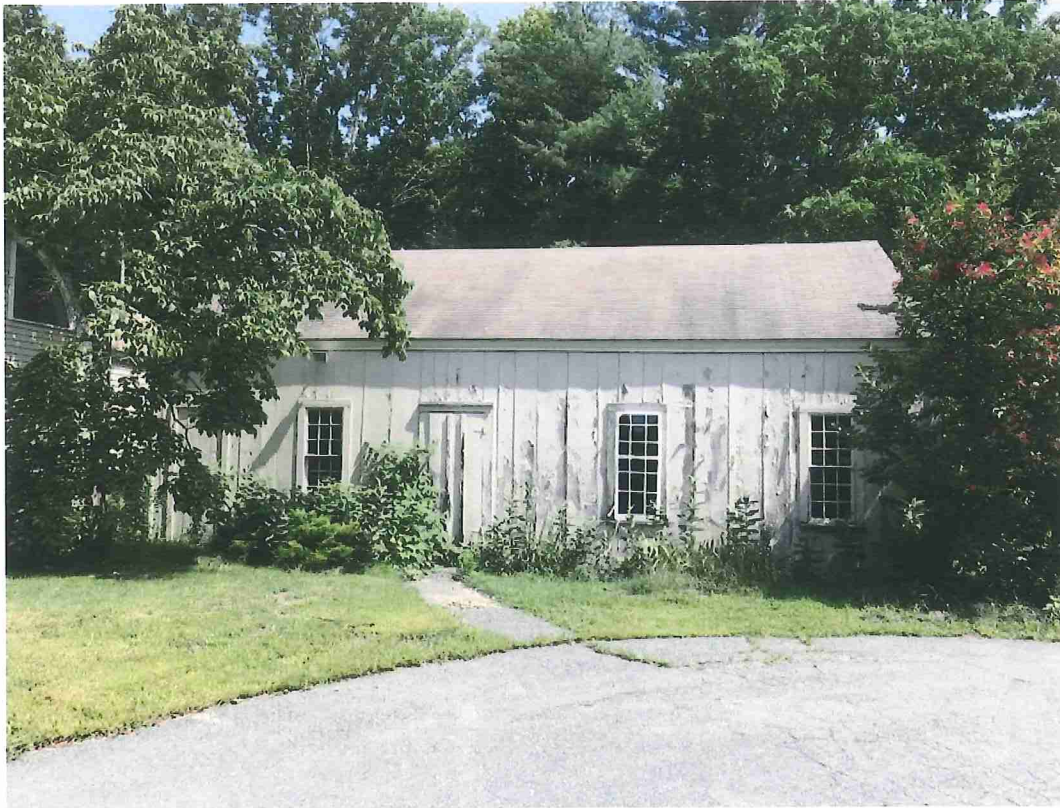
📍 10 Elm Street | Boxford, Massachusetts
📅 Aug 24, 2018 📷 Arron Sturgis

The Barn: The barn is a very early timber framed structure contemporary with the age of the house. It is in remarkable condition for its age. The original form of the barn hosted a shed roof. Its current configuration is very different and the alterations while extensive are reversible. It is currently underutilized for equipment storage.

Recommendations for the barn include its careful documentation and dismantling for repair. Its original shed roof should be reintroduced. Its use could be diverse and amenable to the creative solutions you will discover for the Cummings House. I offer a contingency here as a placeholder within your overall adaptive re-use of the house and property.

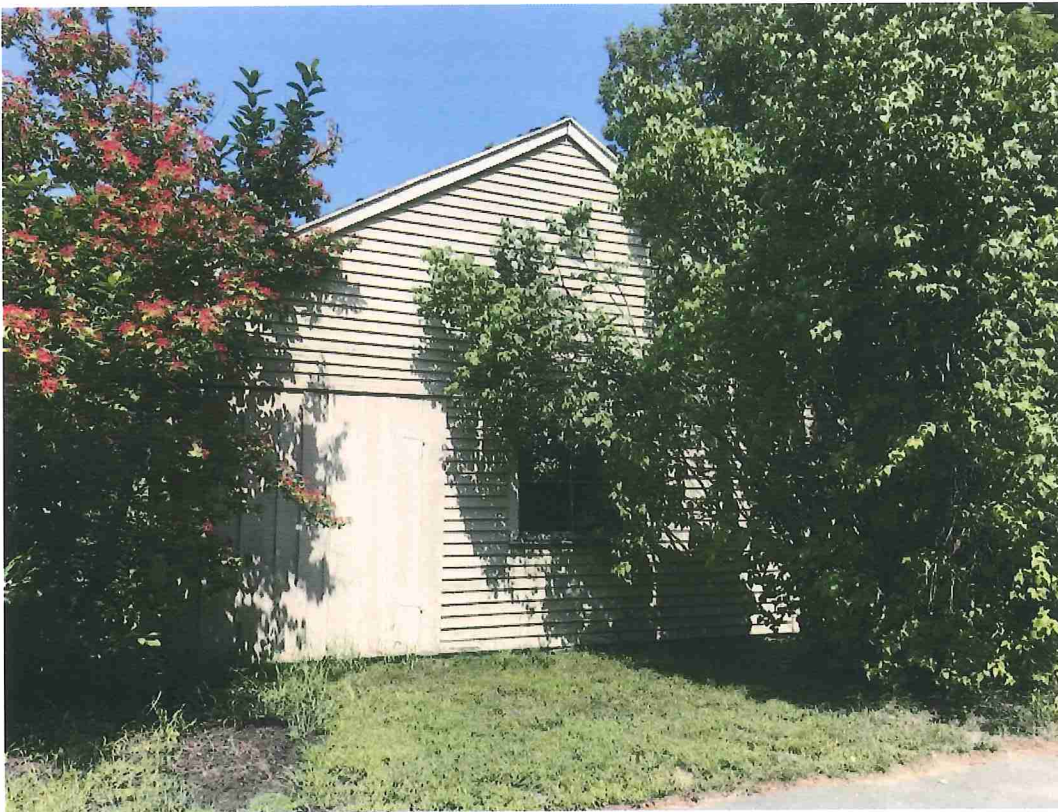
📍 10 Elm Street | Boxford, Massachusetts
📅 Aug 24, 2018 📷 Arron Sturgis

The Barn: The barn South gable is clad with clapboards with sliding doors. Windows are added later. All of the exterior on the barn is much newer than the structure hidden within.
