September 11, 2018

Cummings House Existing Conditions Assessment

Cummings House Boxford, Massachusetts

10 Elm Street, Boxford, MA

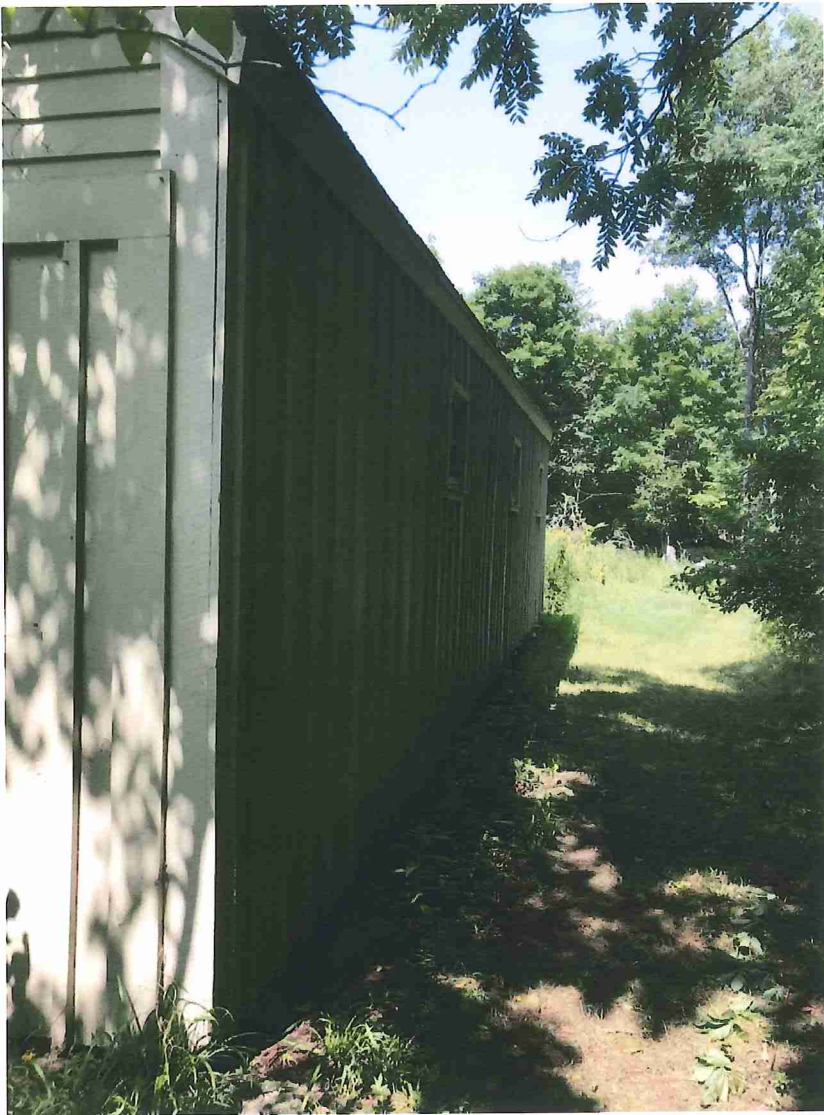
📍 10 Elm Street | Boxford, Massachusetts
📅 Aug 24, 2018 📷 Arron Sturgis

The Barn: The east eave wall is clad with board and batten siding. It is relatively new. Grade around the barn is very high and covers both siding and sill. This structure is quite unique in form and worth saving if a new use can be found.
