EXTERIOR WALL/WINDOW EVALUATION AT
BOXFORD TOWN HALL/LIBRARY
7 Spofford Road
Boxford, Massachusetts 01921

April 10, 2018

**EXTERIOR WALL/WINDOW EVALUATION AT
BOXFORD TOWN HALL/LIBRARY
7 Spofford Road
Boxford, Massachusetts**

**Exterior Wall/Window Evaluation at the
Boxford Town Hall/Library
Boxford, Massachusetts
Gale JN 833440**

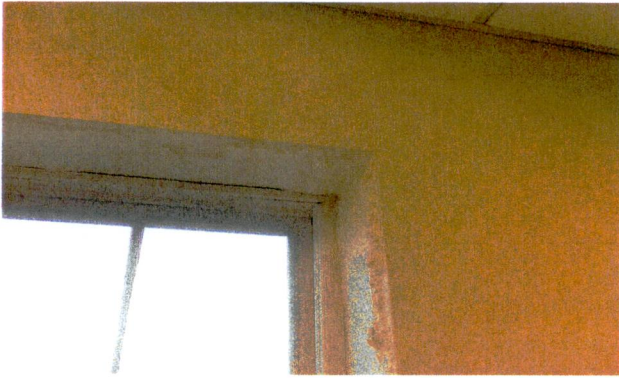
Gale observed 15 active leaks throughout the building. The majority of these leaks appear to be concentrated at or adjacent to window locations on the first and second floors. Damaged interior finishes were observed at leak locations. Interior damage consisted of: stained ceiling tiles, stained interior finishes, blistered and peeling paint, deteriorated gypsum wall board, deteriorated wood trim, corroded metal studs, and stained floor tiles. Typically, interior finishes were damaged at window head and jambs, and at additional isolated locations. Refer to Appendix C of this report for reported leak locations.

Figure 2: Blistered paint on the window header and jambs was observed at multiple locations.

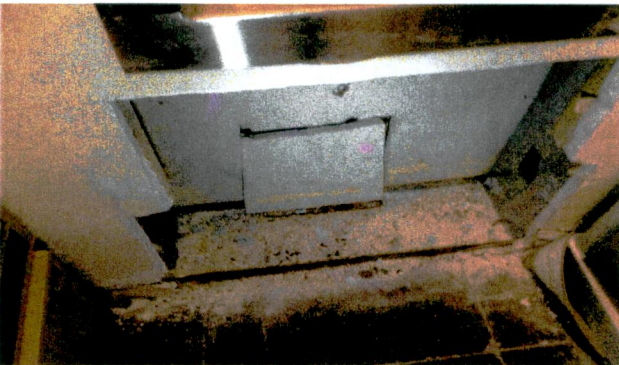
Figure 3: Evidence of water infiltration based on rusted metal-stud framing inside the Payment Drop closet on the 1st floor

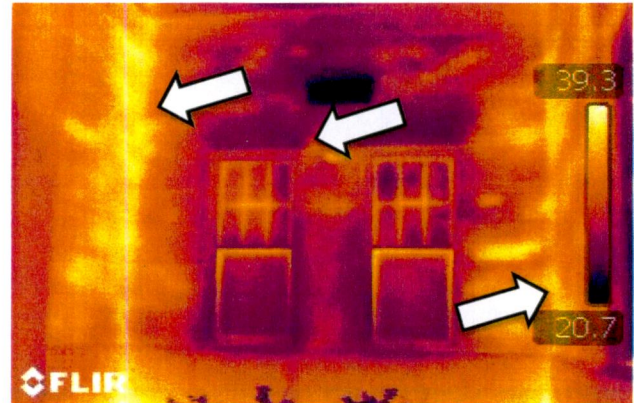
The IR Survey results indicated that areas of energy transfer appeared to typically consist of the window perimeters, the floor lines, inside and outside corners of the walls, below the gable ends of the roof and the roof eaves. Though most areas of energy transfer from the IR scan were at these above-mentioned locations, isolated areas in the field of the wall were observed.

Figure 4: Exterior thermographic image indicates warm energy transfer at the inside corners and at the window perimeters.

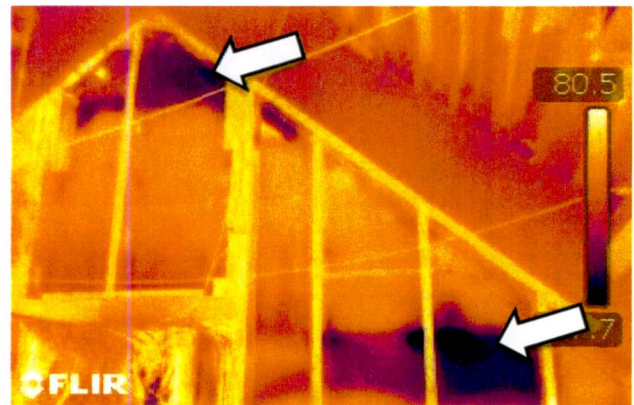
Figure 5: Thermographic image from inside the attic shows cold air infiltration at the gable wall transition to the roof ridge.

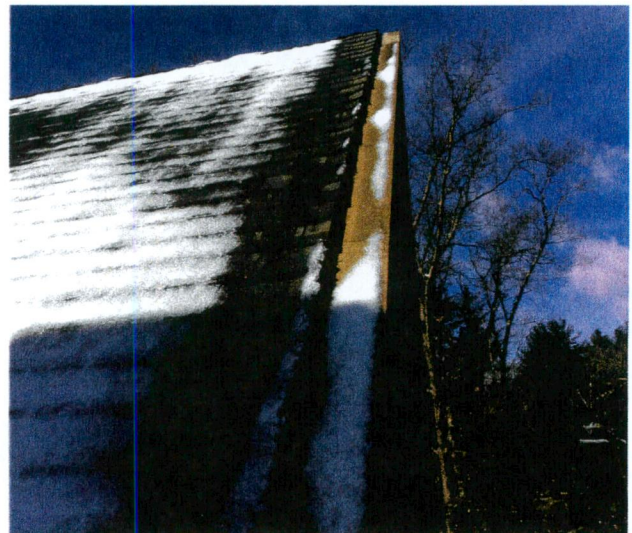
5. Precast units at the rake edge locations extend out further than the roof edge creating shelves for snow, ice, and water to accumulate directly atop the precast.

Figure 8: Exposed precast extends out beyond the roof edge on the rake edges of the roof.

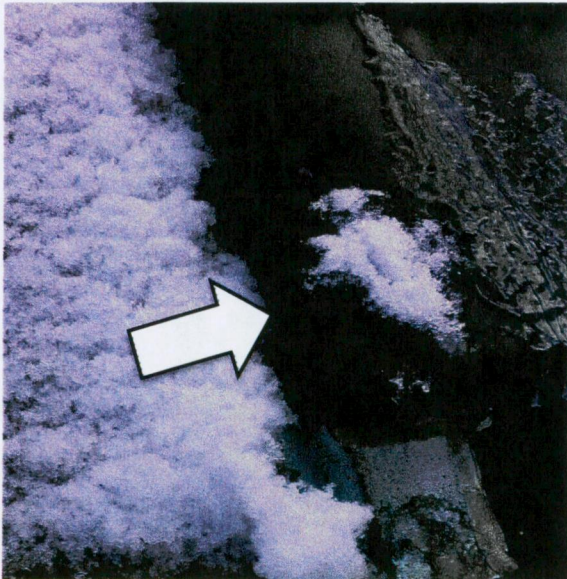
6. Unsealed seams in the sheet metal flashings were observed on the rake edges of the roof.

Figure 9: Open seams were observed in the flashings along the rake edge.

12. Replace all perimeter sealants at windows, doors, control joints and other wall penetrations.
13. Install new sheet metal flashings and caps at roof to wall transitions at the eave and rake edges to fully cover exposed horizontal surfaces of the precast concrete units.
14. Install new step flashing at the brick rising wall along the Assembly Room.

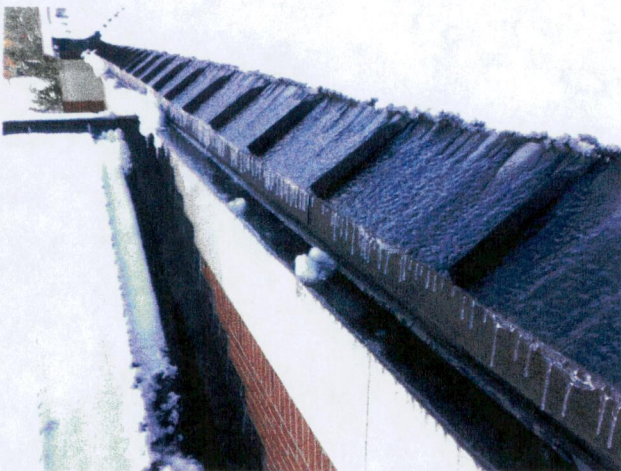
7. A copper sheet metal cap flashing has been installed over the precast stone shelf below the roof eaves. It was reported that the metal cap was installed after the original construction due to snow and ice build-up on the precast shelf, as the roofing was originally designed to stop short of the precast unit (similar to the existing rake edge detail). Note the cap was only installed at the eaves, and not at the rake edges. The metal cap does not appear to be sloped, and ice/snow had accumulated on top of the shelf during the evaluation.

Figure 10: Precast stone shelves are located at the eave locations allowing snow, ice, and water to build up. Eave locations were covered with a sheet metal cap.

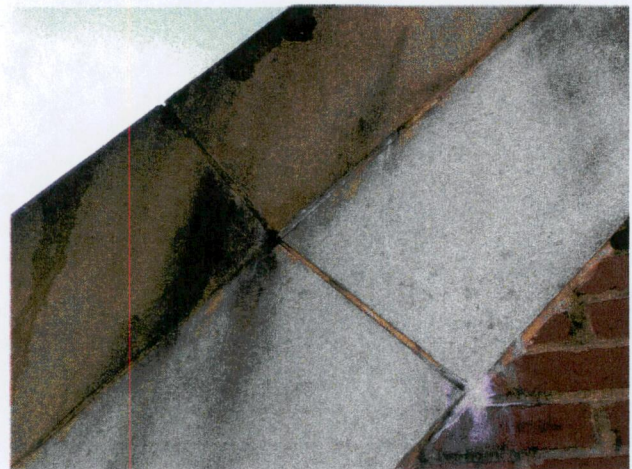
8. The mortar joints in the precast stone units are typically in failed condition in the form of open, cracked, and debonded mortar. The open mortar joints were observed at horizontal surfaces at the rake edges and other isolated areas. Horizontal surfaces are most susceptible to moisture infiltration.

Figure 11: Mortar joints were typically observed to be failed at the precast concrete.

In addition to insufficient TWF, deteriorated mortar joints in the precast concrete units were observed above window units and just below the roof rake and eave edges. The observed unbonded and open mortar joints in the precast can allow excessive moisture to travel into the wall cavity. Defects in the TWF, weather barrier system (DensGold sheathing/Carlisle AVB membrane) behind the exterior masonry cladding, improper transition details at roof to wall connections, building corners, and at window perimeters were observed. These deficiencies allow the moisture within the cavity to penetrate into the interior of the building.

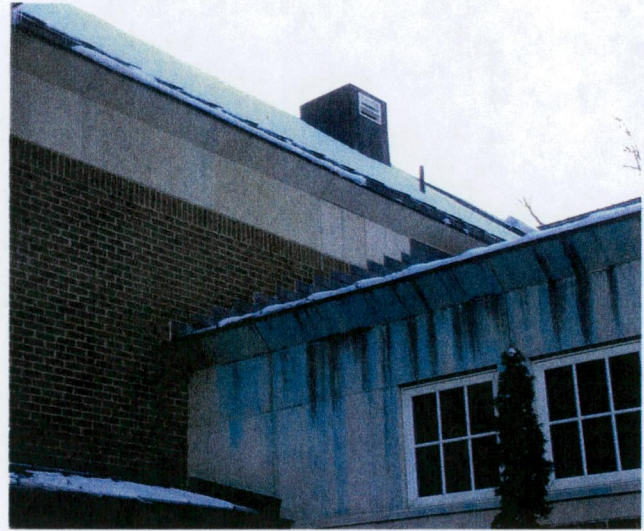
18. Heavy copper staining was observed on the precast stone units along the Assembly Room walls below the copper roof.

Figure 13: Heavy copper staining on the precast was observed along the assembly room walls.

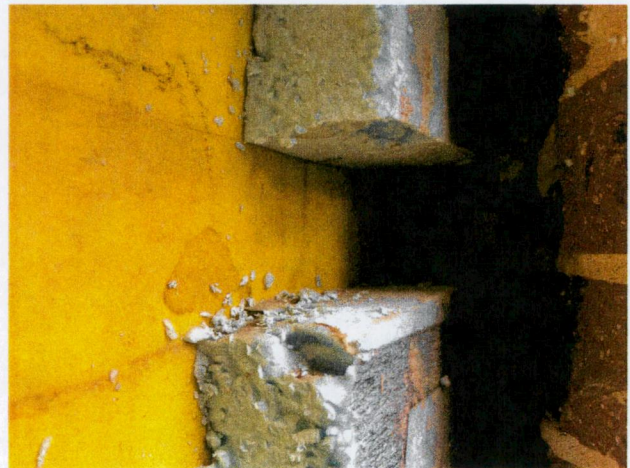
Figure 14: Gaps in the insulation were observed at multiple locations.

The third issue is related to issues associated with improperly installed thermal insulation. The design intent was to provide a continuous layer of insulation onto the exterior of the DensGold sheathing within the cavity wall. The XPS insulation was observed to be non-continuous, as large areas of insulation were missing, large gaps were observed at the joints of the insulation, the joints were not taped, and the insulation typically did not fully extend to the perimeters of the window openings. Additionally, the insulation was not installed tight against the gypsum sheathing in isolated locations, which can allow for air movement behind the insulation.

2. Remove the existing extruded polystyrene insulation (XPS).
3. Remove and replace any areas of deteriorated DensGold sheathing. It is assumed that 5% of sheathing will require replacement.

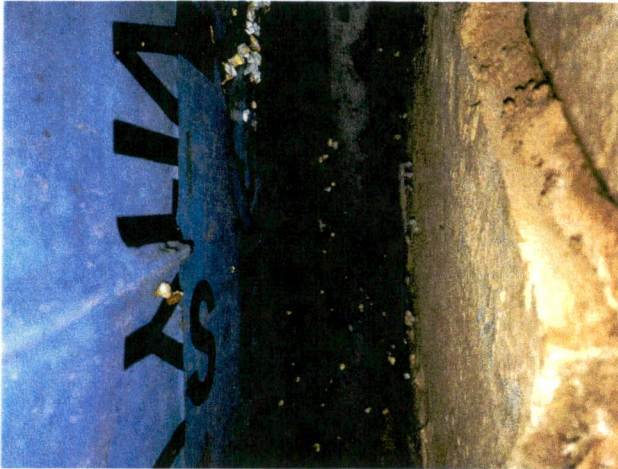
21. Large areas of missing insulation were observed typically behind the precast concrete panels along the rake edge and beneath the roof ridge.

Figure 15: Areas of missing insulation were observed behind the precast units and below the ridge.

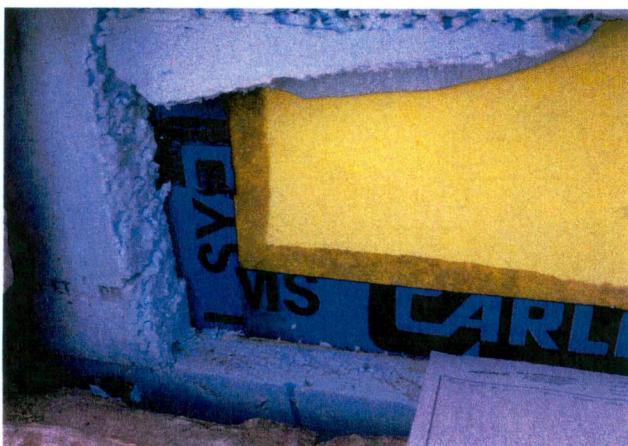
26. The DensGold is installed on the exterior side of the metal stud wall and appears to incorporate the Carlisle SA membrane at the seams. The SA membrane was also used as a transition strip at select window and penetration locations.

Figure 16: The DensGlass Gold sheathing seams appear to be stripped in with AVB transition membrane.

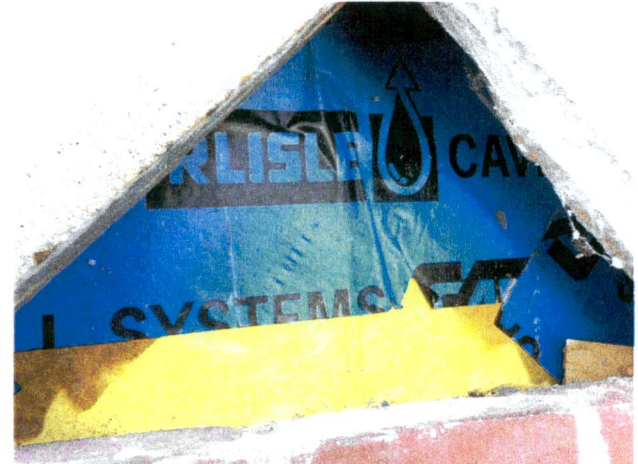
27. Multiple fish mouths and wrinkles were observed in the SA membrane across all test cut locations at gypsum sheathing joints and window perimeter locations.

Figure 17: SA membrane was observed to have multiple fish mouths and wrinkles.

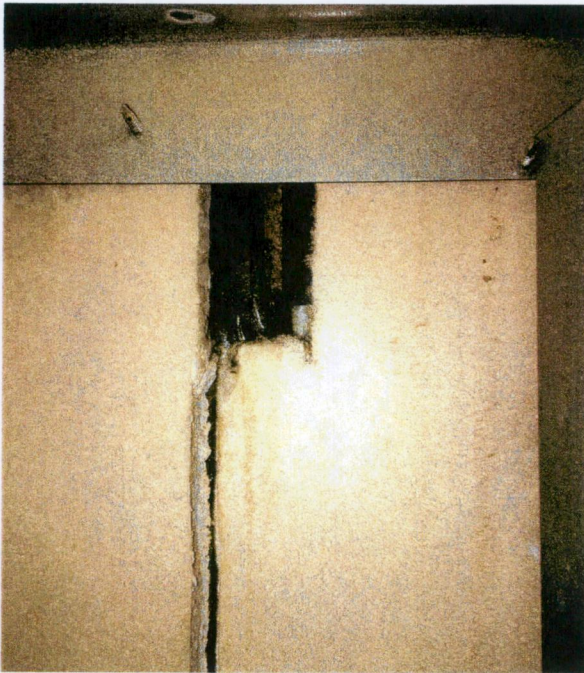
30. Isolated areas of the DensGold show signs of moisture damage in the form of facer delamination.
31. Precast concrete anchors were observed to penetrate the DensGold to secure to structural framing elements. At these penetrations, the DensGold was cut and does not provide a continuous air seal.

Figure 18: DensGold cut to allow steel anchor for precast.

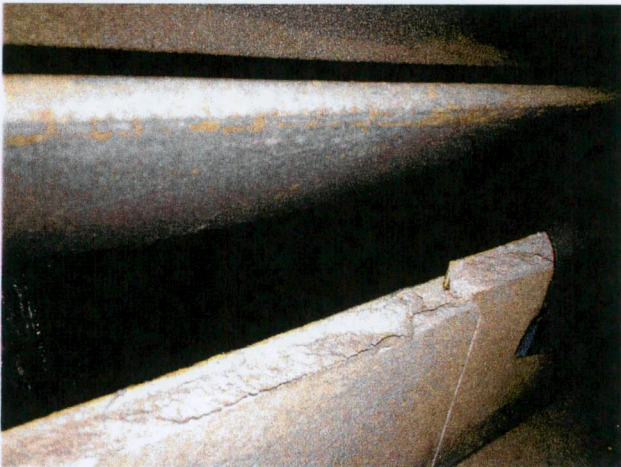
32. The roofing underlayment membrane installed at the roof eave locations transitions to the DensGold wall sheathing; however, the membrane is unsupported and was observed to have tears and open joints.

Figure 19: View of the roofing underlayment that is not supported at the roof to wall transition.

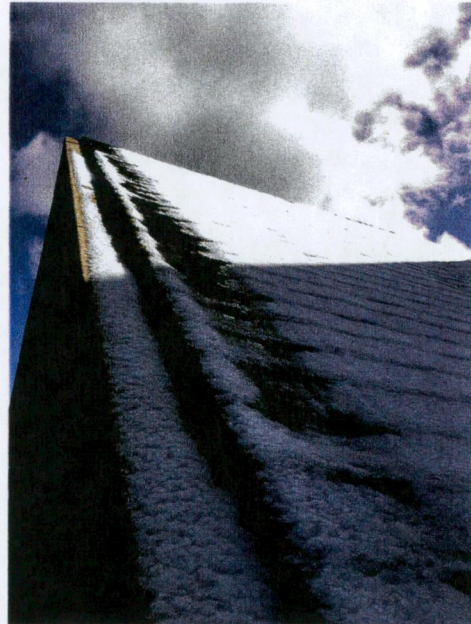
33. There is no continuous insulation from the roof to wall transition, as evident by the original design drawings and by melted snow along the eave and rake locations, which results in energy loss.

Figure 20: Areas of melted snow were observed on the roof rake and eave locations of the roof, these are locations that gaps in the insulation were observed.

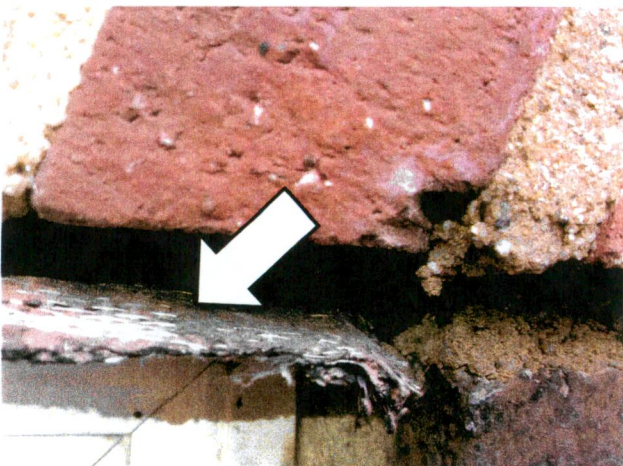
36. Wood blocking constructed at the perimeters of the window appears to be inconsistent. Some areas were observed to have multiple layers of blocking and others had one layer or two layers of plywood.
37. Backer rod and sealant is installed at the window perimeters and is typically in good condition.
38. Continuous air barriers and continuous insulation was not observed between the window jambs and the wood blocking/wall insulation.
39. Sill pan flashings were not observed at window units.
40. At first floor windows with brick masonry jack arches above, fabric coated copper window head flashings appeared to be deteriorated and no end dams were observed.

Figure 22: Deteriorated throughwall flashing was observed at the window heads on first floor windows with jack arches.

below brick jack arches. TWF was not observed at the heads of second floor windows. Even where flashings were observed, they were not installed in accordance with industry standards of practice; the TWF do not extend to the outside face of the wall; do not incorporate drip edges; do not utilize end dams; and were observed to be improperly terminated and sealed to the backup wall. It is important to note that all masonry walls, due to their nature, allows water to penetrate into the cavity between the brick and backup wall. Throughwall flashings are installed to redirect that moisture out of the cavity to the outside, not into the building. Lack of or improperly installed TWF allows water to penetrate the wall into the interior space, as is the case of this facility.

9. Install steel lintels at first floor windows and doors.
10. Install new sheet metal and fabric throughwall flashings at all window and door heads, floor lines, and at the building foundation. Install full head joint baffle weeps at flashings.

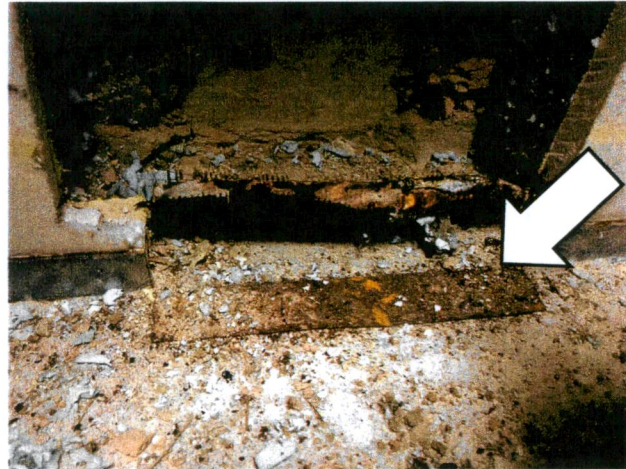
41. The bottom track of the light guard metal stud wall was observed to be corroded below the mail drop box at the South elevation.

Figure 23: The bottom track of the metal stud was observed to be corroded at interior test cut locations.

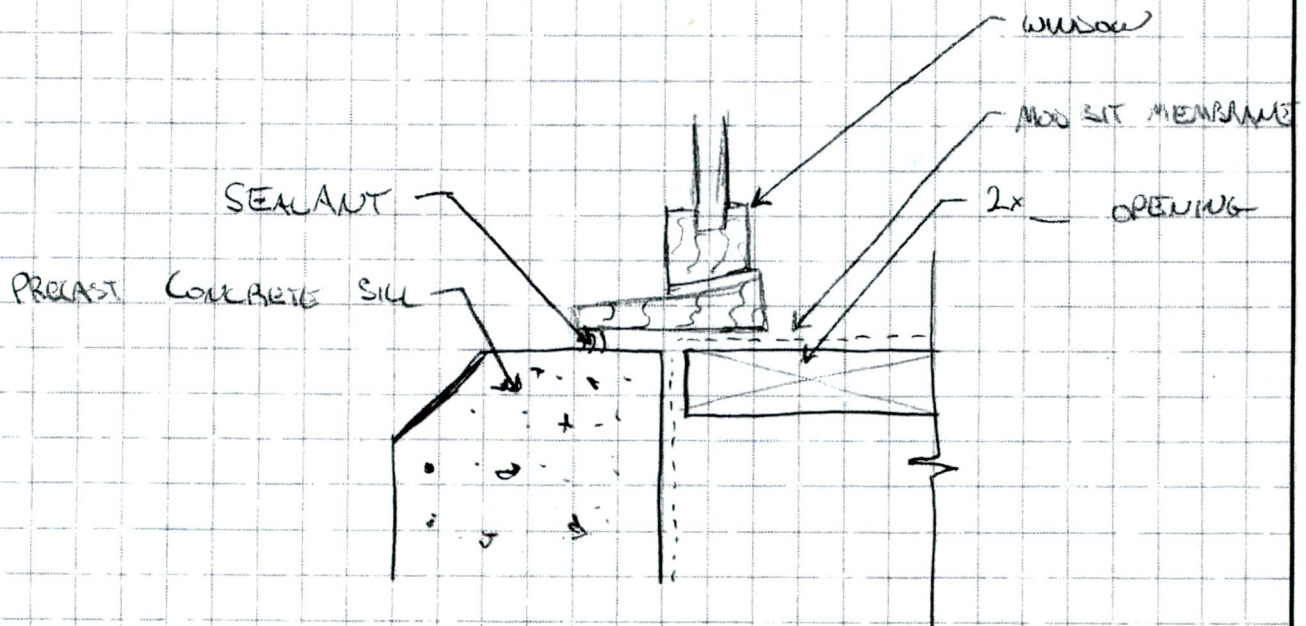
TEST CUT #2A - WINDOW SILL
- LAYER OF ICE ON STONE SILL

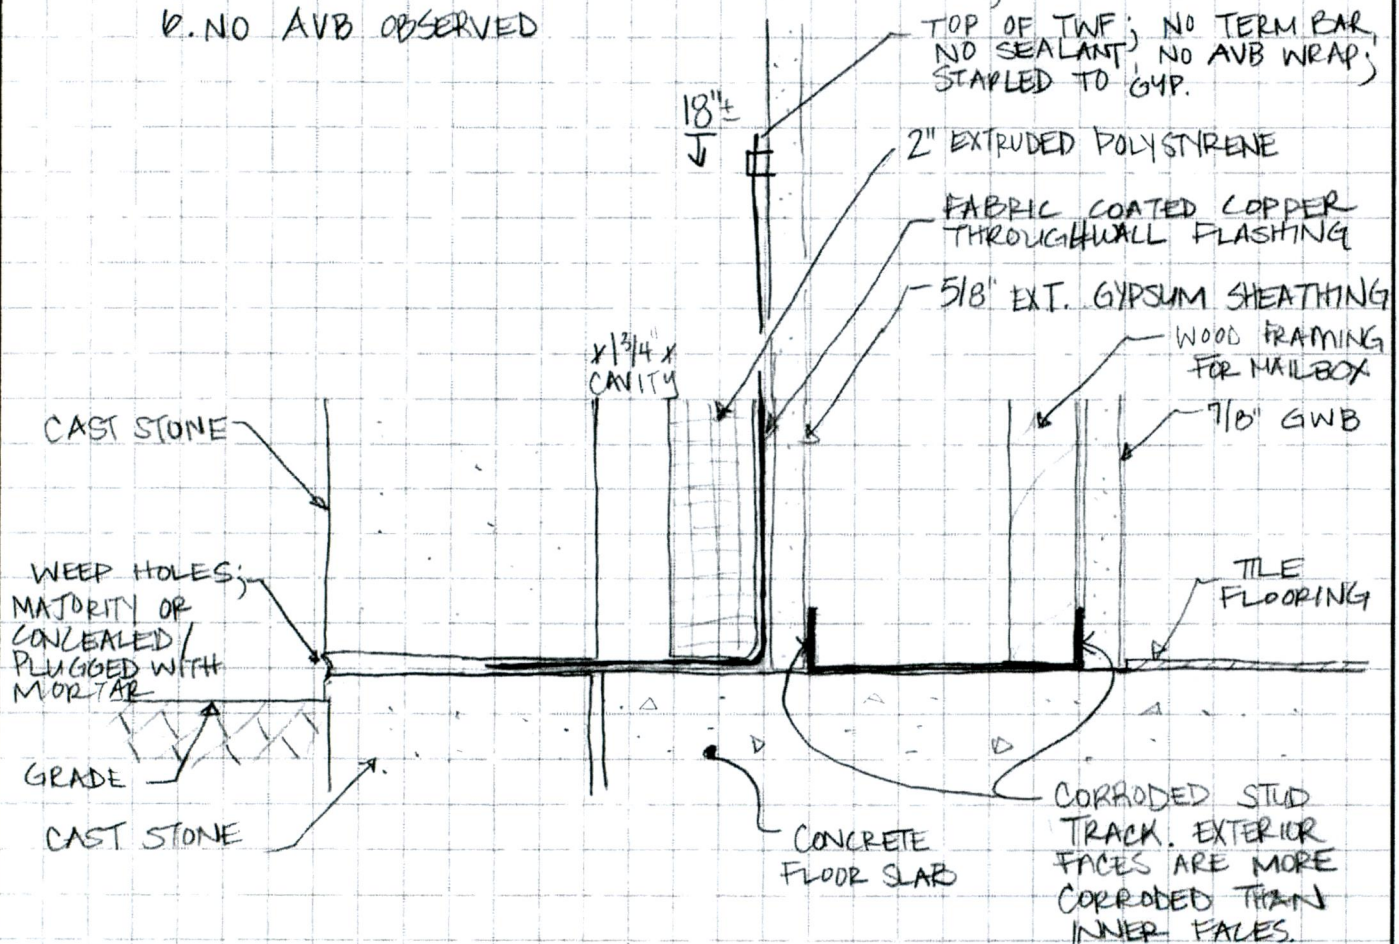
- (INTERIOR SIDE)
- NOTE:
1. BACK SIDE OF FCC TWF SHOWS MOISTURE STAINING
 2. EXTERIOR FACE OF GWB SHOWS MOISTURE DAMAGE; GOLD FACER PEELED OFF
 3. WEERS TYP. PLUGGED
 4. TWF NOT TERMINATED @ TOP
 5. XPS DOESNT EXTEND DOWN PAST FLOOR SLAB, AS DWGS INDICATE
 6. NO AVB OBSERVED

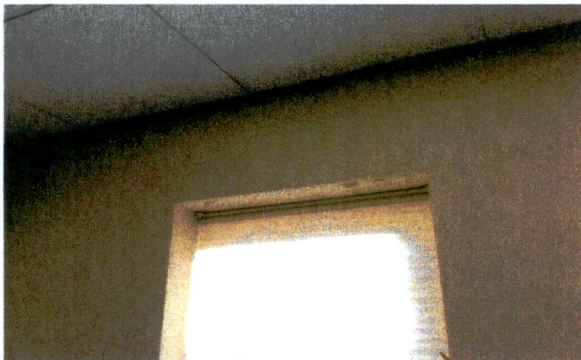
Figure 1: Water infiltration resulted in blistered paint on the window header in Room 220.

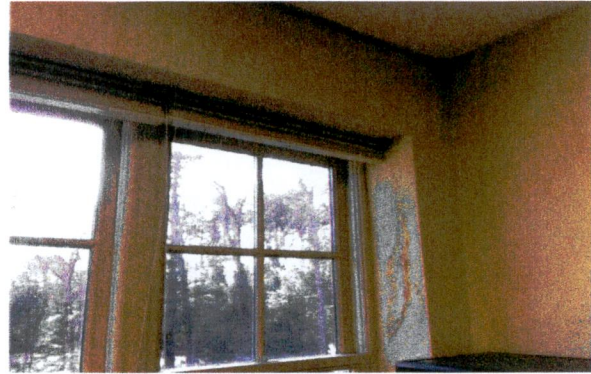
Figure 2: Water infiltration resulted in blistered paint on the window header and jamb in Room 224.

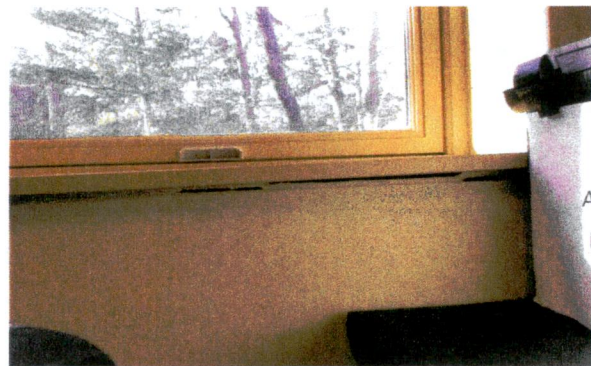
Figure 3: Bowed/displaced interior stool in Room 227.

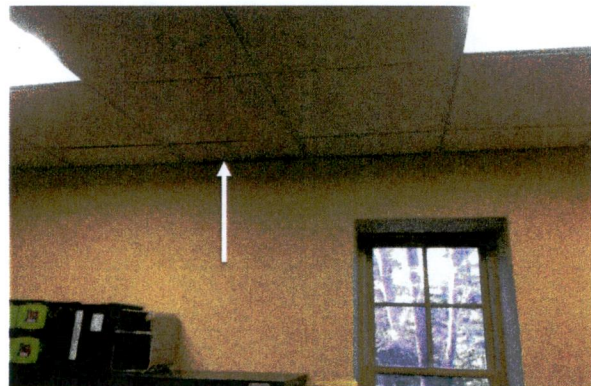
- Leak location #5 Room 229 – Conservation/Planning Office, water staining on a ceiling tile inward of the window header Refer to Figure 5.

Figure 4: Water staining was noted on the ceiling tile inward of the window in Room 229.

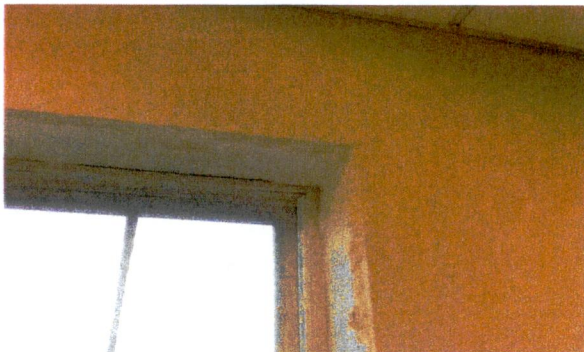
Figure 5: Water infiltration resulted in blistered paint on the window header and jamb in Room 232.

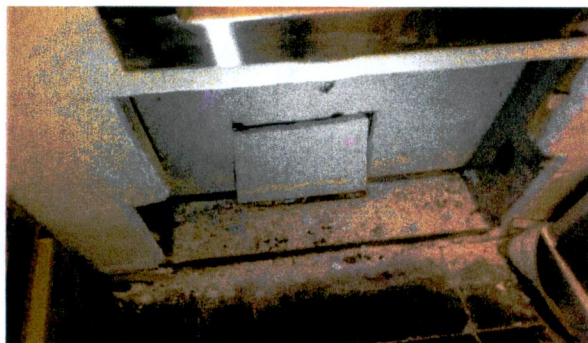
- Leak location #9 Payment Drop Closet Room on the 1st floor, rusted metal-stud framing noted via previously opened interior wall area Refer to Figure 7.

Figure 6: Evidence of water infiltration based on rusted metal-stud framing inside the Payment Drop closet on the 1st floor

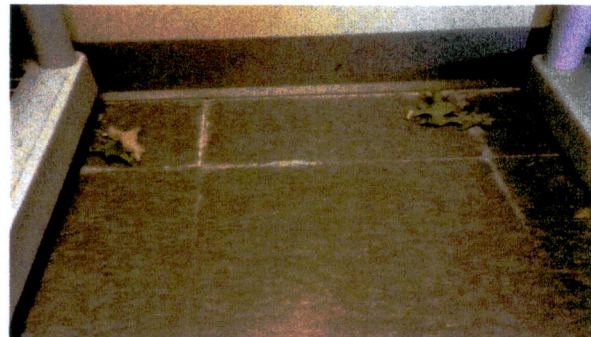
Figure 7: Evidence of water infiltration in the form of efflorescent staining around floor tiles in the closet west of the main entrance.

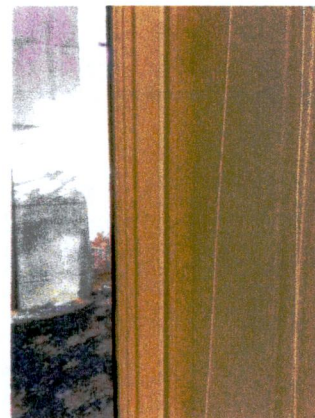
Figure 8: Blistered paint on interior wood trim adjacent to a window.

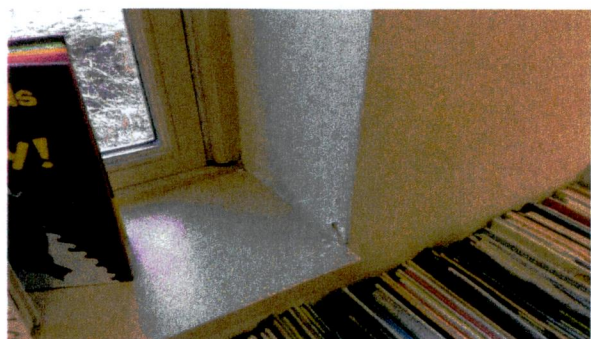
Figure 9: Water infiltration resulted in blistered paint on the window jamb/sill transition in the Children's Library.

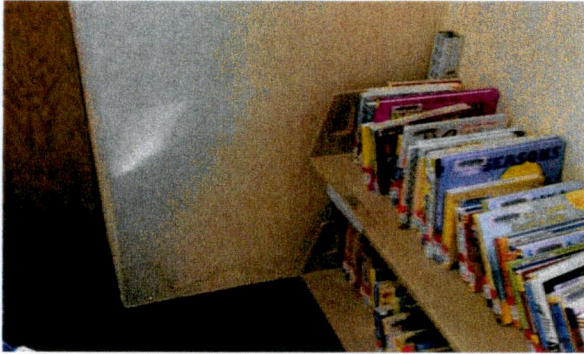
Figure 10: Water infiltration resulted in blistered paint on the interior wall in the Children's Library.

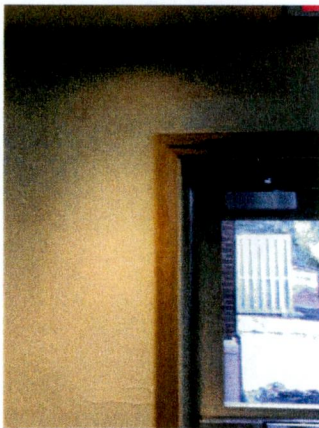
Figure 11: Water infiltration resulted in blistered paint on adjacent to the door in the Assembly Room

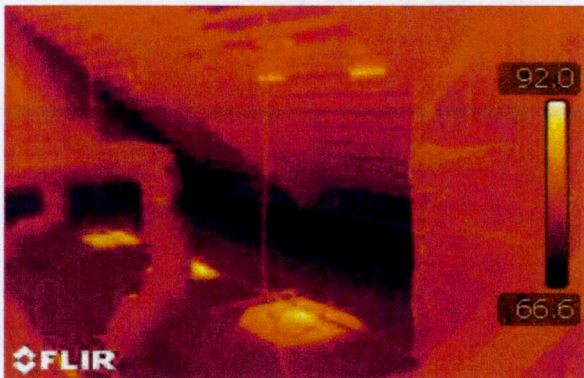
Figure 1: Thermographic image from inside the attic shows cold air infiltration at the wall to roof transition.

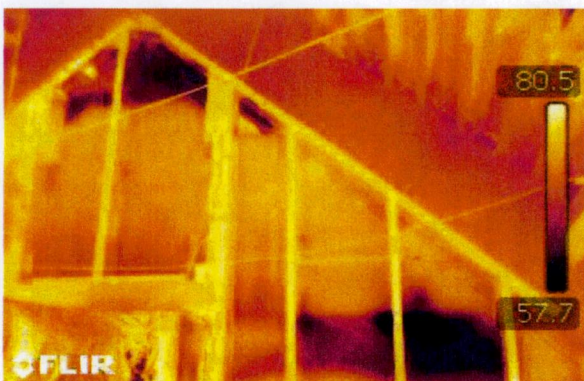
Figure 2: Thermographic image from inside the attic shows cold air infiltration at the gable wall transition to the roof ridge.

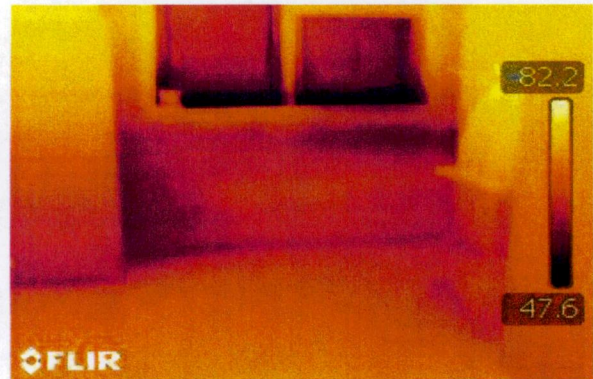
Figure 3: Thermographic image from inside Room 222 shows cold air infiltration in the wall below and around the window.

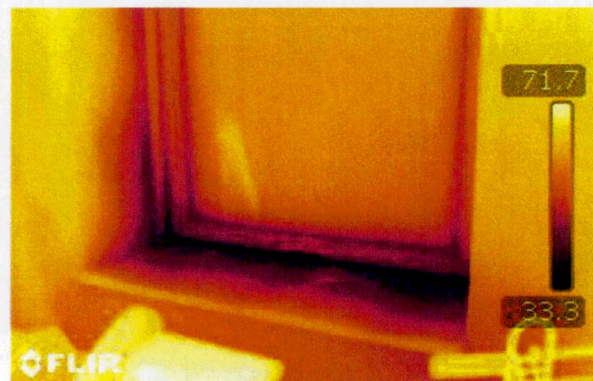
Figure 4: Close-up thermographic image shows cold air infiltration occurring around a window (typical).

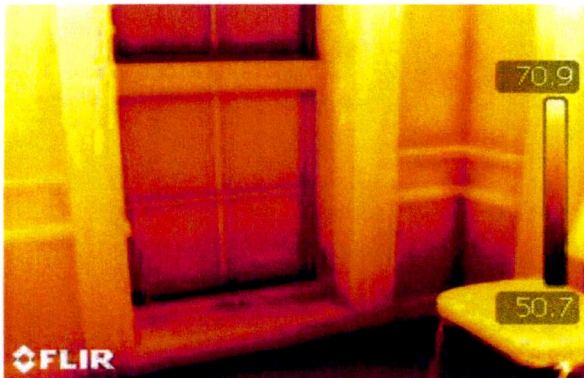
Figure 5: Thermographic image from inside Room 202 shows cold air infiltration in the wall at an outside corner and at the floor.

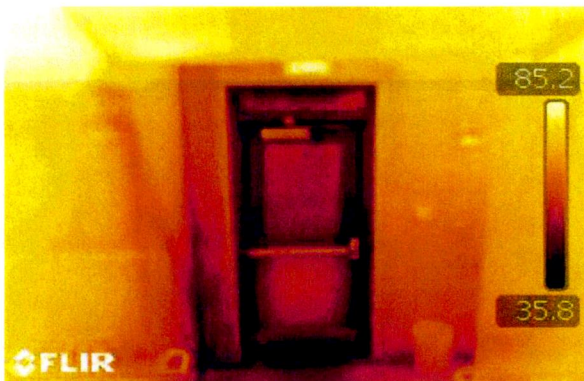
Figure 6: Thermographic image at the base of the stairwell shows cold air infiltration around the north entrance door and at grade.

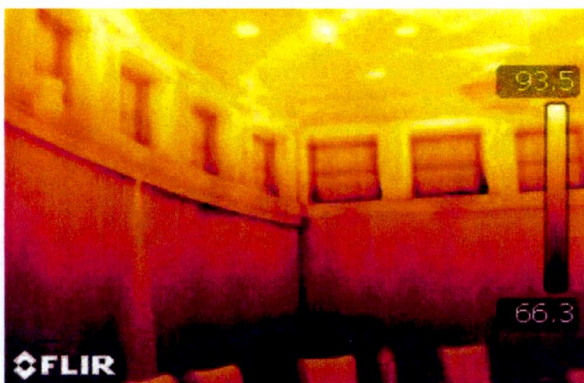
Figure 7: Thermographic image from inside the Assembly Room shows cold air infiltration at many locations.

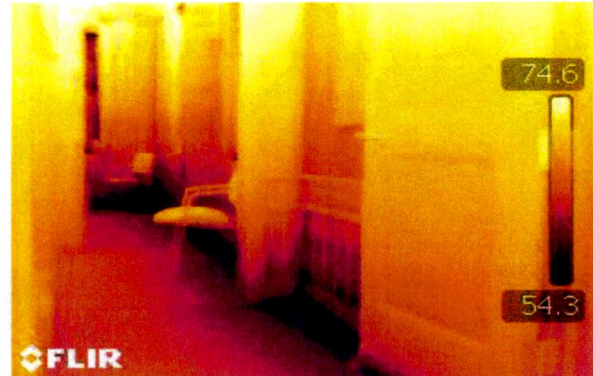
Figure 8: Thermographic image from inside the front corridor on the 1st floor shows cold air infiltration at the wall base transition to grade.
