Re: Peer Review of Gale Associates report titled *EXTERIOR WALL/WINDOW EVALUATION AT BOXFORD TOWN HALL/LIBRARY*, dated April 10, 2018.

BOXFORD TOWN HALL/ LIBRARY

BOXFORD TOWN HALL

Boxford, Massachusetts

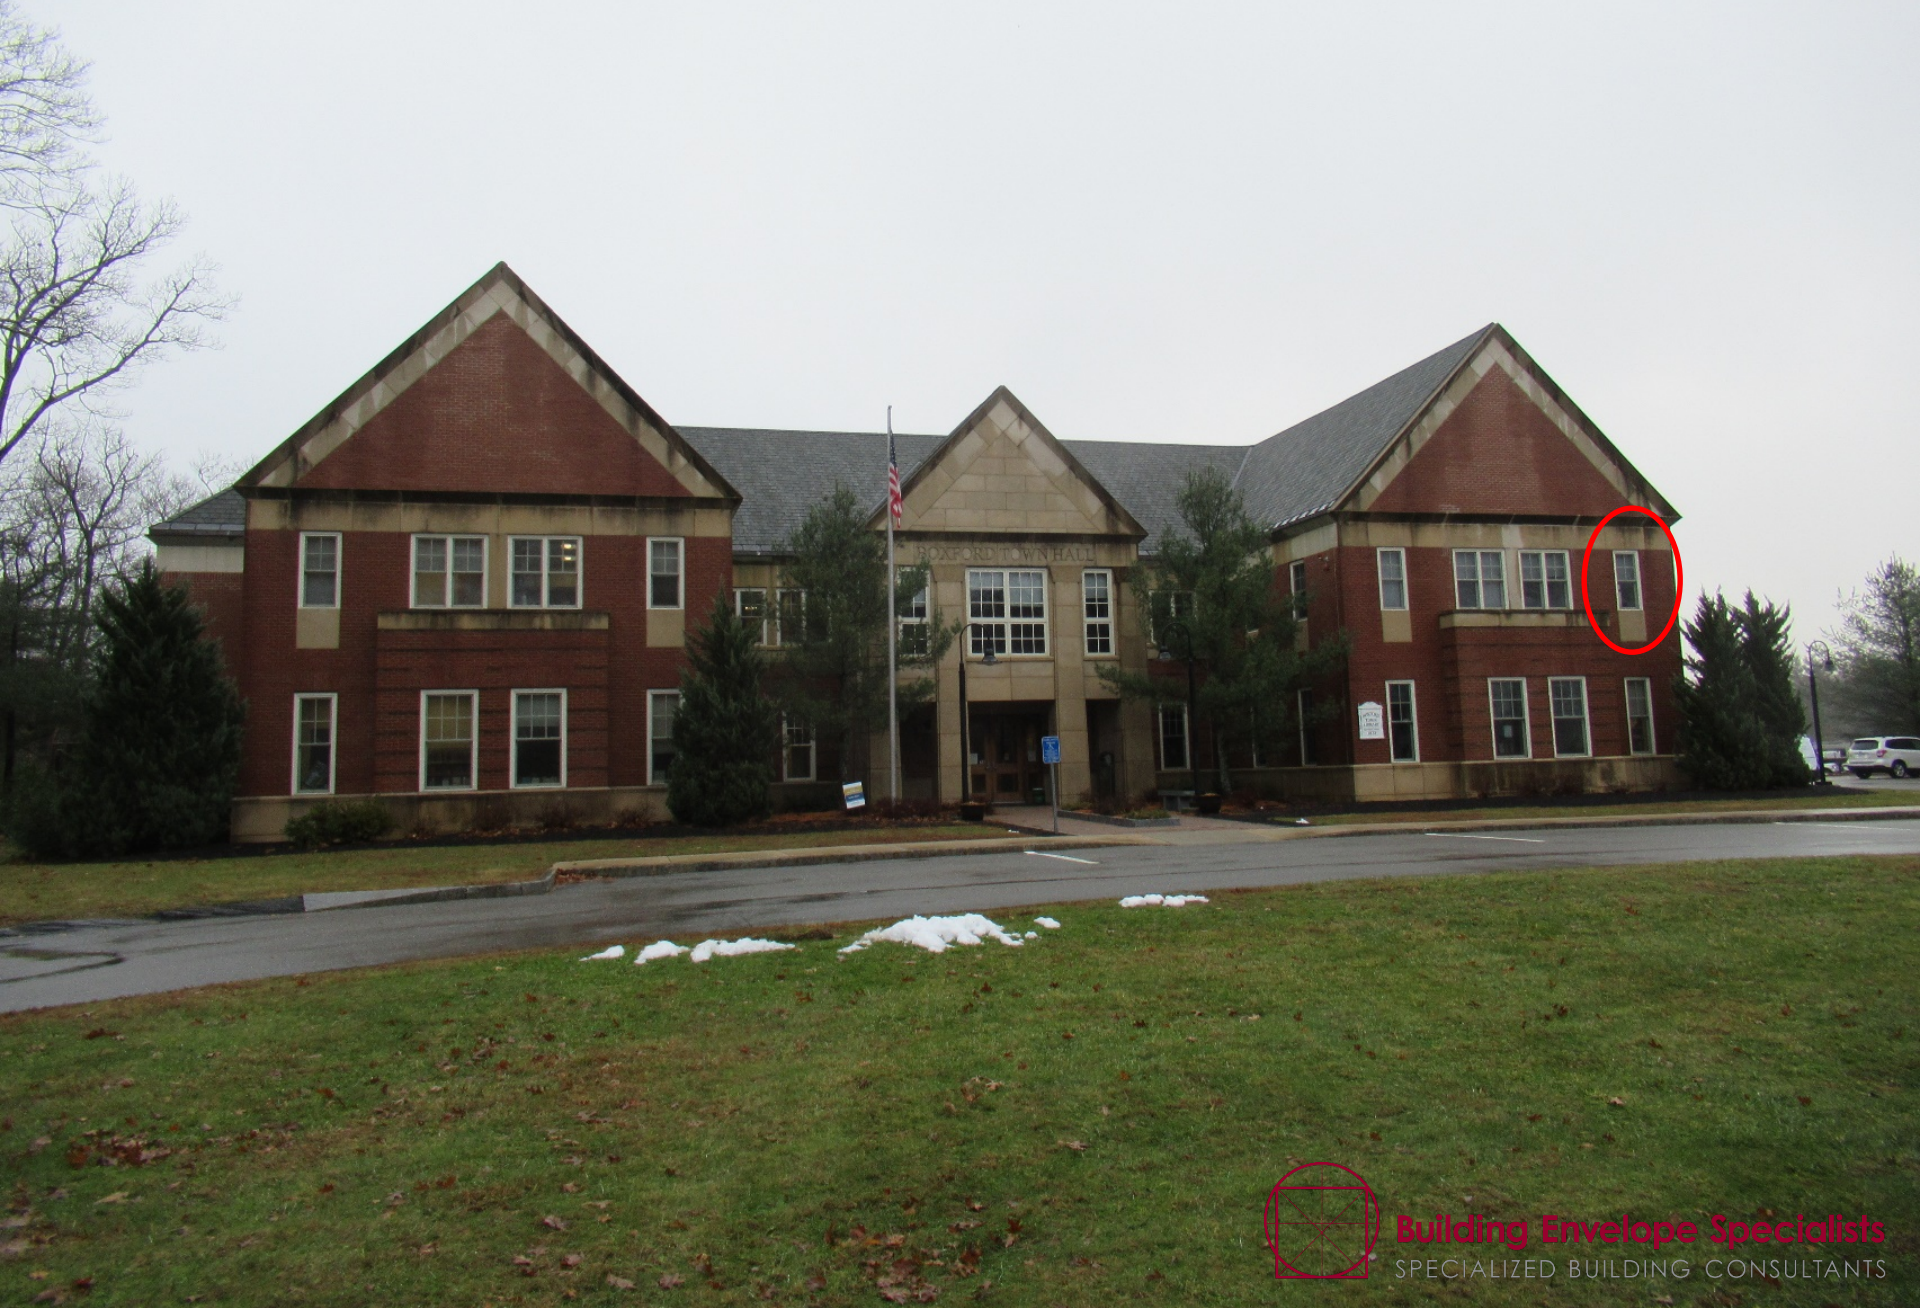
South elevation has most exposure to prevailing winds and worst active leaks at 2nd floor windows

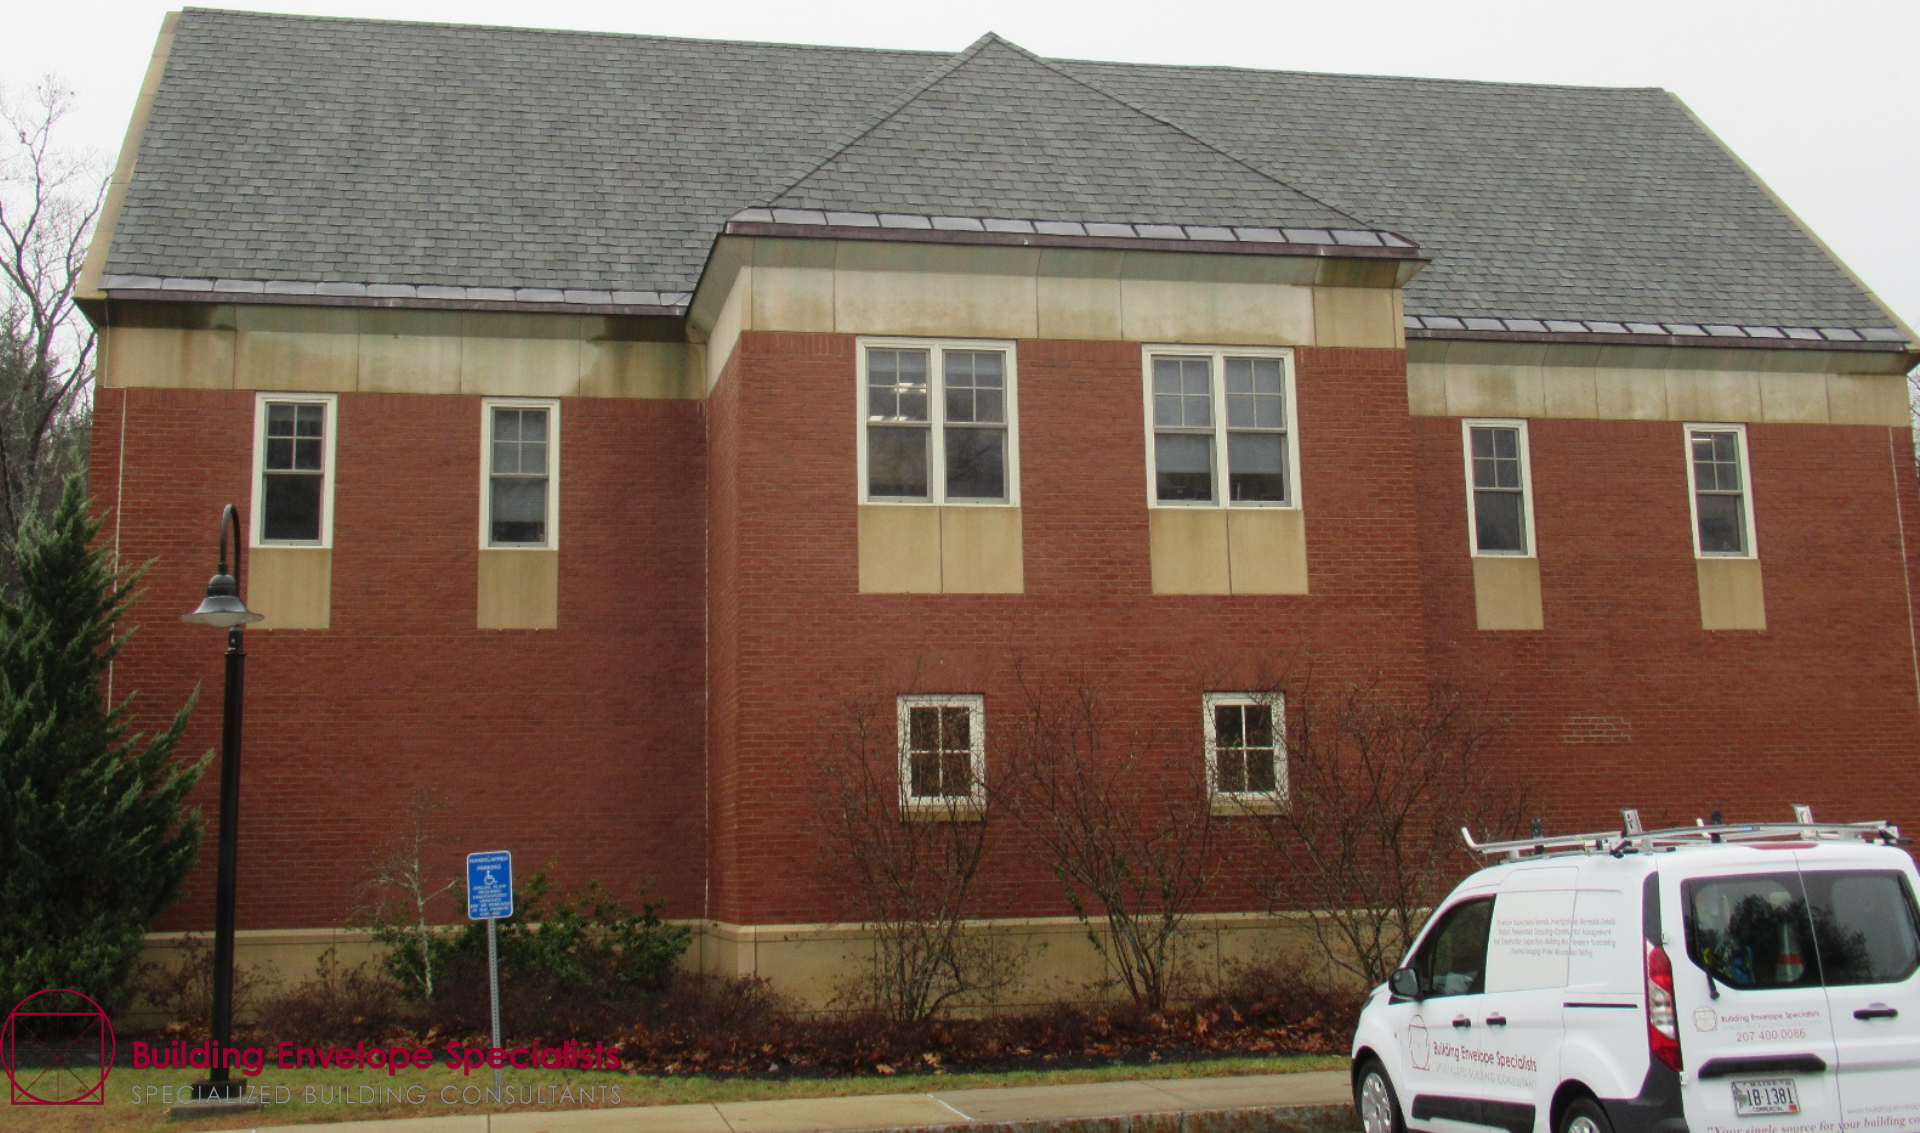
East elevation has the least moisture problems. Note that the corners have significant roof runoff. Add gutters?

- **Roof/ Wall Interfaces:** Roof edges with precast concrete exposed at the rakes requires a new flashing detail. The eaves have been flashed, but the interior corner walls still get very wet due to the volume of water running off from the valleys. BES recommends installing a gutter system to redirect the water properly.

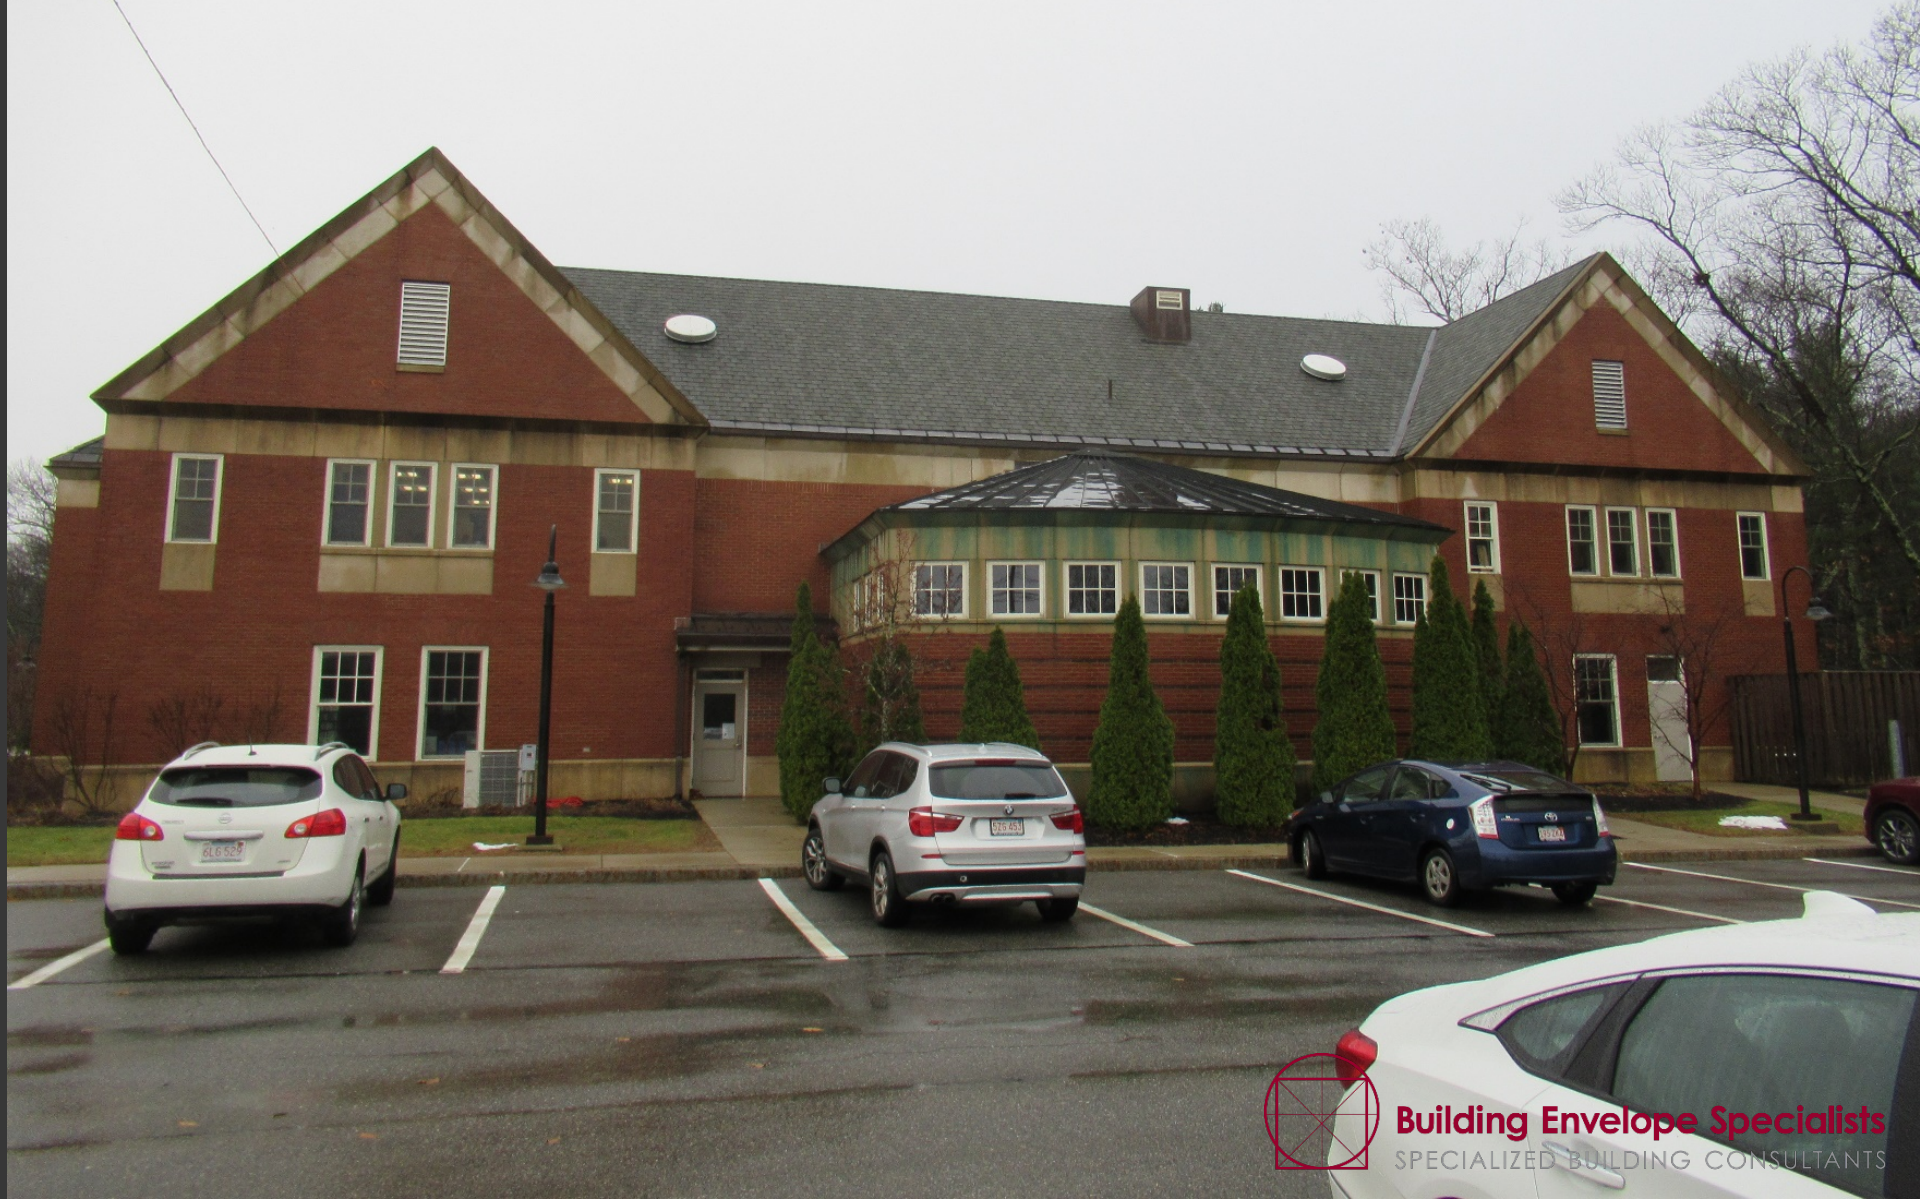
North elevation has had some repairs that have mitigated some of the moisture problems. Note, precast has been discolored.

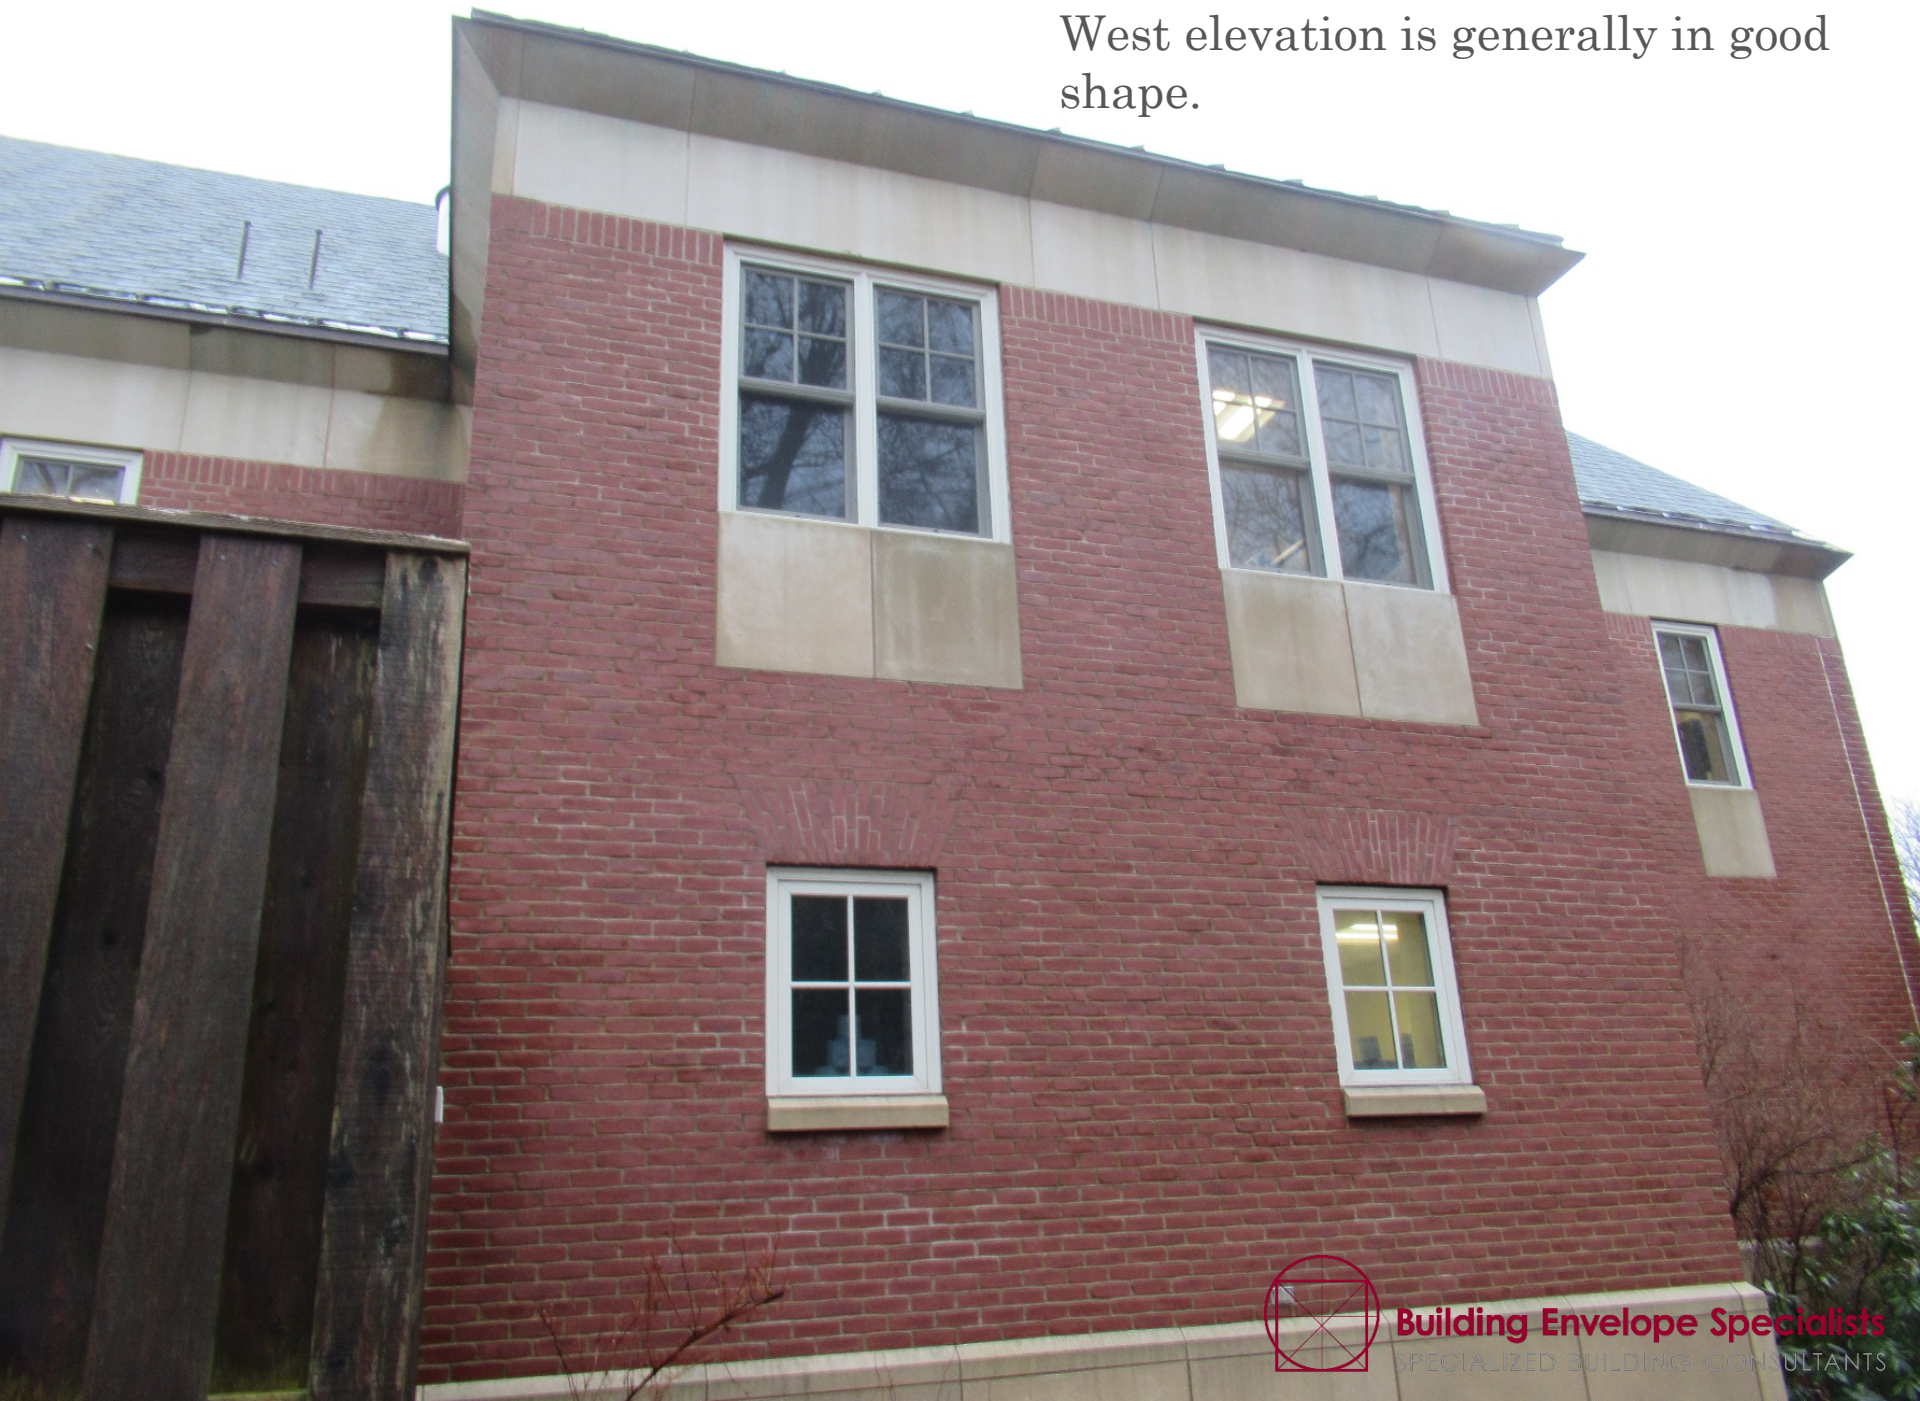
West elevation is generally in good shape.

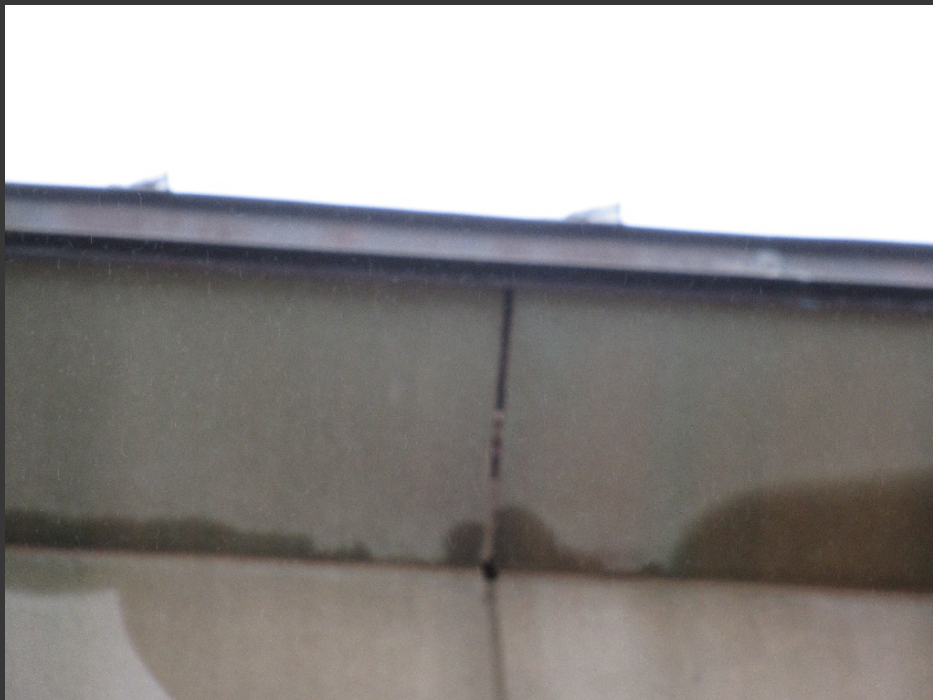
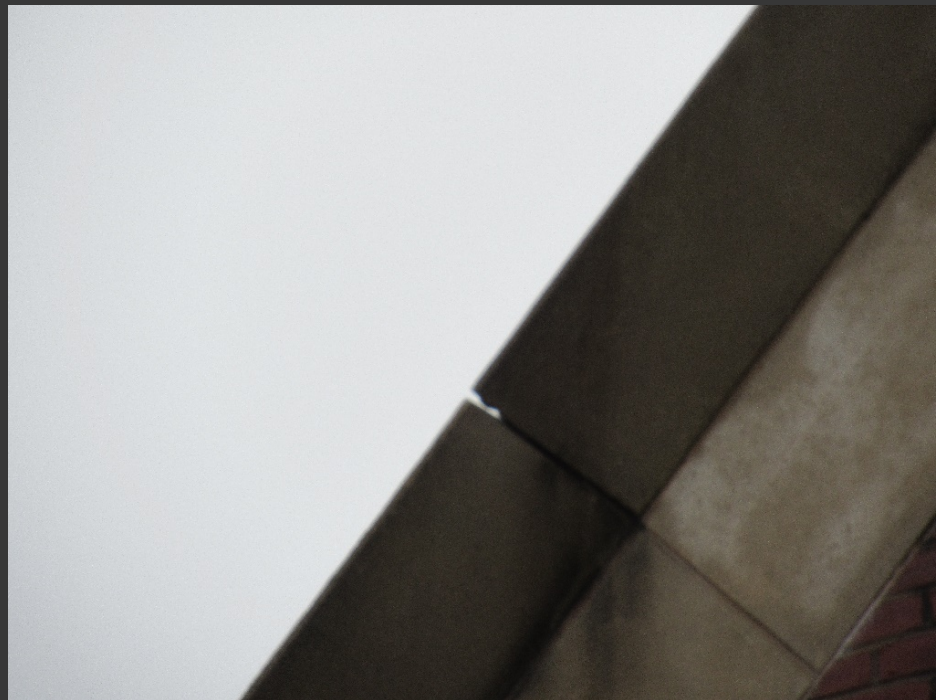
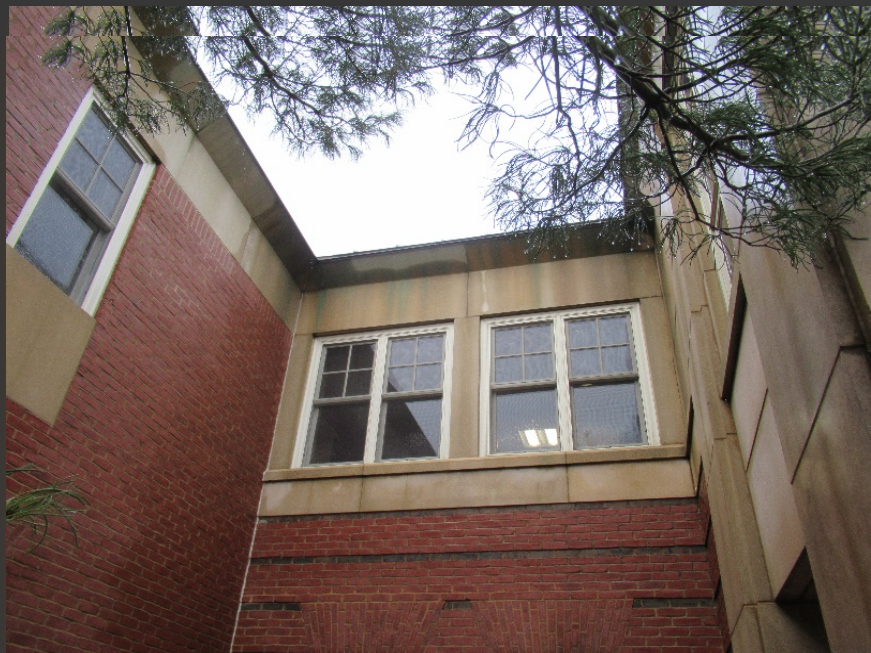
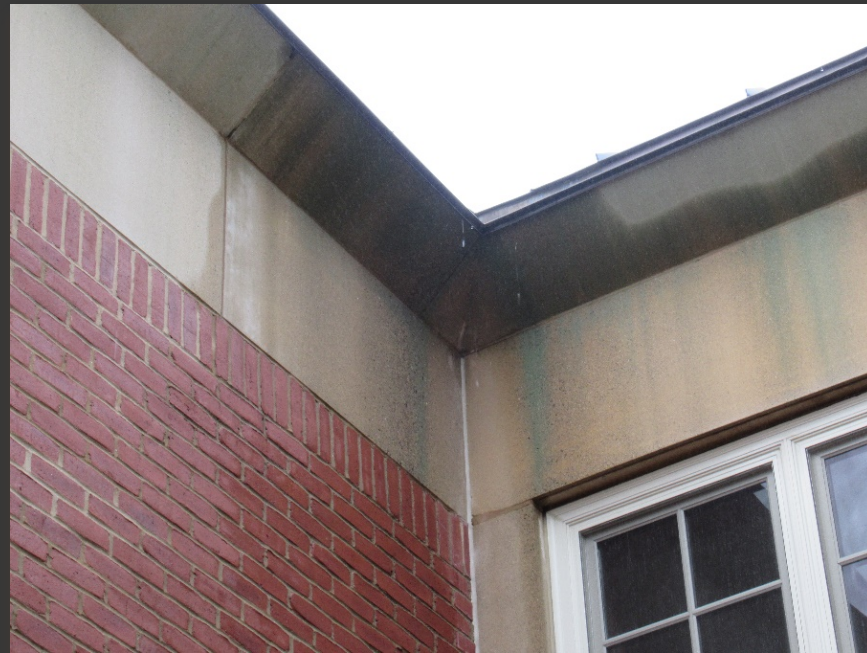
Additional failed mortar joints at eave and rake.

- **Exterior Masonry:** The mortar joints in the precast soffit panels and horizontal entablatures at the gable ends are deteriorated and/or missing. BES recommends all deficient mortar joints be repaired in these areas with new pointing mortar, sealant and/or a lead joint protector depending on exposure.

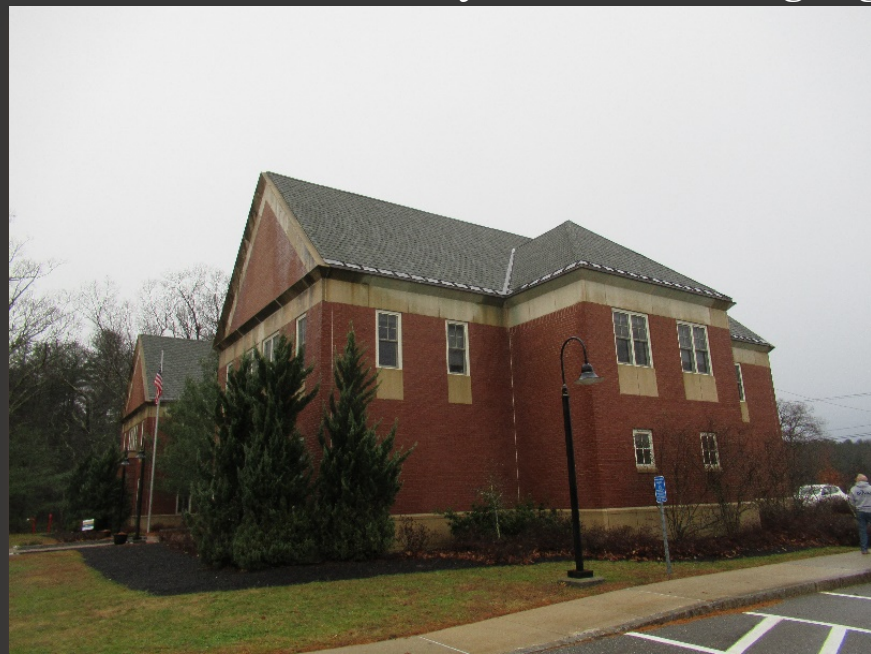
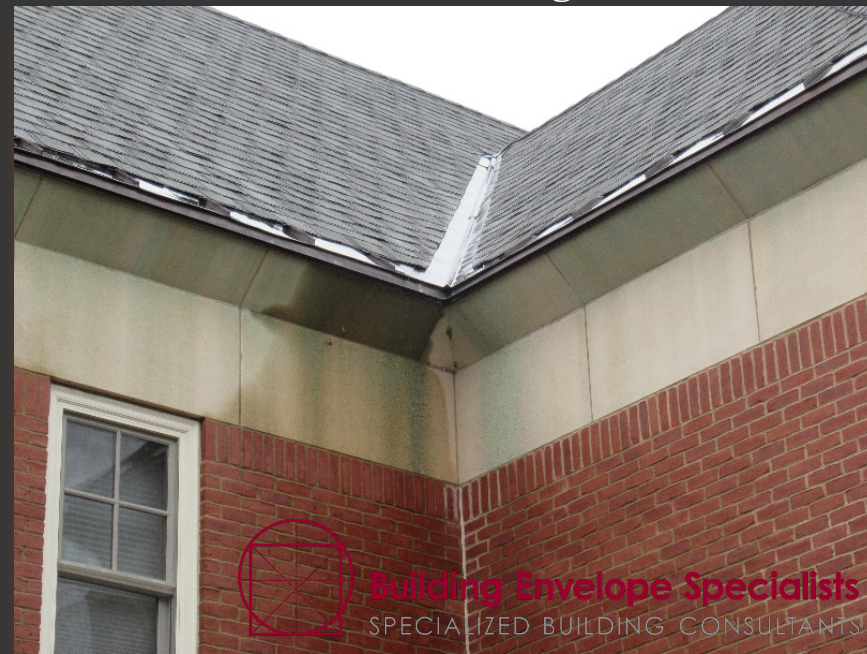
Walls at roof valleys are receiving significant runoff water during rain events.
