January 29, 2016

Re: Haynes Land Recreation Area Project
NHESP Conservation & Management Permit # 010-131.DFW
NHESP Tracking Number 04-16989
Boxford, Massachusetts

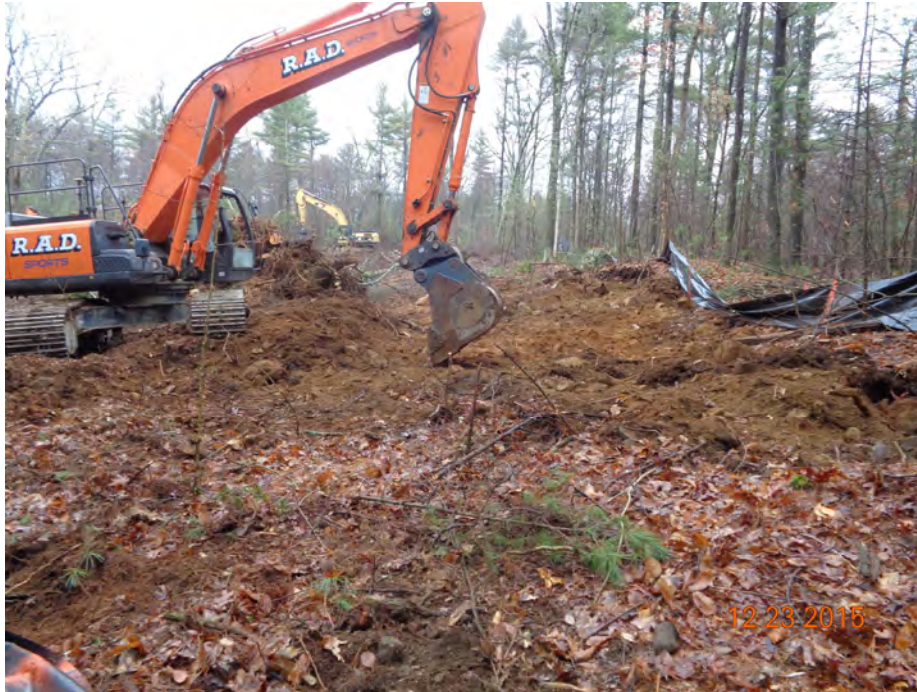
Photograph 1: Overview of Enhancement Area while top soil is being removed to expose native soil material.

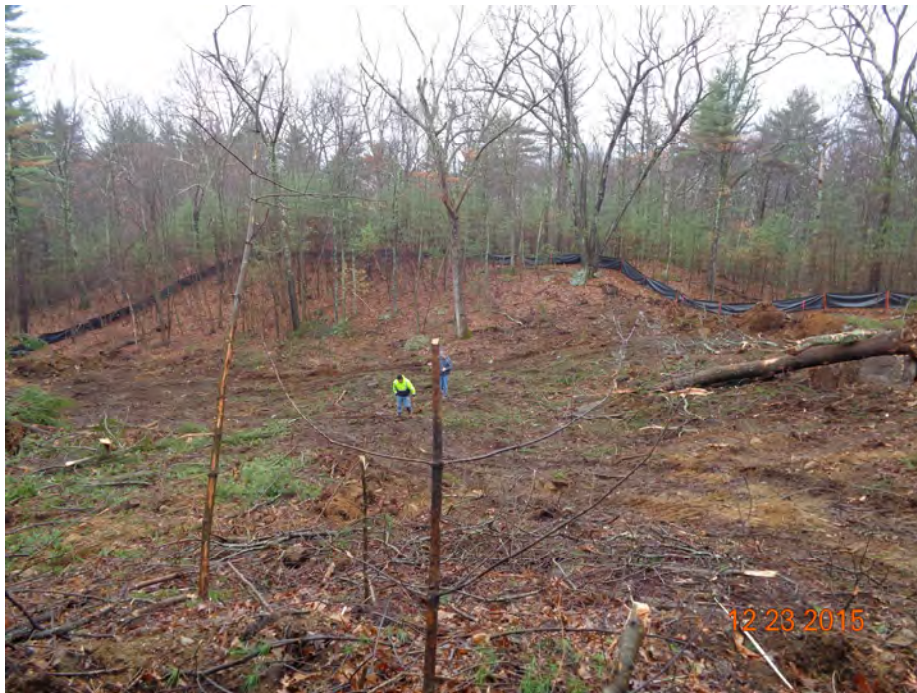
Photograph 2: Overview of the Enhancement Area while vegetation is being removed.

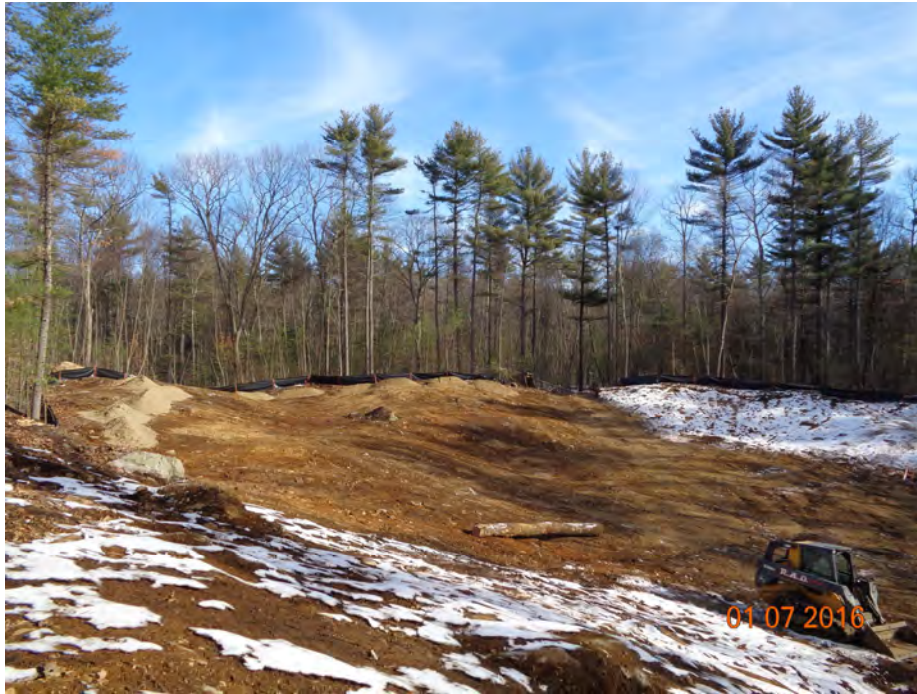
Photograph 3: Overview of Enhancement Area with top soil and vegetation removed, looking northeast.

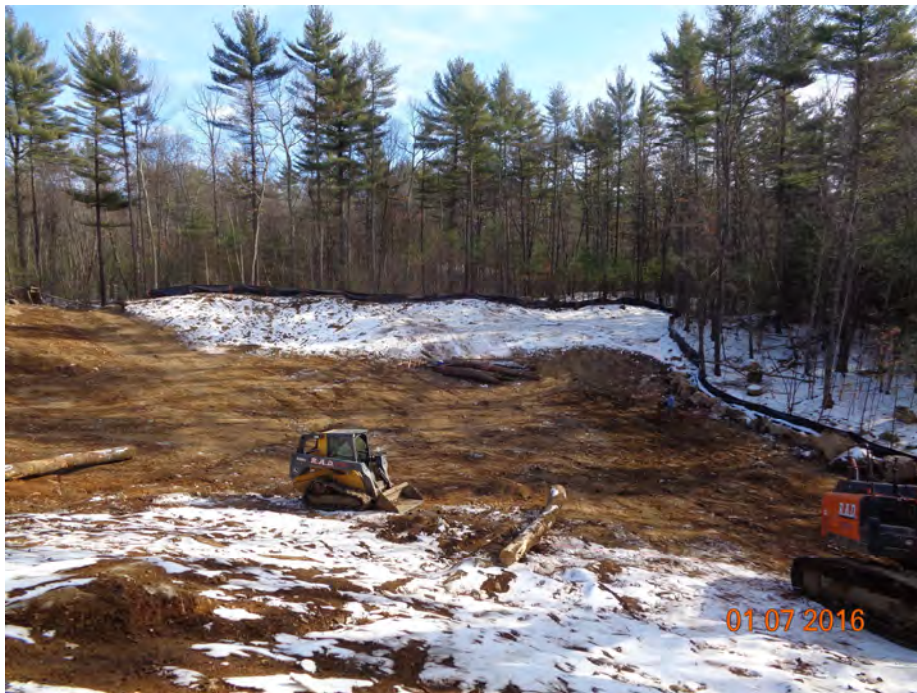
Photograph 4: Overview of Enhancement Area with top soil and vegetation removed, looking east.

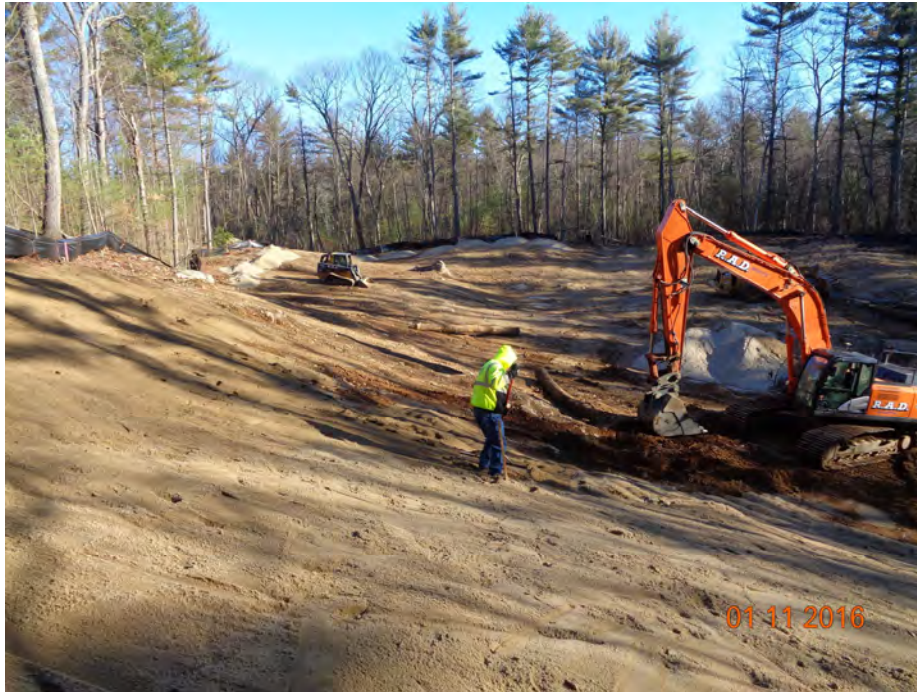
Photograph 5: Overview of Enhancement Area looking north while supplemental course material is added, looking northeast.

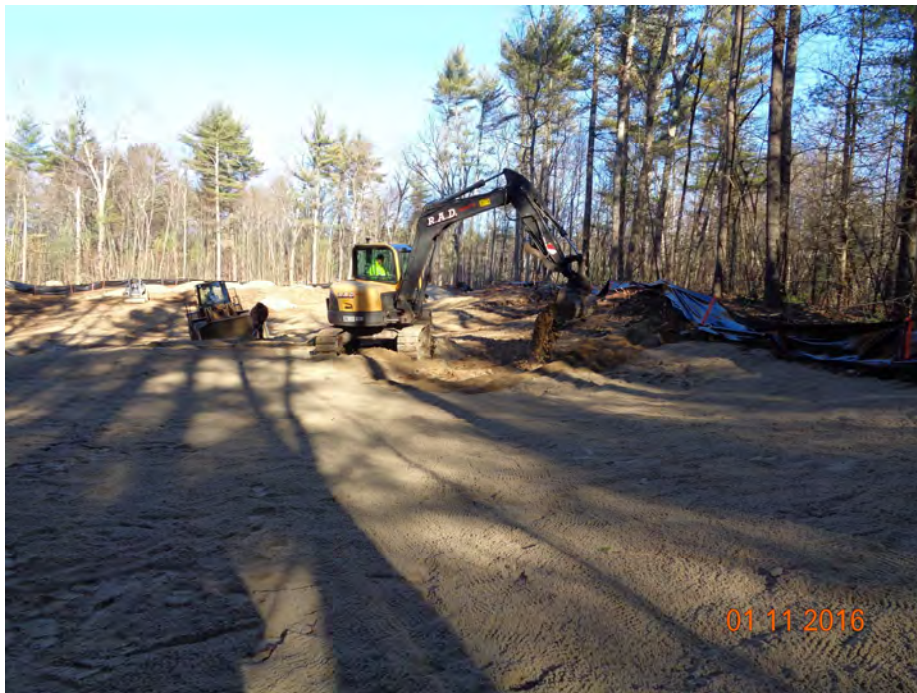
Photograph 6: Overview of Enhancement Area looking north while supplemental course material is added, looking northwest.

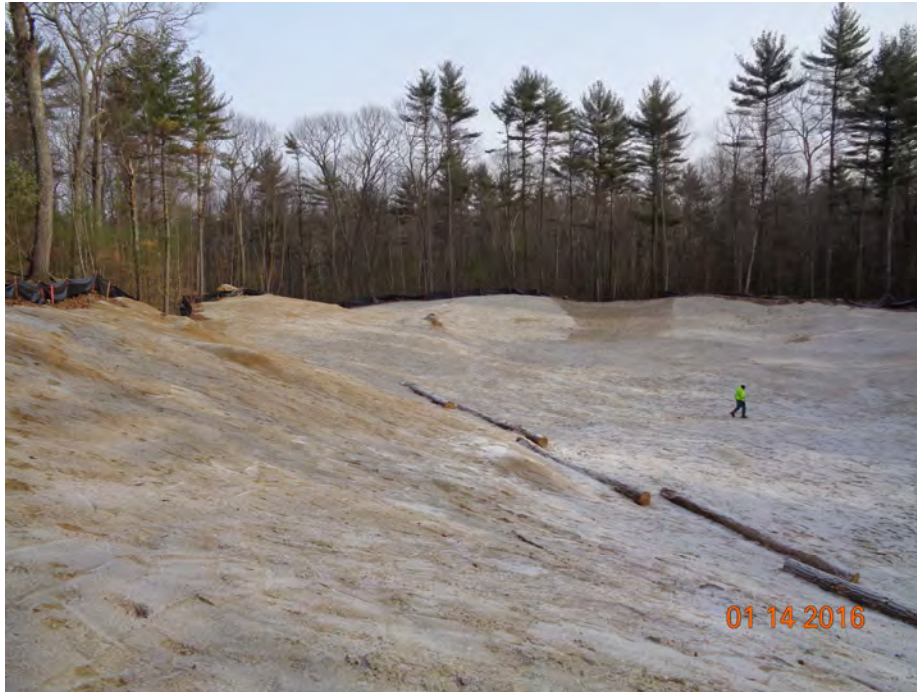
Photograph 7: Overview of Nesting Enhancement Area looking northeast with addition of supplemental soil completed.

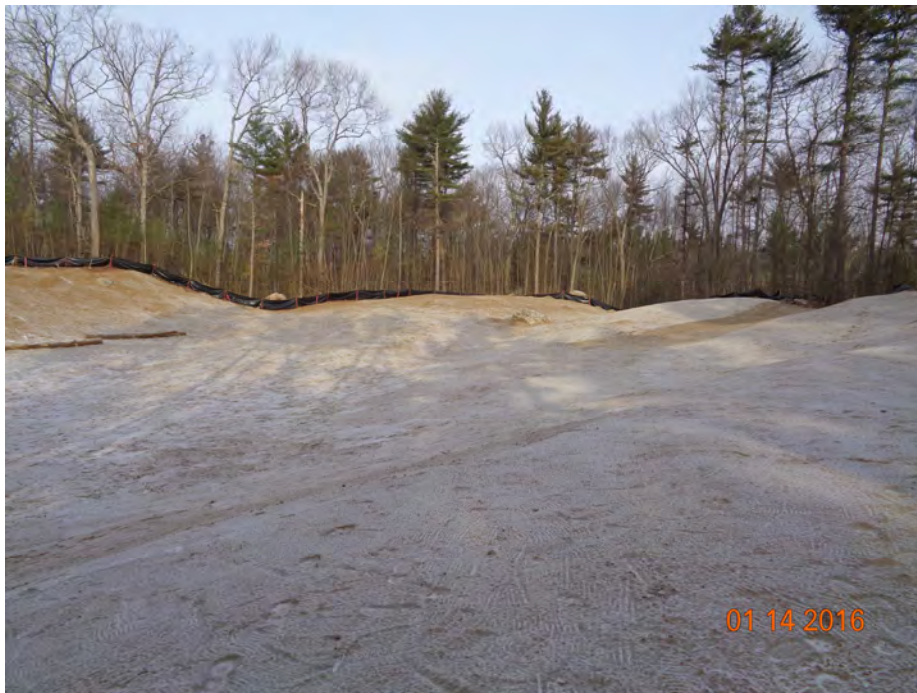
Photograph 8: Overview of Nesting Enhancement Area looking northwest with supplemental soil.

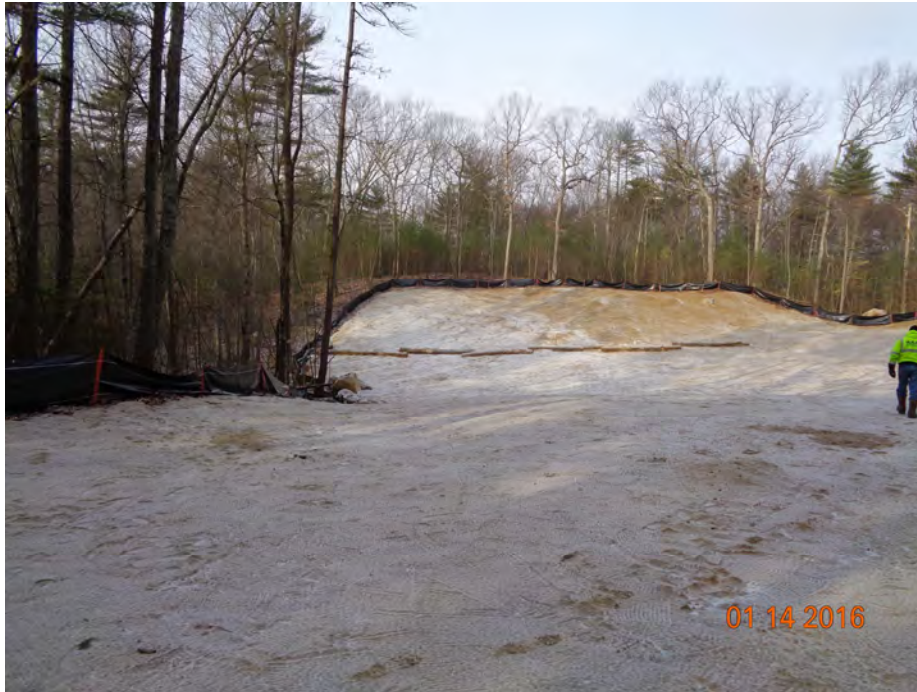
Photograph 9: Overview of Nesting Enhancement Area looking west with supplemental soil.

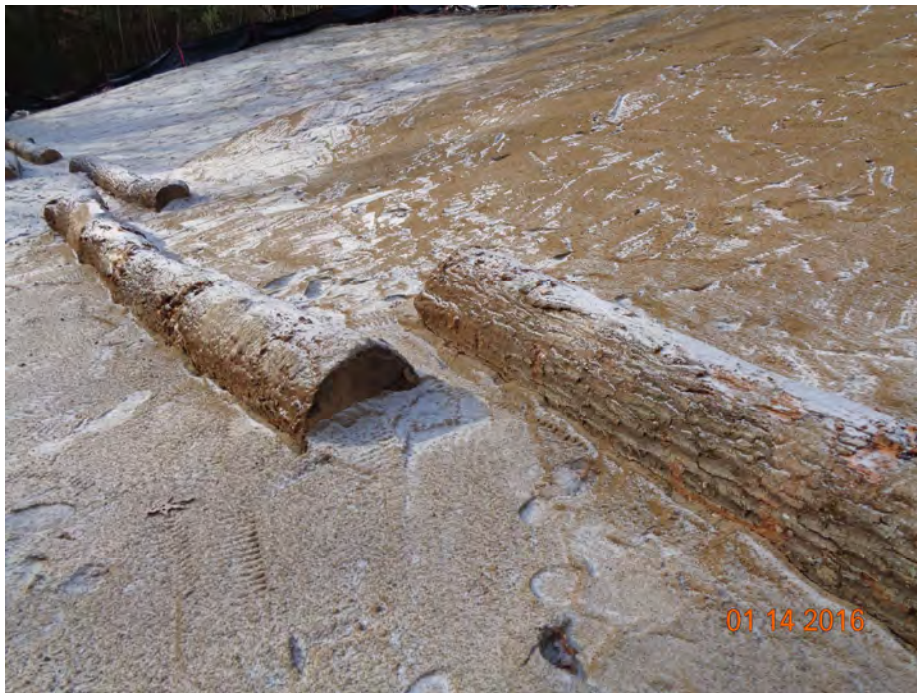
Photograph 10: View of reclaimed snags embedded in slope for stability.

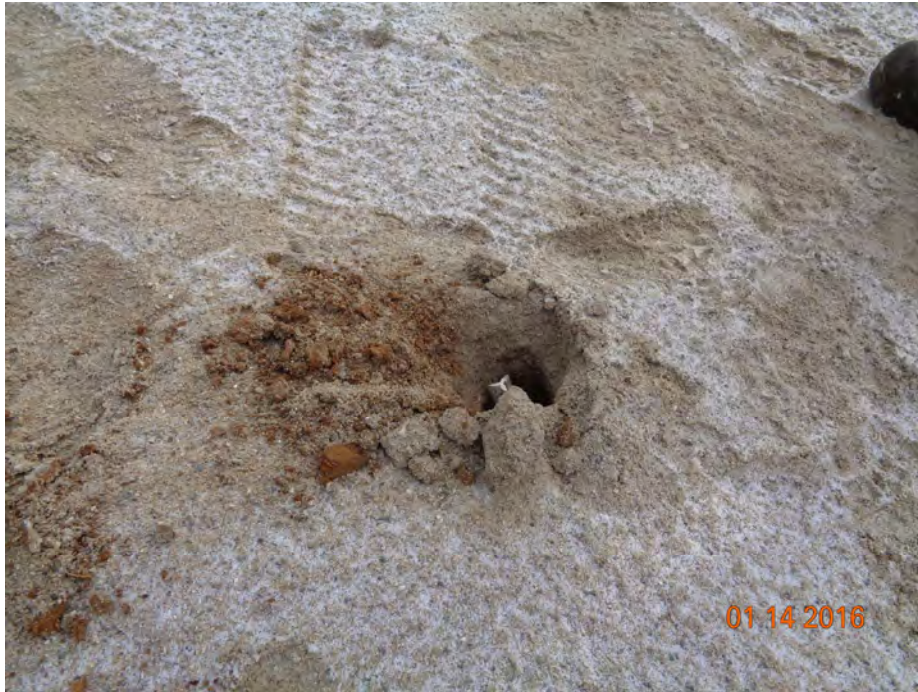
Photograph 11: Close up of nesting area (typical). Note 12+/- inch ruler in hole.

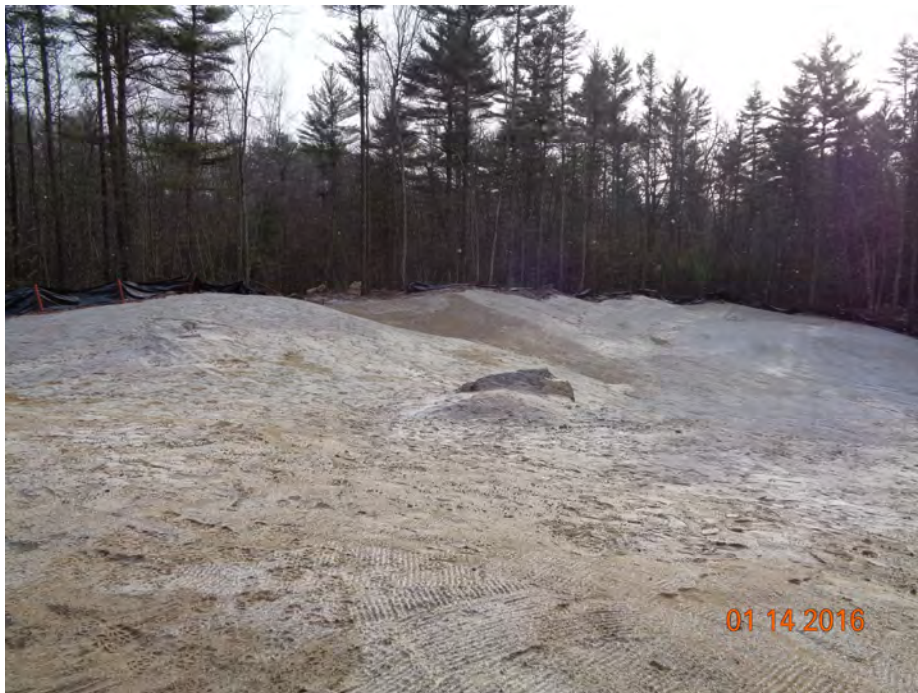
Photograph 12: Overview of Enhancement Area looking south.
