# Safety Issues

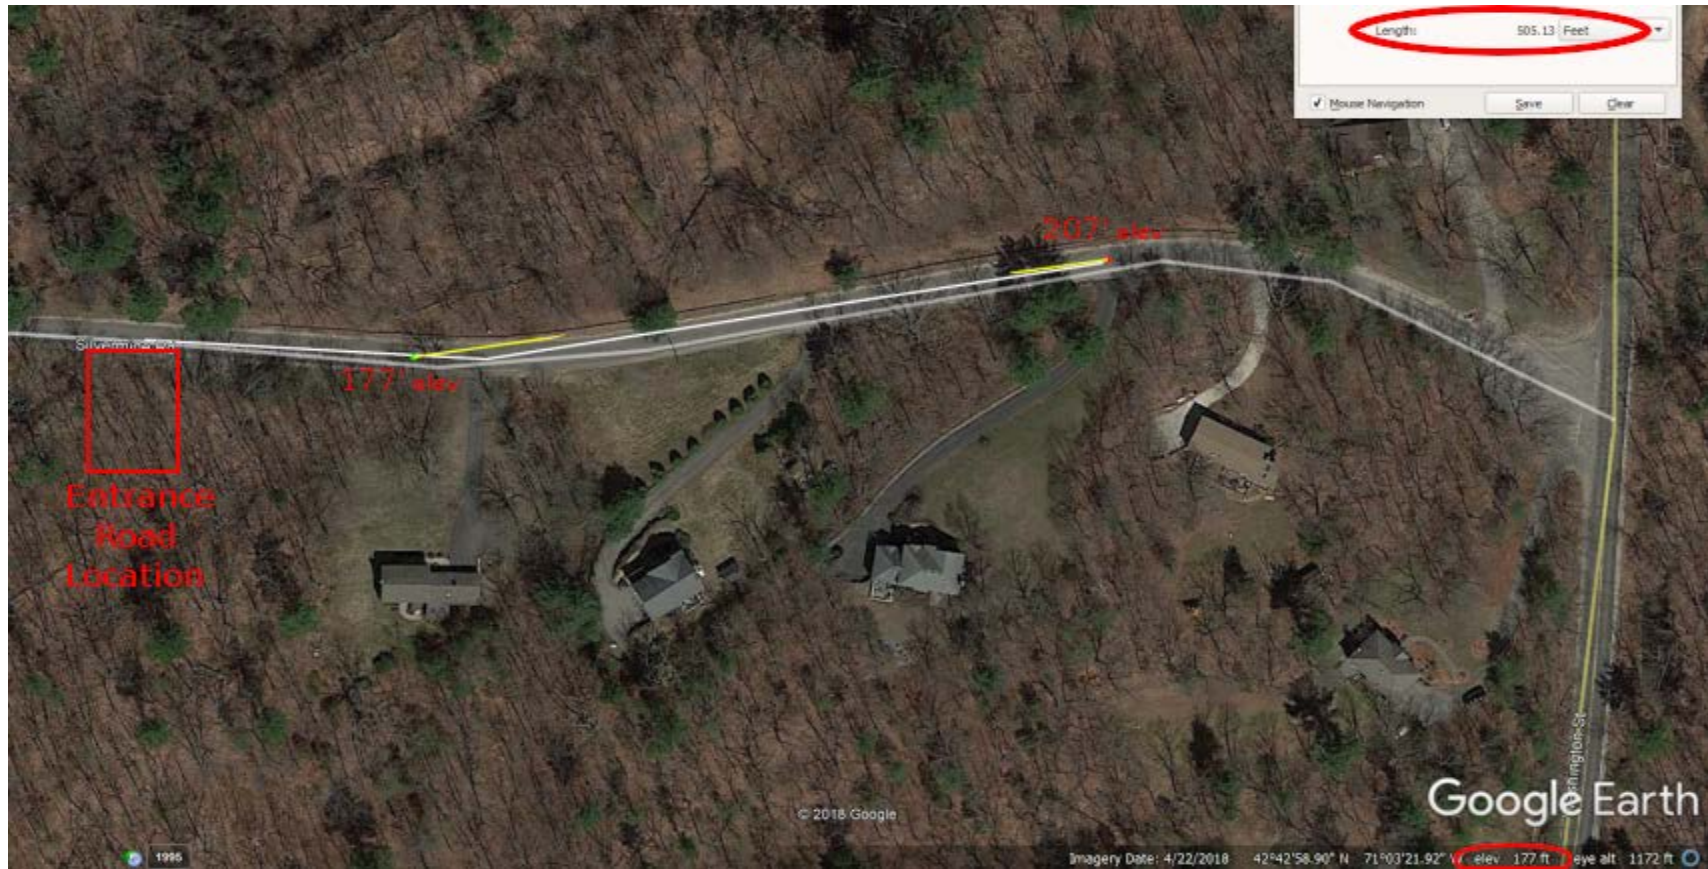
# Steep Hill to Entrance

30ft drop in 500 ft = 6% grade, within 180' of entrance location  
(7% is max highway standard)

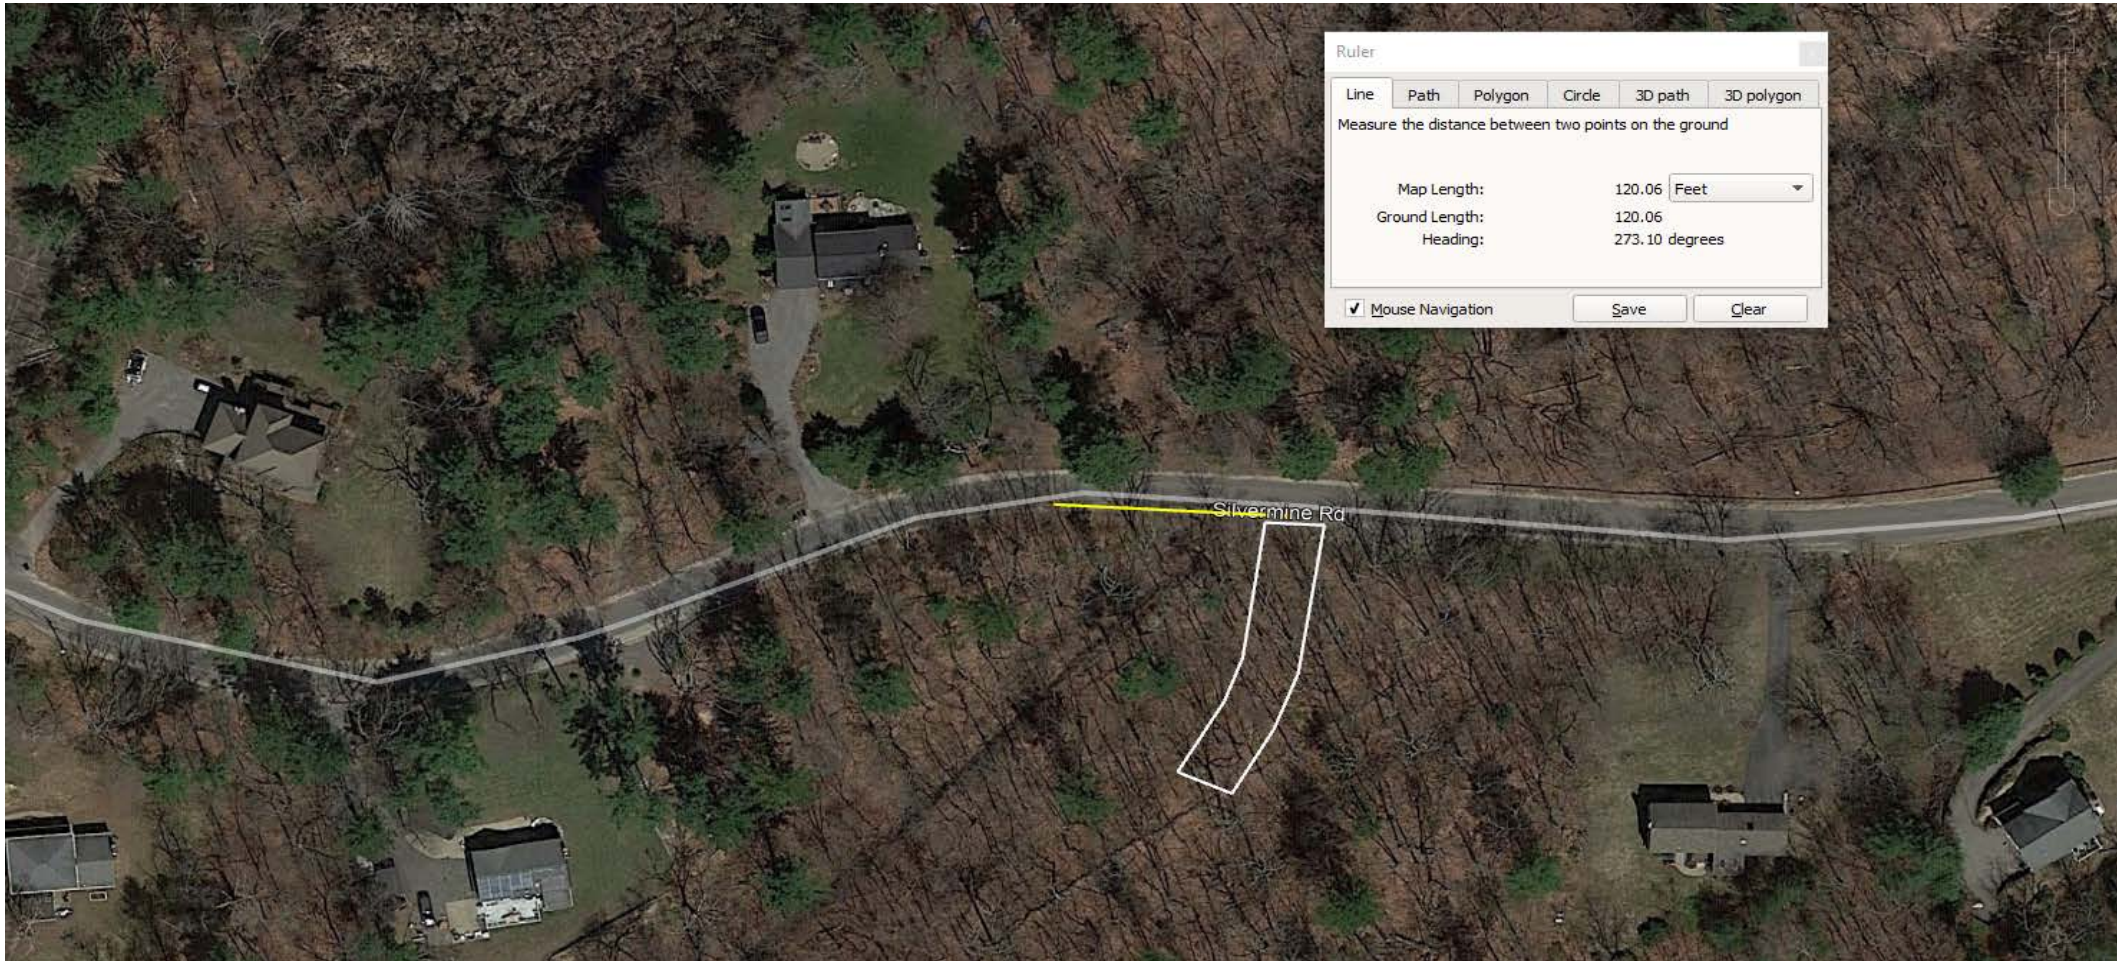
# Creating Dangerous Intersection

New road, bottom of hill, on 3 tight curves. Visibility about 120 ft  
 $30\text{mph} = 2.7$  seconds to see and react

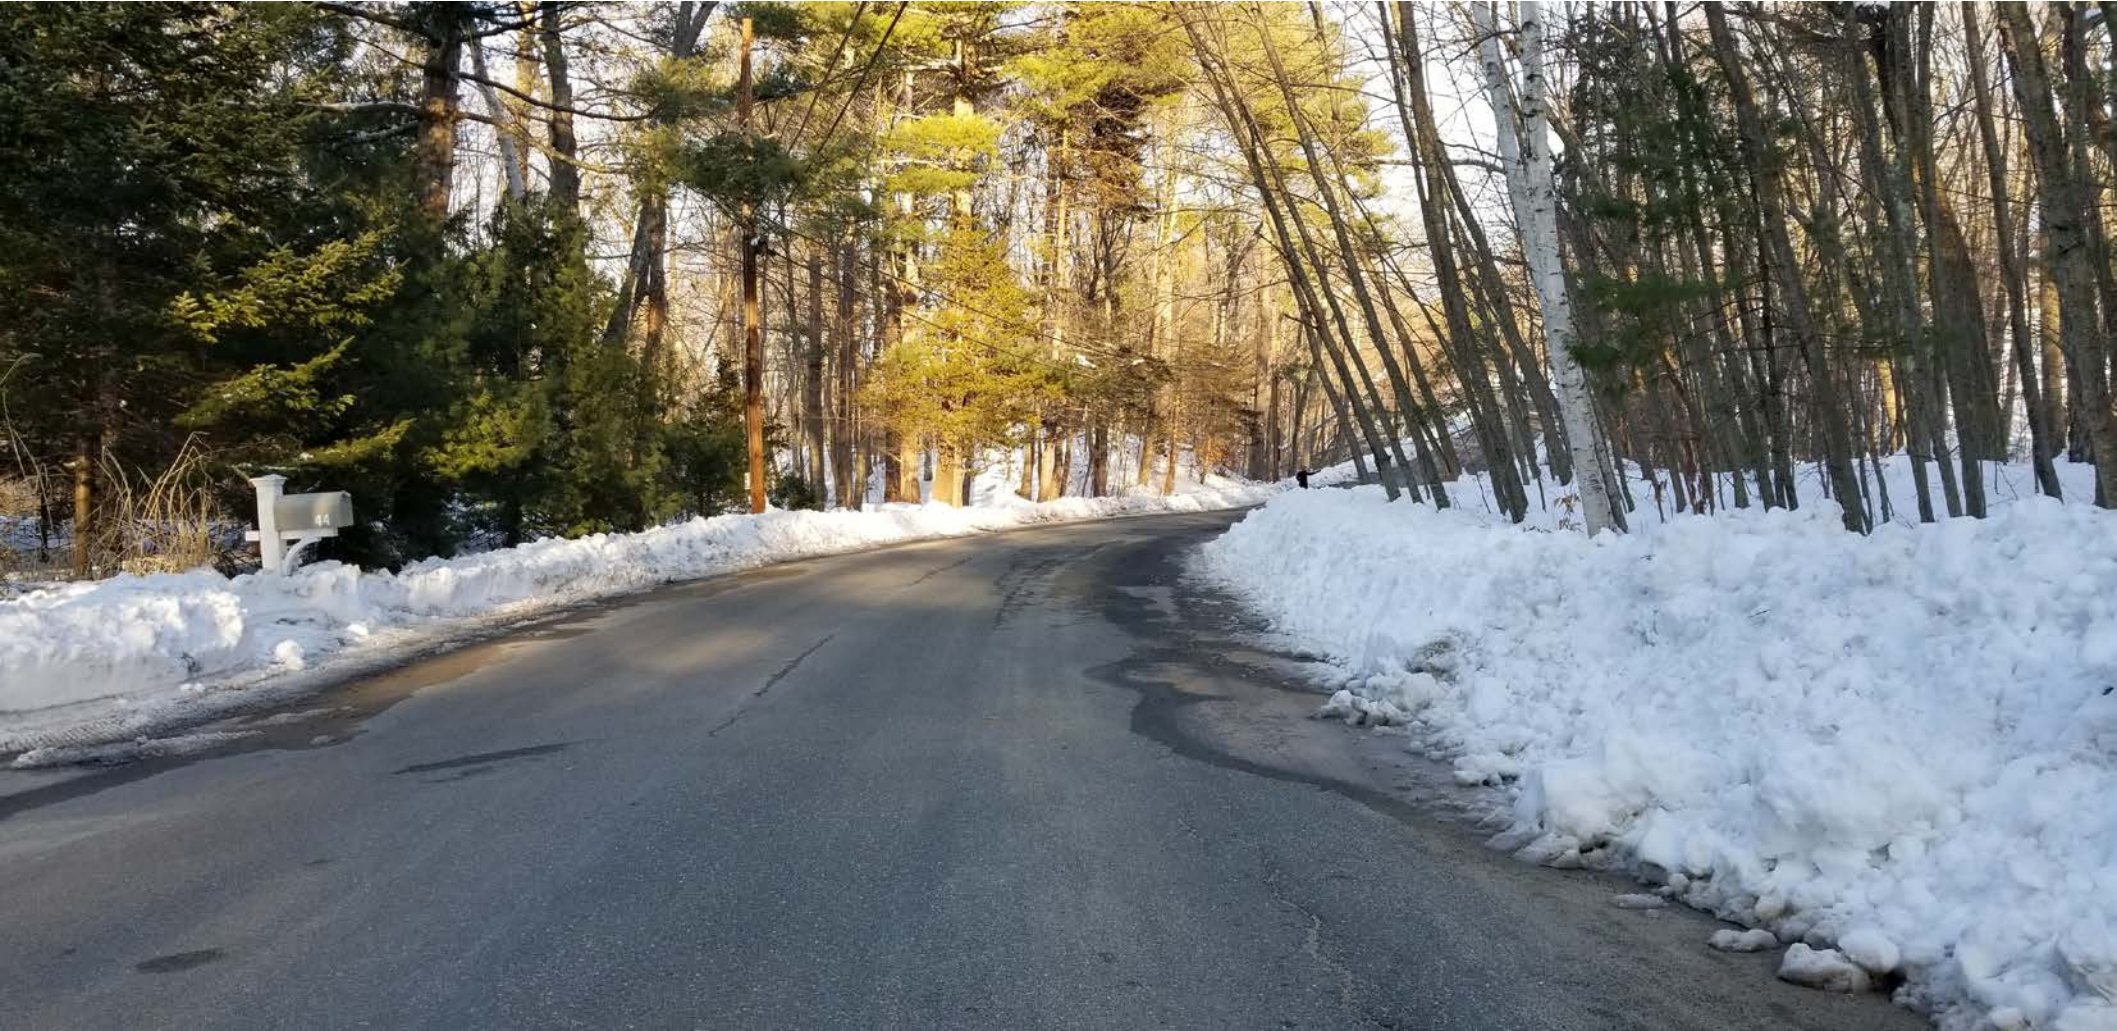
Person on westbound side of road pointing at new intersection location  
~180' away looking east, cannot see entrance

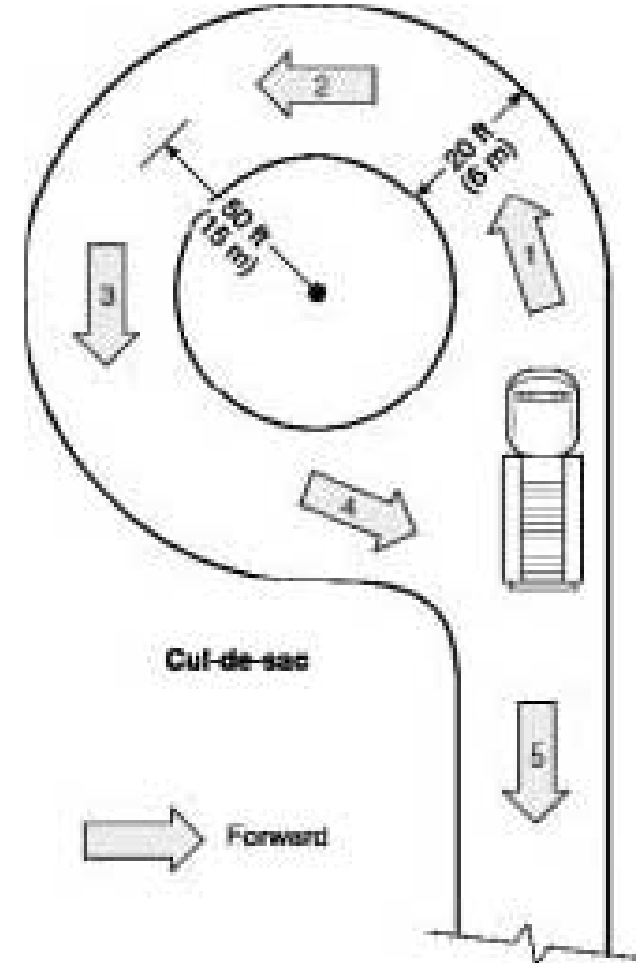
# Required Fire Turnarounds

- Both NFPA 1 and the IFC require turnaround space for dead-ends that are more than 150 feet long. [...] NFPA 1141 requires a 120-foot turnaround at the end of dead-ends more than 300 feet long.
- For Cul-De-Sac, 50 ft radius  
20 ft wide road, = 120 ft Wide

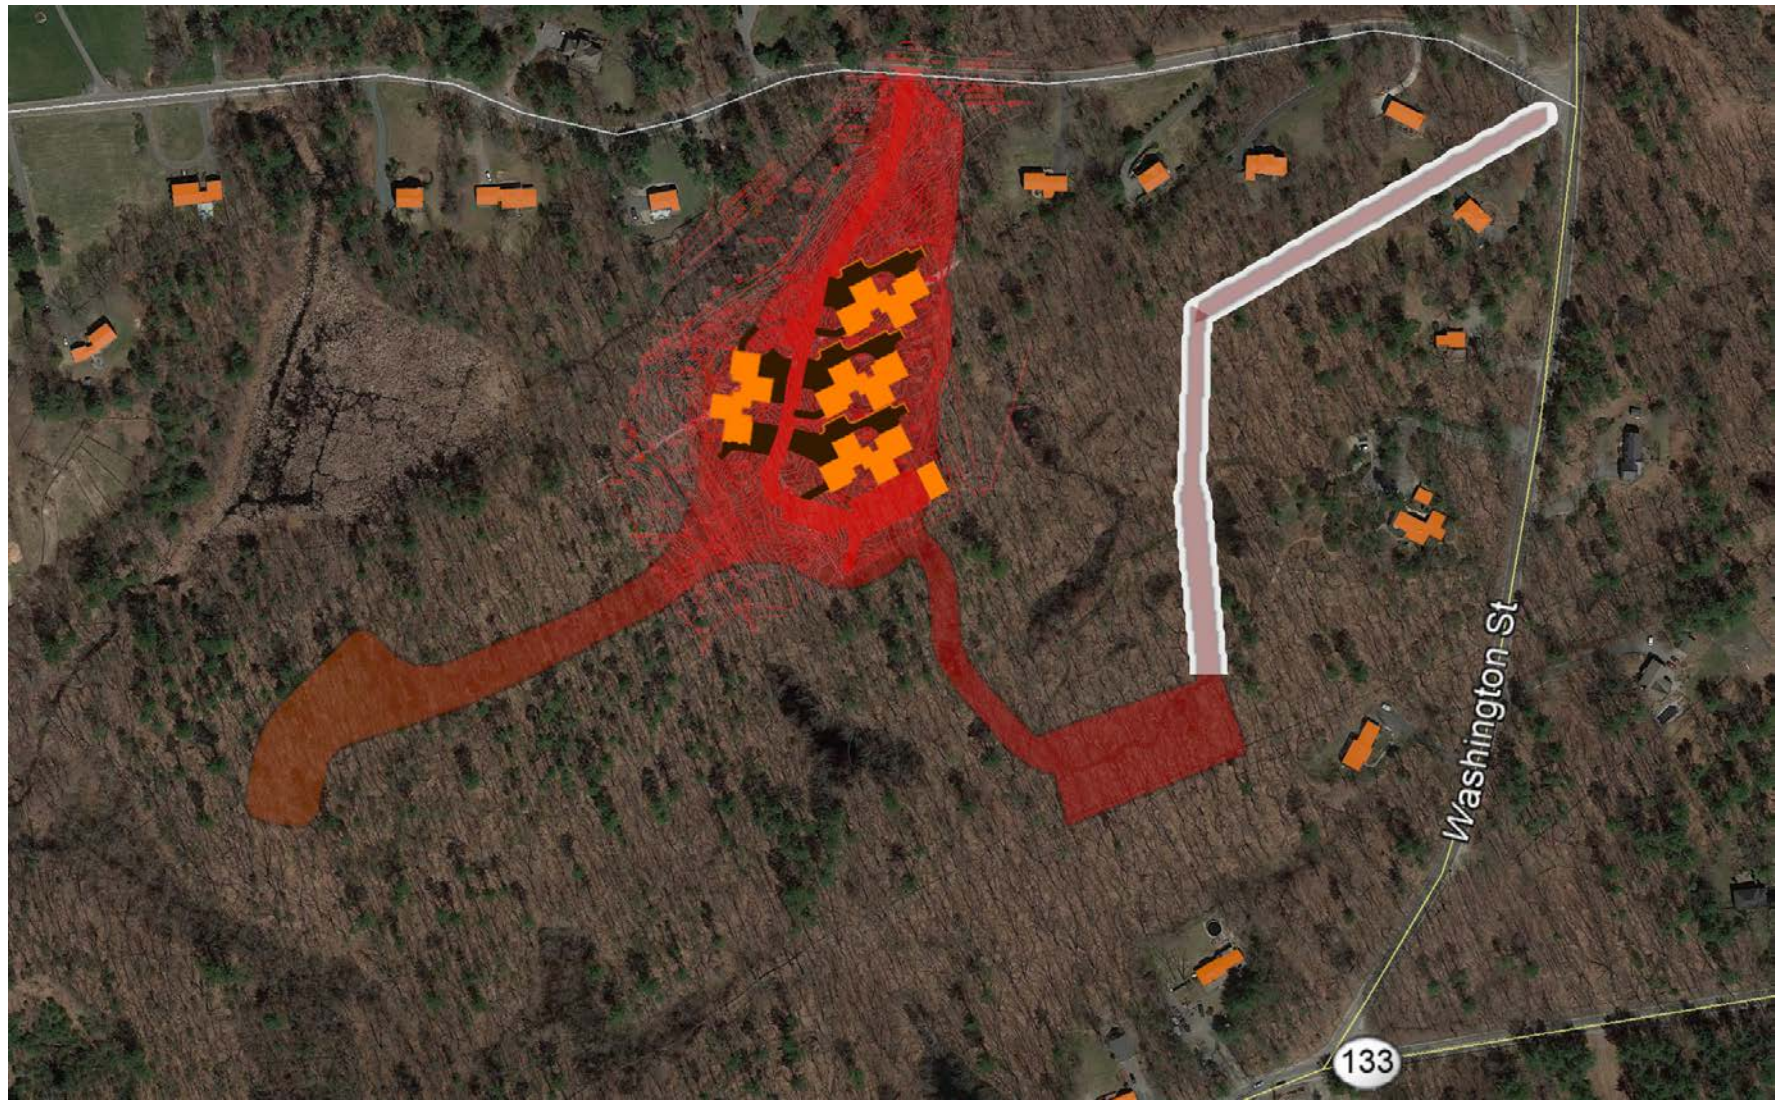
## Planned Access Road Location – NE Corner Area

- Overlaps Driveway & 3-way intersection
- Insufficient width and radius for Fire Equipment
- Slope far too steep for Fire Equipment
- MA Wildlife & Vernal Pools

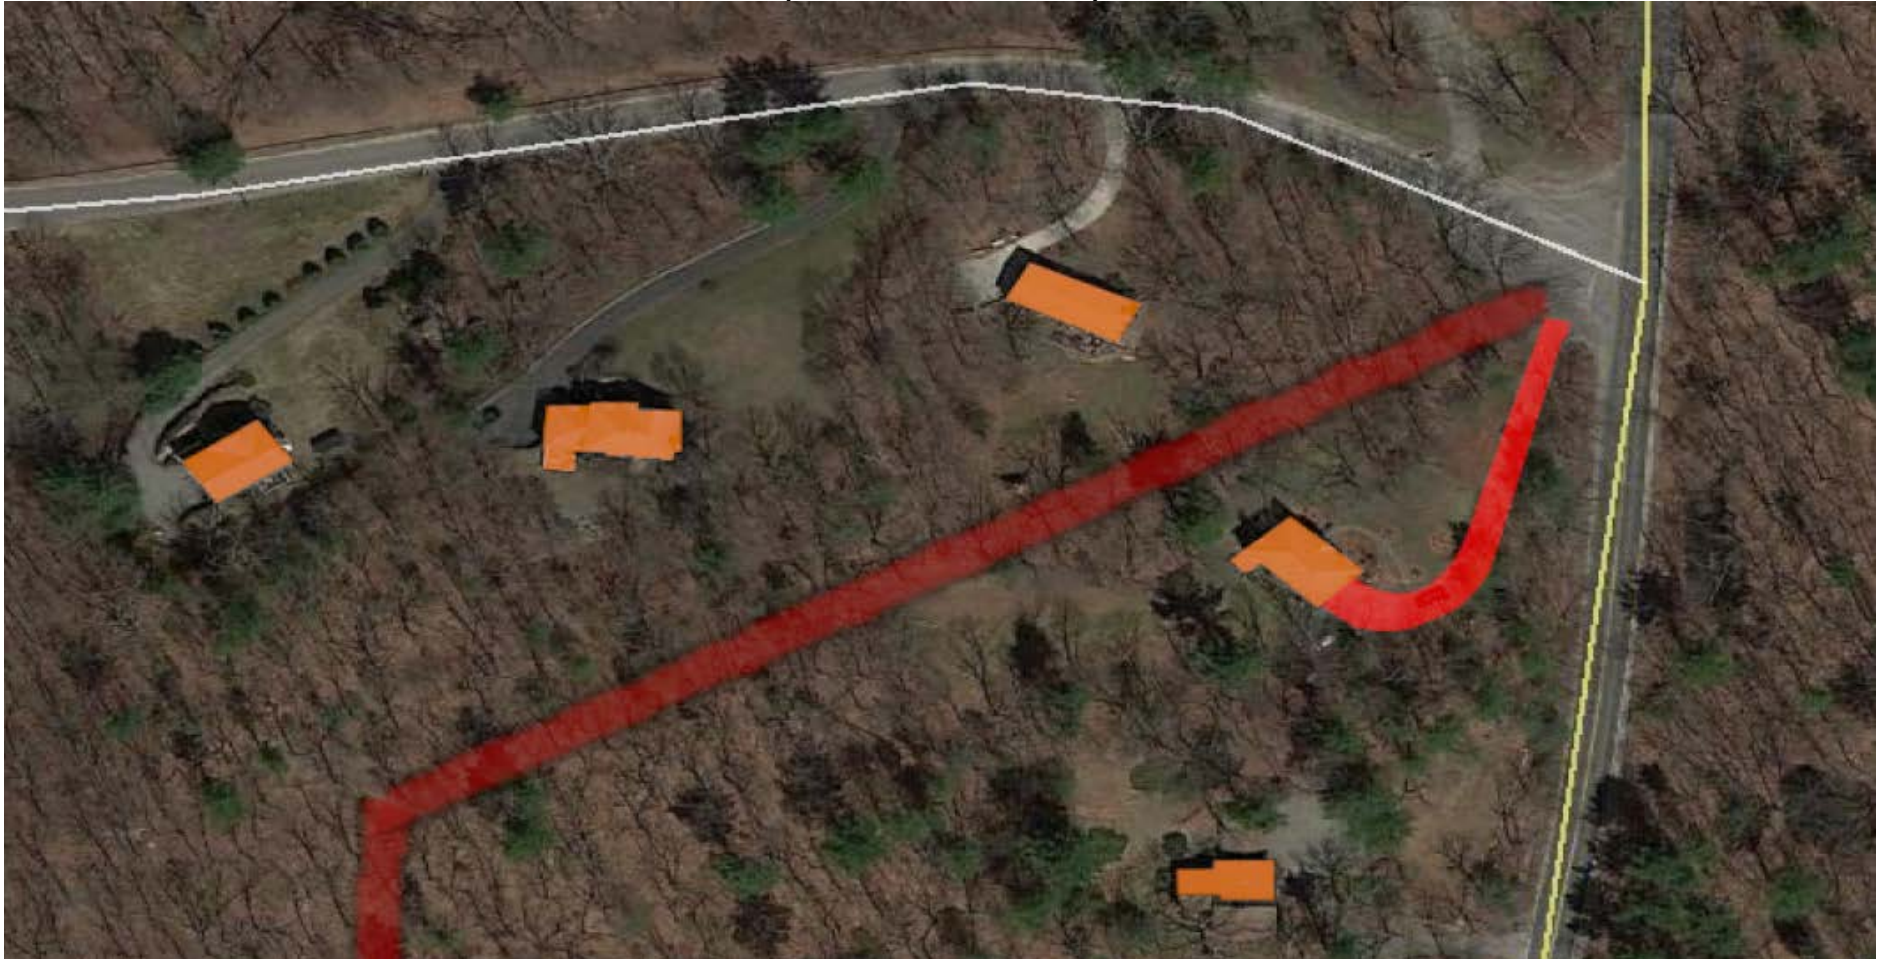
# Emergency “easement” intersects existing driveway & 3-way intersection (rather a mess)

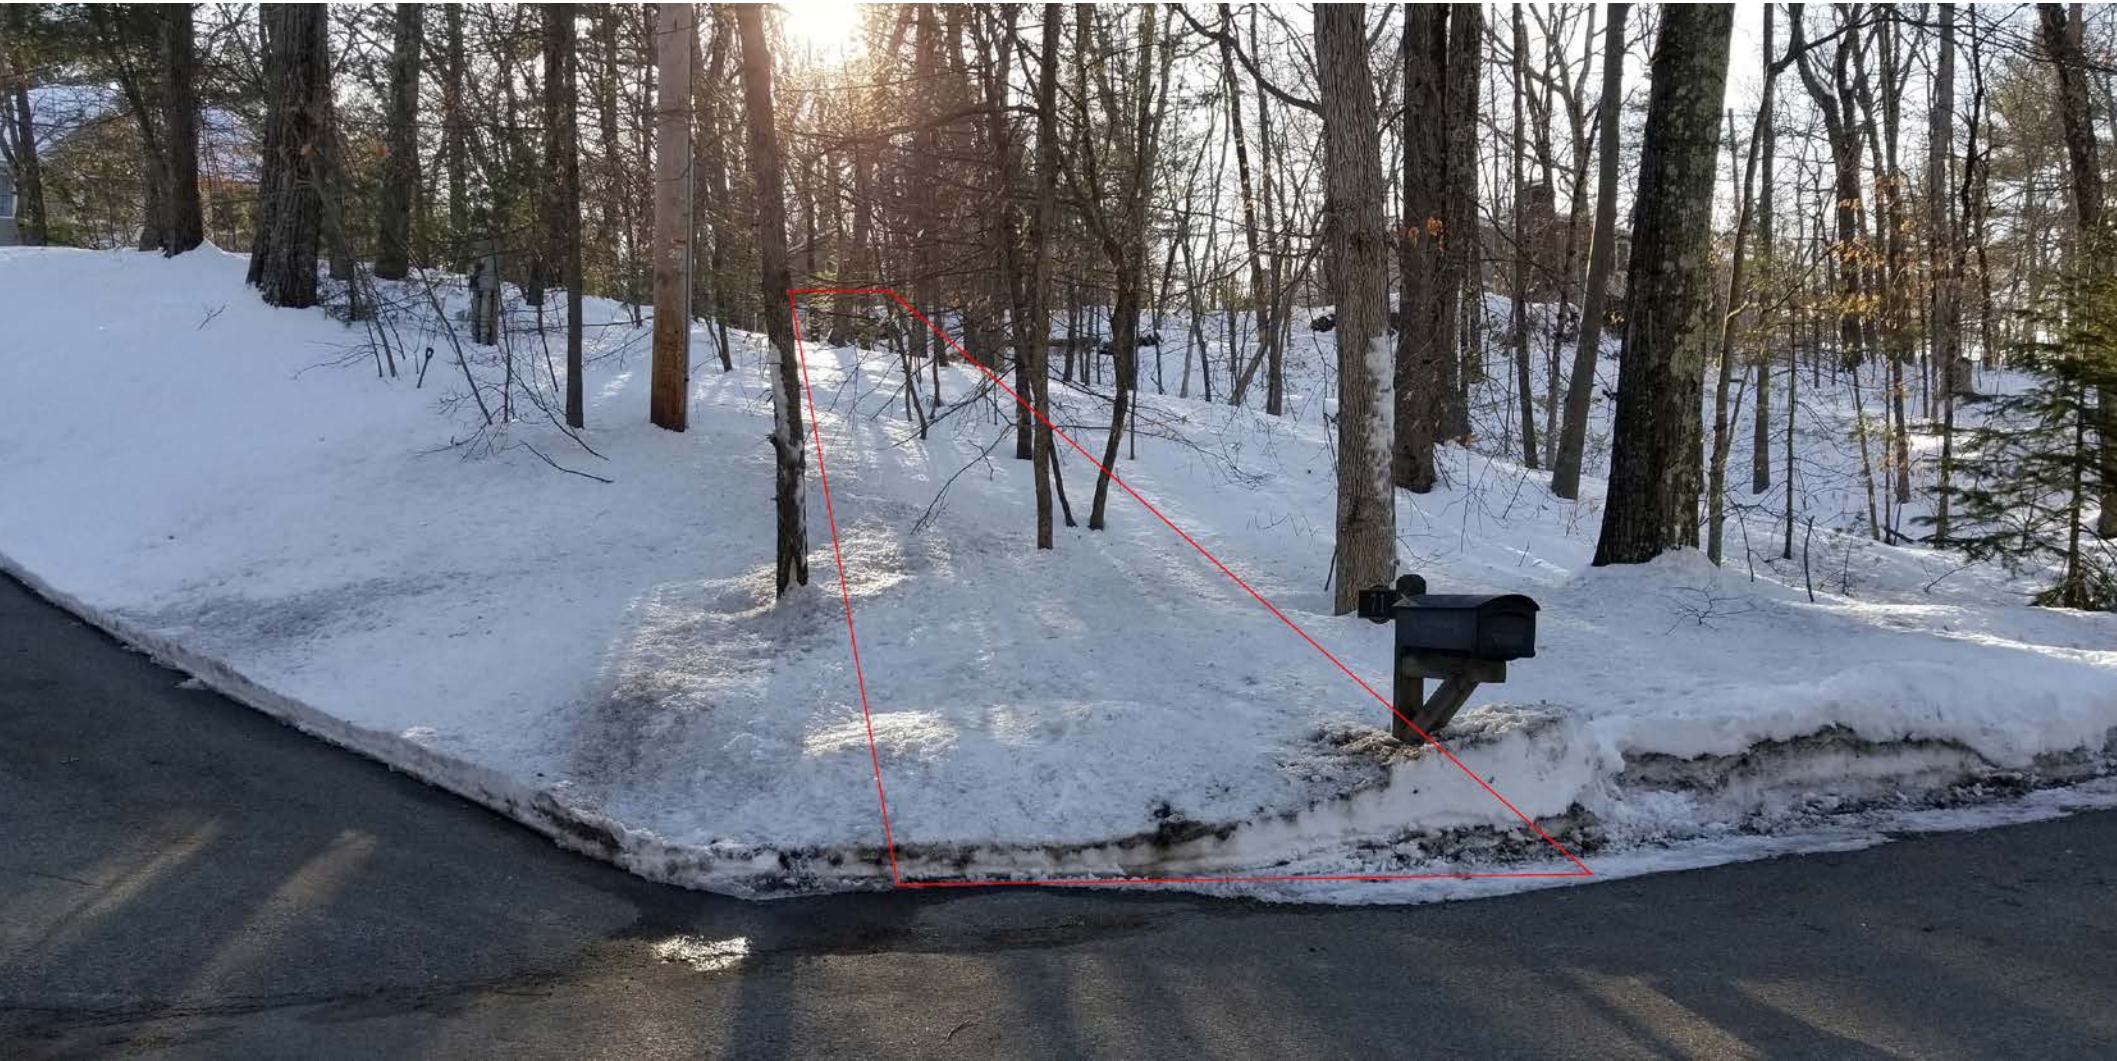
“Easement” STEEP slope w/ large gully -- How Steep?

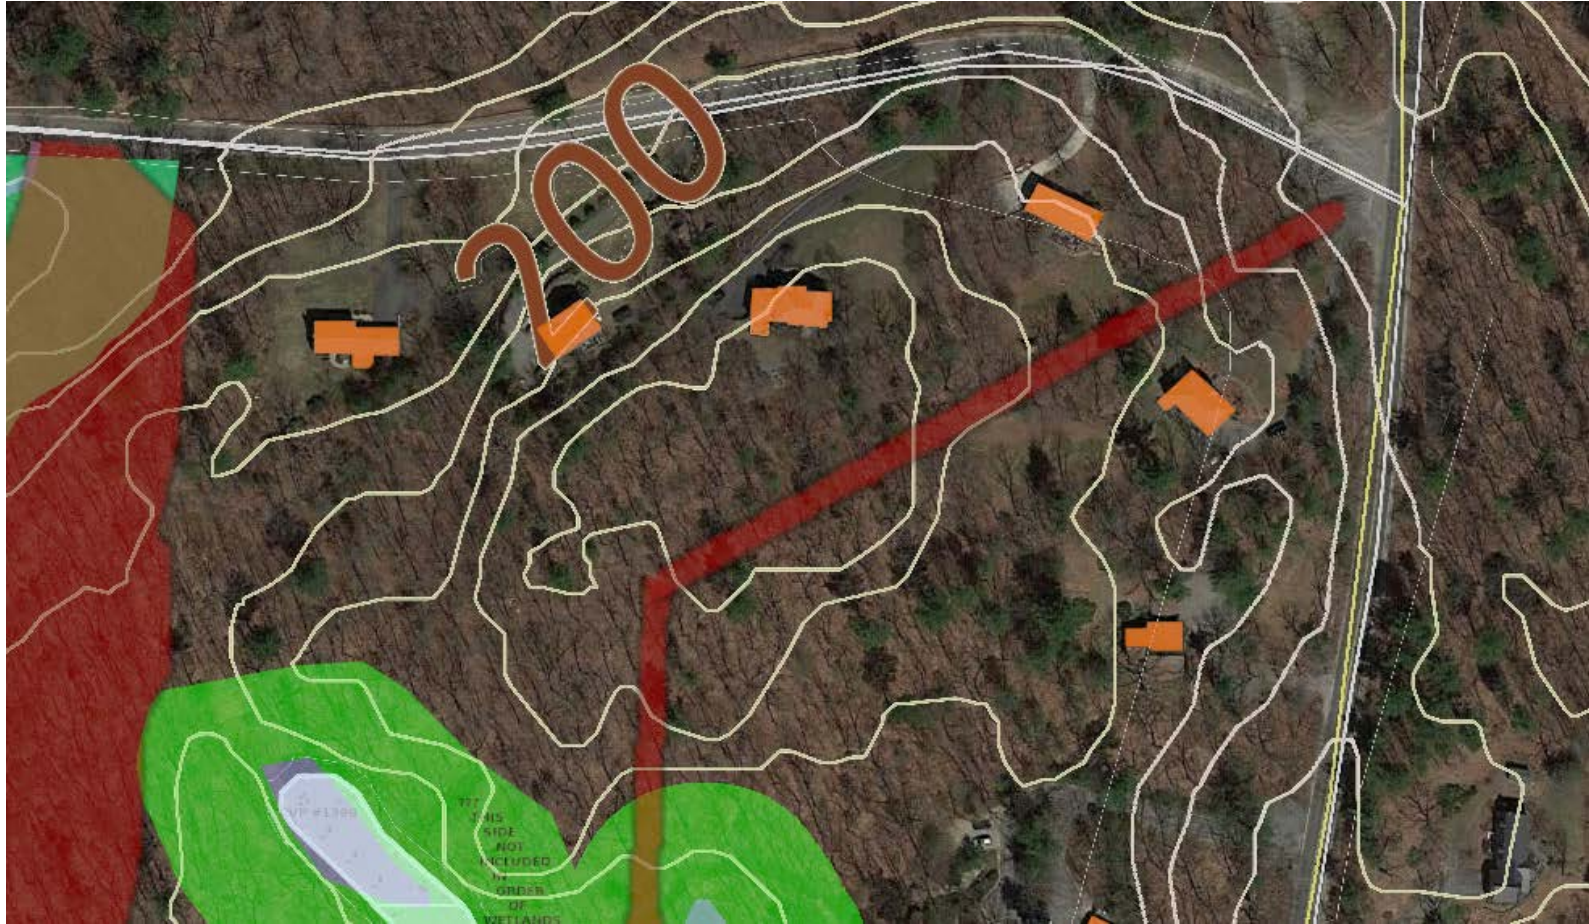
How Steep?

**18.9%** grade

(186' – 221' elev in 185')

Mt Washington Auto Road = **12%** grade

Fire Lane Specs = **5% to 10%** grade, less for some trucks.

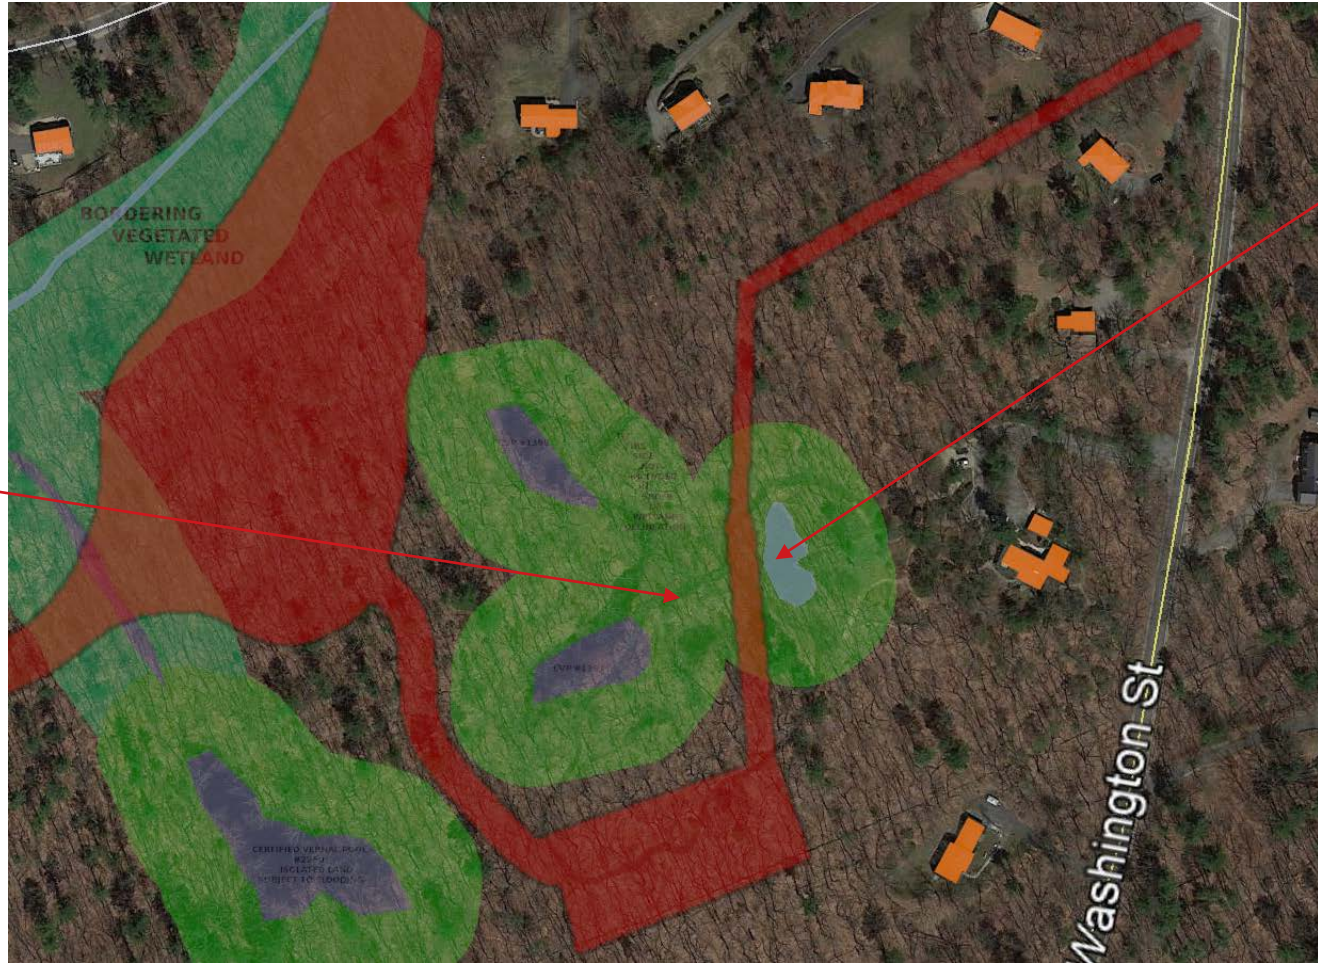
Yet, here is the planned route  
~90' from CVP# 1397 and ~30' from CVP1396
