Plan Of Land

Showing
"As-Built Site Conditions"

Lot 57A - Killam Hill Road

Existing and Proposed Layout Sketch

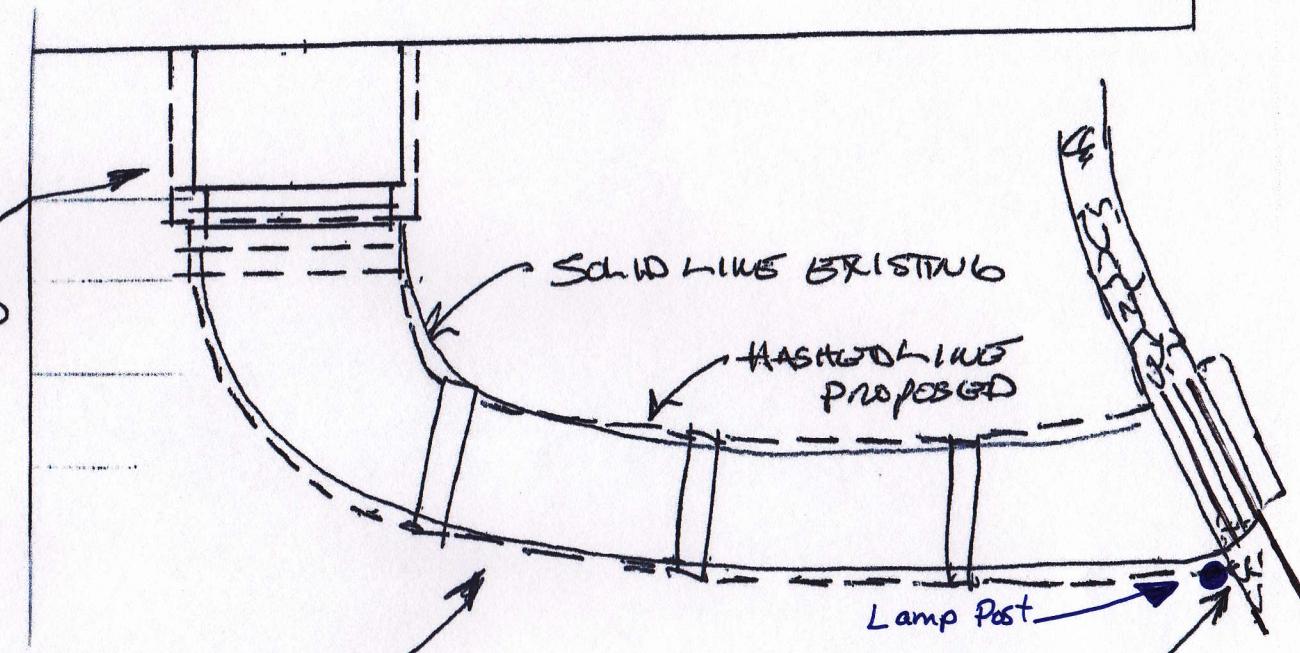
SK
1

EXISTING HOUSE = FRONT LANDING? STAIRS.

EXISTING SLOPED WALKWAY

EXISTING FRONT
LANDING AND
STEPS ARE
 $78'' \times 63''$ - TO BE
REBUILT OR REPAIRED
AS NEEDED

WALKWAY TO BE RECAST IN CONCRETE
ON EXISTING FOOTPRINT ADDING GRANITE
STEPS TO GAGE SLOPES AS NEEDED

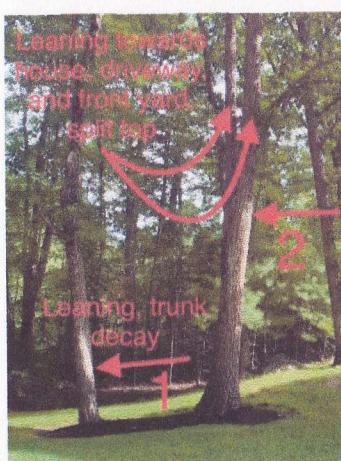
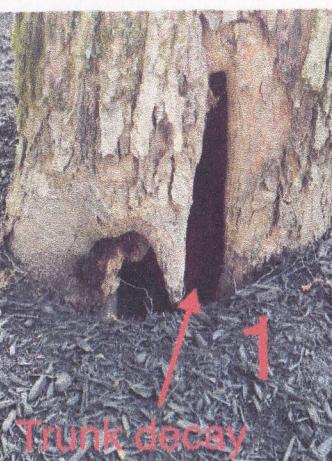
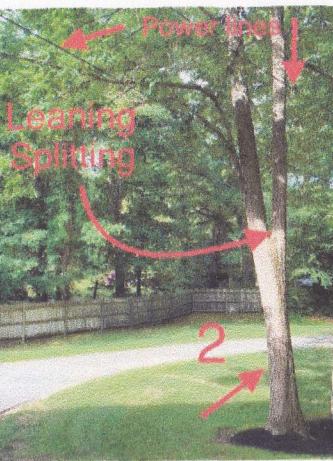
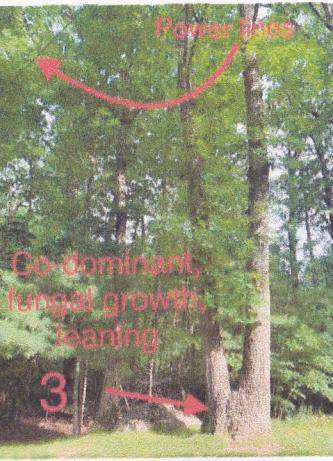
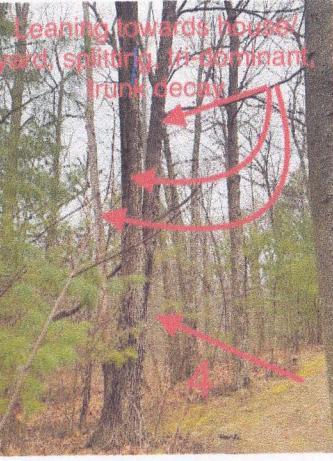
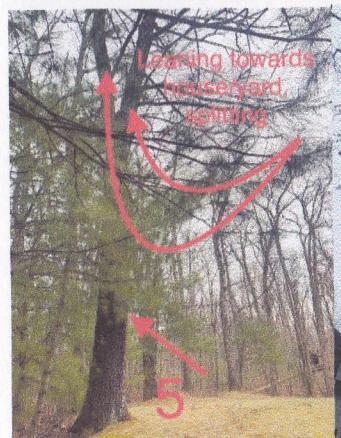
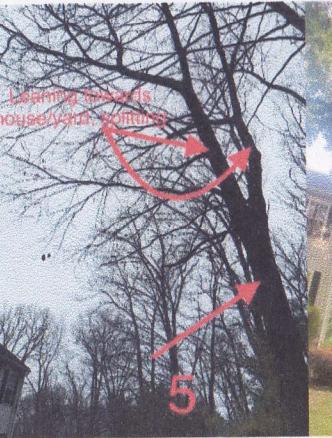
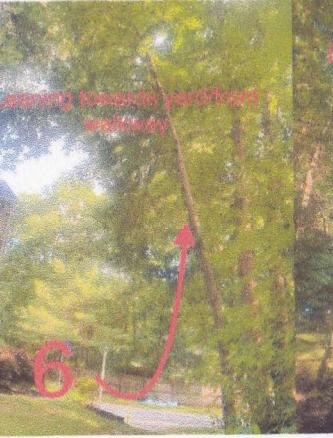
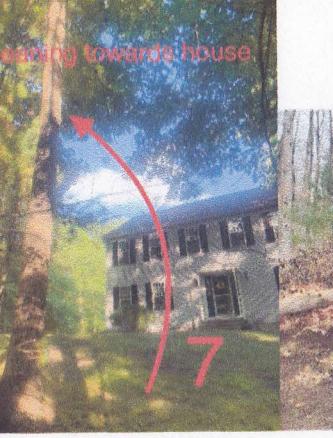
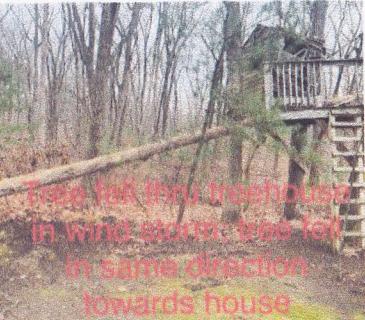
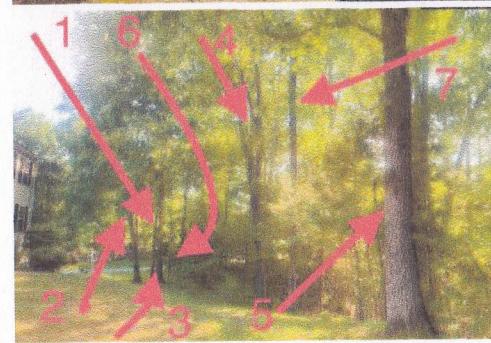
Tree Removal Photos and Collage

- Note: Reviewed conditions with Greg Gagne/Noble Tree on 05/17/22
- Leanings towards house, yard, front walkway, and/or driveway
- Co/tri dominant or split top (2,3,4,5) and trunk decay (1,4)
- Next to power lines (1,2,3) and many others could hit power lines if limb/tree fall
- Branches/limbs on some of these trees fall during high wind events (see photo of tree that fell through treehouse in wind storm; tree is in same line as trees requested to be removed)
- Close proximity to house has resulted in squirrels gaining easy access to roof; exclusion repairs required after squirrels gained access to attic; close proximity blocks sun resulting in growth and quicker aging of roof on front side of house
- If these trees fall, would damage house and other personal property and more importantly, threaten the safety of my family/children
