Boxford Self Evaluation ADA Report

2017

ADA Self-Evaluation Survey Provided for
Boxford Town Hall/Library

7A Spofford Road

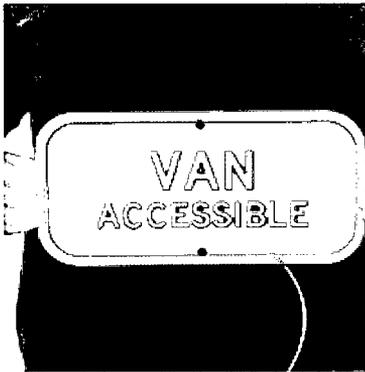
High Intensity Grade

Parking: The Town Hall provides 3 HP (accessible) parking spaces. However, there no van accessible parking spaces provided at this time. My recommendation is to add one Van accessible space with Van accessible above ground sign. The HP signs need to be at least 5 feet above the ground. A “van Accessible” sign should be posted on the pole just under the HP sign.

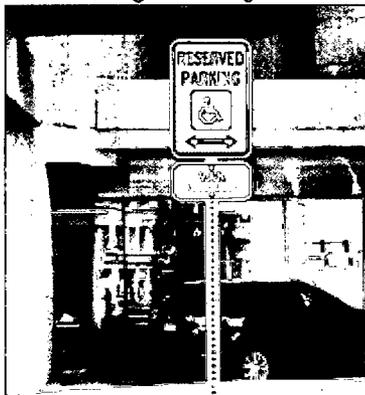
ADA Handicapped Sign: (Van Accessible)

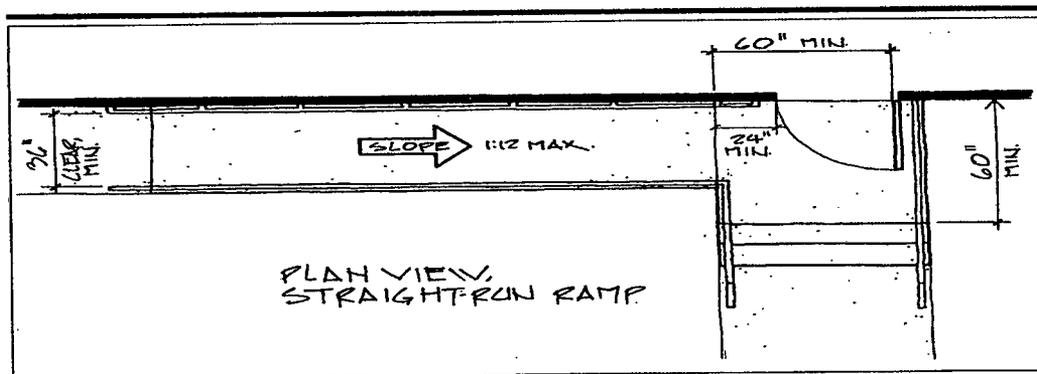
Construct New Ramp: Straight

Ramps are a common method of creating an accessible route, not only for people who use wheelchairs, but also for people with baby strollers, shopping carts, and almost any other device with wheels. A straight ramp is the easiest to use, since it requires no turns by the user. A long straight-run ramp can be a strong visual element, however. If aesthetic requirements are a consideration, an alternate

configuration, such as a dog-leg ramp, might mitigate the visual impact.

Since we are informed that public meetings are sometimes held at the Main Fire Station, we recommend the 7 foot ramp be installed at the main entrance as per the drawing provided. Citizens also visit The East Fire Station in order to apply for permits, etc. Both of the Boxford stations are emergency designated temporary shelters. Please contact us at: (978) 687-4288 if you have any questions or concerns regarding this report.
