Subject: Environmental Monitoring Report
Boxford Common
DEP File Number 114-1166

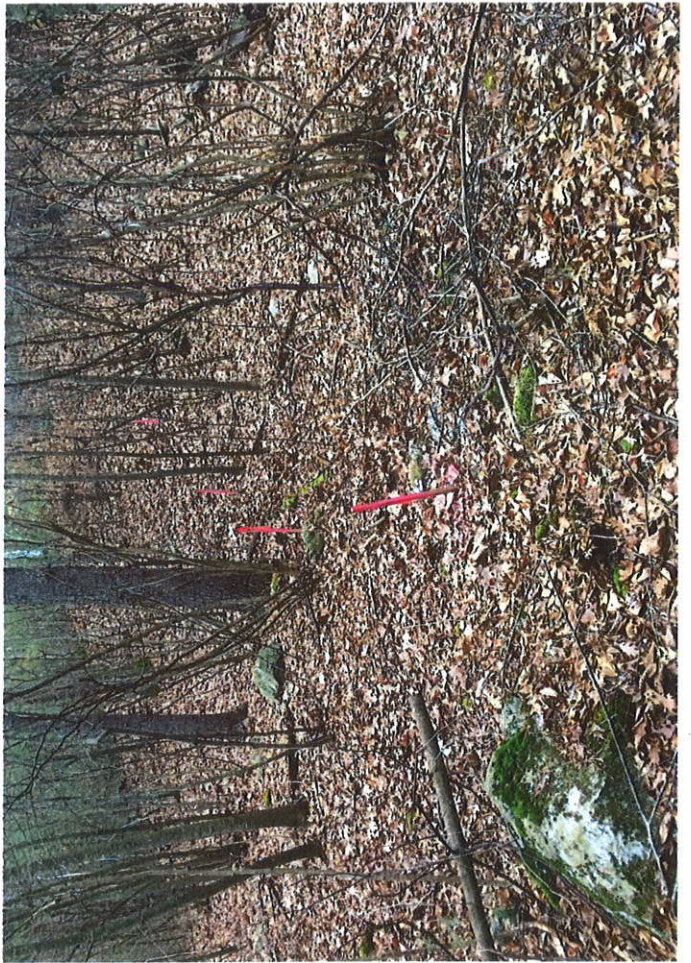
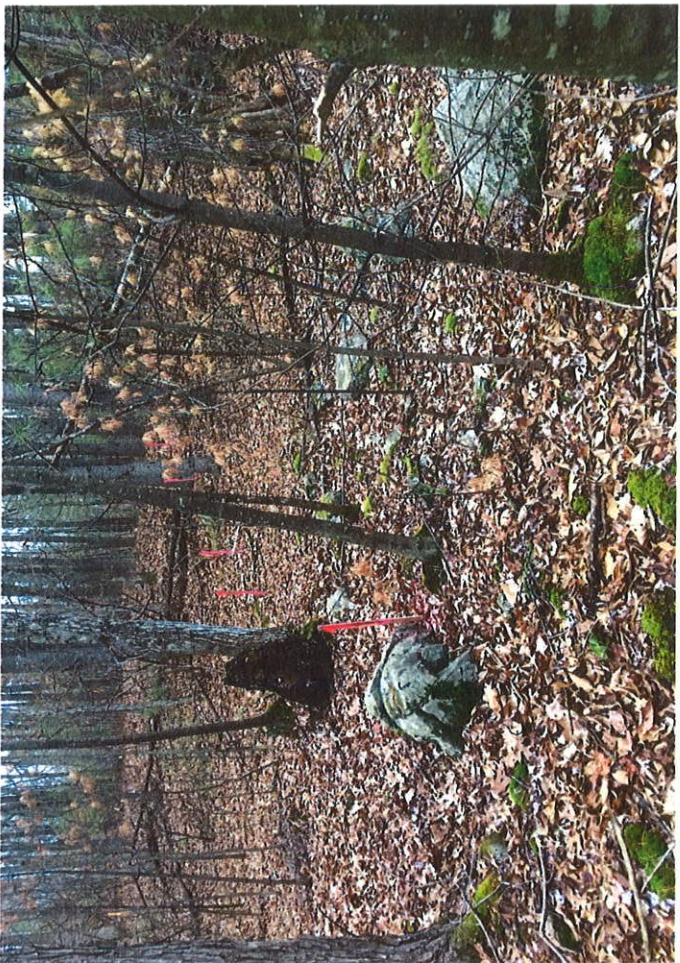
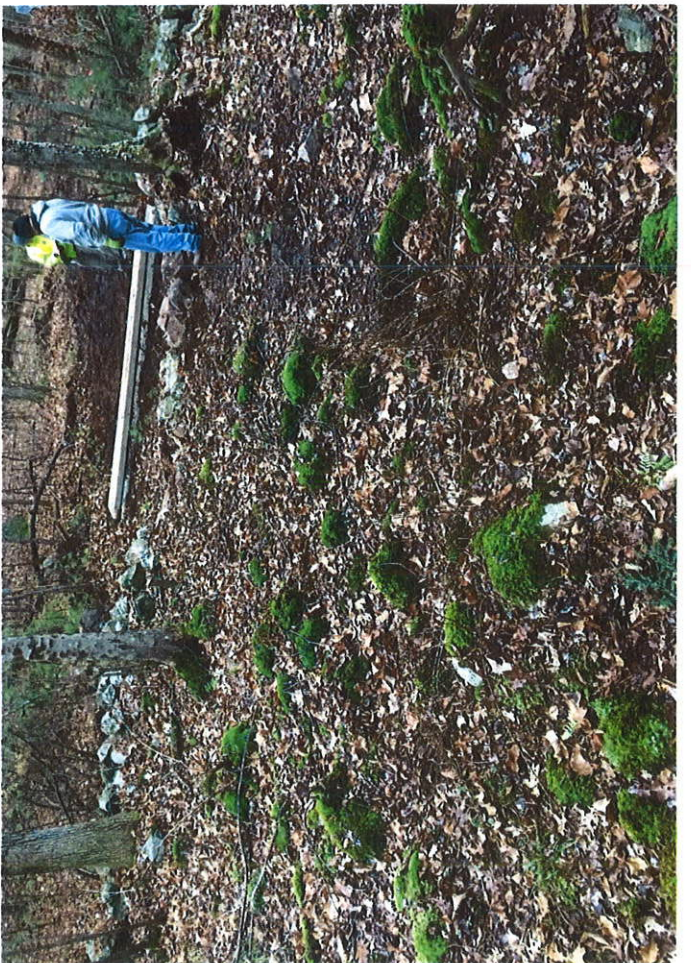
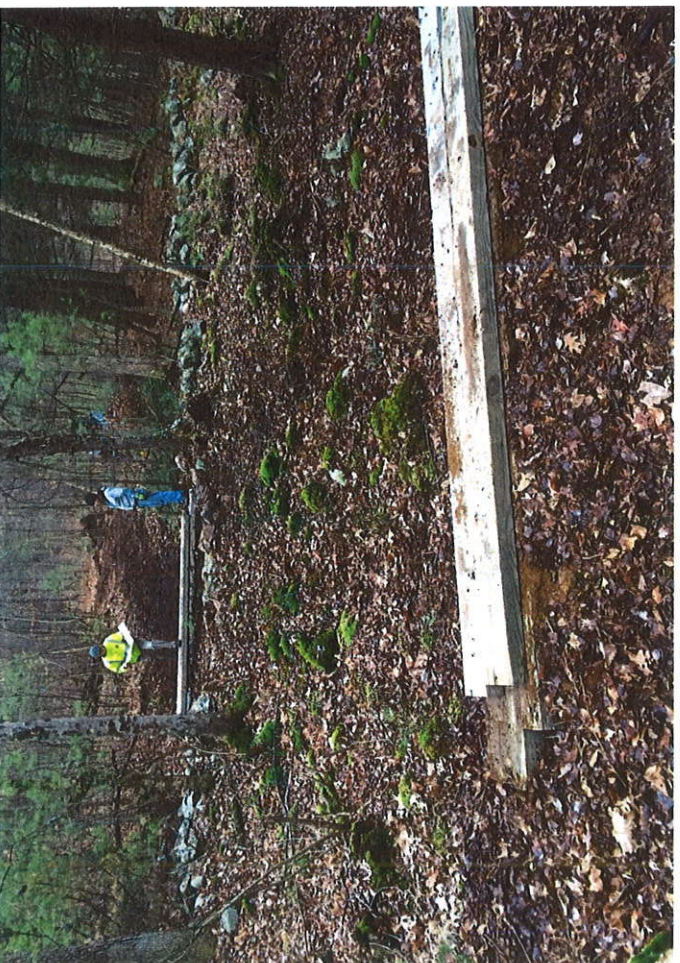
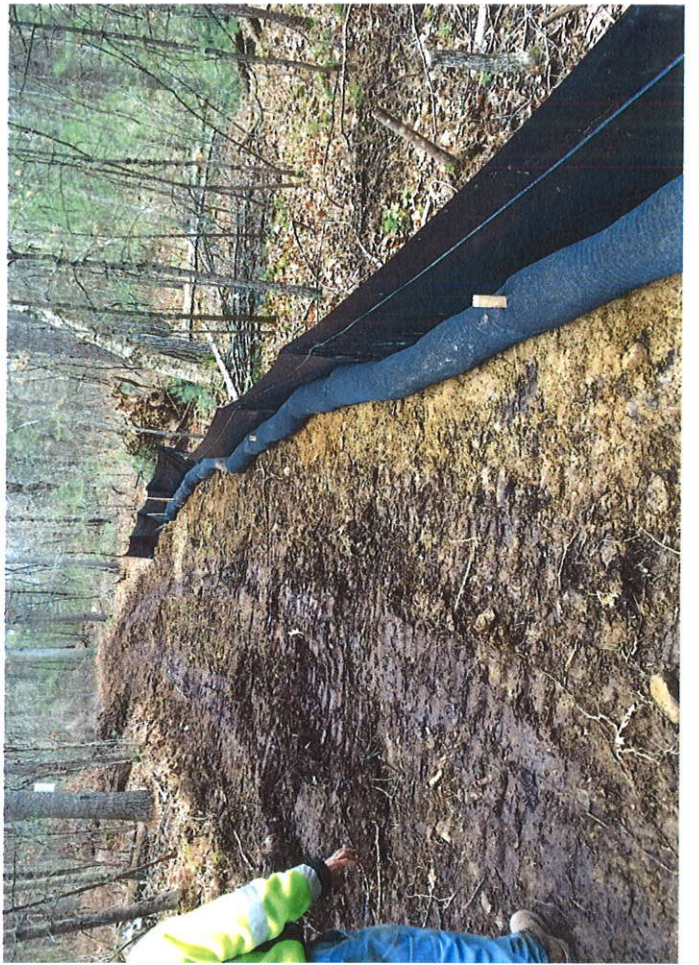
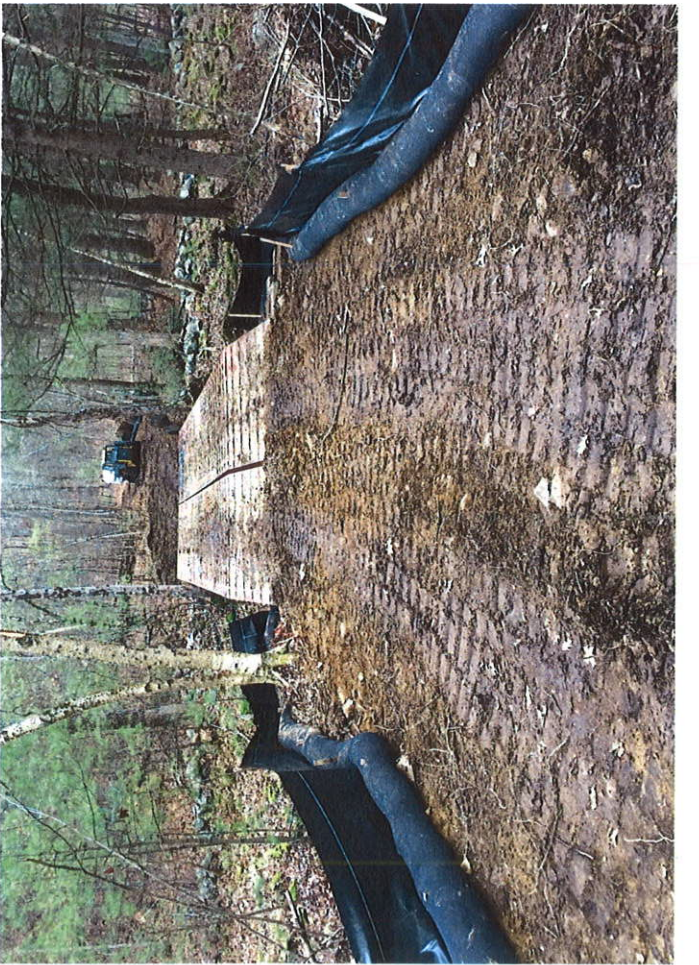
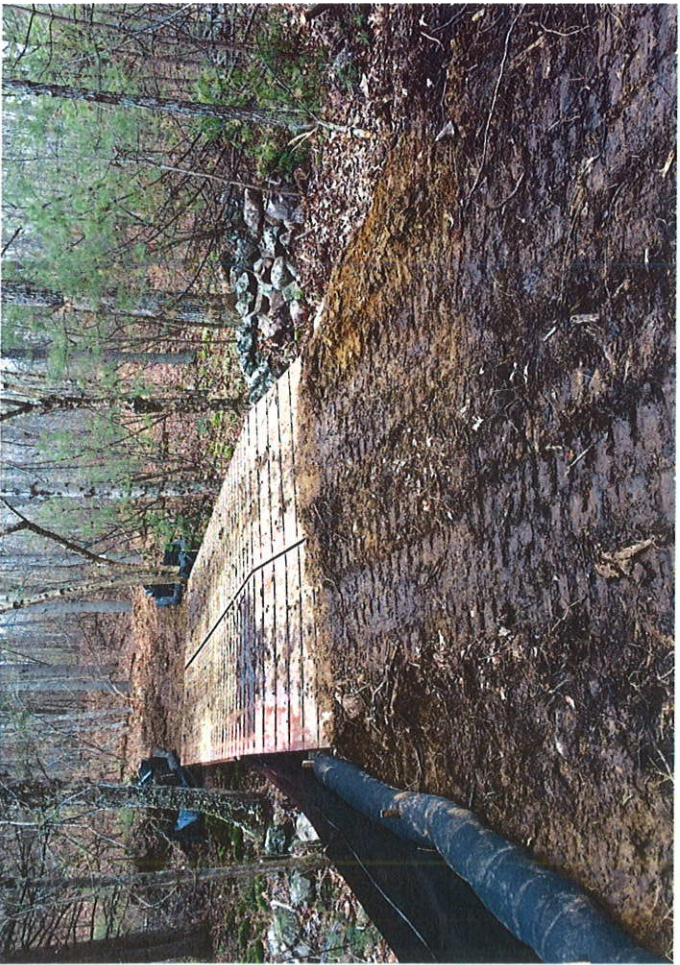
On December 17, 2015 I met with representatives from R.A.D. in the vicinity of wetland flags 886 & 534 to discuss the temporary bridge and the erosion controls at the crossing. R.A.D. informed me that the bridge would be installed shortly and that they would be ready for an inspection of the erosion controls by December 21, 2015. During the meeting we also discussed installing additional erosion controls along the access road in the vicinity of wetland flags M61 & 113. See attached photos showing the wetland crossing as well as the lower portion of the turtle nesting area.

At approximately 12:00 on December 21, 2015 I met with representatives from R.A.D. and inspected the erosion controls at the temporary wetland crossing. The erosion controls were installed correctly; however, I asked that they install something over the middle of the bridge so that sediment doesn't fall through the crack and I asked that they install additional erosion controls where the bridge meets the erosion controls, (see attached photos). The erosion controls were still missing to the north of the bridge and along the access road in several locations. R.A.D. informed
