December 30, 2015

Subject: Environmental Monitoring Report #3 - Boxford Common  
DEP File Number 114-1166

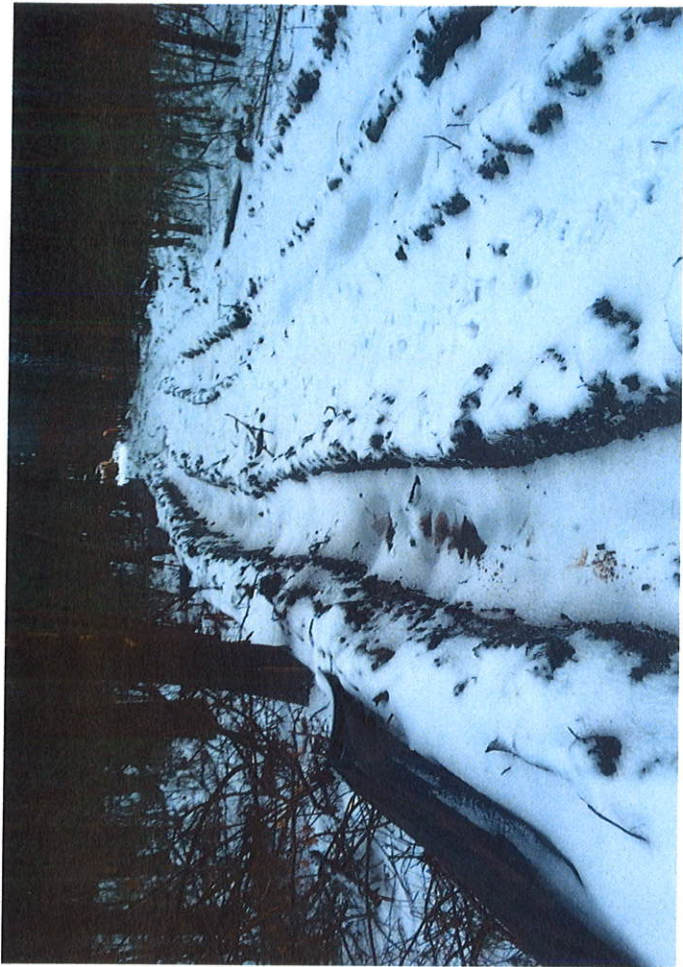
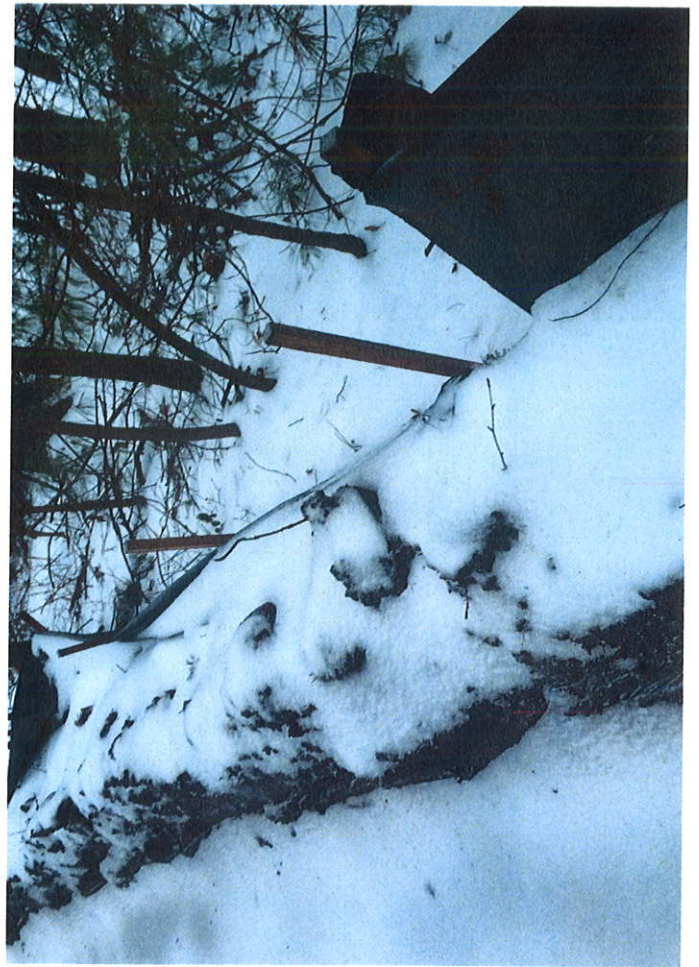
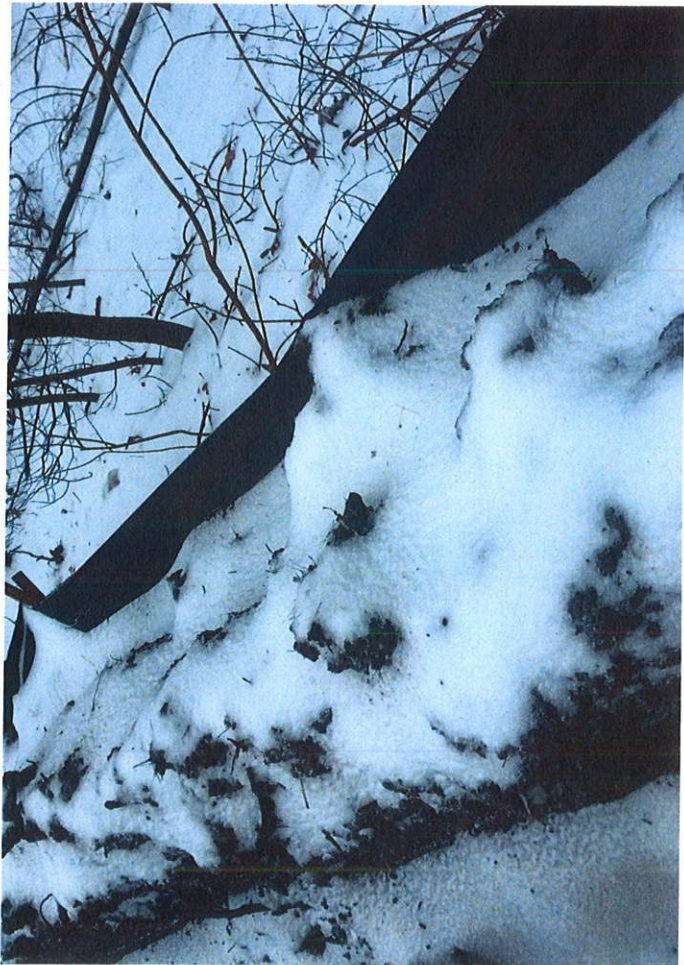
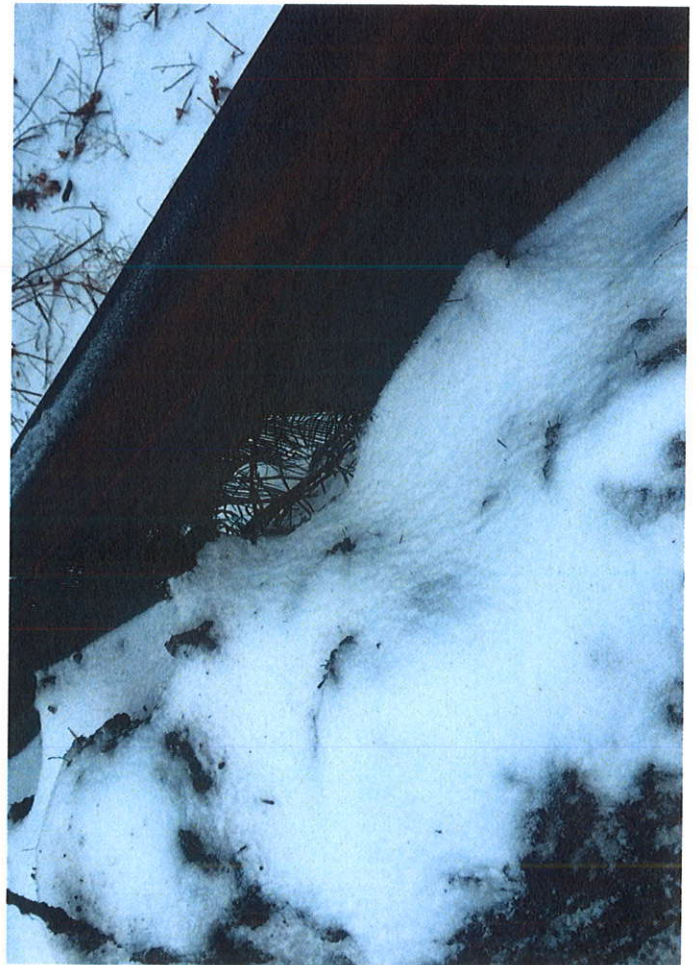
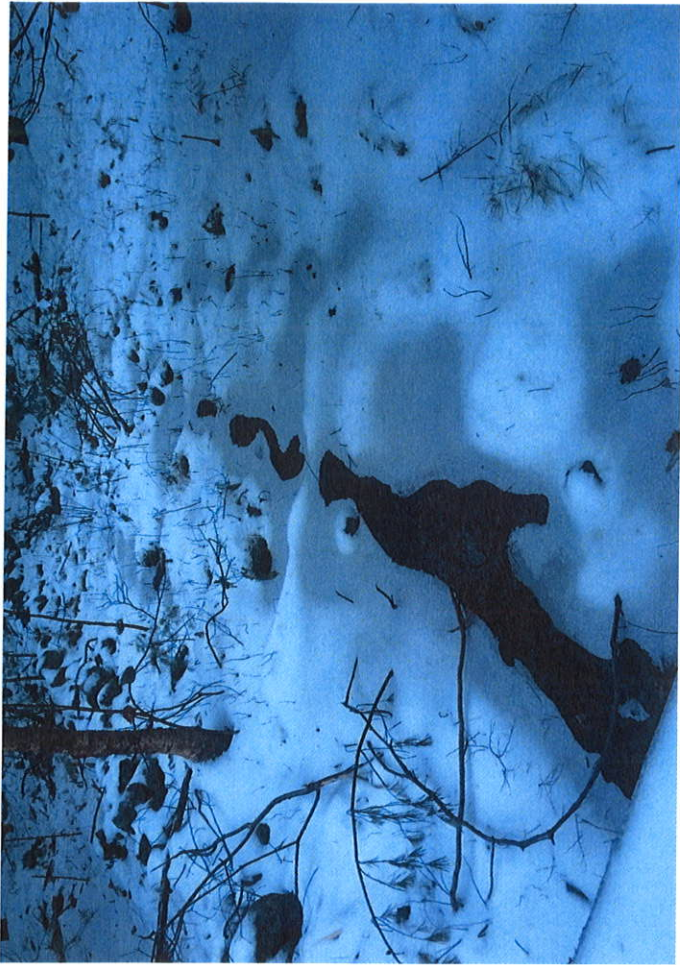
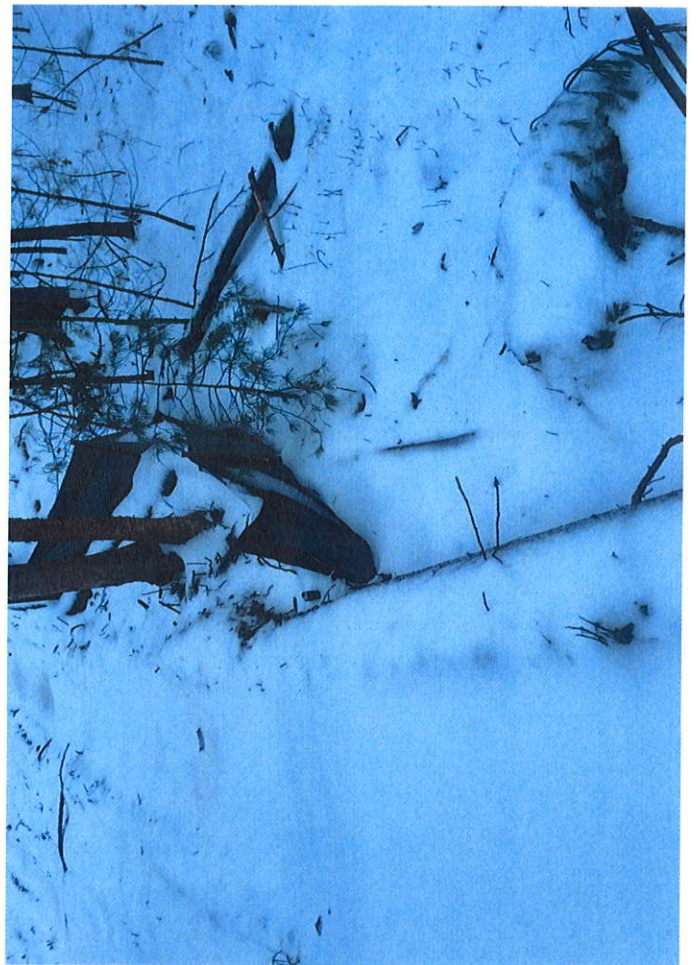
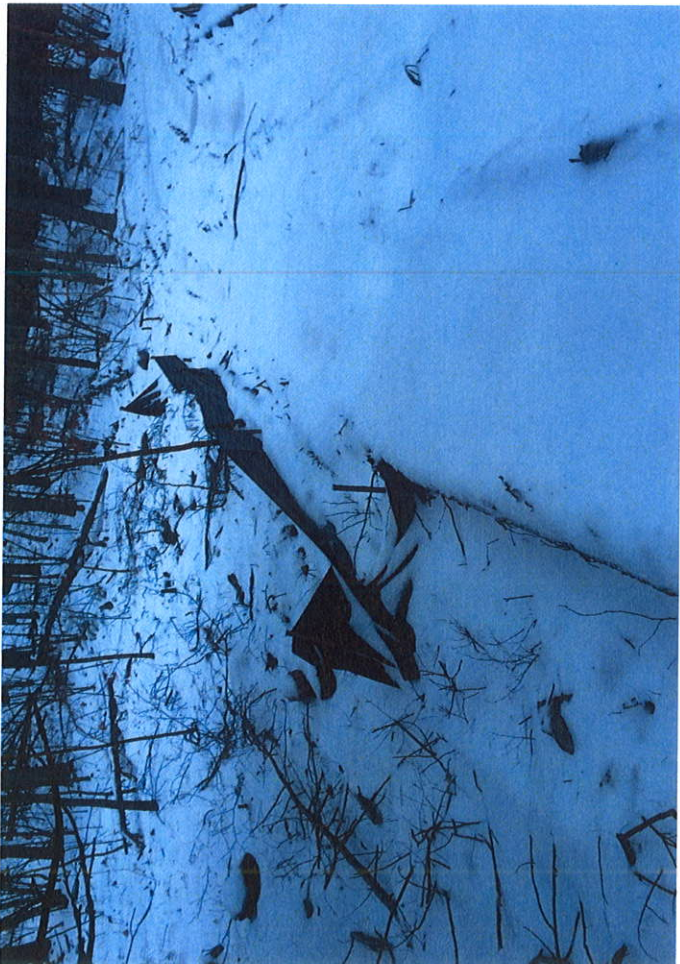
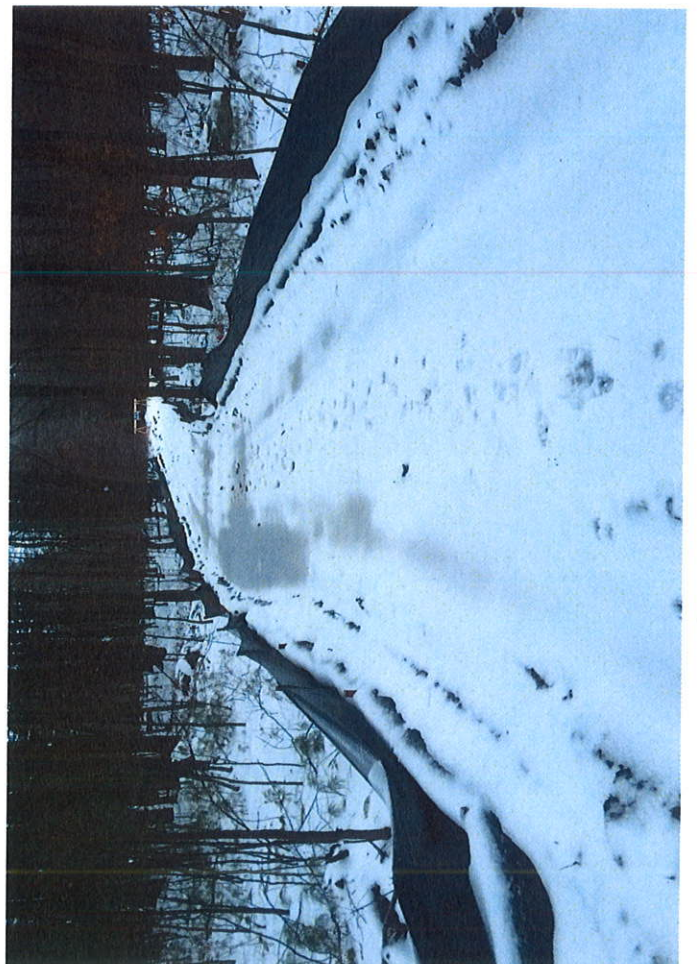
I conducted an inspection this morning following the recent storm, (see attached photos). Several areas of the erosion controls are still in need of repairs. R.A.D. has been responsive and informed me this morning that they will make repairing the erosion controls their top priority. They made repairs on Monday; however, more damage was caused as a result of moving equipment following the tree removal effort.

I did not observe any sediment on the downstream, or wetland, side of the erosion controls. Many of the ruts are acting as an internal barrier and helping to control sediment migration. R.A.D. informed me that they may be putting down some wood chips or other material, on a temporary basis, to help make the road more stable.

R.A.D. informed me this morning that they will be fixing all of the silt fencing today and pulling material off of the mulch sock. They informed me that the erosion controls will be fixed prior to hauling sand out to the turtle nesting area.

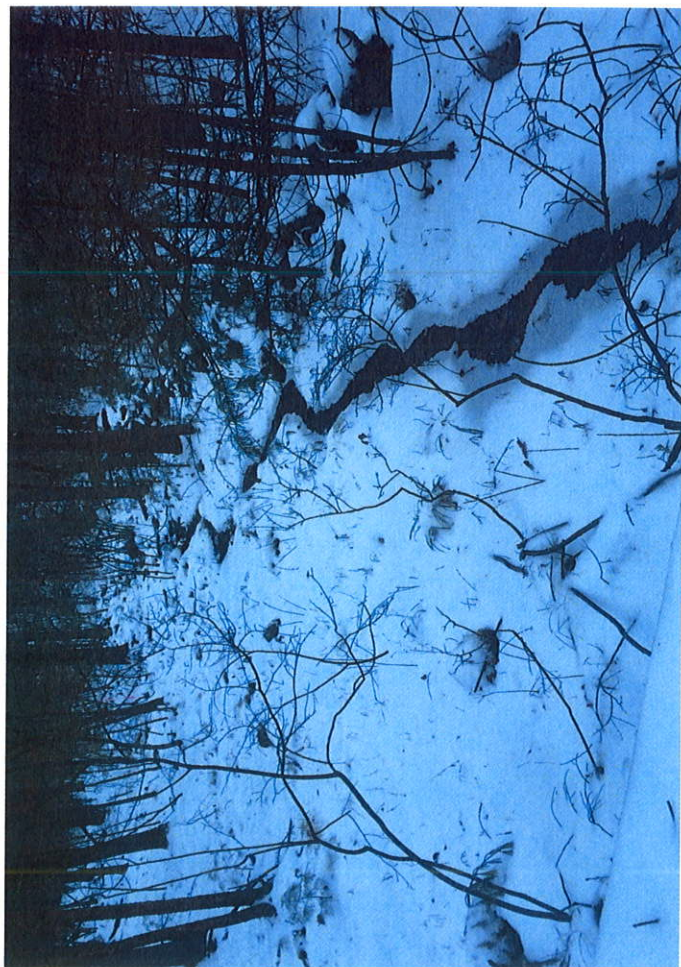
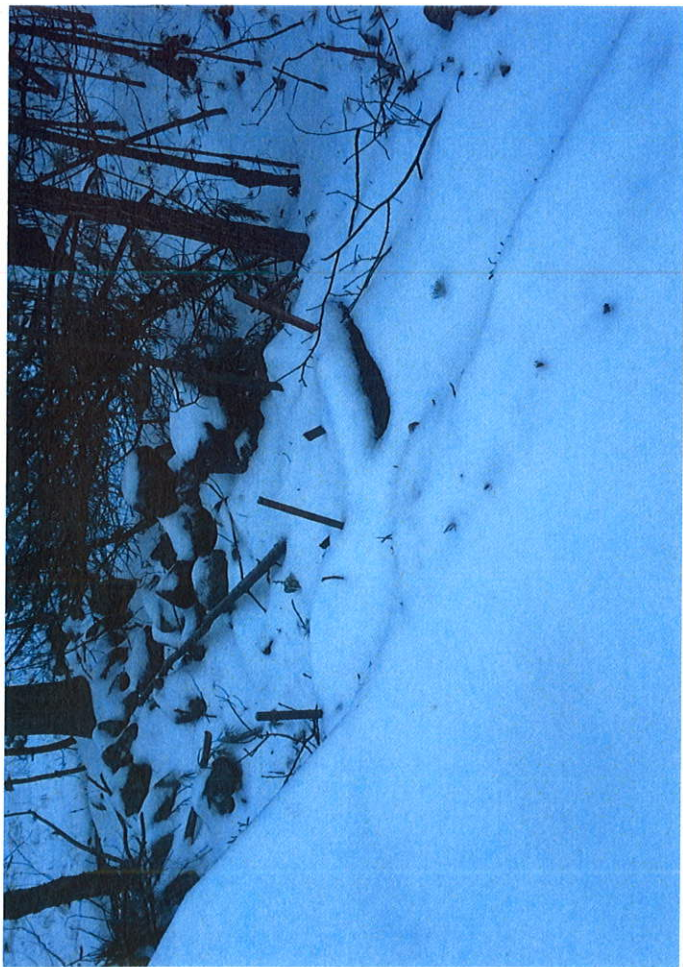
I included a couple photos of the intermittent stream at the temporary wetland crossing. As you can see from the photos, the stream is flowing and there is no sediment in the resource area. The temporary bridge is working well.
