Field Report**Project: Boxford Community****Senior Center****10 Elm Street Boxford, MA 01921****Report No.:****014****GRLA Project No.:****2020120.01****Date of Site Visit:** 28 December , 2021

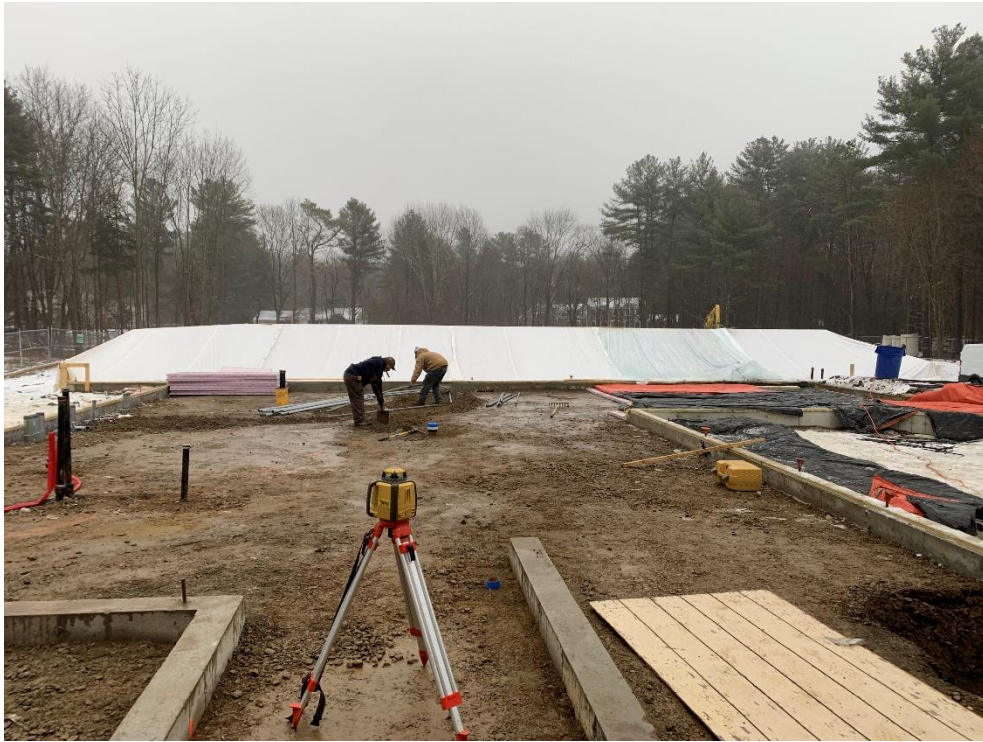
1. Slab poured at Multipurpose/ Kitchen Wing on 12/21/2021, tented and heated during the 7-day wet-cure; Office wing slab to follow next week.

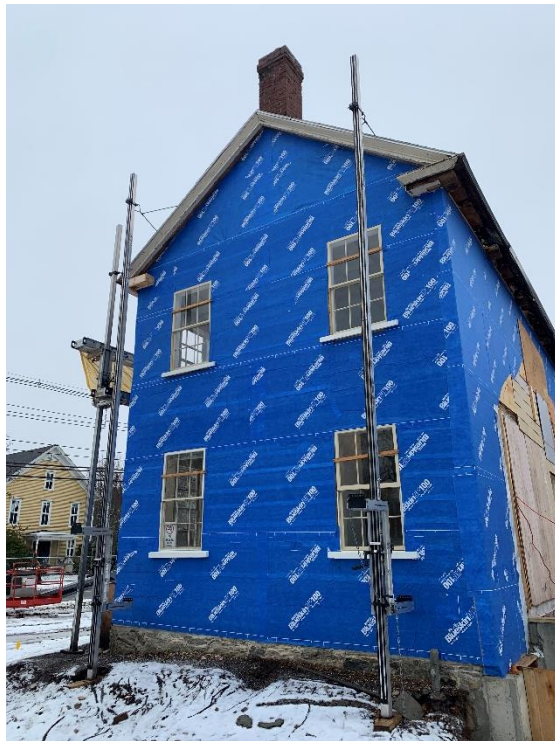
- a. Air Barrier (Henry Blueskin VP-100) is installed at south, west and north sides of Cummings House (photo 2).
- b. Underground plumbing at Office Wing is installed at future restrooms (photo 5.)

2 . Air barrier (Henry Blueskin VP-100) installed completely on South, West and North sides of Cummings House.

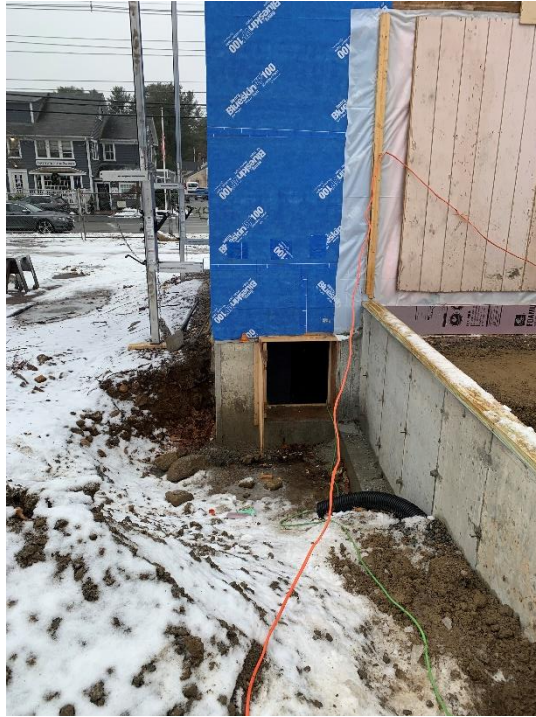
3. Opening for Turtl Access hatch at southeast corner of Cummings Basement/ crawlspace.

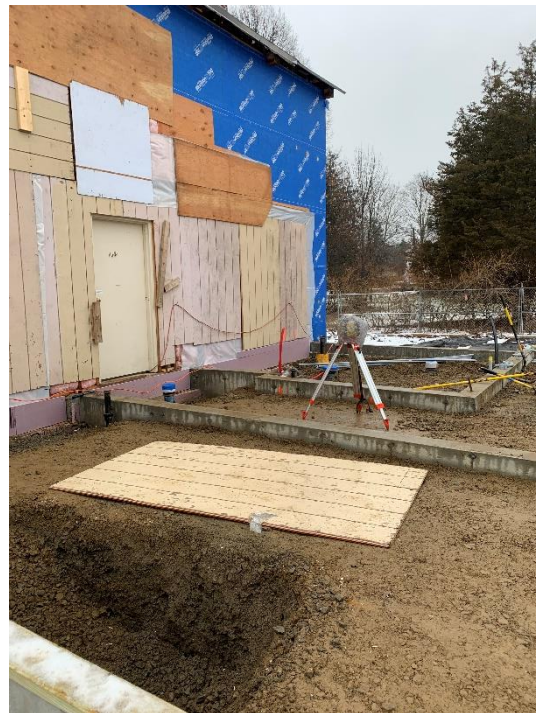
4. New Addition foundation and backfill completed.

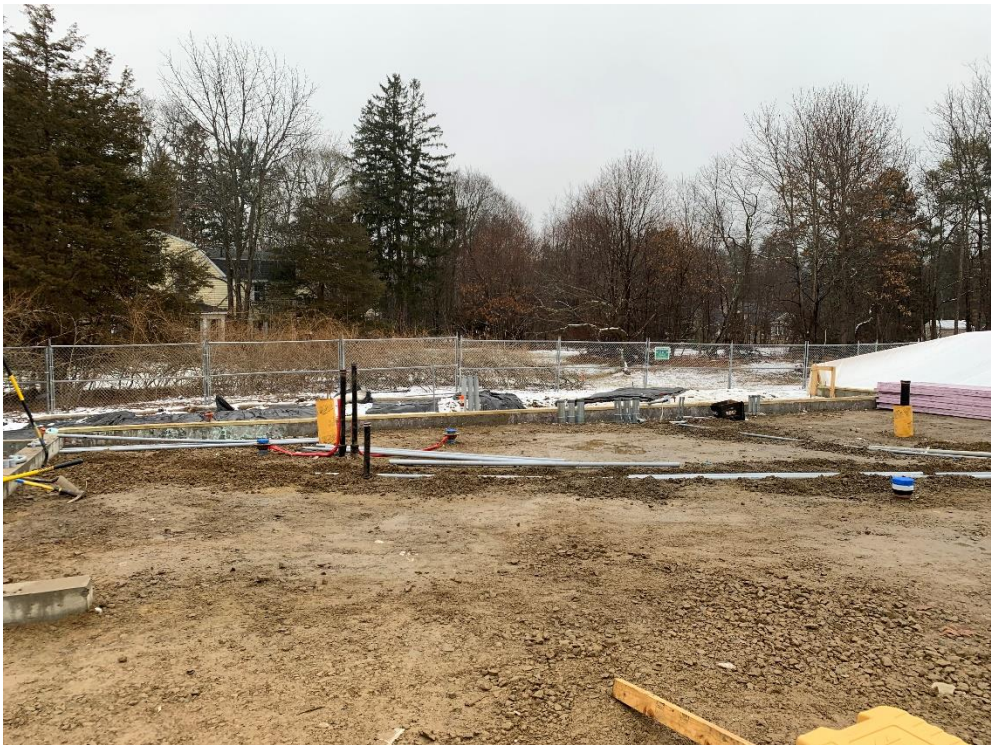
5. Rough plumbing at future restrooms

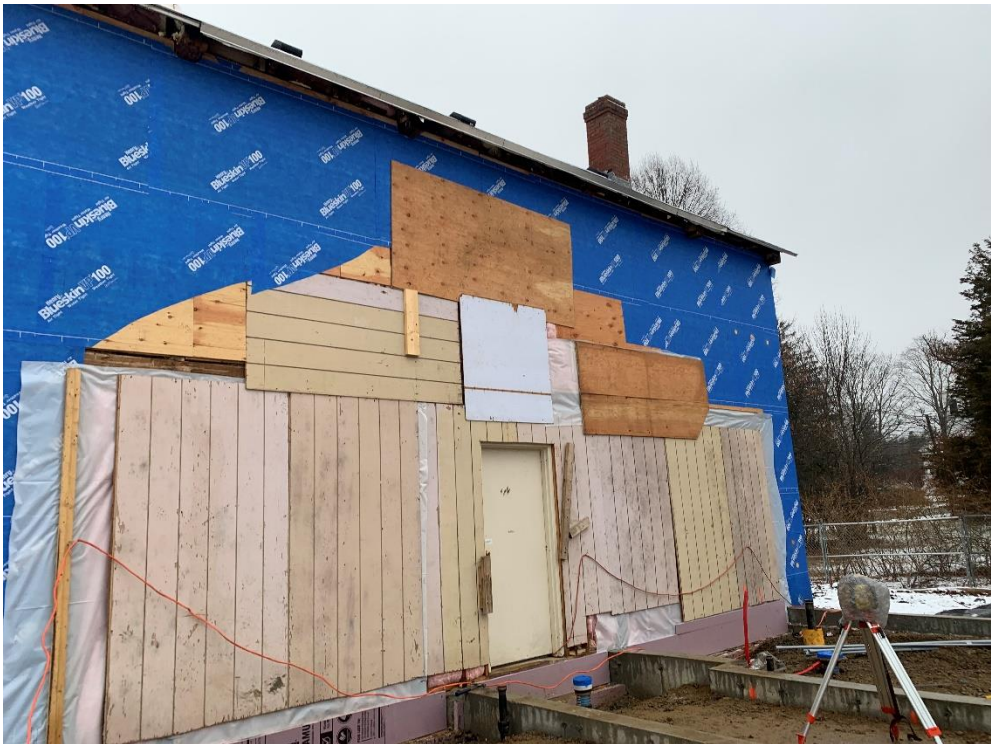
6. East wall of Cummings House with temporary boarding.

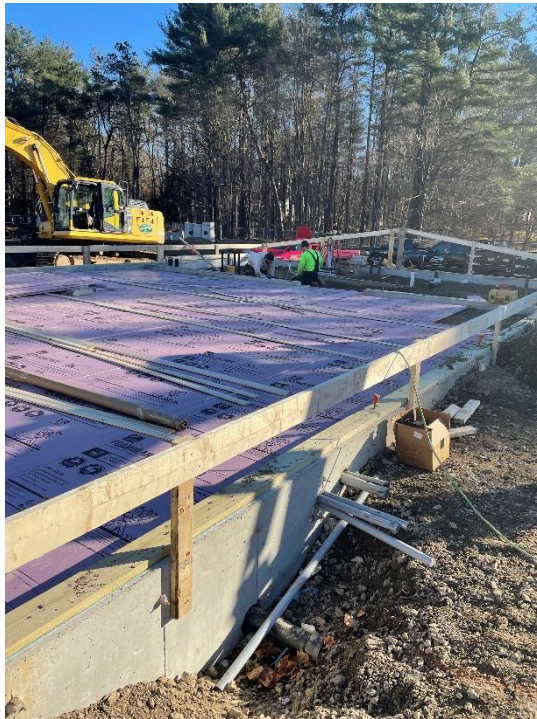
7. Preparation of Multipurpose/ Kitchen slab with rigid insulation and wood framing for heating tent (photo by Fred Scibelli 12/17/21)

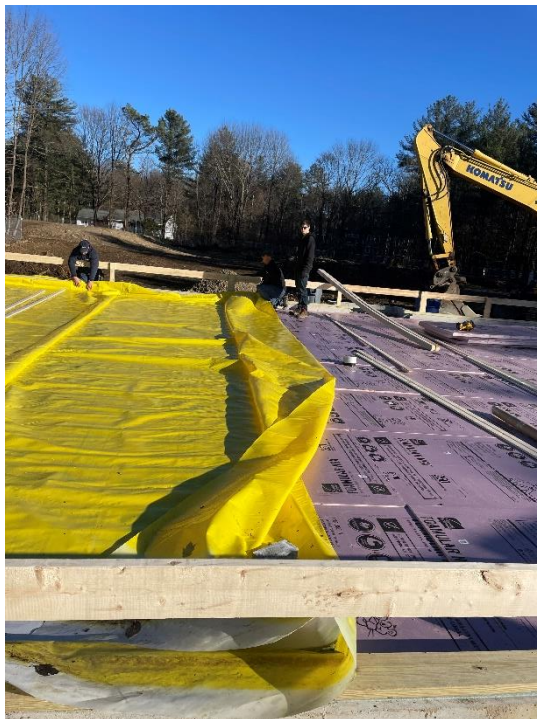
8. Installation of 15 mil Stego Wrap vapor barrier at Multipurpose/ Kitchen Wing prior to slab pour (photo by Fred Scibelli 12/17/21)

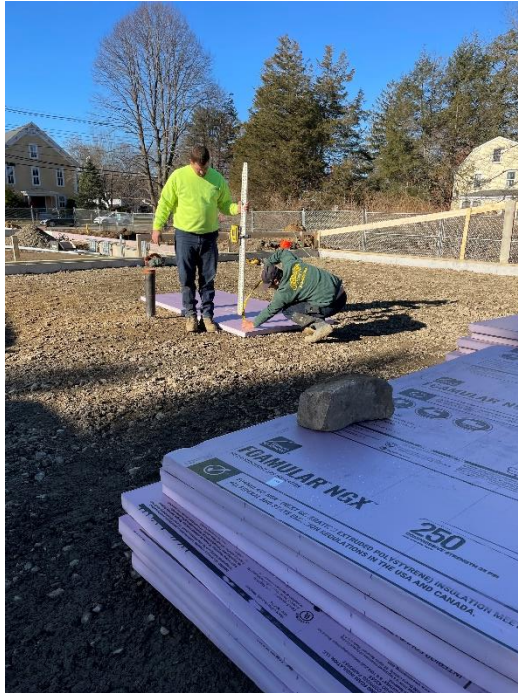
9. Verification of top of insulation elevation to ensure 4" min. slab thickness (photo by Fred Scibelli 12/17/21)

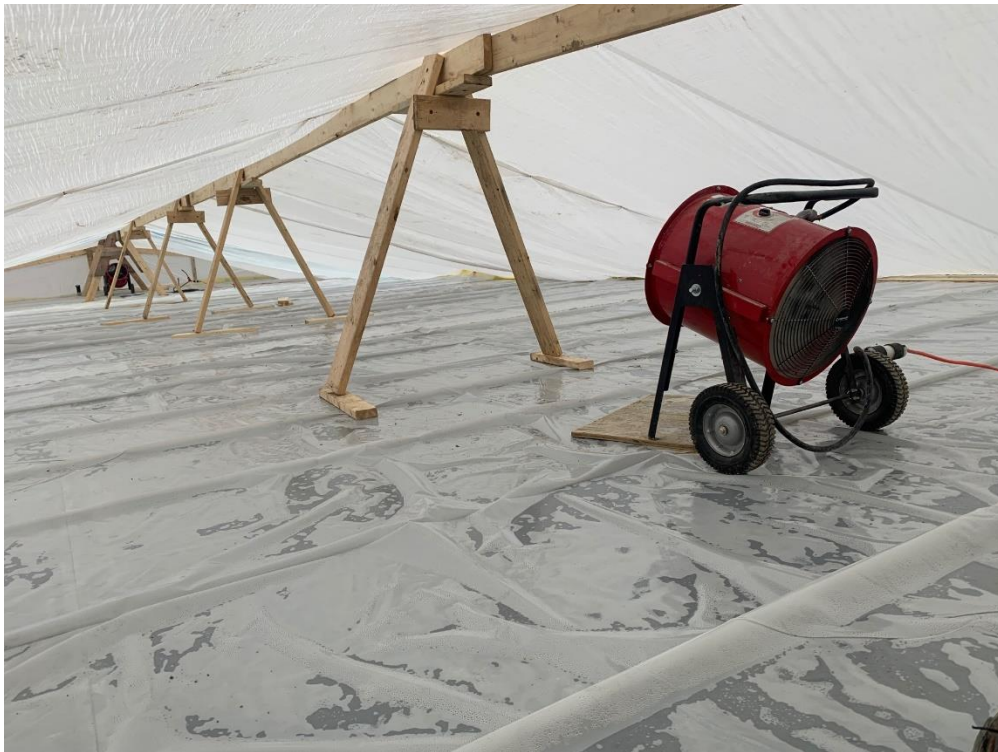
- a. Slab at Multipurpose/ Kitchen Wing, poured on 12/21/21) is tented and heated during its wet-cure.
- b. *NOTE: photos include preparations for the Multipurpose/ Kitchen slab pour taken by Fred Scibelli (project Clerk-of-the-works) on 12/17/2021 and photo of the wet-cure inside the heated tent by Bryan Gannon (project Superintendent) taken on 12/22/21.*

10. Inside tent with heaters (photo by Bryan Gannon 12/22/21)
