Re: Assessment of Rusty 55-Gallon Barrel  
Anderson Drive  
Boxford, Massachusetts

### Site Layout Sketch

## Site Photographs

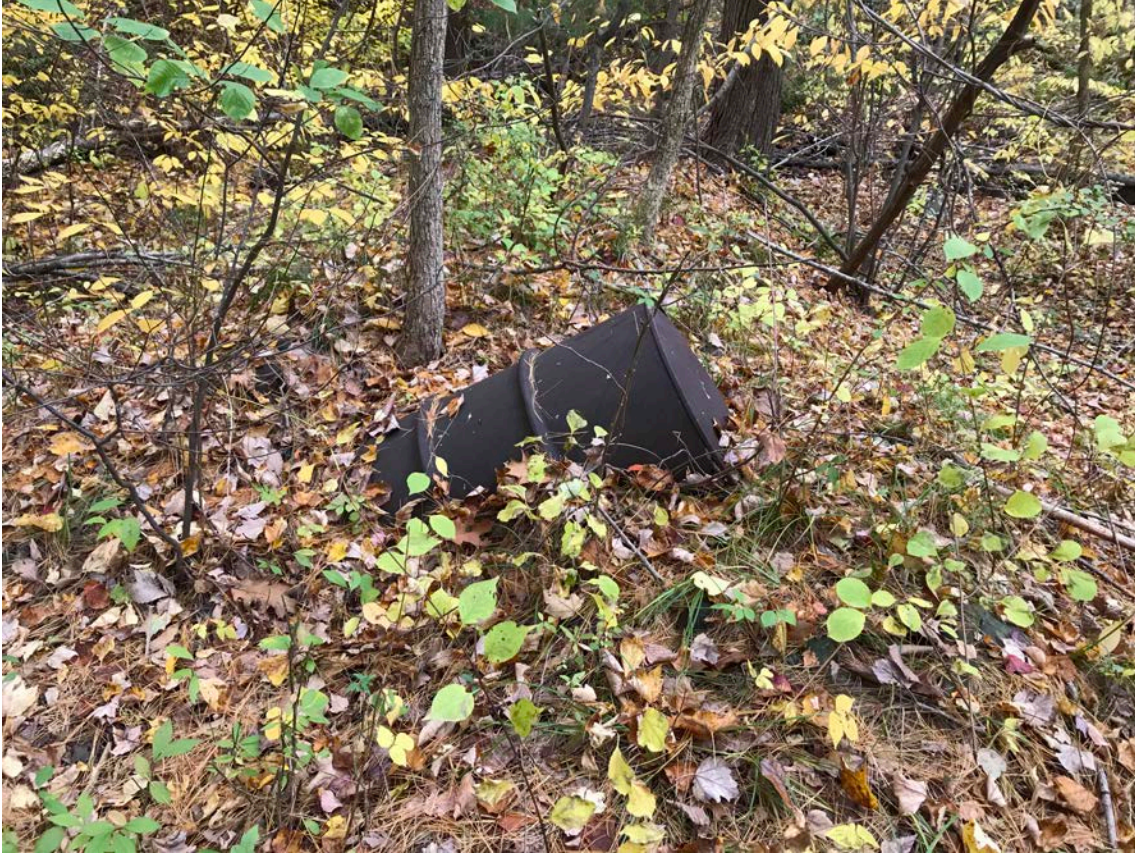
A site visit was performed by Steven and Julie Shope of Exeter Environmental Associates, LLC on October 20, 2020. The empty barrel was observed to be corroded and is estimated to be greater than 60 years old in our opinion and experience (Photo #1). We attempted to move the barrel but the top half separated from the ground and no bottom half was present as it had completely corroded (Photo #2).

Photo #1. Barrel *in-situ*.

We have no recommendation for further assessment relative to the subject barrel.

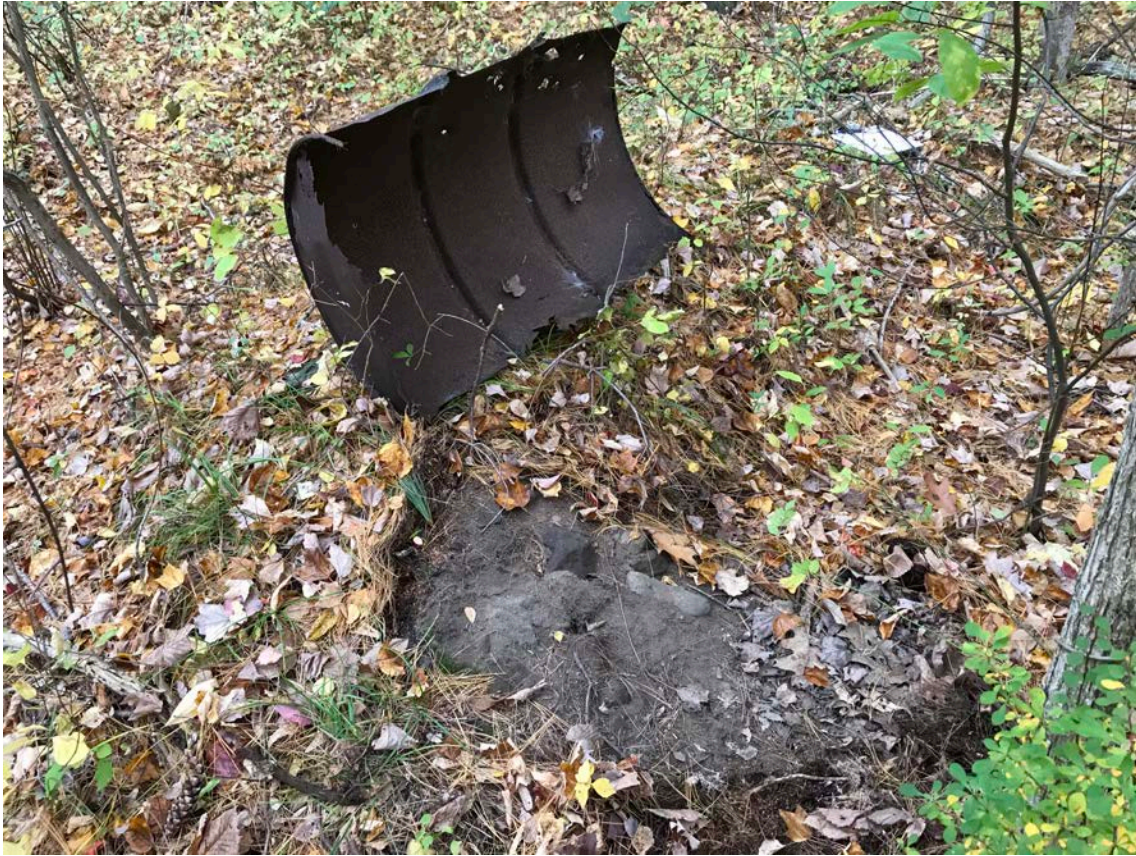
The soil beneath the barrel was brown in color with no staining or odors. A soil sample collected beneath the barrel was screened with a properly-calibrated photoionization detector. A reading of less than 1 part per million was measured. This reading is considered to be background, meaning that no volatile chemicals such as gasoline or solvents are present.

Photo #2. Barrel after removing rusted top half.
