River Herring Spawning and Nursery Habitat Assessment: Four Mile Pond, 2019-2021

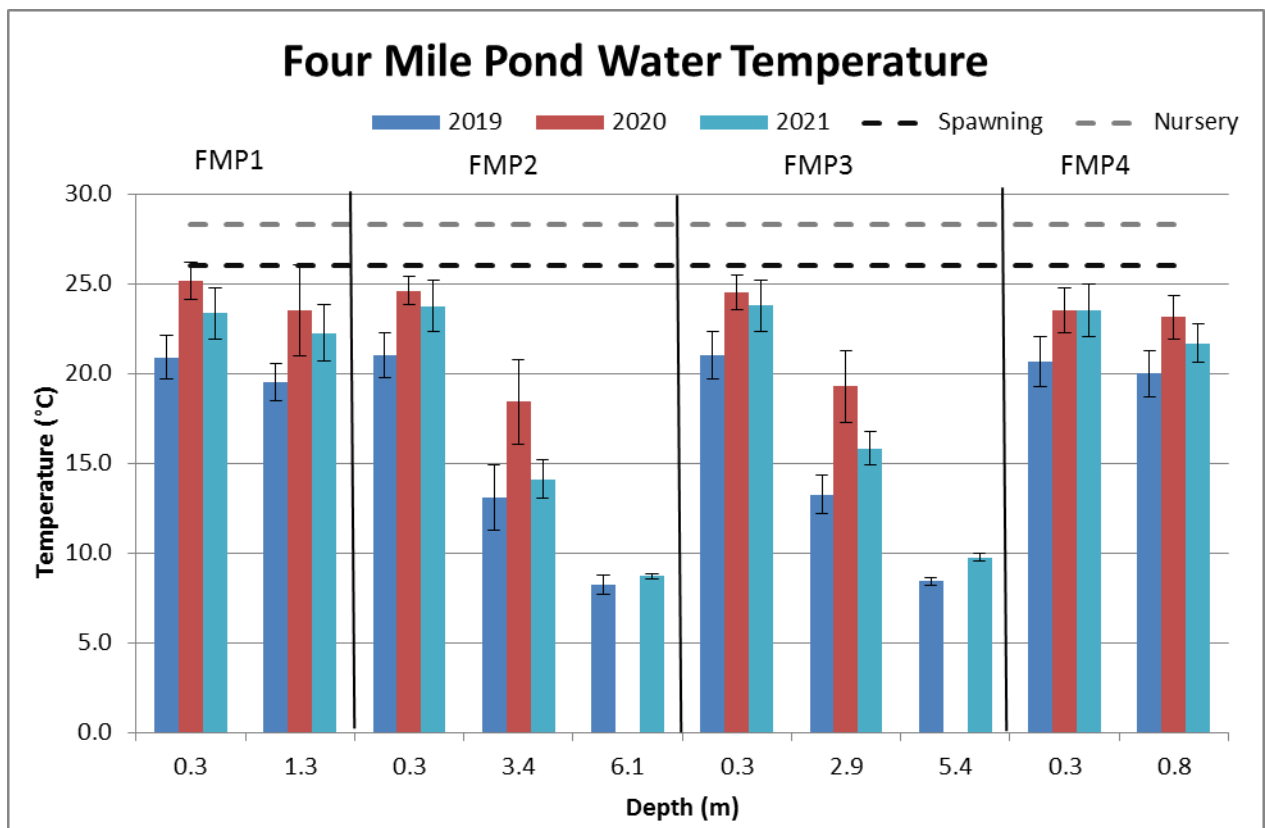
Surface water temperatures at Four Mile Pond exceeded the spawning threshold of 26.0 °C during the spawning period on June 23, 2020 at site FMP1 with a temperature of 28.5°C, site FMP2 with a temperature of 27.4°C, site FMP3 with a temperature of 27.1°C, and at site FMP4 with a temperature of 26.2°C. There were no spawning or nursery temperature exceedances in 2019, 2020 or 2021. Average water temperatures were suitable for both spawning and nursery periods (figure 2, table 1).

Figure 2. Average water temperature (May-September) at Four Mile Pond monitoring stations, +/- 2 S.E.

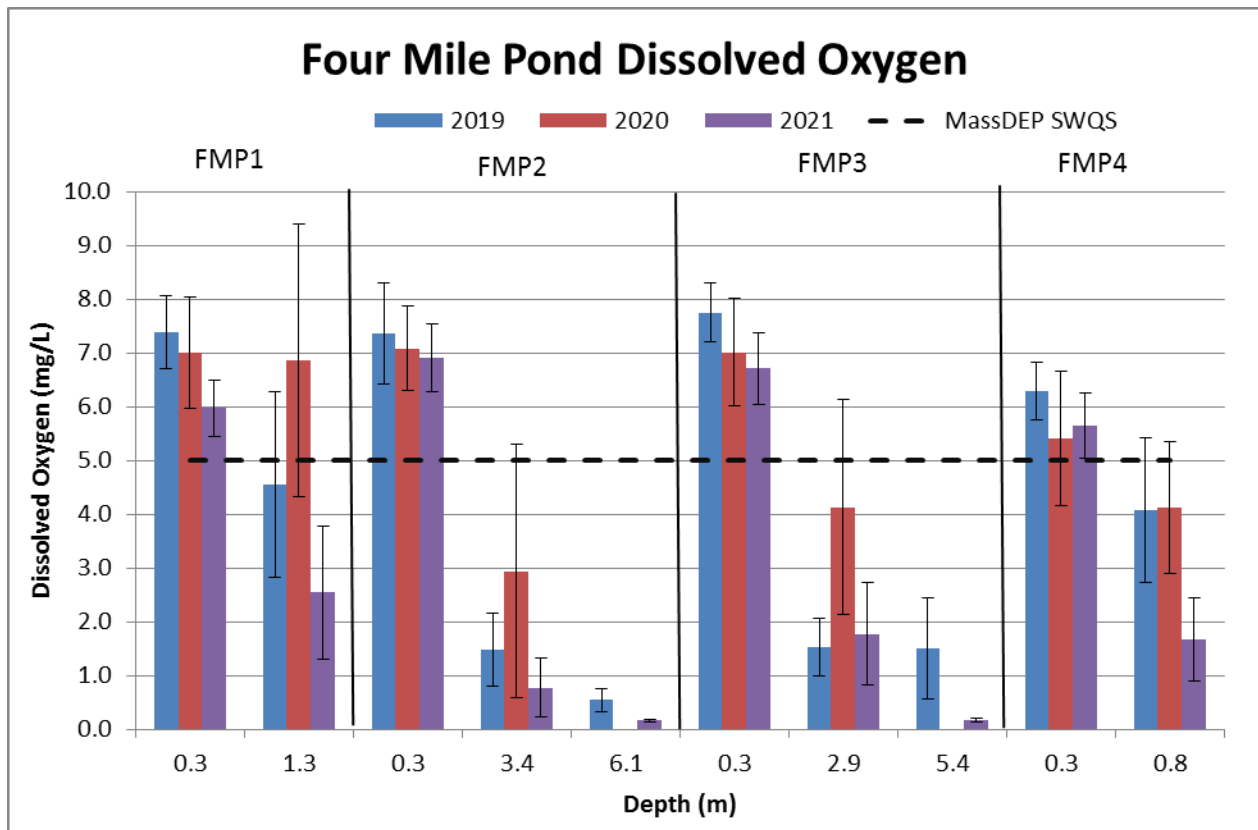
The amount of dissolved oxygen (DO) in water depends on numerous factors, including the temperature of the water and the gas exchange across the air-water interface. DO concentration is inversely related to water temperature, so will decrease when water temperatures increase. Other primary factors affecting DO include oxygen production through photosynthesis and depletion through biochemical oxygen demand due to respiration and other oxygen-demanding processes. DO changes on a diurnal basis as well as seasonally, and is affected by cloud cover and other weather conditions. The most critical time for organisms is in the early morning hours in the summer when water temperatures are high, and photosynthesis has ceased producing oxygen since sunset. Stratification can also occur when water temperatures prevent surface waters from replenishing oxygen at the deepest strata. Dissolved oxygen measurements exceeded the water quality criteria of 5mg/L among 45% of the total samples. Most exceedances occurred at the deepest strata of sites FMP2 and FMP3 (figure 3). Average surface water DO levels were generally suitable from 2019-2-2021.

Figure 3. Average dissolved oxygen concentration (May-September) at Four Mile Pond monitoring sites, +/-2 S.E.

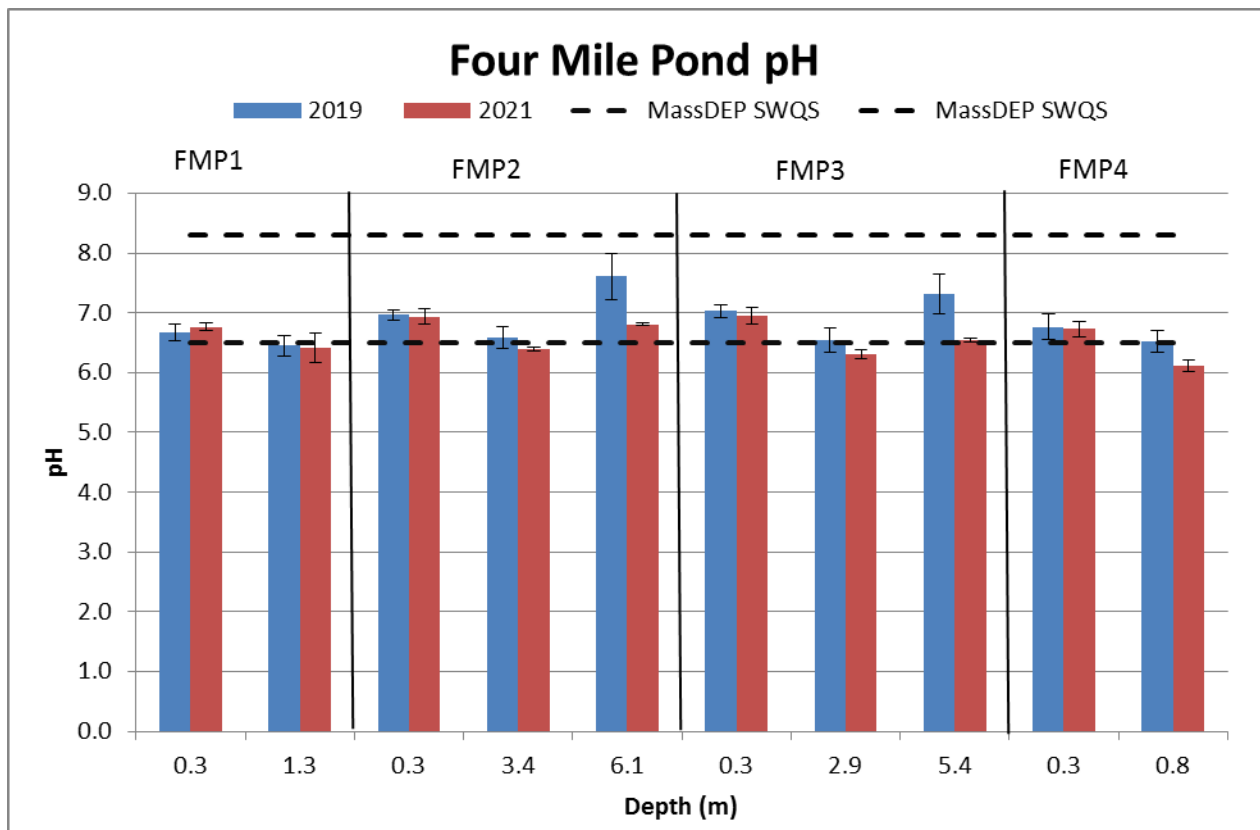
Suitable pH conditions are also important for the life history of fish and other aquatic organisms. Monitoring for pH was limited to 2019 and May-July 2021, since the water quality sonde was not available in 2020 or August-September 2021. During this time, the preferred range of ≥ 6.5 and ≤ 8.3 was exceeded among 36% of samples (table 1). This would technically lead to an *Impaired* designation, however, exceedances were slight and average pH was within the preferred range (figure 4), so a best professional designation of *Suitable* was applied. The minimum pH value recorded was 5.96 at the bottom strata (1.3m) depth FMP1 on 6/25/2019. The maximum value observed was 7.45 at the bottom strata (6.1m) of site FMP2 on 8/24/2019.

Figure 4. Average pH (May-September) at Four Mile Pond monitoring sites, +/- 2 S.E.

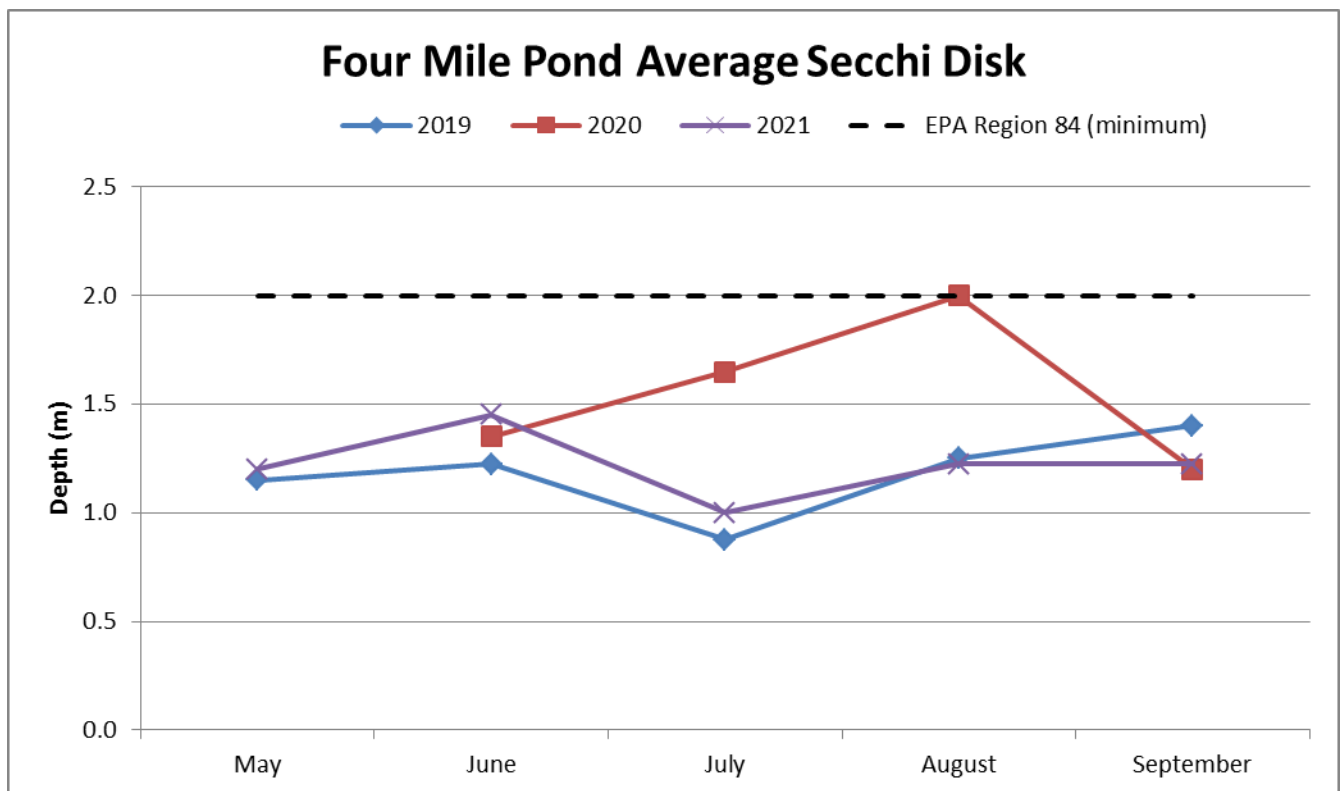
Secchi disk transparency depth indicates the degree of clarity or turbidity related to plankton and suspended solids. High concentrations of organic and inorganic particles can increase turbidity, making a water body less suitable for aquatic life. The monitoring sites of Four Mile Pond were evaluated against the minimum standard adopted by the assessment QAPP of 2.0 m. Evaluation of Secchi disk data was limited to the deep sites FMP2 and FMP3. The minimum visibility standard of 2.0 m represents the point at which water quality may be considered degraded, but this alone may not prevent herring spawning success and may not be a critical factor where spawning would more likely occur in shoal areas, where visibility is at maximum depth when the substrate is not obscured by vascular plants. Due to this, observations of eutrophication as an indicator of water clarity were rated as *Impaired*, however a best professional judgement classification of *Suitable* may be acceptable (table 1).

Figure 4. Average Secchi disk transparency by month at Four Mile Pond monitoring stations.

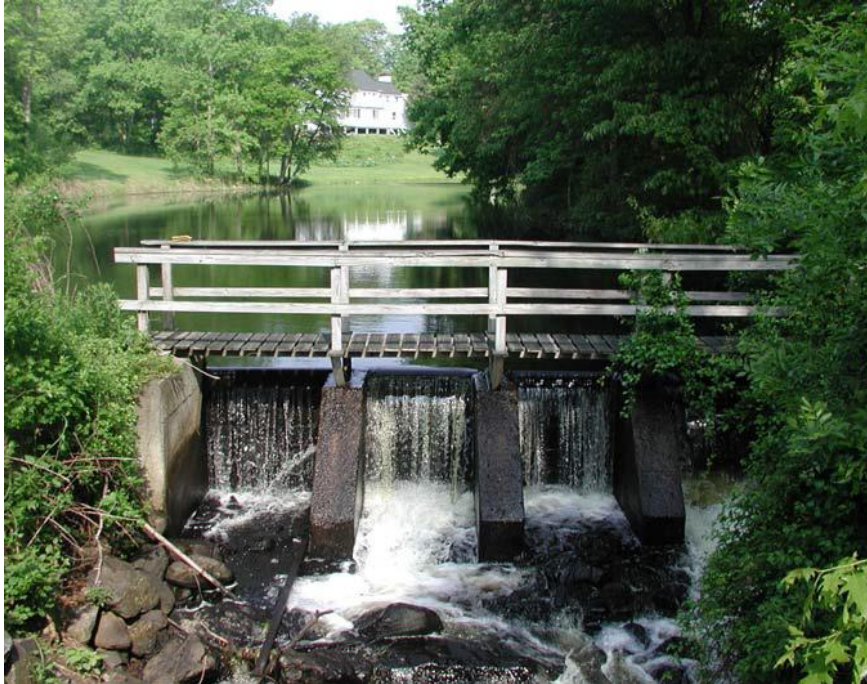
The Howlett Brook Dam is located on Howlett Brook, near the confluence with the Ipswich River. It is a 4.6 foot high privately owned structure which currently has no fish passage device installed. According to local knowledge and field observations, it formerly had a concrete & stone step pool fishway on river left (remnants can still be seen), which allowed for some anadromous fish passage. The dam and fishway were severely damaged in the Mother's Day Storm of 2006 and the fishway was not reconstructed when the dam was repaired. In its current configuration it provides no upstream passage for adult river herring.

Figure 6. Howlett Brook Dam. Photo from DMF, 2005.

The dam spillway consists of stop boards that can be removed to fully lower the impoundment. A fish passage device will be installed in 2021 or 2022 as the dam owner chooses to operate the dam with the impoundment full throughout the year. Downstream migration does not appear to be directly inhibited by the dam.

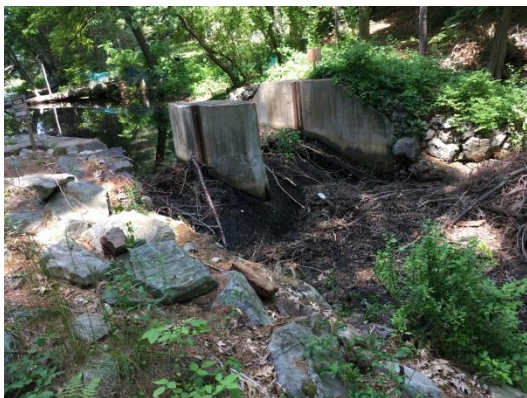
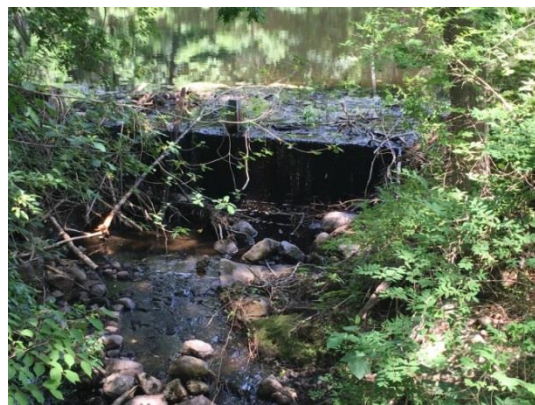
Low Pond is retained by an earthen berm and a concrete wall. The earthen berm makes up a majority of the 260' combined length of the structure with the concrete wall acting as the main spillway. There is no fish passage structure associated with this dam. Four Mile Pond is impounded by the Four Mile Pond dam on Pye Brook at the east end of the pond. This is an approximately 15' concrete dam located near Georgetown Road. No fish passage structure is present. Downstream migration would not appear to be impacted at either structure under suitable flows.

Figure 6. Four Mile Pond Dam (left) and Low Pond Dam. Photos taken on 6/23/2020.

Streamflow can influence fish passage independently of structural barriers. Flow conditions were noted at the Four Mile Pond dam during each monitoring visit. Drought conditions occurred during 2020 and low flows were observed at each dam as a result (figure 6). Flows could be observed downstream of each dam, however. Both Pye Brook and Howlett Brook are low gradient streams surrounded by wetlands for much of their length. Beaver dams are present along the length of this stream network and several culverts are equipped with beaver deceivers to mitigate damming. Channel maintenance work is ongoing, especially hand pulling of cattails on Pye Brook, to improve passage where dense cattail stands obscure the main channel. Downstream migration should not be impacted by streamflow under most conditions, so a classification of *Suitable* was applied.
