Wetland Consulting Services

WCS Proj #: Boxford-27

RE: Request form Determination, Guardrail Replacement, Georgetown Road

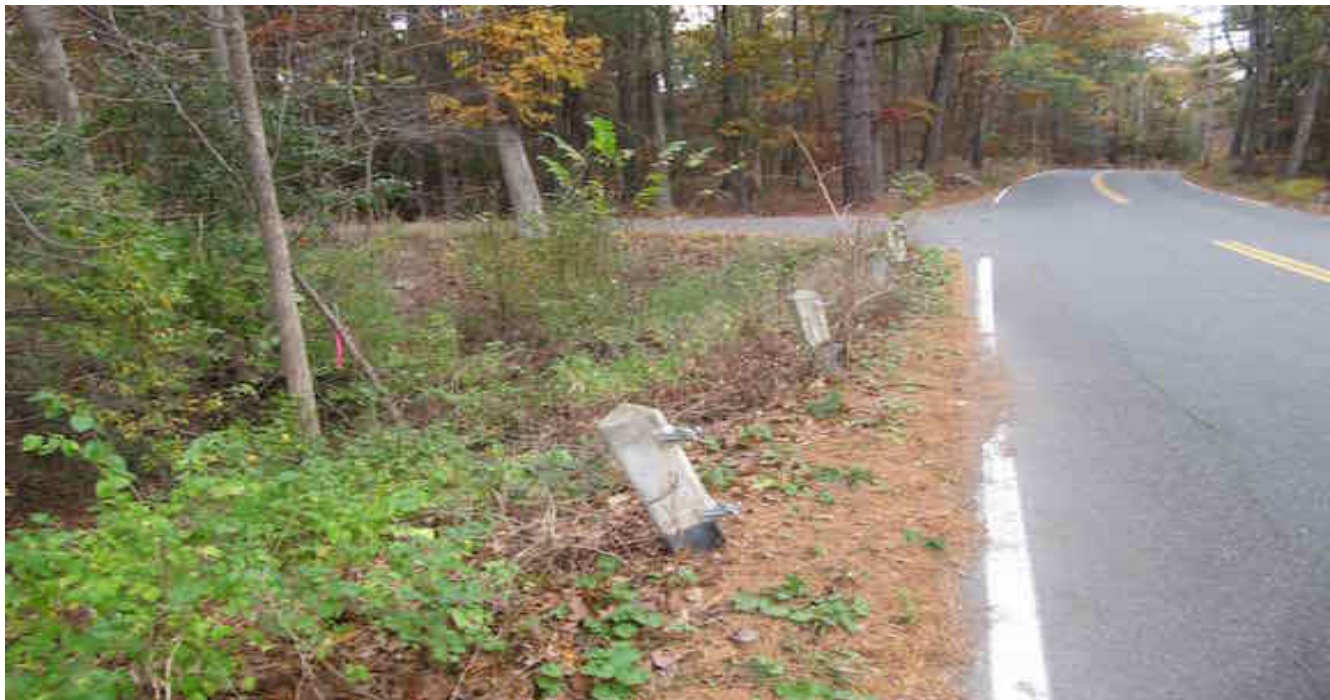
Photo A. Example of one of the eight guardrails proposed for repair and replacement. This particular guardrail is located on the western side of Georgetown Road just south of Hillside Road. The wetland with the “G” labeled flags lies at the road toe-of-slope. Photo taken by B. Prokop on 11/05/17.

The Boxford DPW plans to replace 8 degraded or failing guardrails along the southern end of Georgetown Road just north of Ipswich Road (see Photo A). This work is proposed for the Fall of 2018. Eight sections of guardrail would be replaced. The locations of these guardrails are shown on Figure 1. Bordering Vegetated Wetlands (BVW) lie below the guardrails at the road toe of slope at 7 of the 8 locations.

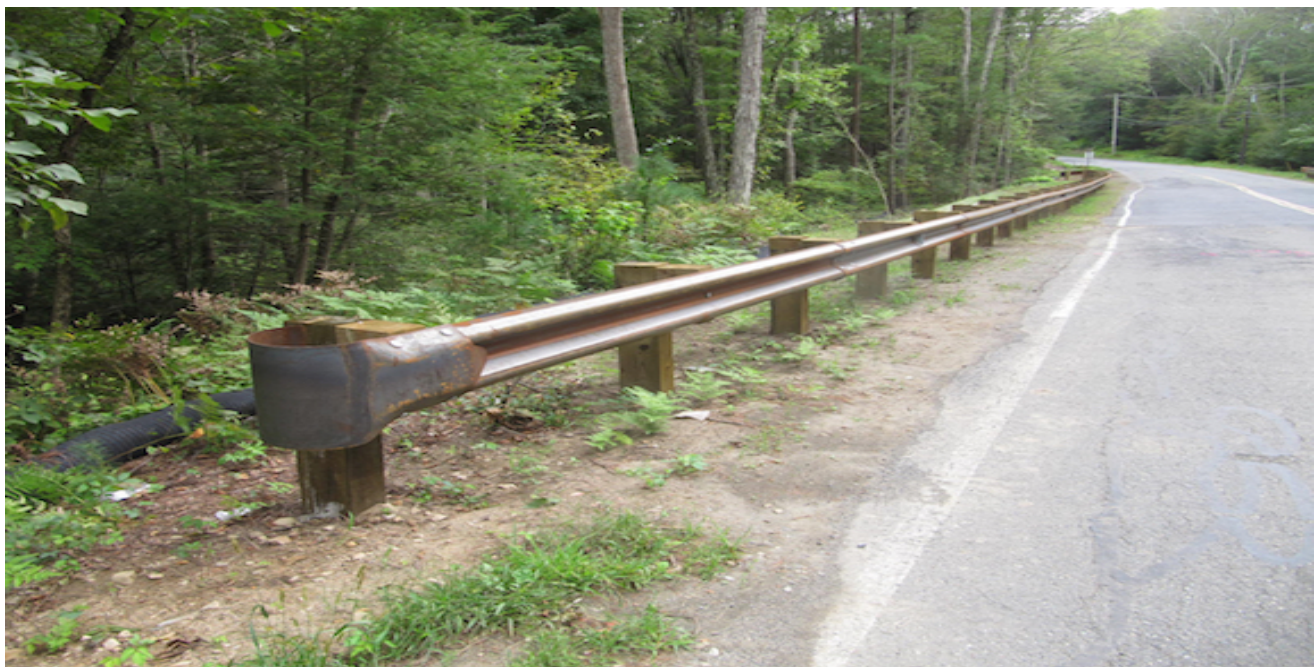
Photo B-1. Example of guardrail with pressure treated post. Guradrail installed off Middleton Road. Photo taken by B. Prokop on 09.17.18.

The existing cable and concrete post guardrails would be replaced with cortten steel rails with pressure treated posts. The rails would be tinted to maintain a rural character (see Photo B-1). Where bordering slopes are excessively steep, pressure treated posts would be replaced with tinted cortten steel I-beam posts (see Photo B-2). The contractor would decide which posts are most appropriate for each site. Posts would be pile driven into the ground. No wetland impacts are proposed, but some herb and shrub vegetation clearing is likely where the old guardrails are removed and the new guardrails would be installed. No erosion control is proposed since this installation would require unnecessary vegetation clearing and ground disturbance on very steep slopes.

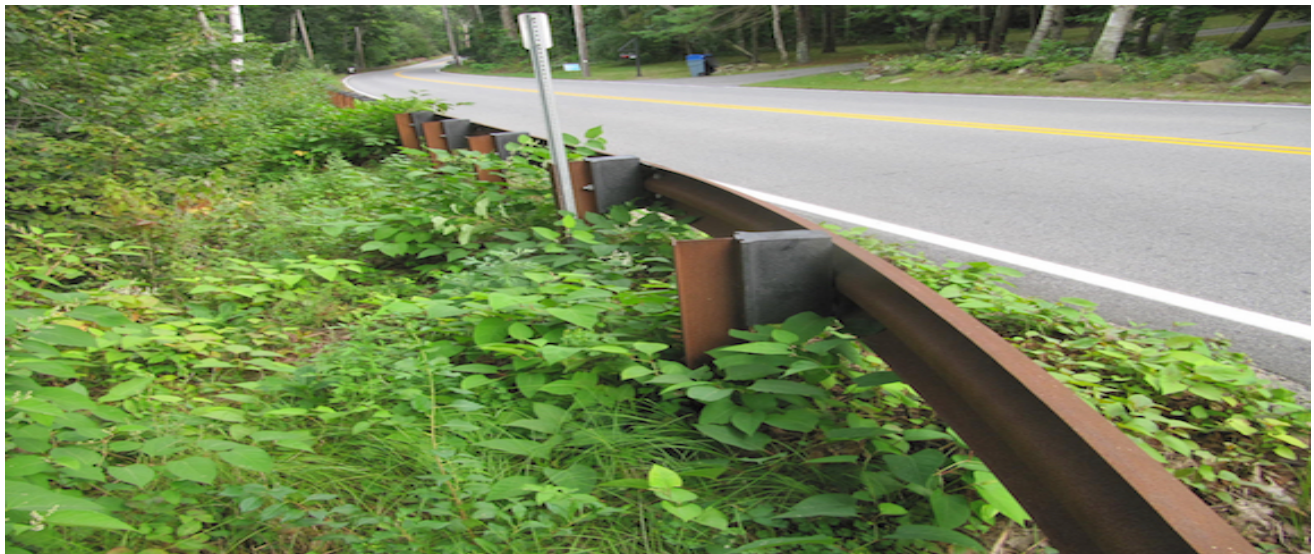
Photo B-2. Example of guardrail with corttel I-beam posts. Photo taken by B. Prokop on 09.17.18.

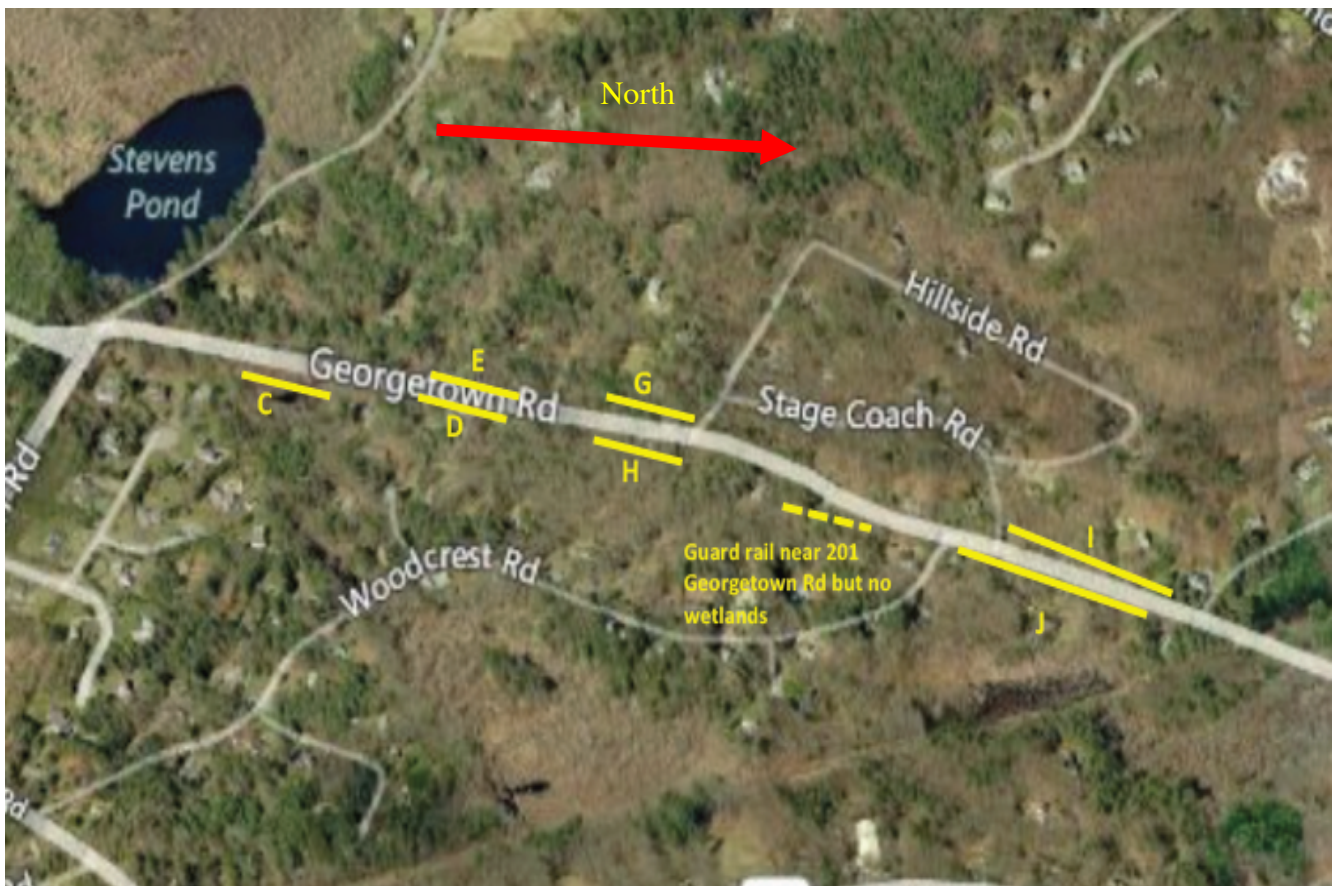
Figure 1. Georgetown Road just north of Ipswich Road where 8 guardrails are proposed for replacement. The various flagged wetlands (in letters) located below the guardrails are also shown.

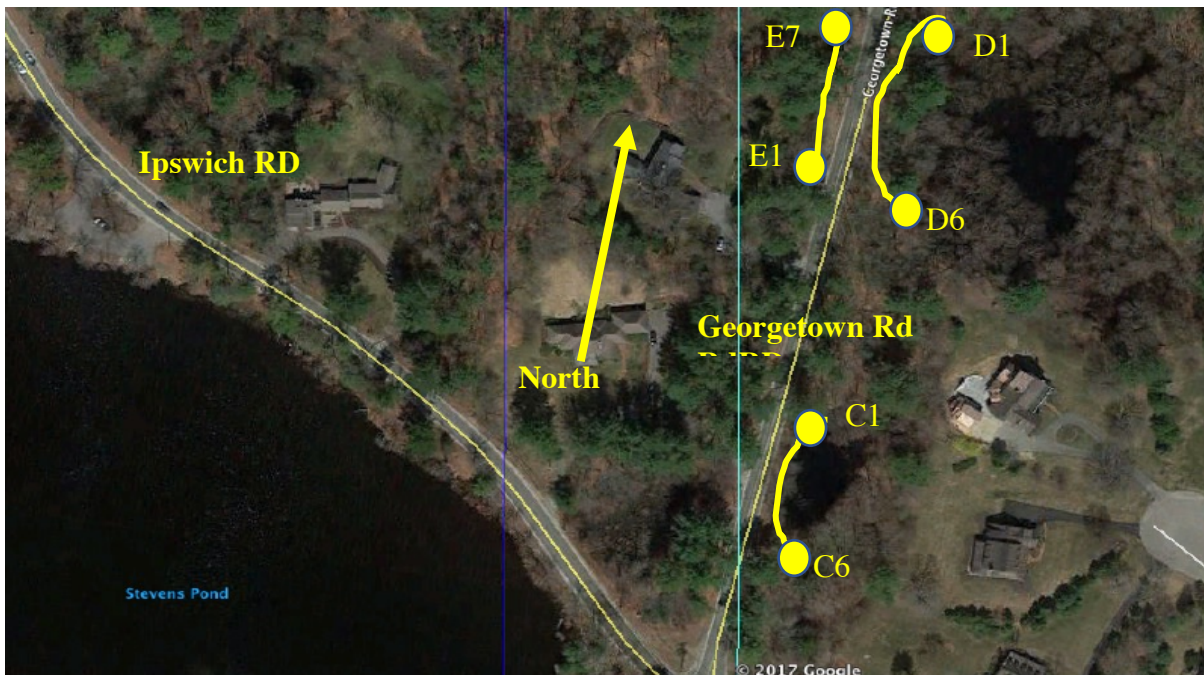
Figure 3. Sketch of wetlands C, D and E in relation to the other delineated wetlands.

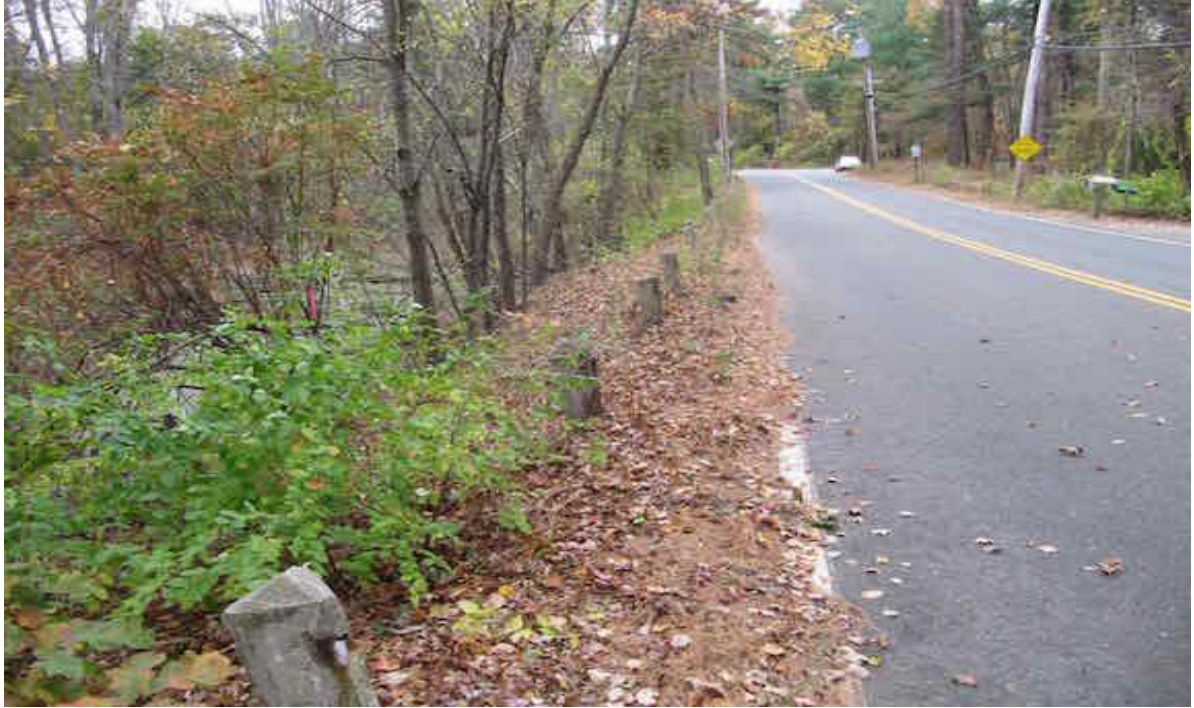
Photo C-1. Southerly view of guardrail adjacent to wetland C. Photo by B. Prokop 11/5/17.

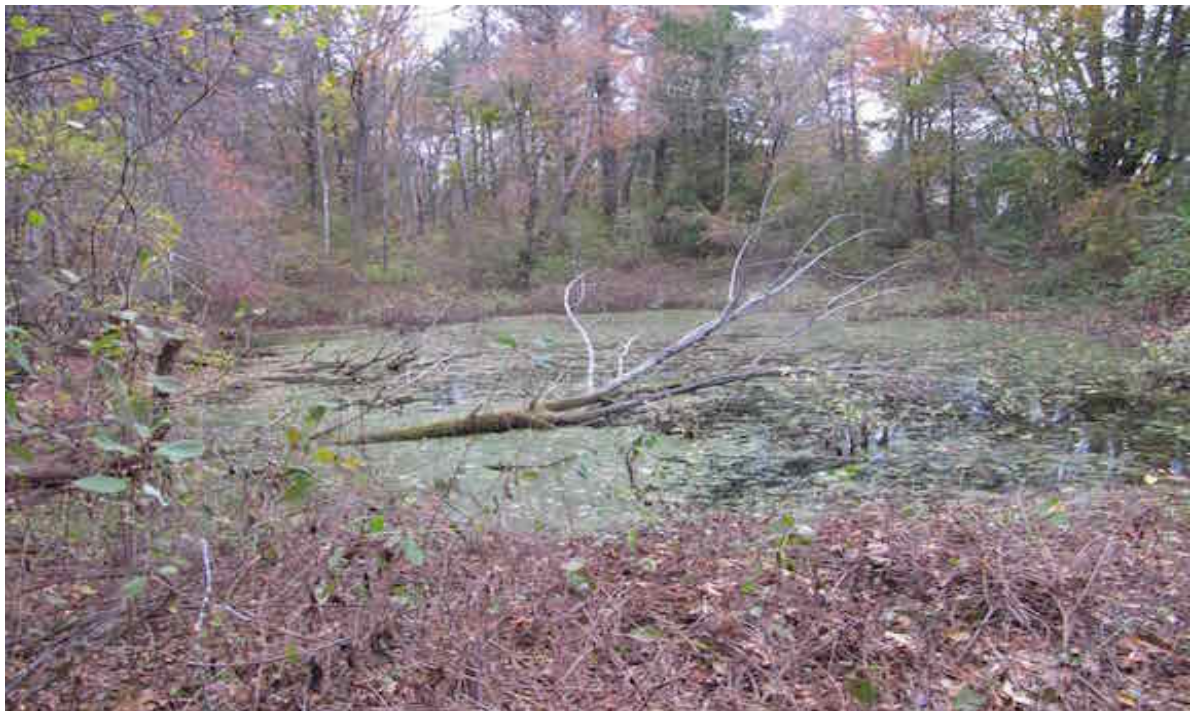
Photo C-2. Vernal pool located approximately 40 ft from guardrail at wetland C. Photo by B. Prokop 11/5/17.

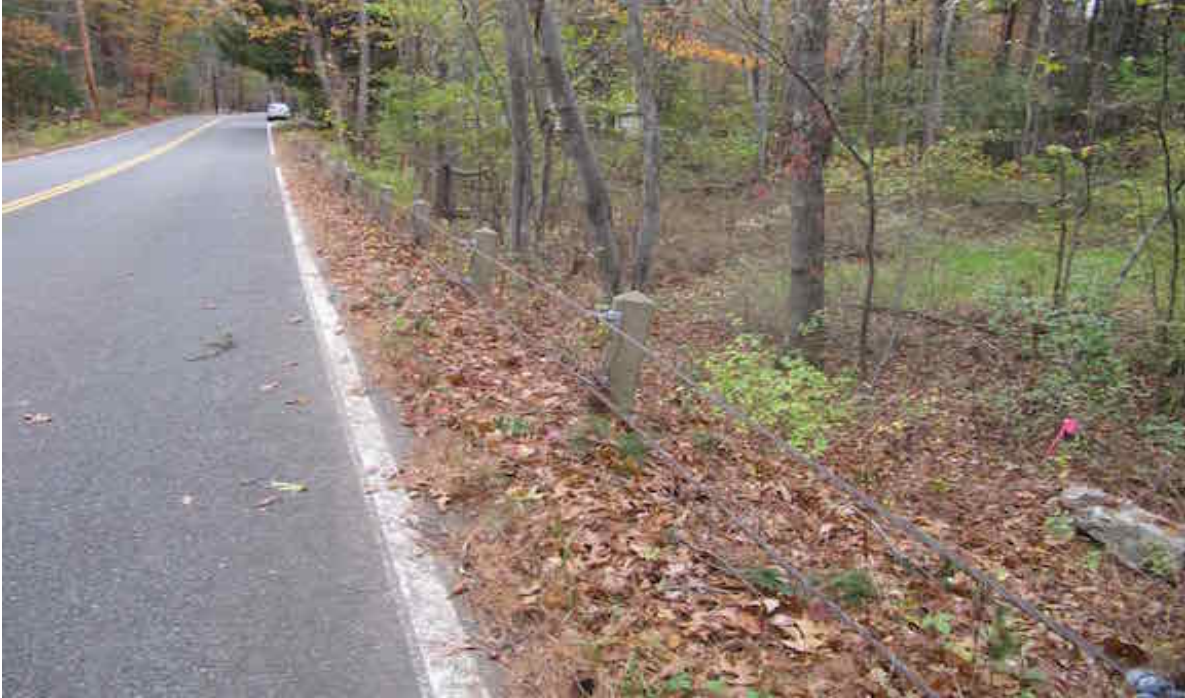
Photo D-1. Northerly view of guardrail adjacent to wetland D. Photo by B. Prokop 11/5/17.

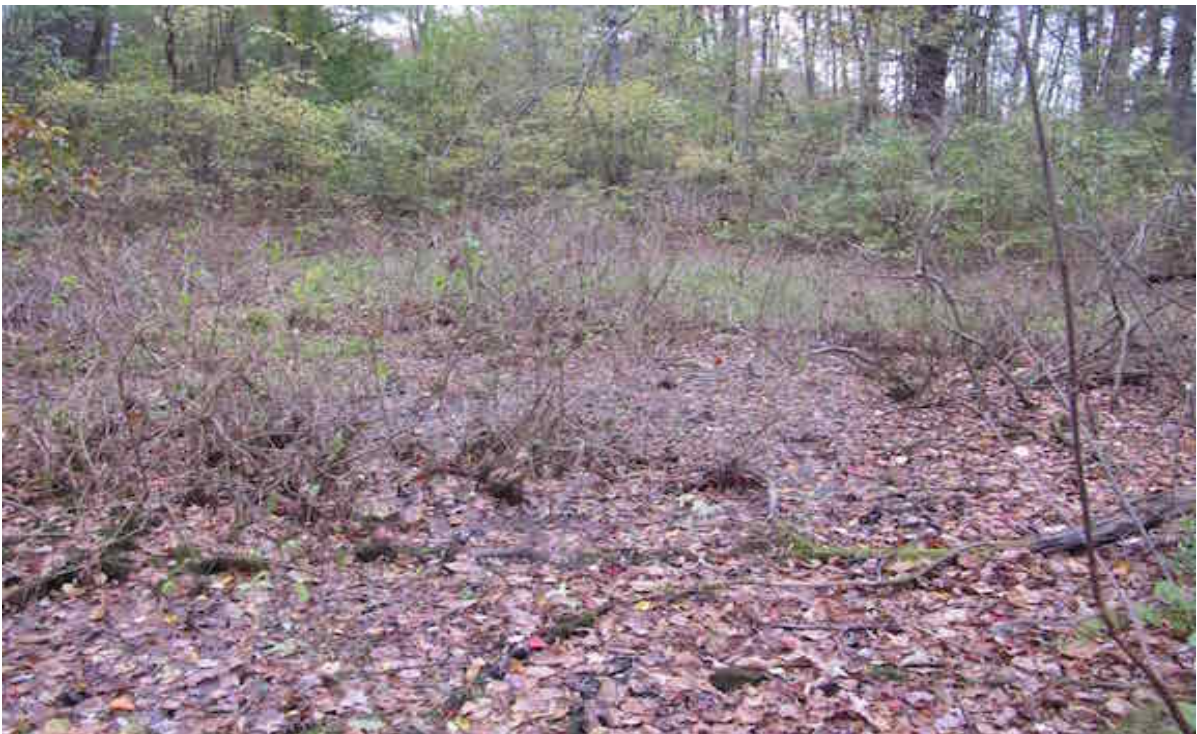
Photo D-2. Vernal pool located approximately 30 ft from guardrail by wetland D. Photo by B. Prokop 11/5/17.

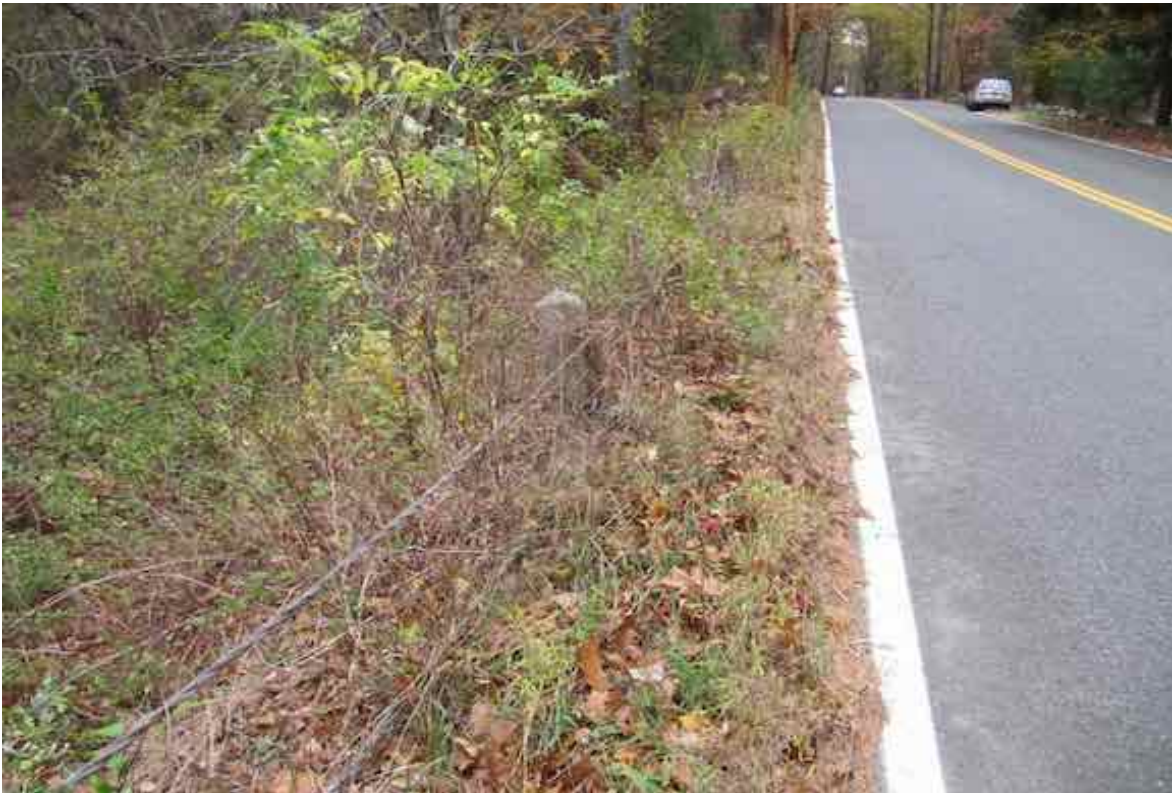
Photo E. Northerly view of guardrail adjacent to wetland E. Photo by B. Prokop 11/5/17.

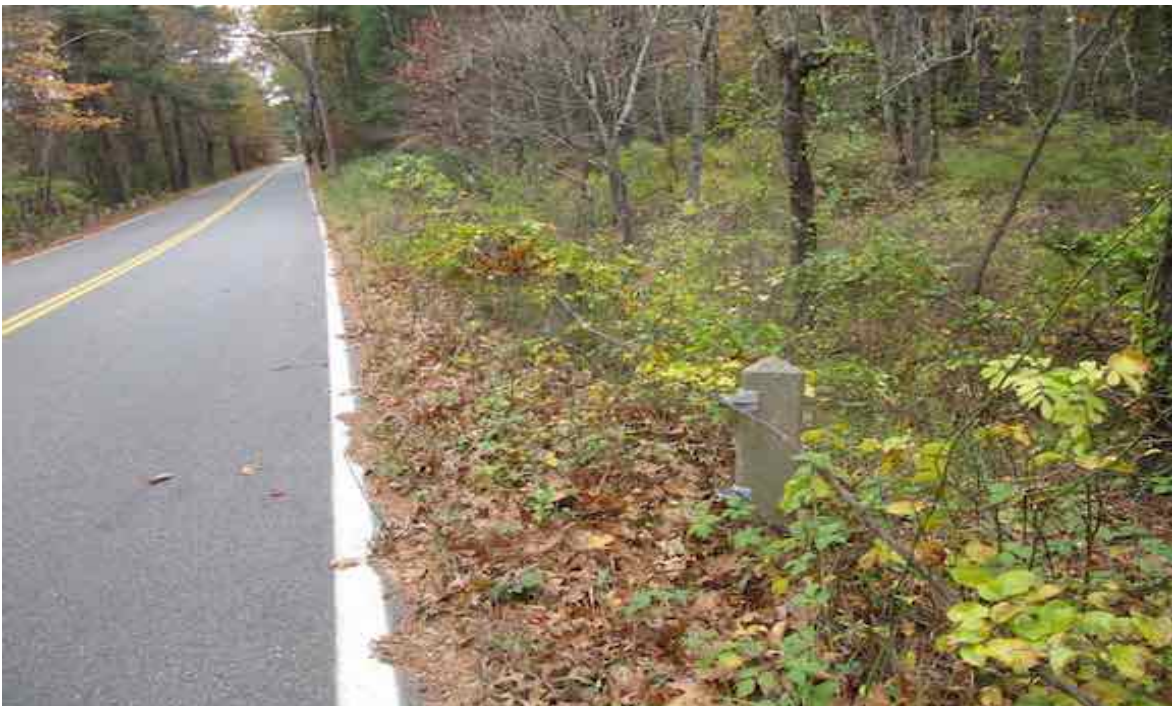
Photo G-1. Southerly view of guardrail adjacent to wetland G. Photo by B. Prokop 11/5/17.

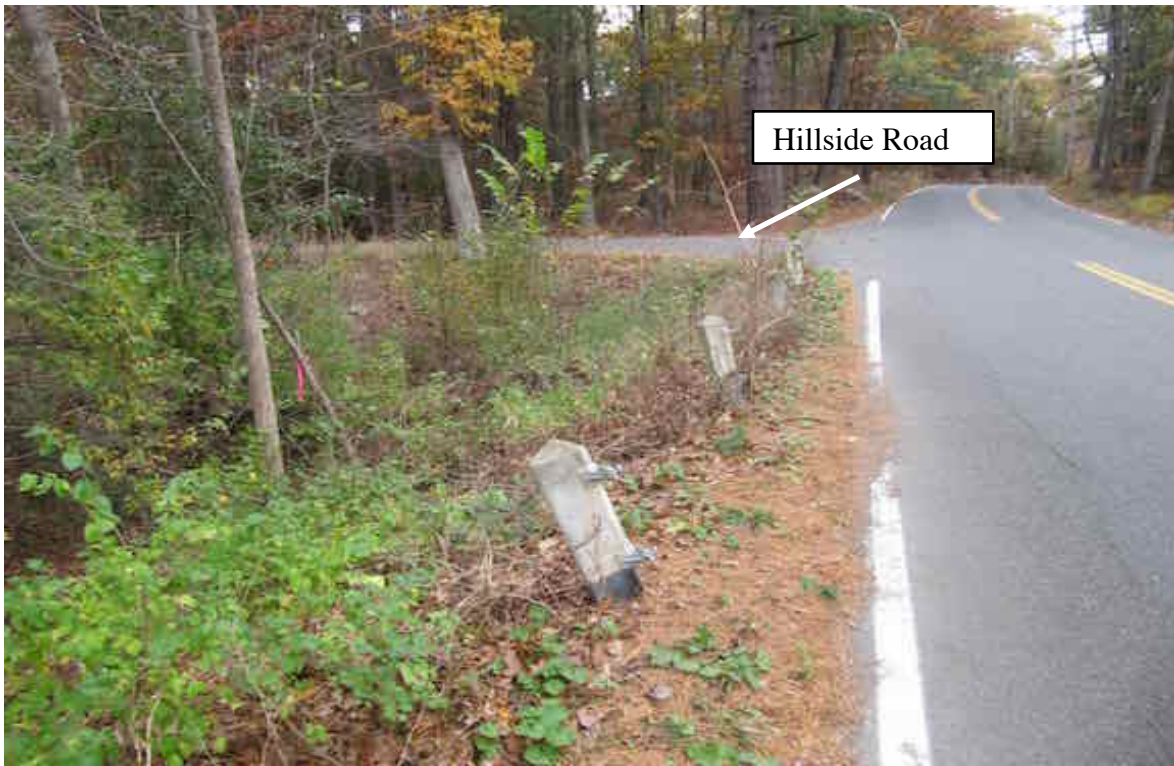
Photo G-2. Northerly view of guardrail adjacent to wetland G. Photo by B. Prokop 11/5/17.

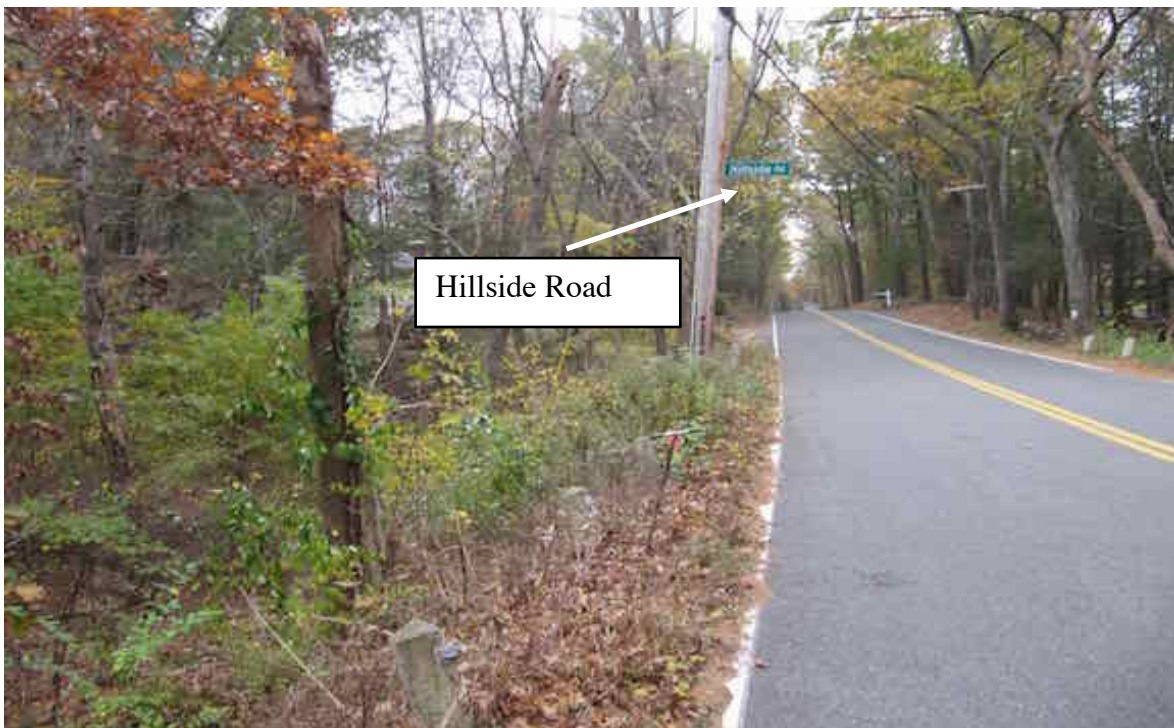
Photo H. Southerly view of guardrail adjacent to wetland H. Photo by B. Prokop 11/5/17.

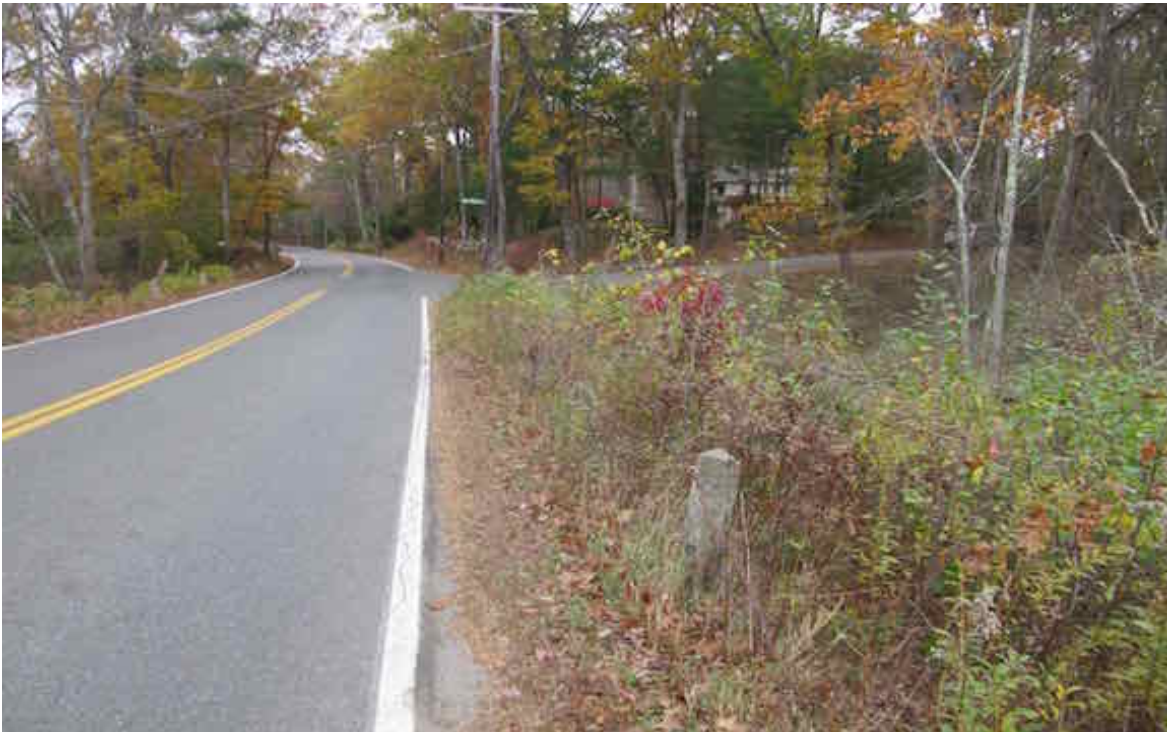
Photo I-1. Southerly view of guardrail adjacent to Wetland I. Photo by B. Prokop 11/5/17.

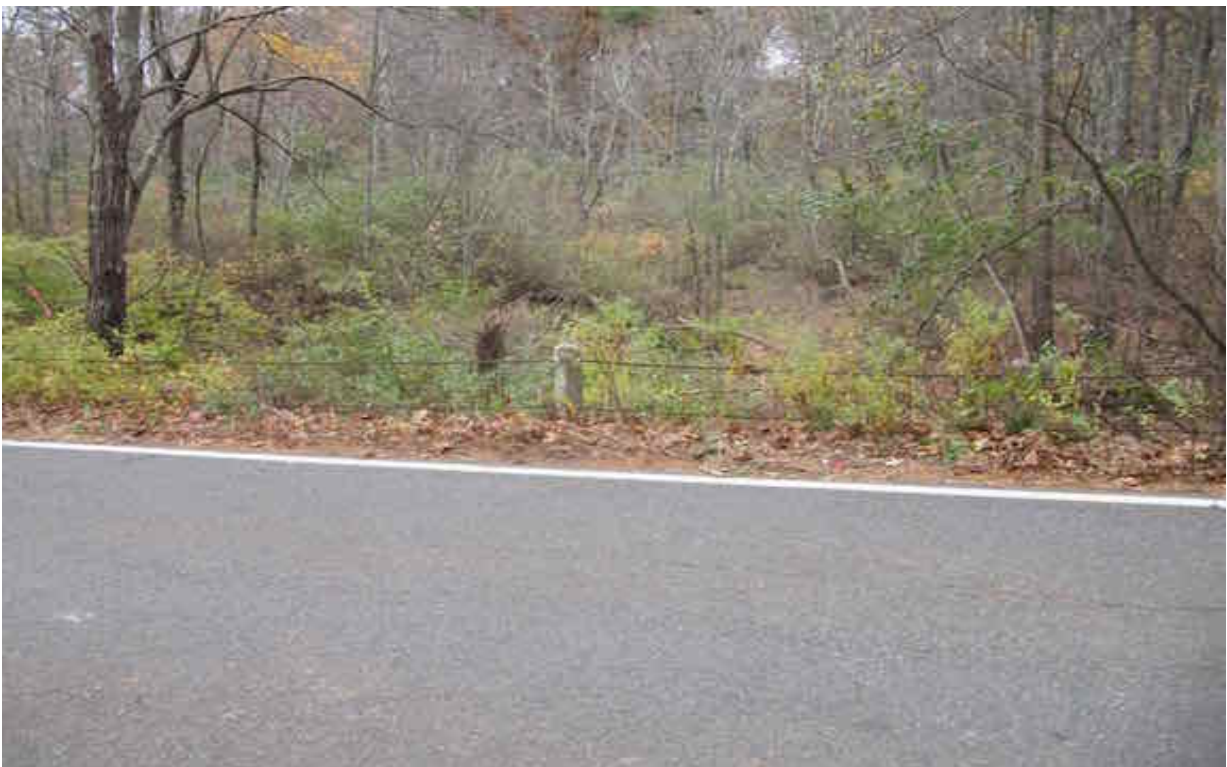
Photo I-2. View of guardrail adjacent to Wetland I. Photo by B. Prokop 11/5/17.

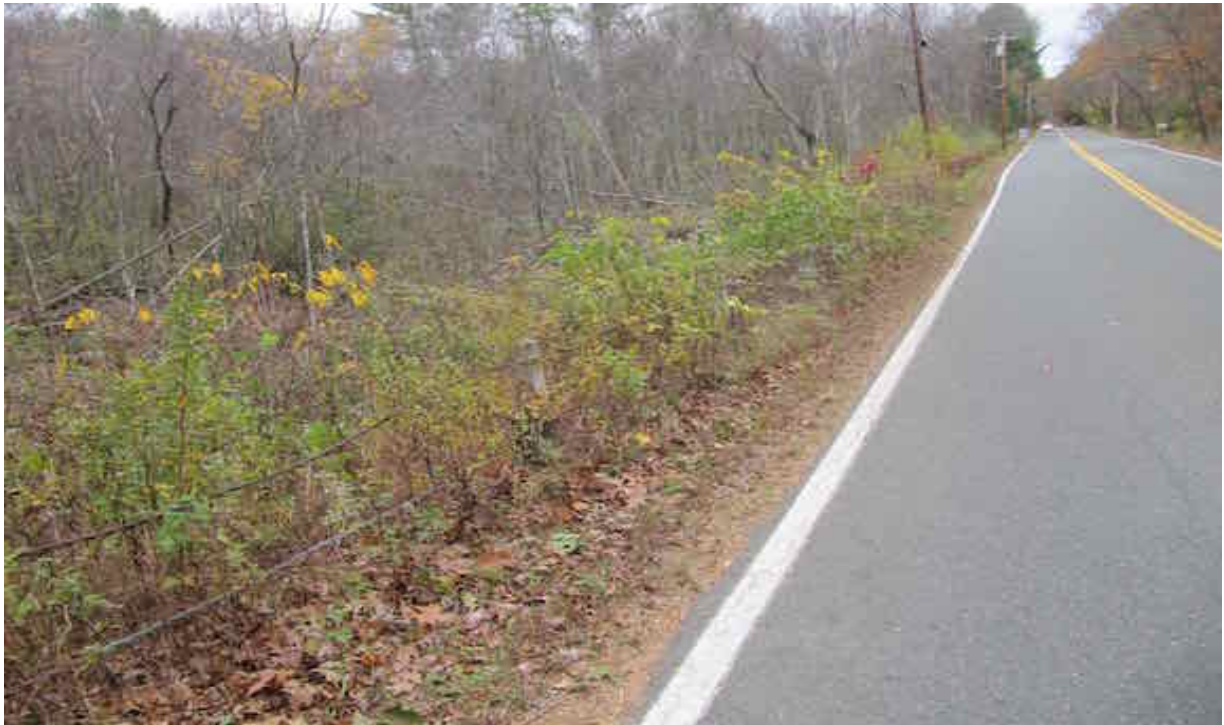
Photo J. Southerly view of guardrail adjacent to Wetland J. Photo by B. Prokop 11/5/17.

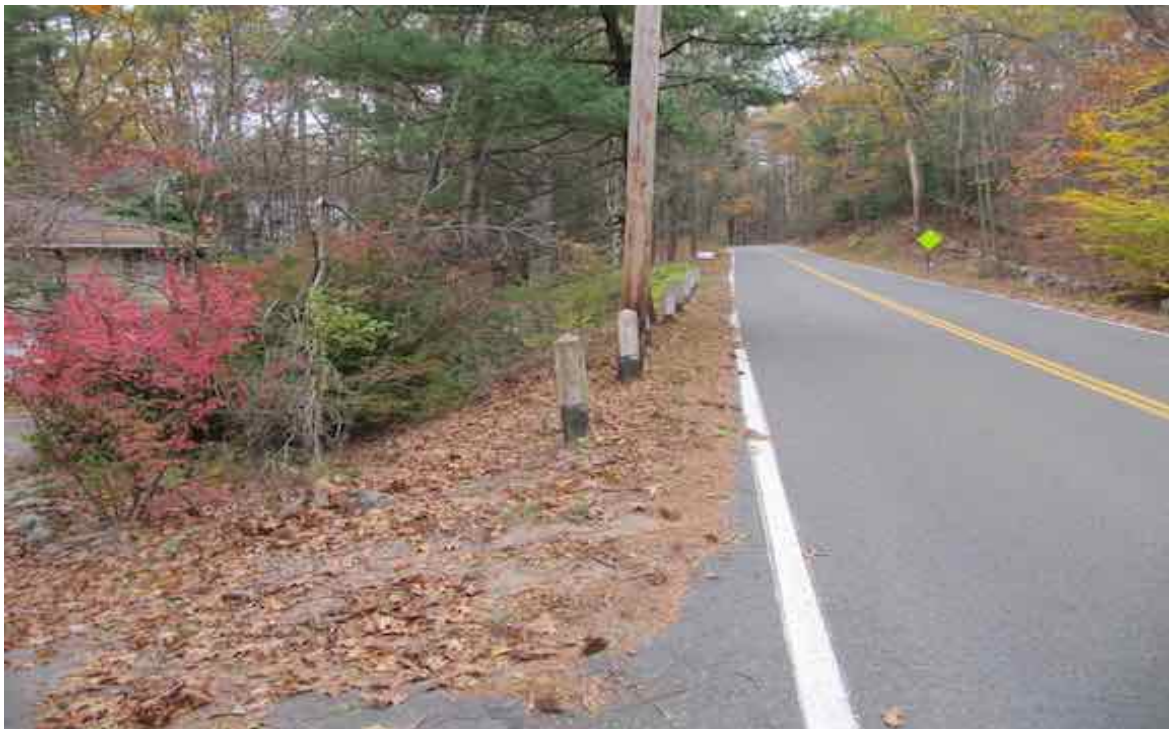
Photo K. Southerly view of guardrail adjacent to 201 Georgetown Road. No wetlands exist near this guardrail. Photo by B. Prokop 11/5/17.
