HARRIMAN
Architects + Engineers

Town of Boxford Facility Master Plan

September 18, 2018

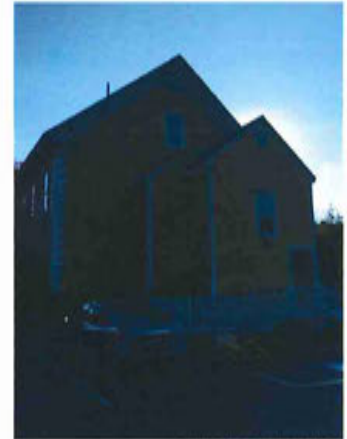
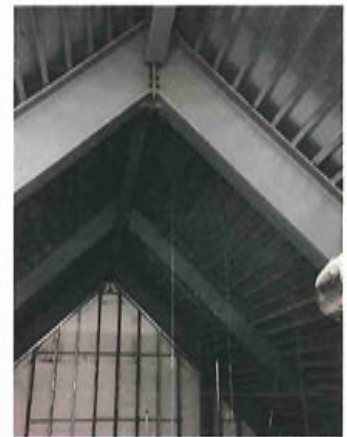
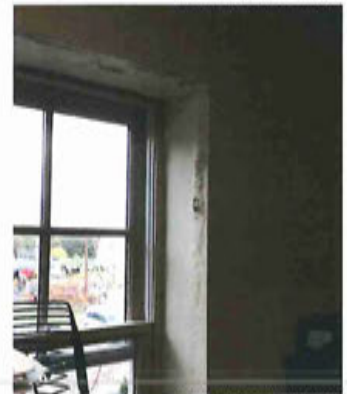
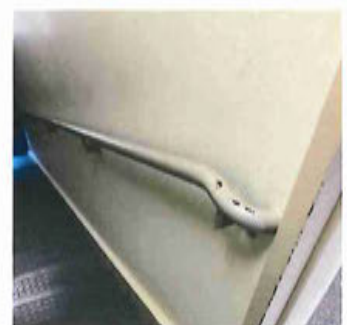
TOWN HALL

The facility, which was constructed in 2004, is two full stories plus a composition of steep pitched roof that houses the building's mechanical systems. During the time of the assessment, the building was being actively modified to consolidate Town Hall function and add square footage for the Boxford Library. Most materials are in good condition with the exception of steel doors and lintels which have a high level of corrosion.

Building systems have been replaced since construction and environmental controls are deficient due to poor functionality of the mechanical system.

Site	Contaminated soils nearby limit potential additions to this building.
Structural	Minor rusting at bolted connections in the attic was observed. Noteworthy rusting at most exterior steel lintels was observed.
Building Envelope	Extensive staining was observed. Masonry facade and cladding are noted in poor condition due to evidence of staining from unknown sources. Significant water infiltration was observed on interior sides of exterior windows, especially on north facade. Rust and corrosion was observed on many exterior metal surfaces including lintels, doors and frames. Rot was observed at wood fascia locations.
Building Interior	ACT ceiling is water stained in several locations. The building interior, is in good condition except at GWB window return locations which are heavily water damaged.
Life Safety	No significant issues or needs were observed for this category.
ADA	Door clearance and railing extension issues were observed.

Mechanical	HVAC system has area control issues due to lack of/or removal of adjustable flow capabilities (VFD). The system is operational but is very inefficient. Some air handlers were observed to have been replaced since the building's construction in 2004. Maintenance of HVAC equipment appears to be good. Most major mechanical systems are located in the attic /mechanical mezzanine with access limited to a service ladder.
Plumbing	Building plumbing is in good condition.
Electrical	Several fluorescent lighting fixtures were observed to require re-lamping or repair/replacement.

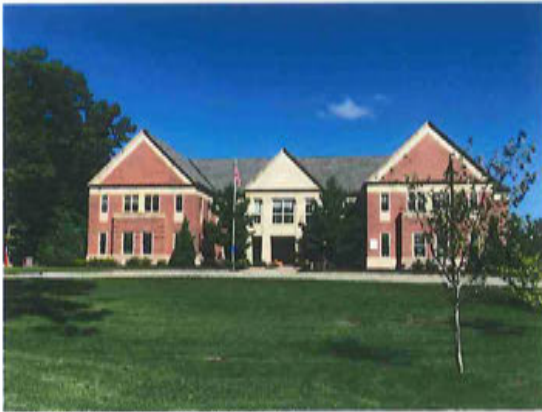
BUILDING EXTERIOR / MAIN ENTRY

Address	7A Spofford Road
Year Constructed	2004
Use	Municipal
Building GSF	14,352
Number of Floors	2 (1, 2, Mechanical Mezzanine)
Construction type	Steel with masonry veneer
Average rating (scale of 0-5)	2.92
Overall Condition Rating	Fair - Good (2.9/5)

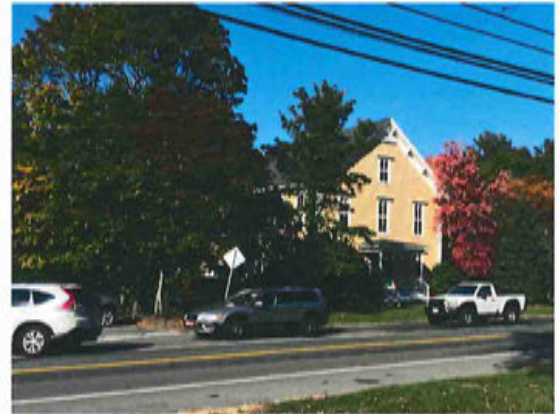
BUILDING EXTERIOR / MAIN ENTRY

Address	4 Middleton Road
Year Constructed	1890
Use	Municipal
Building GSF	3,000
Number of Floors	(B, 1, 2, Mezzanine)
Construction type	Wood and heavy timber
Average rating (scale of 0-5)	2.45
Overall Condition Rating	Fair - Good (2.5/5)

The facility has been reasonably well maintained, although its age and historic architectural character have made it difficult to update to current codes. Substantial work should be done to renovate or replace the building's addition to better accommodate accessible access, internal building circulation, and infrastructure such as toilet rooms and kitchen.

Site	Access through the original front and side entrances is limited and visitors must enter the building from the rear parking lot.
Structural	Steel lally columns on concrete footings were observed throughout the basement. Typical structure is timber and rough cut joists. Roof structure was not observable.
Building Envelope	Siding and trim appeared to contain original material which would require careful restoration for replacement. Corner areas of siding and trim are in good condition. Exposed granite block and fieldstone foundation is in good condition.
Building Interior	Doors are categorized as poor because there is very little accessible hardware. Condition of finishes varies from space to space but a complete upgrade in finishes is recommended for any future renovation work. Stage on 2nd floor is only accessible by stair.
Life Safety	Building is not sprinklered, but has fair to good early detection and exit signage. Assembly space on second floor has 2 means of egress but would not be difficult to navigate in an emergency exiting situation. Stairways require railing and guardrail upgrades to meet current codes. Emergency lighting is old but in fair condition.

ADA	Current LULA Lift is old and lacks many current safety features such as gates and automated controls. Improvements to toilet room accessories are required. Stage is only accessible by stair.
Mechanical	The building has no ventilation. Kitchen and pantry areas require upgrades in exhaust ventilation.
Plumbing	Plumbing fixtures are older and do not meet ADA requirements.
Electrical	Electrical systems are generally in good condition with the exception of limited lighting controls.

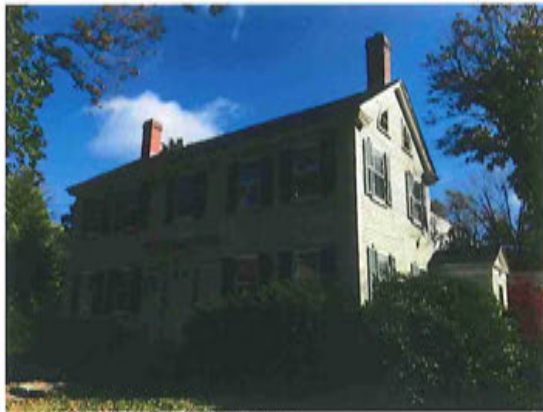
BUILDING EXTERIOR / MAIN ENTRY

Address	10 Elm Street
Year Constructed	1841
Use	Municipal
Building GSF	1,500
Number of Floors	2
Construction type	Wood
Average rating (scale of 0-5)	2.48
Overall Condition Rating	Fair - Good (2.5/5)

The Cummings House, located in the center of Boxford's East Village was constructed in 1841 and has an area of roughly 1,500 gross square feet (GSF). It is a building of historic significance that is in need of restorative repair. Deferred maintenance items such as exterior trim are necessary to ensure the building's historic character remains solvent.

Site	Existing library addition is to be demolished by the Town. The free standing barn and water well, located in the 'Pony Field', need to be considered in any potential development of the site.
Structural	No significant issues or needs were observed for this category.
Building Envelope	Extensive rot was observed at many wood trim and siding locations. Any work to the building will require approval by the Town's Historic Commission. Chimneys were observed to require repointing, as well as replacement/repair of broken window panes
Building Interior	Interior finishes are not original or historic and should be removed, if possible, to reveal any remaining original construction. Accessibility upgrades are required regardless of future municipal use.
Life Safety	Life safety is limited given the age and character of the building. The building is not sprinklered, but early detection is in good condition. The fire alarm panel will need to be relocated when the library addition is demolished.

ADA	When a use for the original house is determined, ADA access will need to be integrated into any renovation plans.
Mechanical	There is no mechanical ventilation or air conditioning. The hot air furnace should be evaluated during the design of the future addition.
Plumbing	Plumbing is limited to a kitchenette on the second floor.
Electrical	No significant issues or needs were observed for this category.

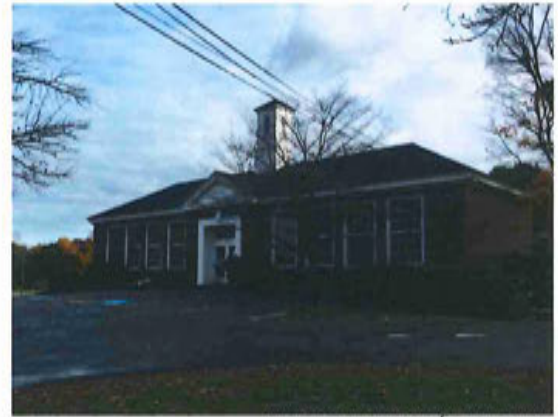
BUILDING EXTERIOR / MAIN ENTRY

Address	188 Washington Street
Year Constructed	1926
Use	Municipal
Building GSF	2,500
Number of Floors	2 (Basement, 1)
Construction type	Masonry
Average rating (scale of 0-5)	2.45
Overall Condition Rating	Fair - Good (2.5 / 5)

The Morse School building, was constructed in 1926 and has an area of roughly 2,500 gross square feet (GSF). It is located in West Boxford and is currently utilized as a storage facility for the Boxford Library. Access to the building is limited to a marginal condition at the front entry with no means of handicap access from the ground level to the basement. There is a back door that opens at grade from the landing level between the building's 2 floors. The basement also contains a second exit stair leading up roughly 5 feet to grade.

The masonry structure is in good condition. Interior finishes are generally in poor to fair condition and require replacement. The masonry construction will create complications for any future modifications.

ADA	See plumbing comments. There is no elevator or lift.
Mechanical	The building has no mechanical ventilation and limited air conditioning which consists of several window A/C units. The boiler is efficient, but old and should be replaced with a more modern system.
Plumbing	Fixtures are very old and generally do not meet ADA requirements. Steam pipe insulation in stairwell corridor appears to be asbestos
Electrical	Electrical systems including junction boxes, wiring and lighting are old and need to be improved or replaced.
Misc.	Building uses a cesspool which is located at the southwest corner of the larger building footprint. Construction of a septic system would be required for any new building program in coordination with adjacent wetland restrictions.

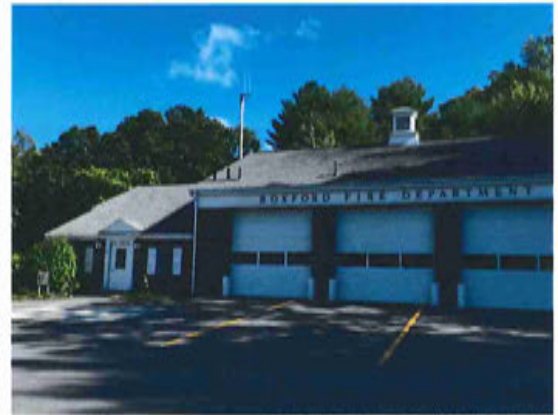
BUILDING EXTERIOR / MAIN ENTRY

Site	Site size prohibits expansion of needed program areas.
Structural	No significant issues or needs were observed for this category.
Building Envelope	No significant issues or needs were observed for this category. Painted wood soffits are in need of repair. The roof was not observed during this review. The masonry furnace chimney requires pointing.
Building Interior	Finishes are older but generally in fair condition. Rusting was observed on several interior doors.
Life Safety	The building has limited life safety systems. The recently renovated mezzanine is limited to 1 means of egress.
ADA	Toilet fixtures and accessories need to be ADA requirements.
Mechanical	The building has relatively new boilers but no mechanical ventilation beyond the apparatus bay.
Plumbing	No significant issues or needs were observed for this category.
Electrical	Electrical systems are older but no major issues were identified.

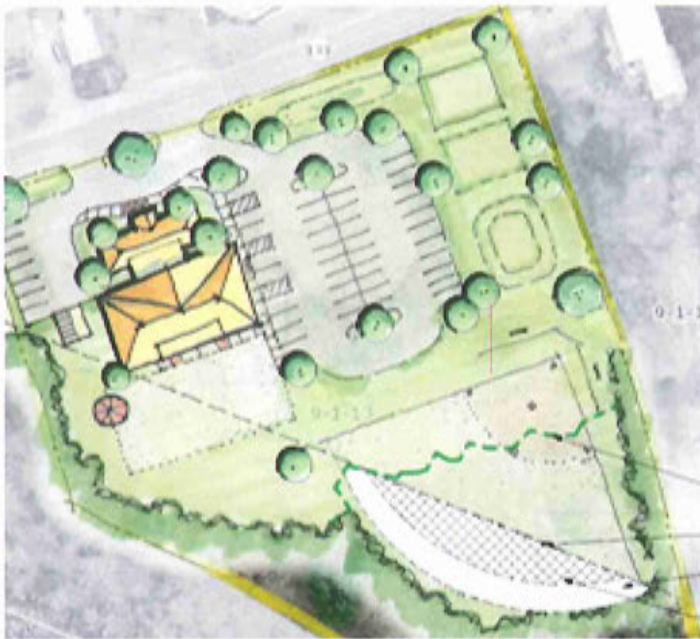
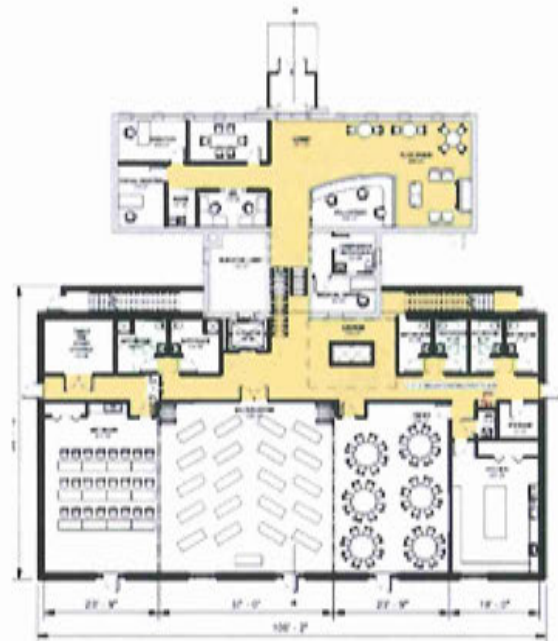
COA at 188 Washington Street Alternative Option 4: Site sketch and floor plan layout.

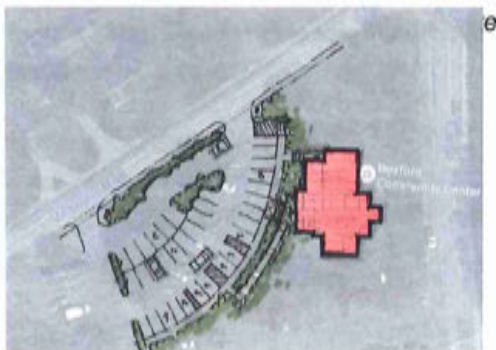
Alternative 3: Site sketch and floor plan layout

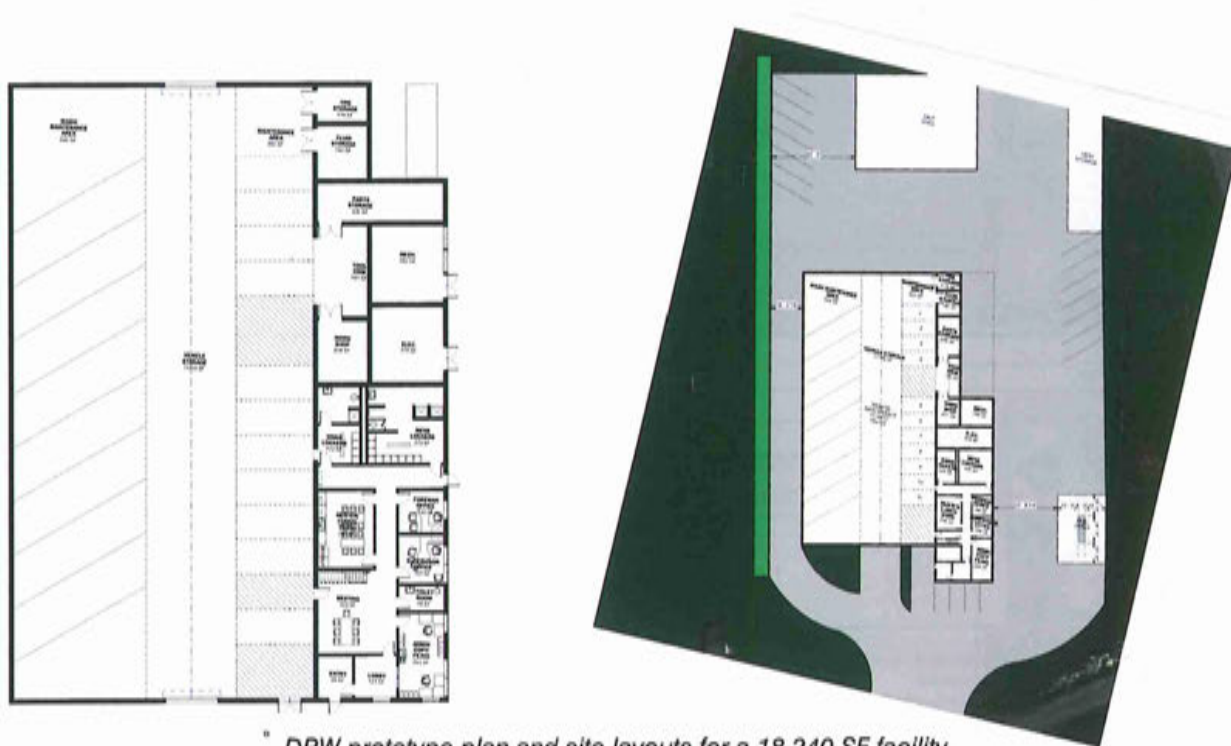
** DPW prototype plan and site layouts for a 18,240 SF facility.*

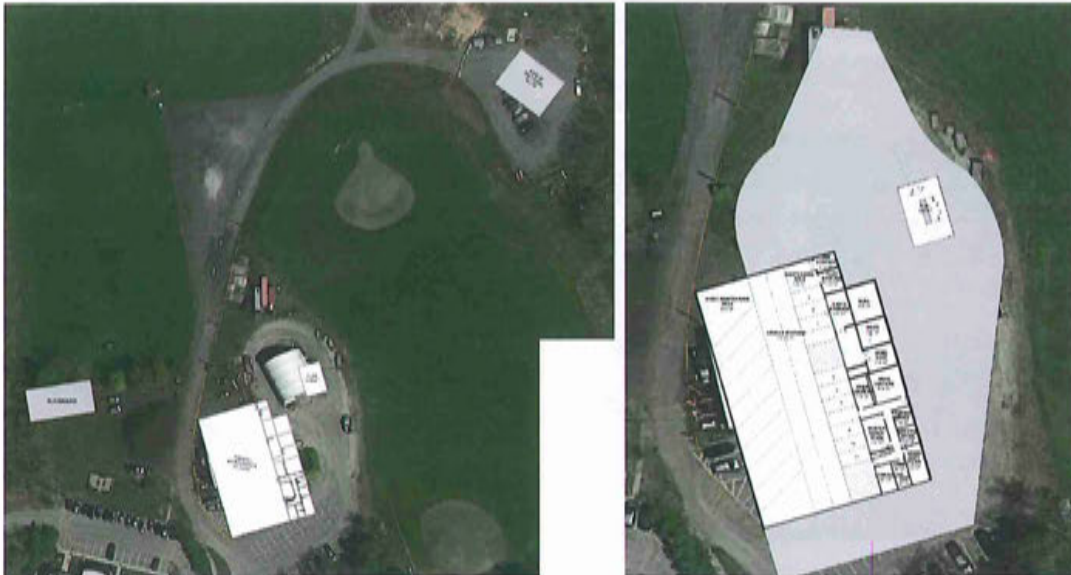
DPW Option 1: Replace in-place. Site blocking sketch and floor plan layout show lack of space on the site for salt barn, visitor/staff parking, and vehicle movements.

Option 1, replace in-place did not contain the area required to meet the program requirements listed above. As the site plan depicts, a new building and fuel island barely fit with not enough room for the salt barn, yard storage, or vehicle circulation. Expansion to accommodate the balance of required program would result in taking one of the Johnson Fields which is problematic as this is a capped landfill and cannot be breached. In addition, replace in-place displaces the current DPW operations for the during construction. These factors, along with the risk of building on the closed landfill site, were presented to the Task Force and Option 1 was decided to be a nonviable option.

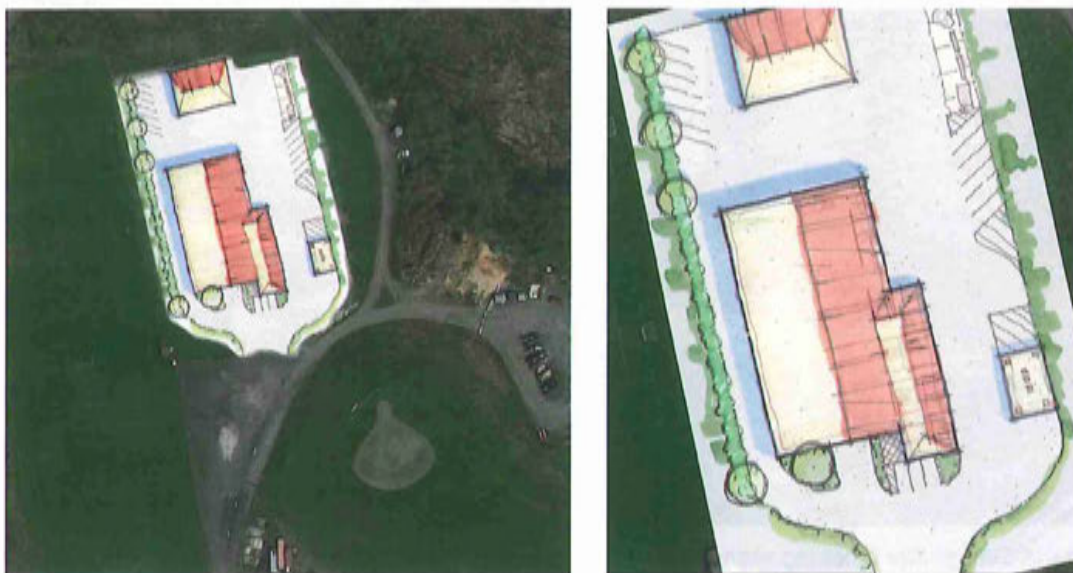
DPW Option 2: Chadwick 3 recreation field: Site blocking sketch shows appropriate area for all program requirements.

Option 2, Chadwick 3 site provided a convenient location for the DPW and enough area to support a new facility. However development would displace a currently used playing field that contains roughly a twenty foot depth of clay soils. Given the soil conditions require expensive and complicated foundation systems, Option 2 was decided to be a nonviable option.

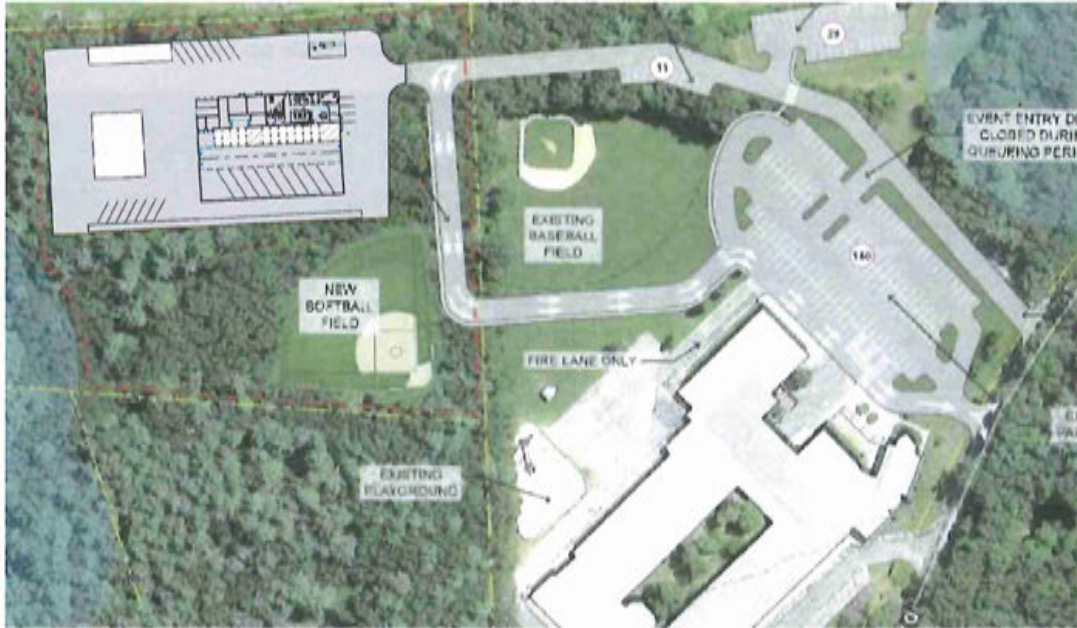
Option 3, Area 4: Site blocking sketch shows appropriate area for all program requirements and DPW site access connected to the Spofford Pond School. Alternative site access would connect to the DPW from the top left corner of the diagram above.

Option 3, Area 4 site was explored in previous studies as an area that had good development potential. The area was suitable for a new DPW although access was determined to be unacceptable. One option was to connect the DPW entrance to the Spofford Pond School parking lot and was unpopular for school safety concerns. Other access options created the longest access drive of all the DPW alternatives. Option 3 was decided to be a nonviable option.

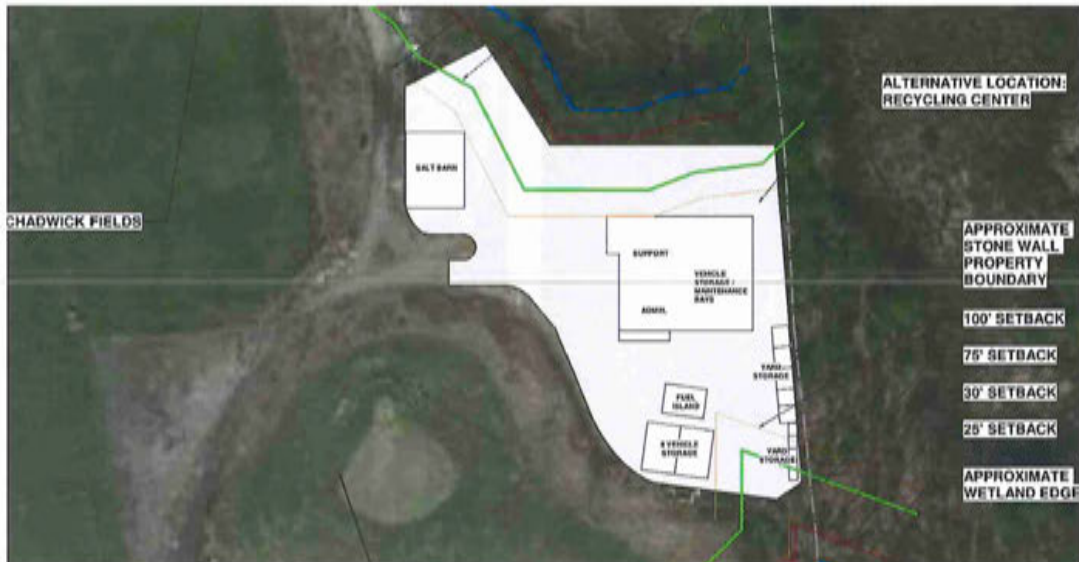
Option 4, Recycle Center: Site blocking sketch shows site layout constraints from the adjacent Johnson Field (lower-middle) and wetland setback boundaries which are depicted by red, orange, and green lines. These constraints forced an awkward layout that results in poor site circulation.

Option 4, recycle center site emerged as a compromise between Site 1 and replace in-place but it did not yield enough area to be a viable option.

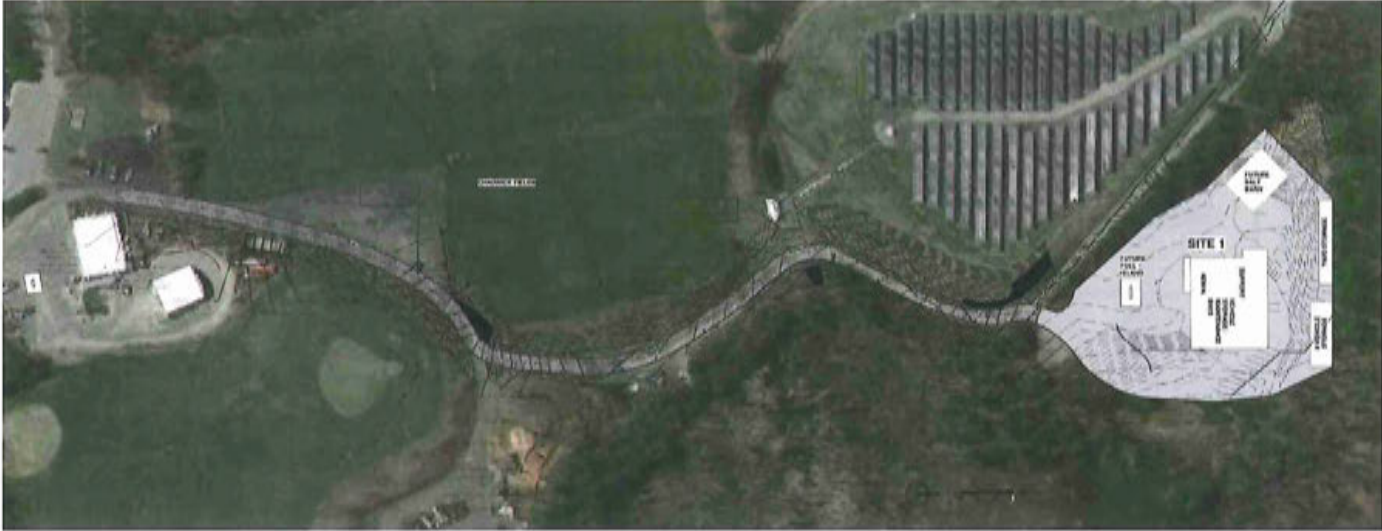
Option 5, Site 1: Site blocking and access drive diagram show appropriate area for all program requirements and DPW site access.

Option 5, Site 1 was the location of a previous study for DPW development. There was concern about the cost of developing the access drive past a capped landfill and wetland edge. Additional survey, geotechnical, and civil design work was performed to clarify an OoM cost for the access drive and facility development at Site 1. This option emerged as the most viable alternative.

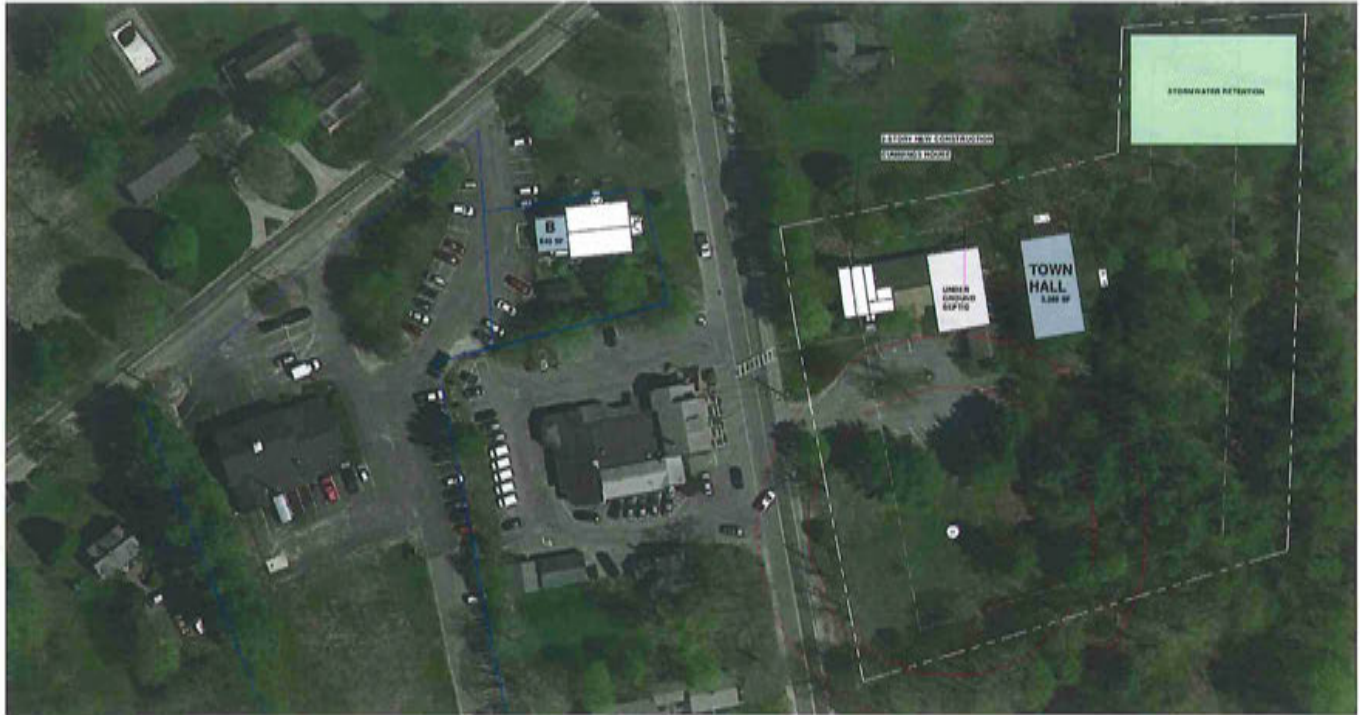
Option 1 develops a new, 7,750 SF two-story building behind the Cummings House at 10 Elm Street. The proposed footprint is a stand-alone facility not connected to the Cummings House. This option assumed that the Library would occupy the entire building at 7A Spofford Road, dislocating the existing Town Office program. The 10 Elm Street deed restriction was still in place when the Town Hall alternatives were being considered.

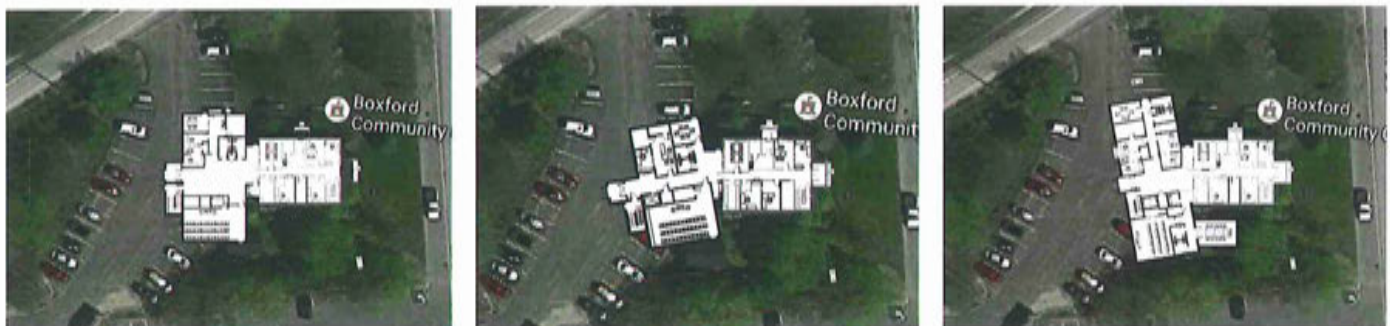
Town Hall Option 2: 4 Middleton Road multiple site blocking diagrams.

Option 2 assumes the COA temporarily moves to 188 Washington Street and develops the current Community Center building at 4 Middleton Road. The proposed facility includes 3,370 SF of renovated space and 4,838 SF of addition. The addition footprint extends off the back side of the existing building into the current parking lot. Three alternatives were created for Option 2 to understand how different addition shapes would affect the compact site. Site diagrams and floor plan layouts were created for each alternative.

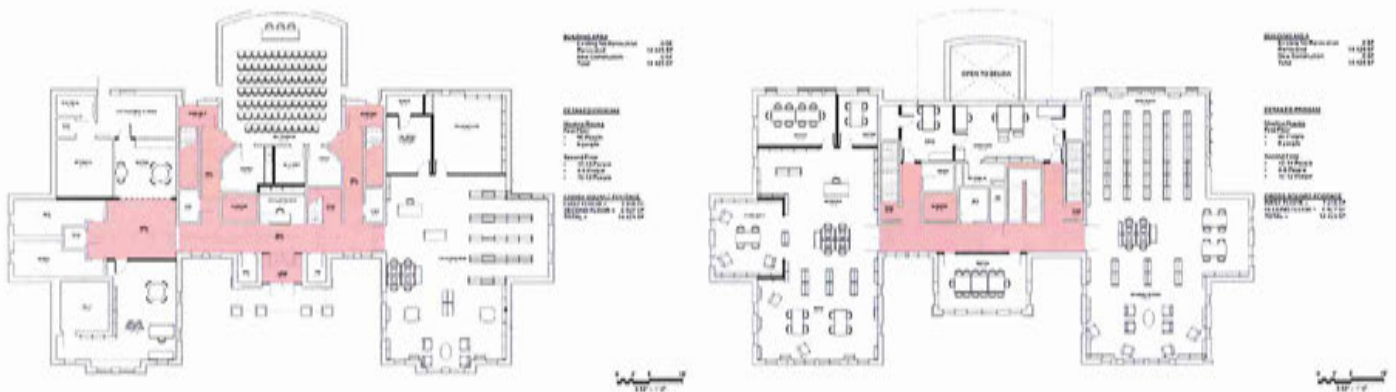
Library Option 1: renovation only lower and upper floor plan layouts

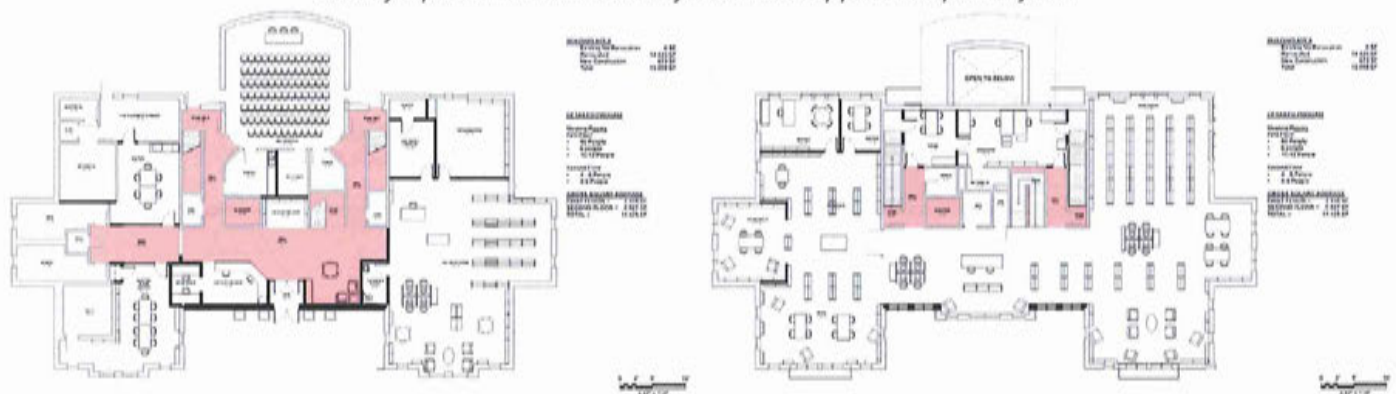
Library Option 2: renovation and minor addition lower and upper floor plan layouts

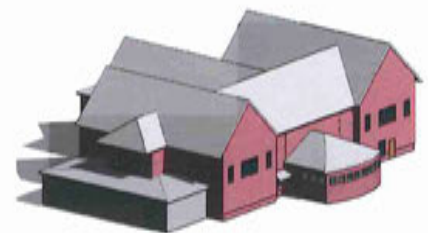
3D VIEW OF 1 STORY LIBRARY ADDITION

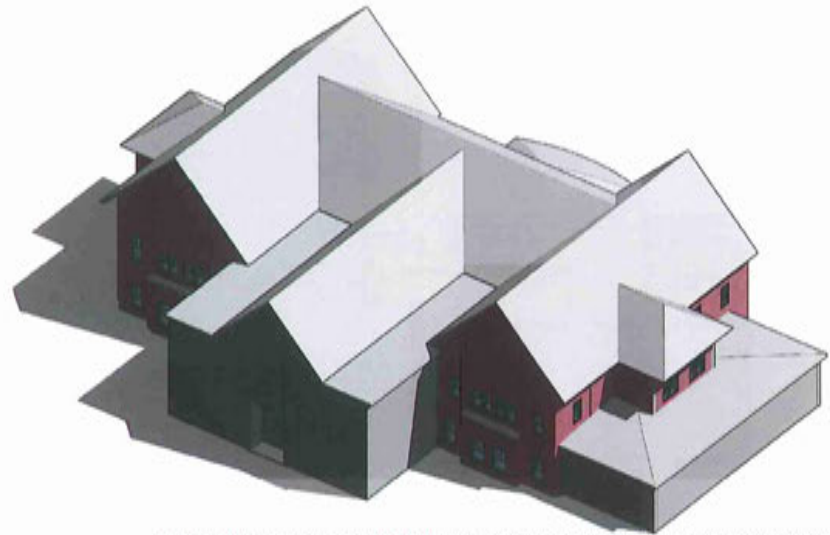
3D VIEW OF 2 STORY MAIN ENTRY AND 1 STORY LIBRARY ADDITION

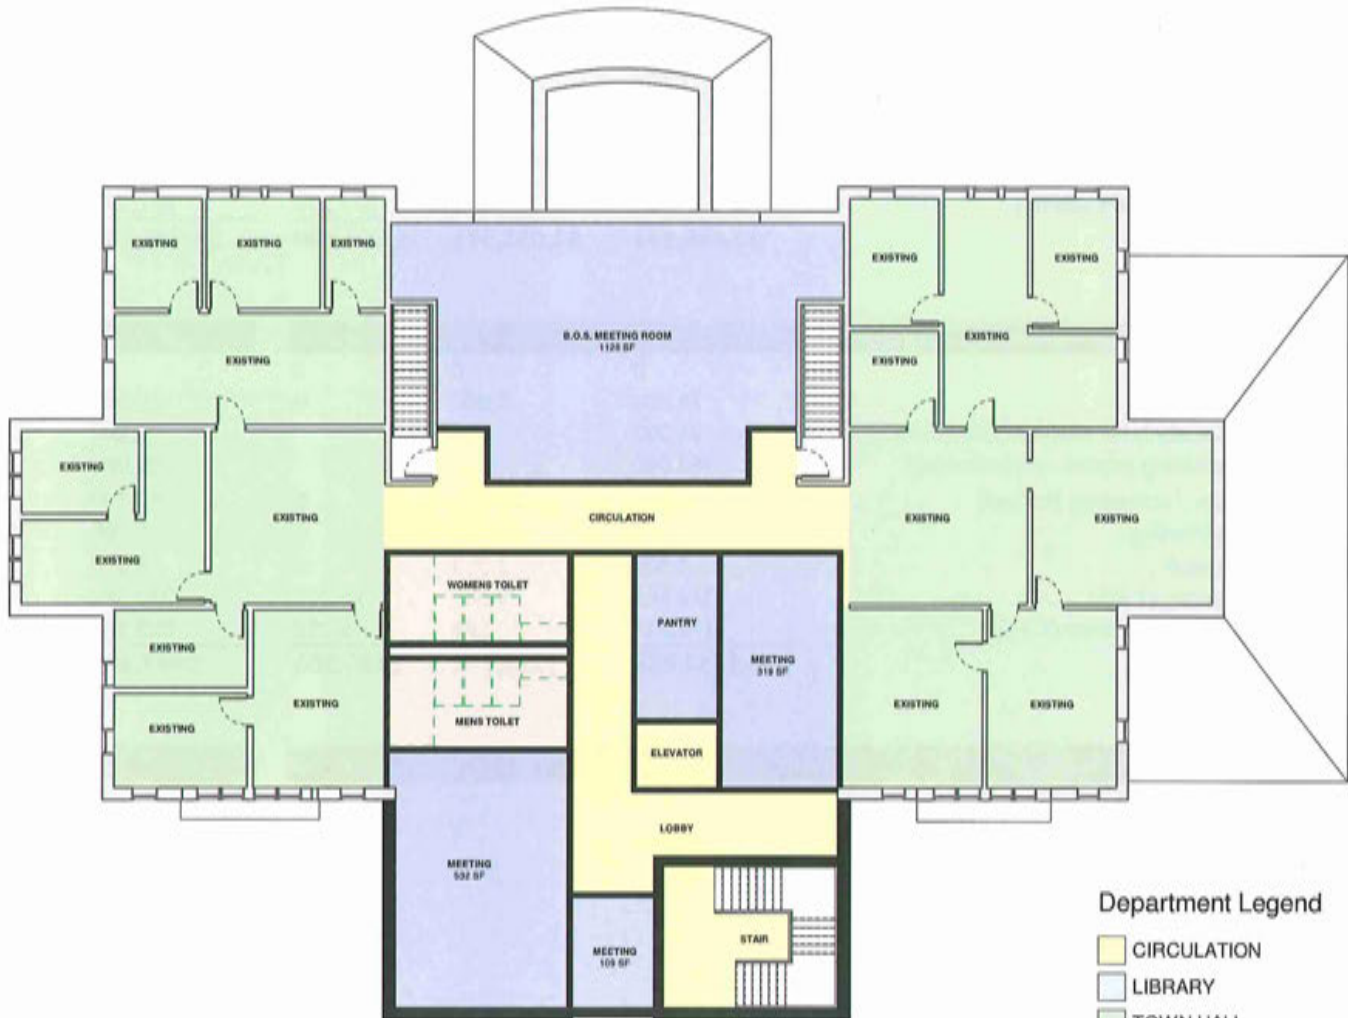
**COMBINED TOWN HALL / LIBRARY
LOWER LEVEL FLOOR PLAN**

TOTAL BUILDING = (*1.37) 20,055 SF

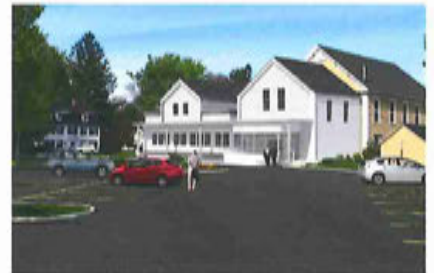
RENDERING OF A PREVIOUS VERSION OF A COA ADDITION

The Task Force recommendation for an expanded Community Center and Council on Aging (COA) utilizes the existing parking area for building development. Feedback from the COA, HDC, and the public indicated that the triangular green space at the intersection of Elm Street and Middleton Road should be left undeveloped.

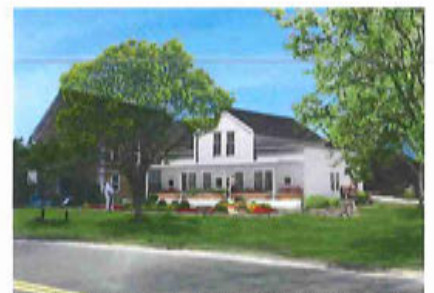
RENDERING OF A PREVIOUS VERSION OF A COA ADDITION

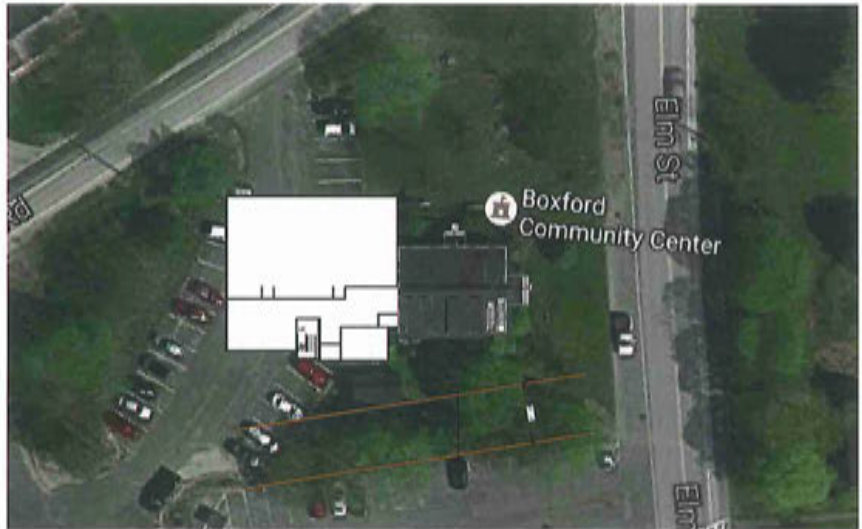
CONCEPTUAL SITE PLAN DIAGRAM OF A NEW ADDITION OFF THE BACK OF A RENOVATED COMMUNITY CENTER

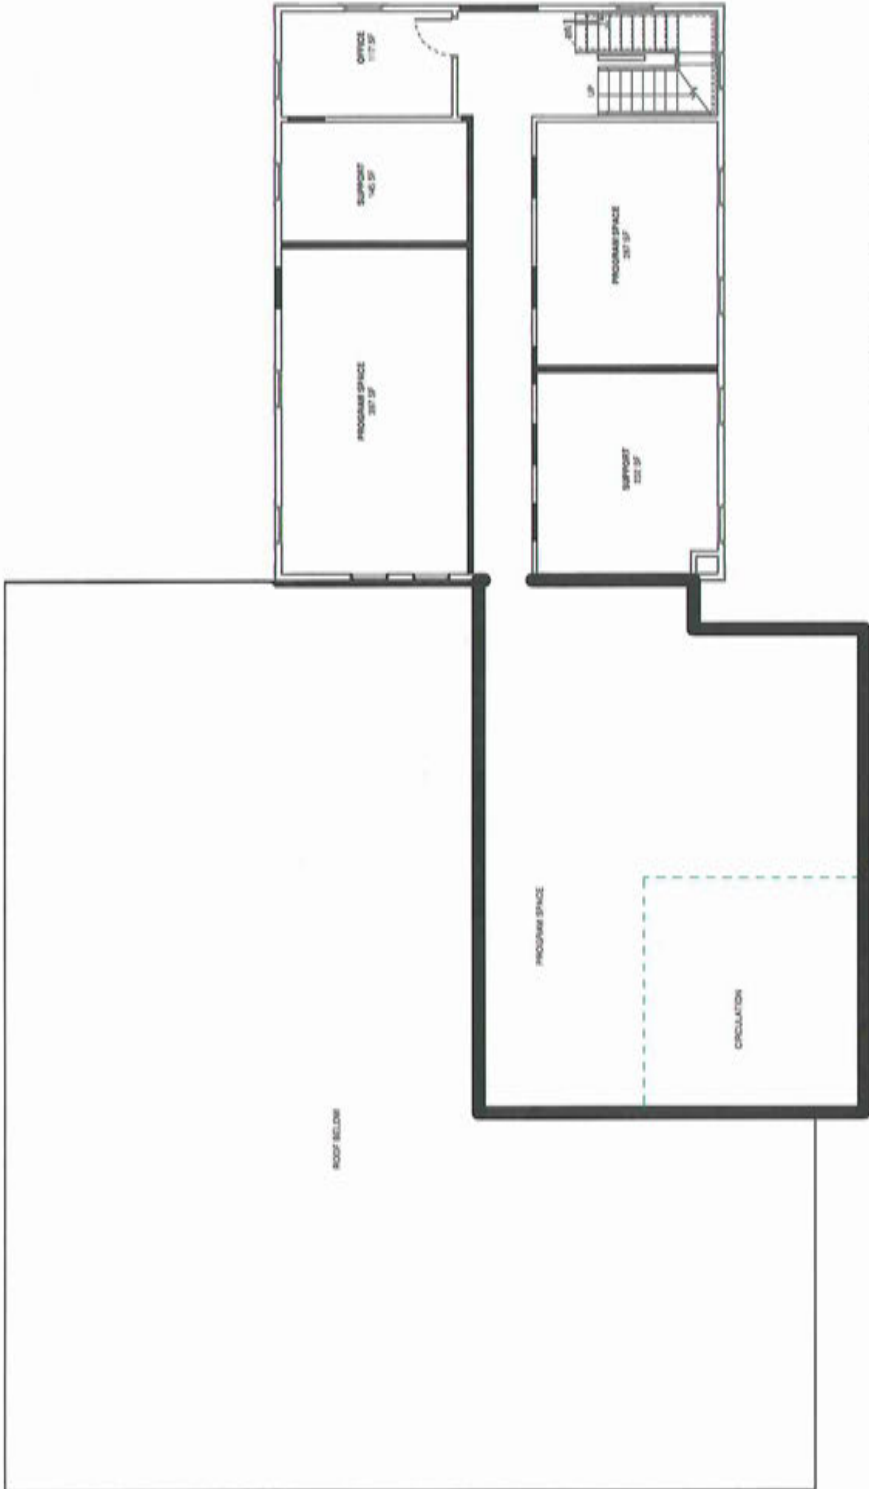
LOWER LEVEL FLOOR PLAN BLOCKING DIAGRAM

COMMUNITY CENTER / COA

GROSS SQUARE FOOTAGE

- EXISTING BUILDING**
- FIRST FLOOR = 1,685 SF
 - SECOND FLOOR = 1,685 SF
 - TOTAL EXISTING = 3,370 SF
- NEW ADDITION: 2 STORY**
- FIRST FLOOR = 4,930 SF
 - SECOND FLOOR = 1,300 SF
 - TOTAL ADDITION = 6,230 SF
- TOTAL BUILDING**
- FIRST FLOOR = 6,615 SF
 - SECOND FLOOR = 2,985 SF
 - **TOTAL = 9,600 SF**

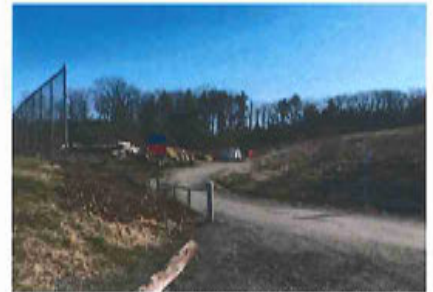
ACCESS DRIVE TO SITE 1

Site access via an improved drive was developed with additional wetland delineation, site survey, and geotechnical borings investigations. Utilizing the updated information, the consultant team created options to improve the existing access drive to accommodate DPW vehicles. The recommended option creates the least impact on the adjacent wetlands and creates a buffer zone off the adjacent landfill liner. To minimize impact to the wetland, the access drive profile is proposed to slope away from the wetland side.

Findings from the geotechnical report stated that the existing access drive is suitable to build on for DPW use. Recommendations include adding a 12" to 16" gravel base with 5" to 6" of pavement. The complete geotechnical report can be found in Appendix F of this report.

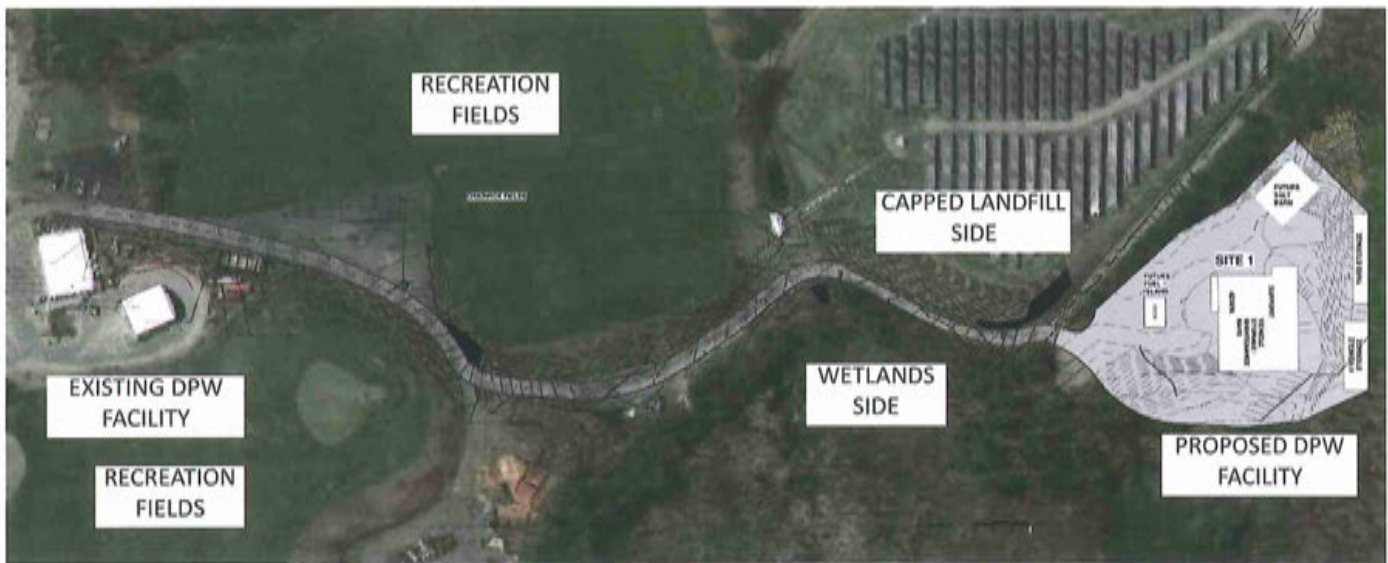
CONCEPTUAL SITE PLAN OF THE PROPOSED DPW AND ACCESS DRIVE ON SITE 1

The project cost estimate includes scope to secure the solar array with fencing. The conceptual budget includes options for reusing the existing salt barn and fuel island with securing and monitoring provisions in the even they remain in place.

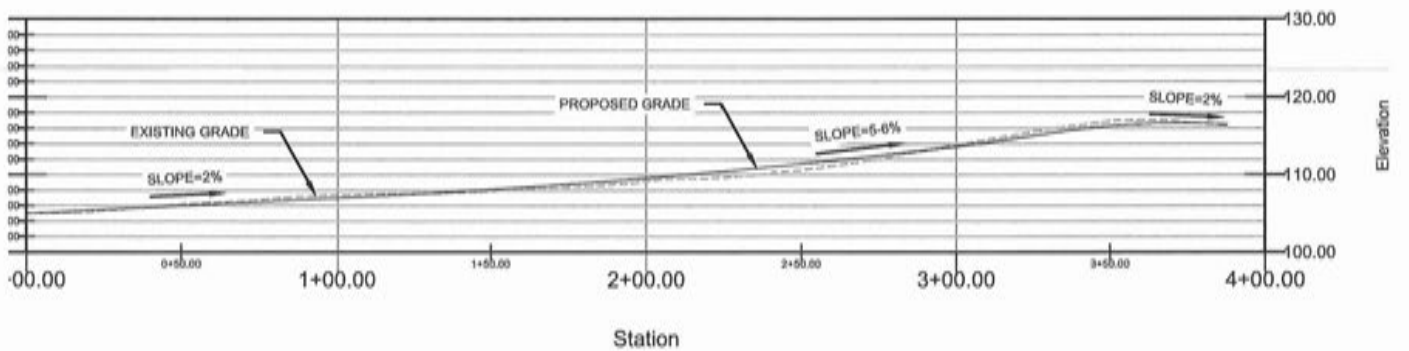
DPW ACCESS DRIVE
CONCEPTUAL PLAN AND GRADING PROFILE

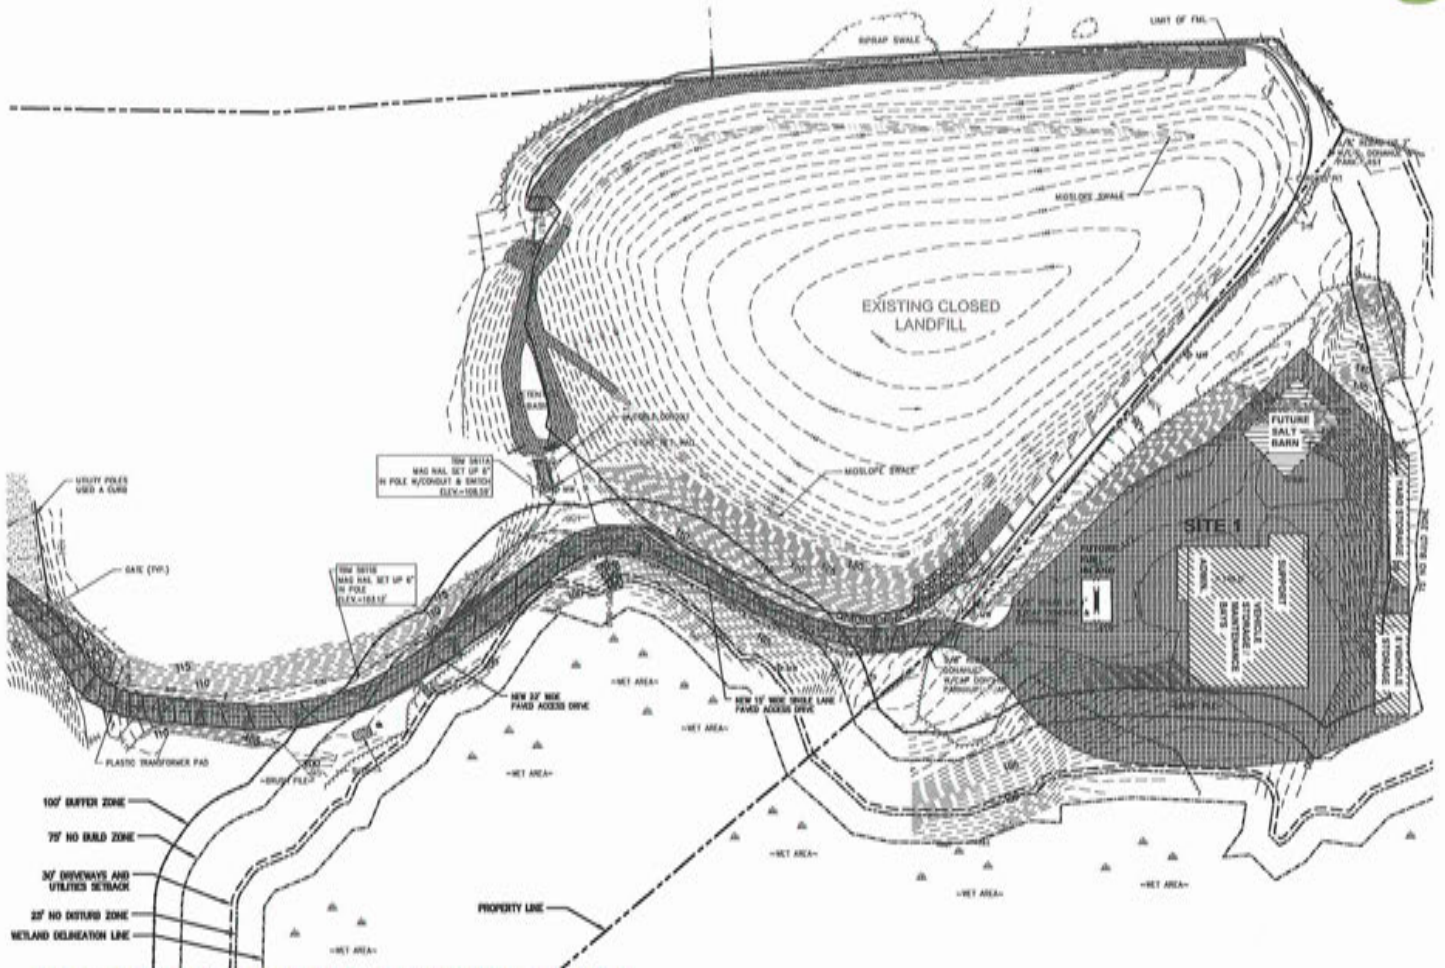
DPW AND ACCESS DRIVE SITE PLAN: ZONE A

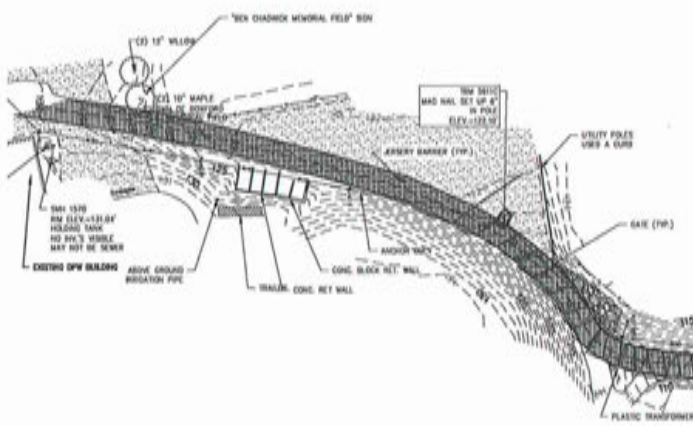
DPW AND ACCESS DRIVE SITE PLAN: ZONE B
