# Boxford Culvert & Bridge Asset Management

Prepared for: **Boxford DPW**  
7B Spofford Road  
Boxford, MA 01921

Prepared by: **TEC, Inc.**  
146 Dascomb Road  
Andover, MA 01810

July 26, 2021

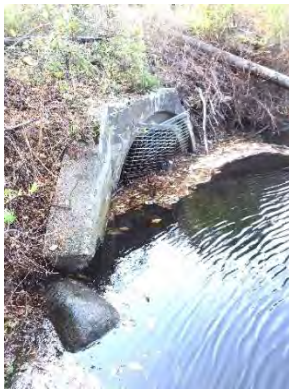
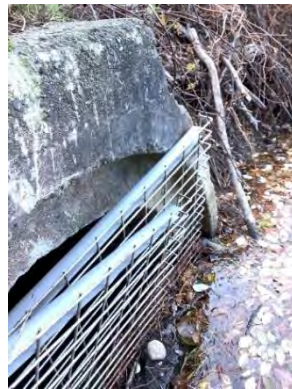
Inlet (Poor): Moderate scaling throughout the pipe due to water, and sporadic spalls and missing concrete was observed. The embankment shows moderate erosion around the headwall, with a crack observed in the middle of the headwall and scaling to high water.

**Overhead wires are present near the culvert's outlet, and a guardrail in fair condition is present near the inlet.** Conversations with an abutting neighbor revealed beaver activity observed within and outside of the culvert. The estimated remaining service life for this culvert is 5 to 10 years. TEC recommends a full culvert replacement with a three-sided box culvert. The estimated cost of replacement is \$600,000 to \$750,000, depending on the results of the field survey, hydraulic study, and geotechnical investigations.

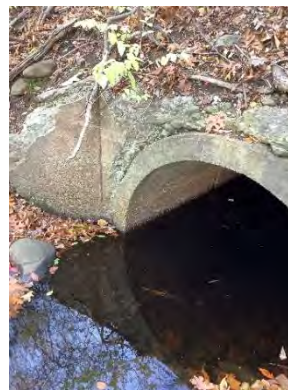
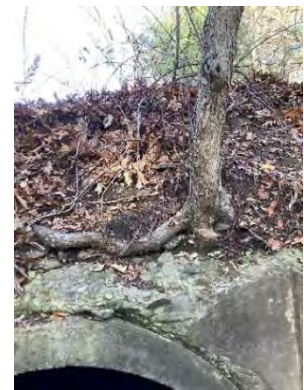
Outlet (Failing): Moderate scaling throughout pipe due to water, and sporadic patches of exposed rebar was observed. The embankment was observed to have severe erosion with sediment and tree growth seeping over the headwall. The headwall itself was observed to have severe deterioration with moderate scaling on the bottom 1' of wingwalls.

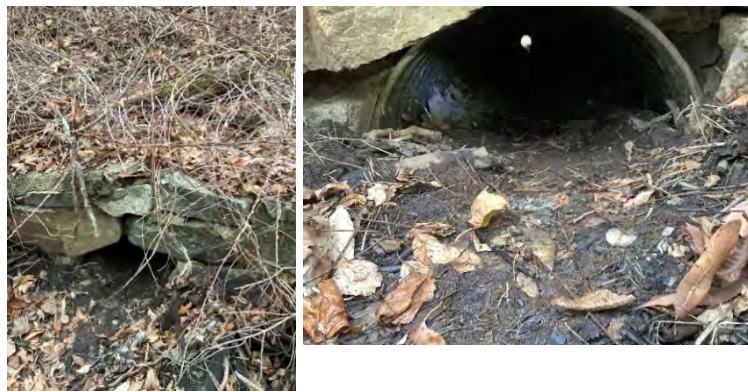
Inlet (Poor): The pipe inlet was observed to be obstructed by sediment and leaf/branch buildup, with moderate to severe erosion on the embankment and the headwall was observed to be actively overturning. Upstream a beaver structure was noted, as well as an oil sheen on top of water near the inlet.

Overhead wires and traffic safety features are present, with the guard rail observed to be in fair condition. The estimated remaining service life for this culvert is 5 to 10 years. TEC recommends a full replacement with a three or four-sided concrete box culvert. The estimated cost of replacement is \$400,000 to \$500,000, with costs depending on the results of a field survey, hydraulic study, and geotechnical investigations

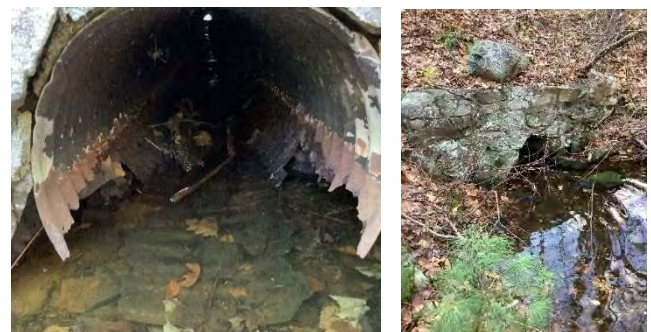
Outlet (Failing): Sides of the pipe have rusted away, dropping the bottom into the substrate. Severe rust and patches of pipe were observe to be missing throughout the pipe. The embankment shows moderate erosion, with **the headwall actively overturning and the bottom 6" of mortar is missing.**

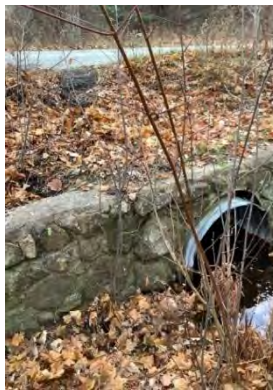
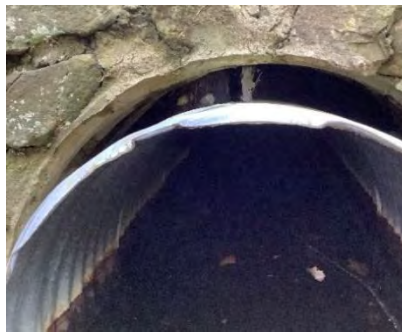
Inlet (Failing): The bottom of the pipe has rusted away, and moderate to severe rusting was observed throughout the rest of the pipe. The embankment shows severe erosion, and the headwall is completely separated from culvert, indicating pipe settlement. In **addition, the bottom 6" of mortar is missing from the headwall.**

No traffic safety features were present at either inlet or outlet, however an aboveground water connection was present indicating water utilities near the inlet. Overhead wires were observed near the outlet. The **estimated remaining service life for this culvert is 5 to 10 years. It is TEC's recommendation to fully replace** the existing culvert with a three or four-sided concrete box culvert. The estimated cost of replacement is \$400,000 to \$500,000 depending on the results of the field survey, hydraulic study, and geotechnical investigations.

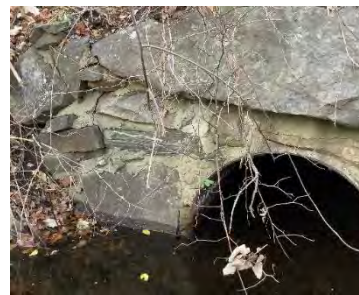
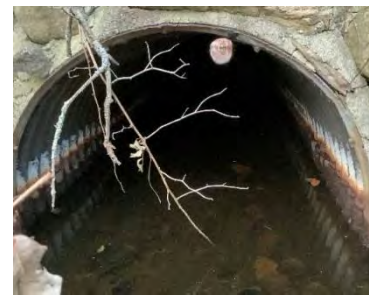
Outlet (Poor): Severe rust was observed throughout the culvert. The embankment shows minor to moderate erosion with sediment seeping over the headwall.

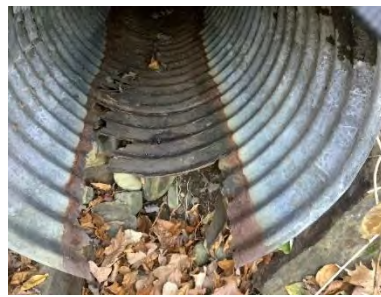
Outlet (Failing): The first approximately 1 foot of the bottom of pipe is rusted away, with severe rust and patches of pipe observed to be missing throughout the length of pipe. The embankment was observed to have severe erosion with sediment seeping through the headwall. The headwall itself is failing, as the majority of stones are either missing or collapsing..

At both the inlet and outlet, guard rail was observed to be present and in satisfactory to fair condition. Overhead wires were observe above the outlet. The estimated remaining service life for this culvert is 5 to 10 years. It is **TEC's recommendation to complete a full replacement with a three or four-sided concrete box culvert**. The estimated cost of a full replacement is \$450,000 to \$600,000 depending on the results of the field survey, hydraulic study, and geotechnical investigations.

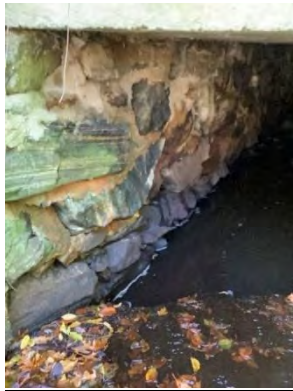
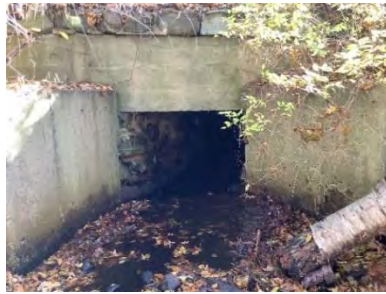
Inlet (Fair): The inlet was observed to be missing mortar from the bottom 2' of the structure, and the embankment was observed to have minor to moderate erosion. The headwall and wingwalls had severe scaling and minor scour observed at the bottom of the wingwalls.

Guardrails from satisfactory to poor condition were present near both the inlet and outlet, and overhead wires were present near the inlet. The estimated remaining service life for this culvert is less than 5 years, with immediate maintenance potentially extending the service life. Immediate maintenance would include the repair of the undermined headwall/wingwalls with new stones and mortar. Estimated cost of maintenance repair is \$50,000 to \$100,000.

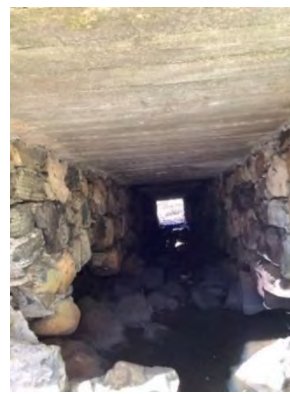
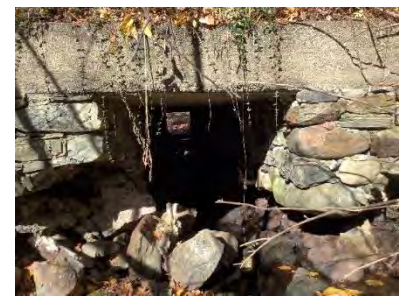
Outlet (Failing): The bottom 2'-3' of stones lining the culvert were observed to have collapsed into Pye Brook. The embankment was observed to be moderately eroded, with the headwall and wingwalls showed signs of moderate scour. Additionally, stones from the wingwall were observed to have collapsed at the bottom, and a large settlement crack was observed in the concrete.

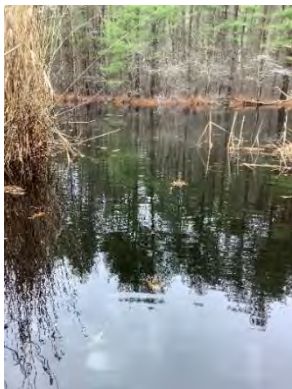
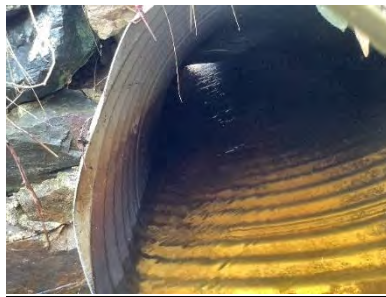
Culvert B – 222 carries a tributary to Fish Brook through an approximately 33-inch corrugated metal pipe that according to StreamStats can see up to a 21.8 cfs flow during a 10-year storm. The condition of the culvert was assessed to be Fair at the inlet and Poor at the outlet, with a large indent approximately 5 feet into the culvert from the inlet causing a significant hydraulic restriction. The culvert is considered critical based on the condition of the pipe, and the risk of flooding upstream if the structure were to fail.

Inlet (Fair): A large dent was observed at the top of the pipe at approximately 5' from the mouth of the inlet.

This dent significantly restricts the hydraulic capacity, and poses a threat for surficial failure on the roadway due to a potential void. A moderate amount of rust was observed on all sides of the pipe, and severe scour was present. The embankment was observed to have minor to moderate erosion, with vegetation growth growing through the headwall. The headwall was observed to have sporadic patches of missing mortar.

An electrical box was observed near the culvert, with assumed underground wire utilities being present. There were no traffic safety features observed near the culvert at either the inlet or outlet. The estimated remaining service life for this culvert is 5 to 10 years. TEC recommends a full replacement with a three or four-sided concrete box culvert. The estimated cost of replacement is \$350,000 to \$450,000, depending on the results of the field survey, hydraulic study, and geotechnical investigations.

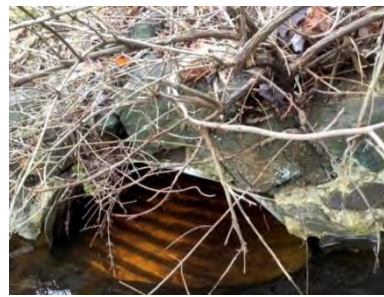
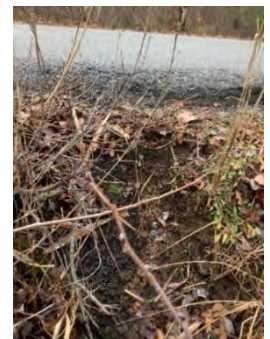
Outlet (Poor): Moderate surface rust was observed at the bottom and sides of the pipe due to water, and moderate scour was also observed. The embankment was observed to have a severe washout on the right side of the headwall, and vegetation growth through the headwall was also observed. The headwall showed sporadic patches of missing mortar and stones were missing throughout the headwall.

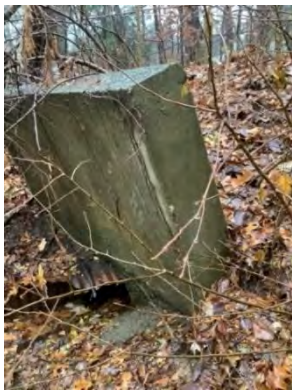
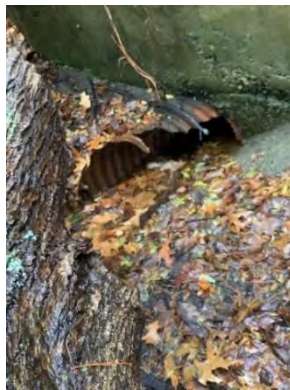
Northern side (Failing): The majority of the pipe was observed to have rusted away with severe rust throughout the remaining pipe also observed. The embankment was noted to have severe erosion, and the headwall is actively overturning. It was observed that a large tree trunk may be what is supporting the headwall.

A guardrail and steel cable were in failing condition at both the southern and northern openings, with overhead wires observed above the southern opening. The estimated remaining service life for this culvert is less than 5 years. TEC recommends a full replacement with a three-sided concrete box culvert. The estimated cost of replacement is \$400,000 to \$600,000, depending on the results of the field survey, hydraulic study, and geotechnical investigations.

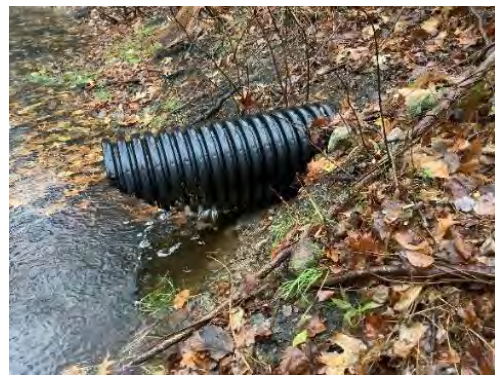
Southern Side (Poor): The observed pipe is a 12 inch diameter HDPE which either joins the 18 inch CMP on the north mid-span, or was slid through **the 18" due to failure. It was noted that the bottom** of the pipe is completely missing from the first approximately 12 inches. The embankment was observed to have minor to moderate erosion.

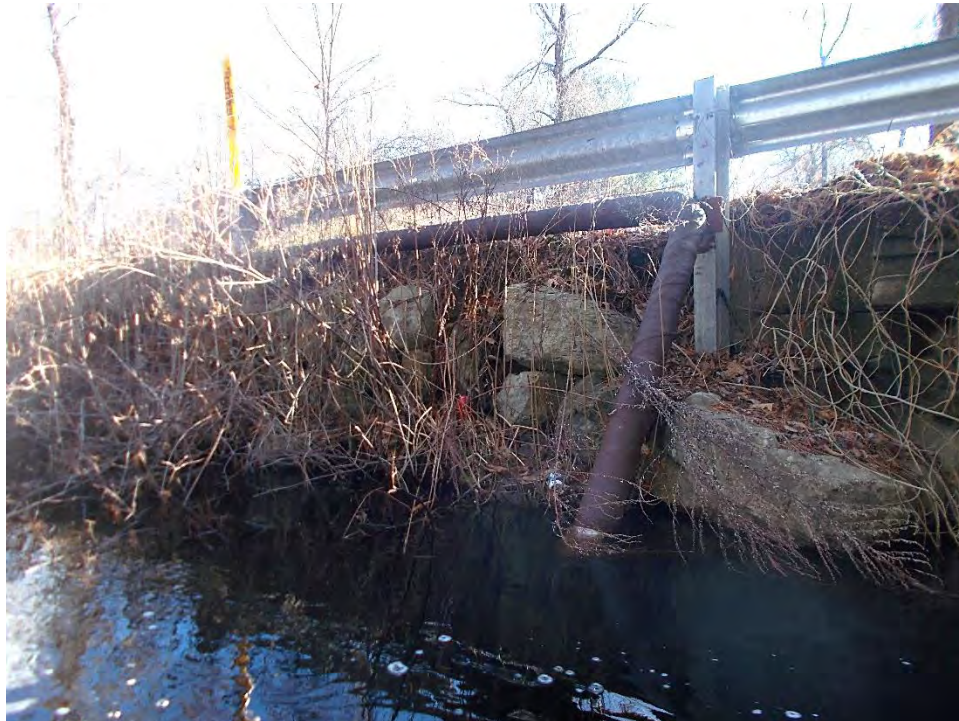
**Figure 4: Typical vegetation growth at northwest corner - B-19-001**

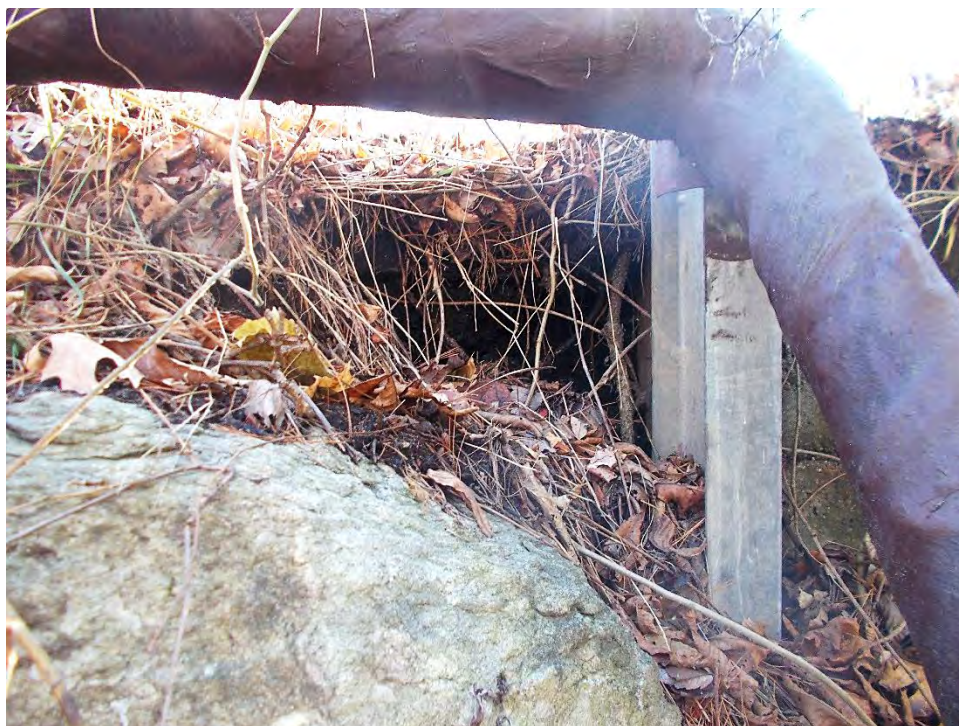
**Figure 5: Erosion/washout behind the north abutment (west fascia) - B-19-001**

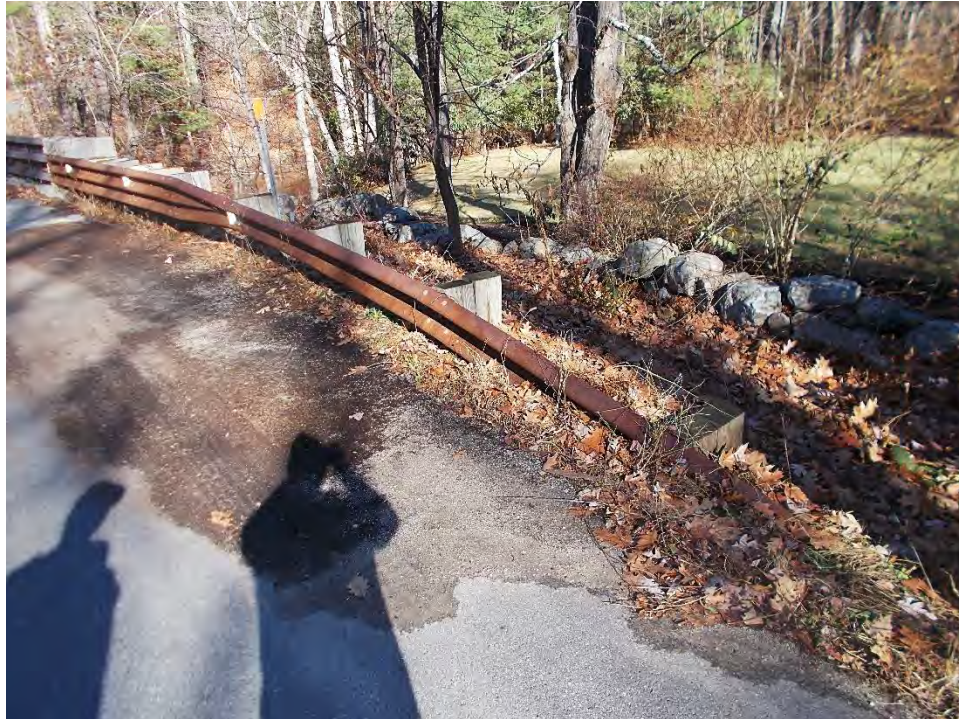
**Figure 7: Typical leaf accumulation and vegetation growth under all four guardrail approaches and transitions- B-19-002**

Clear the roadway surface, bridge railing, and guardrail of any vegetation growth/debris buildup (typical bridge maintenance)

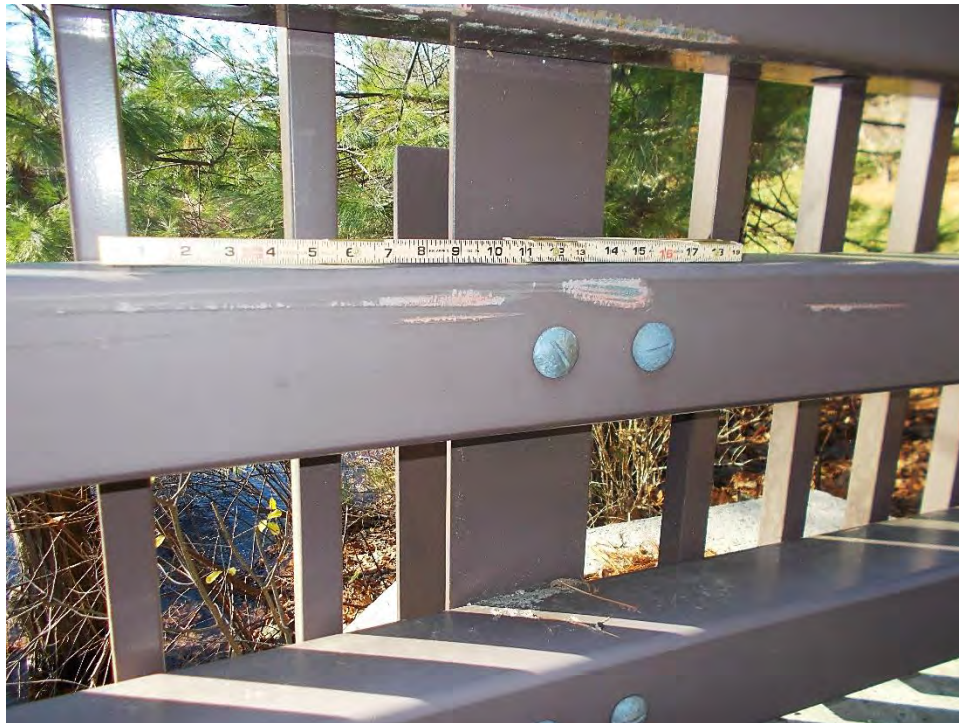
**Figure 8: Typical minor sporadic scrapes to S3-TL4 bridge railing - B-19-002**

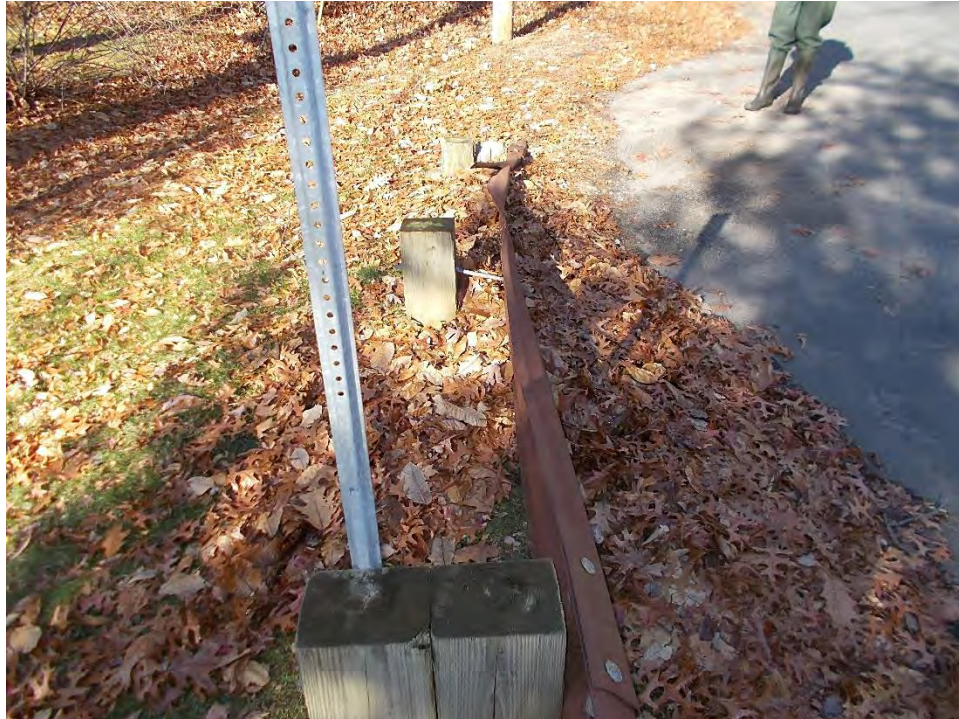
**Figure 9: Impact damage to northwest approach guardrail - B-19-002**

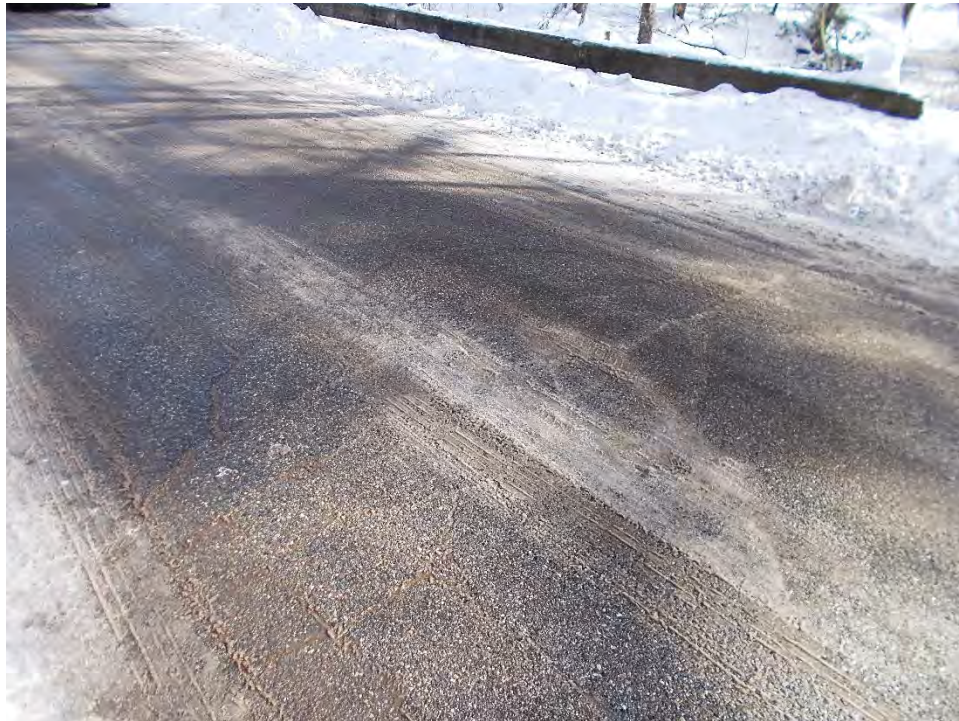
**Figure 12: Transverse pavement cracking at west bridge joint (looking south) - B-19-003**

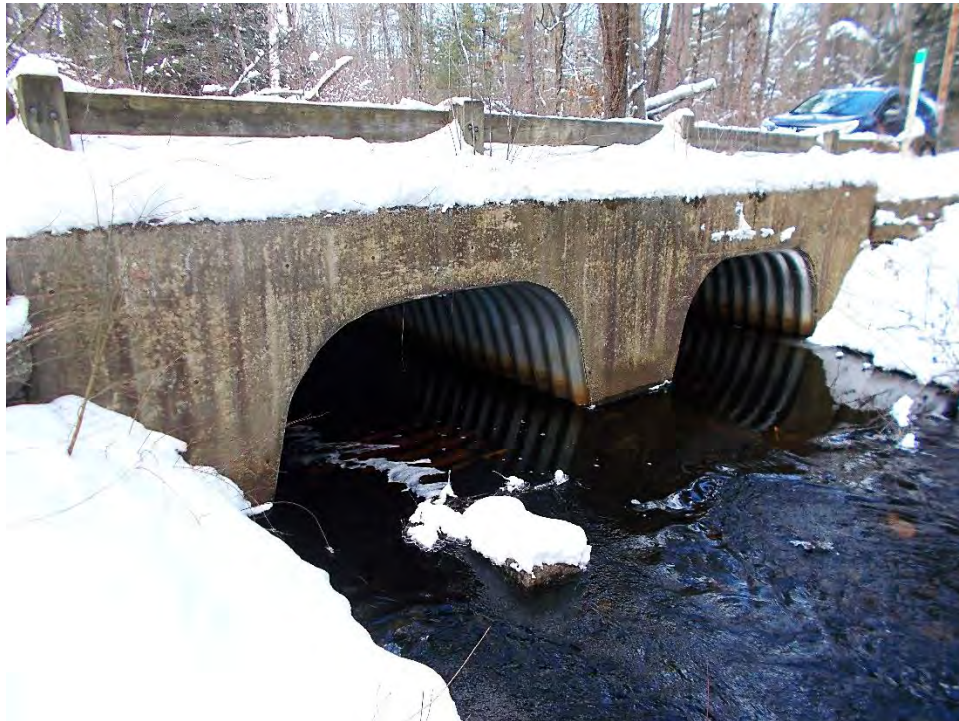
Generally, both headwalls look sound from a visual inspection (Figure 14). The four wingwalls appear to be stacked stones with some minor voids and misalignment (Figure 15). Due to the water depth/stream flow rate, the corrugated aluminum arches were unable to be inspected by TEC.

**Figure 14: Southern head wall and channel mouth (looking north) - B-19-003**

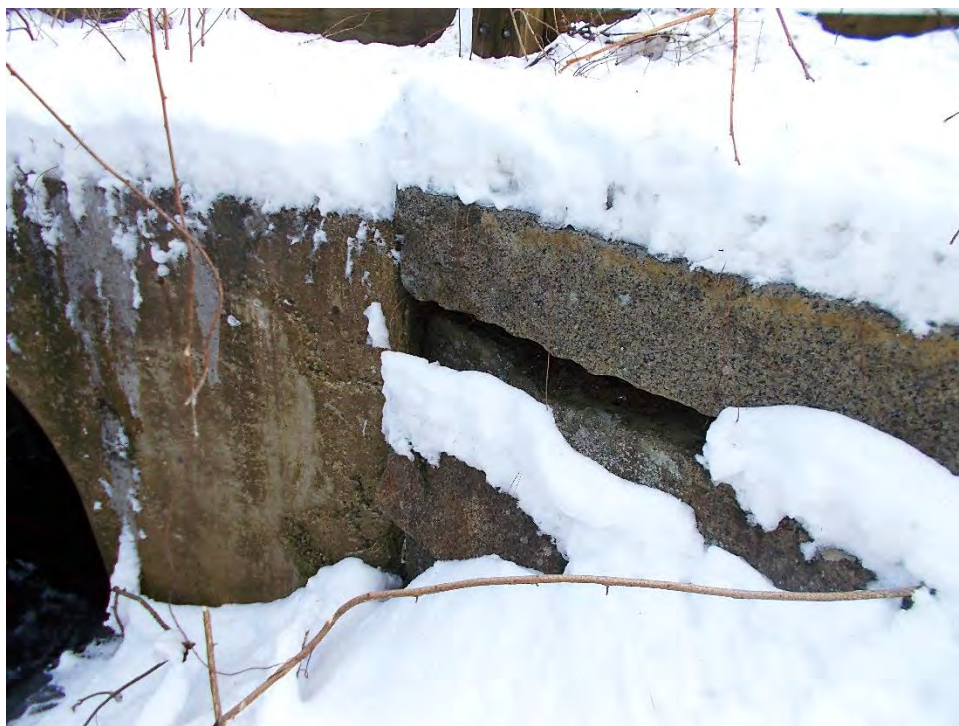
**Figure 15: Typical stone wingwall - B-19-003**

<b>Lockwood Lane over Fish Brook (B-19-003)</b>	
<b>Cost Estimate</b>	
<b>Construction Costs</b>	<b>\$120,000</b>
<b>Safety Improvements (guardrail replacement)</b>	<b>\$90,000</b>
<b>Maintenance (wingwall repairs)</b>	<b>\$30,000</b>
<b>Engineering Cost</b>	<b>\$8,000</b>
<b>Total</b>	<b>\$128,000</b>

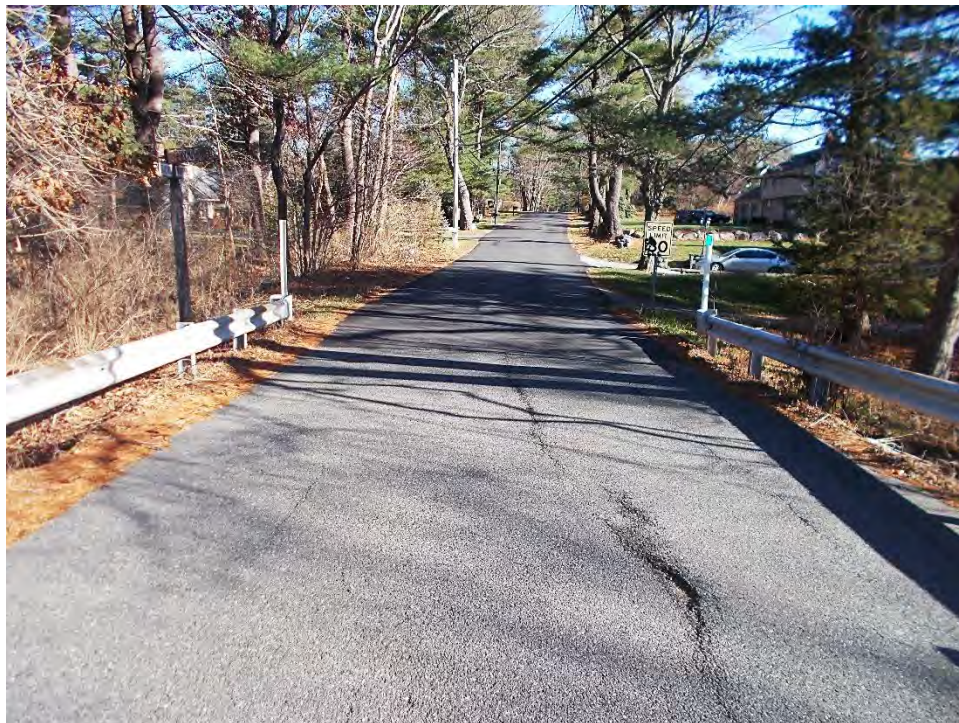
There is new pavement that begins at the east approach near the Topsfield/Boxford town line. The adjacent, older pavement has random longitudinal cracking, predominantly at the gutter lines. A small pothole is present near the center of the roadway and connects to smaller longitudinal cracks. There is some minor transverse cracking. Generally, the wearing surface was in satisfactory condition (Figure 18), equating to a 6 per the MassDOT bridge inspection condition rating guide.

**Figure 18: Typical wearing surface – B-19-004**

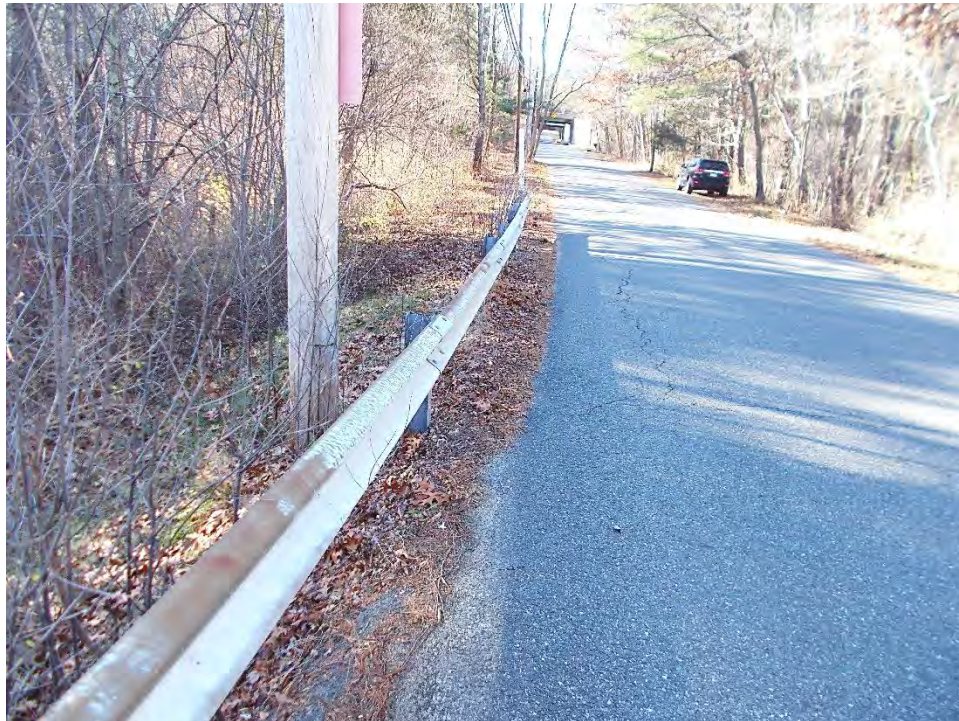
The guardrail is bolted to the concrete headwall over the bridge, on both sides. There is typical cracking, delamination, and sporadic areas of spalled concrete surrounding the guardrail baseplates. There is minor rust staining and impact damage to both guardrails. The south guardrail appears to be missing a post (Figure 19).

**Figure 19: Typical rust staining and impact damage to guardrail – B-19-004**

Fuller Lane over Fish Brook (B-19-004)	
Cost Estimate	
Construction Costs	\$140,000
Safety Improvements (guardrail replacement)	\$90,000
Maintenance (headwall Replacement)	\$50,000
Engineering Cost (survey, design, permitting, const. oversight)	\$45,000
<i>Total</i>	\$185,000

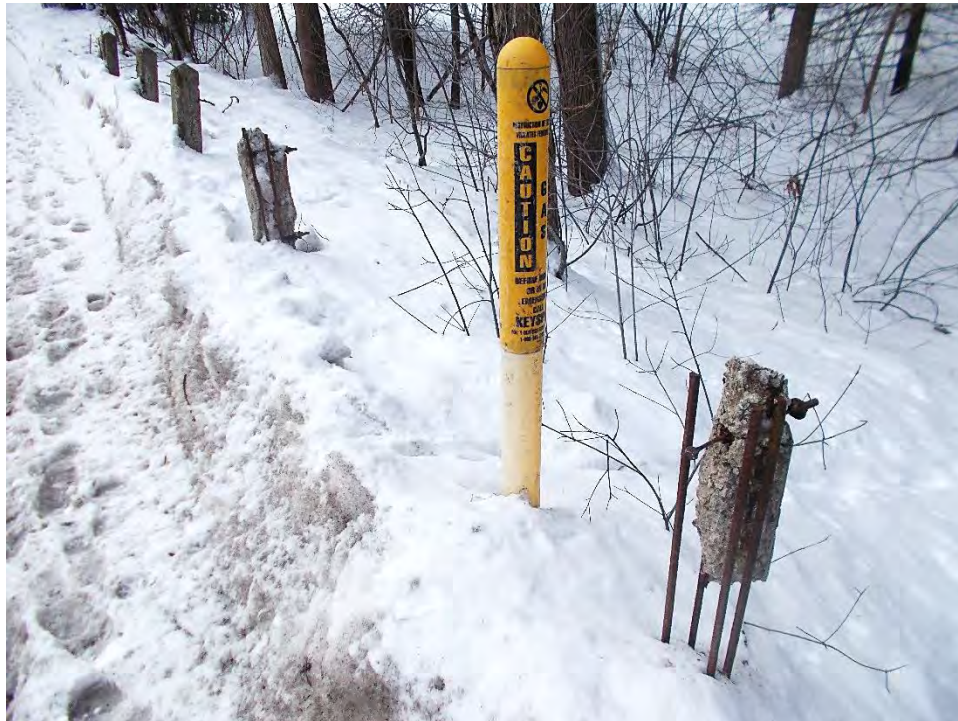
The east and west bridge railings consist of concrete posts with timber railings. Generally, there is heavy spalling all on all posts with exposed rusted rebar. The timber railings are not attached to the approach guardrail (concrete posts with wire rail). The approach guardrail has heavy spalling and exposed rusted rebar on the concrete posts with some missing posts. The wire rail is disconnected from the concrete posts and broken in some areas (Figure 23).

**Figure 23: Typical condition of concrete posts at bridge approaches - B-19-005**

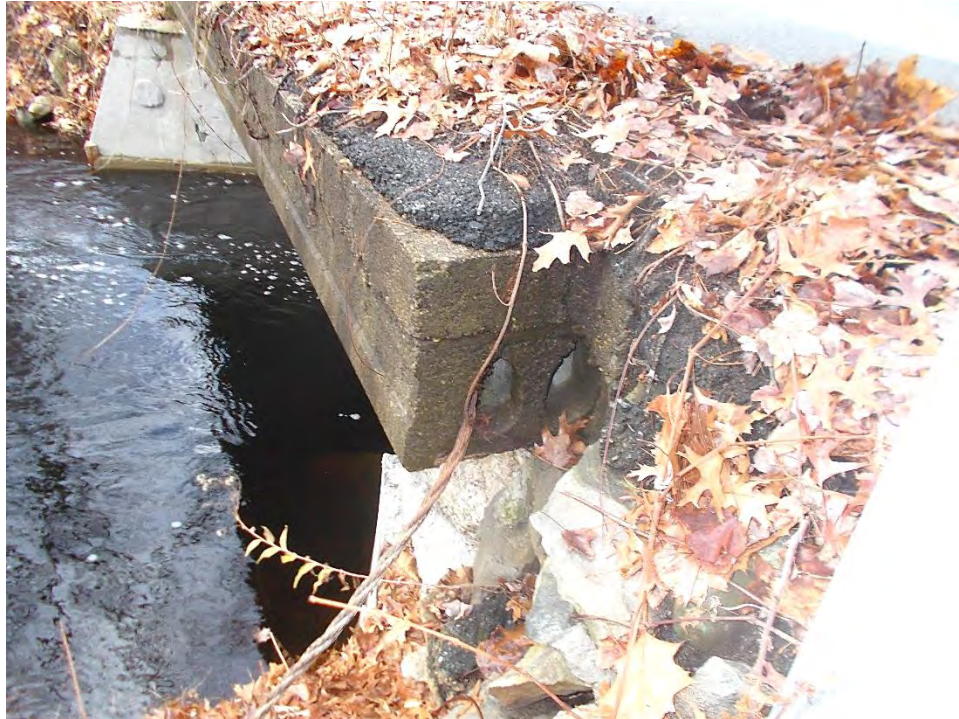
Generally, the wearing surface is sound and appears to be placed directly on top of the prestressed concrete slab. There is minor sporadic cracking in the wearing surface along the length of the bridge. There is embankment erosion at all four corners of the bridge, exhibiting the prestressed concrete slab ends to be visible (Figure 26).

**Figure 26: Typical exposed prestressed slab at northeast corner – B-19-018**

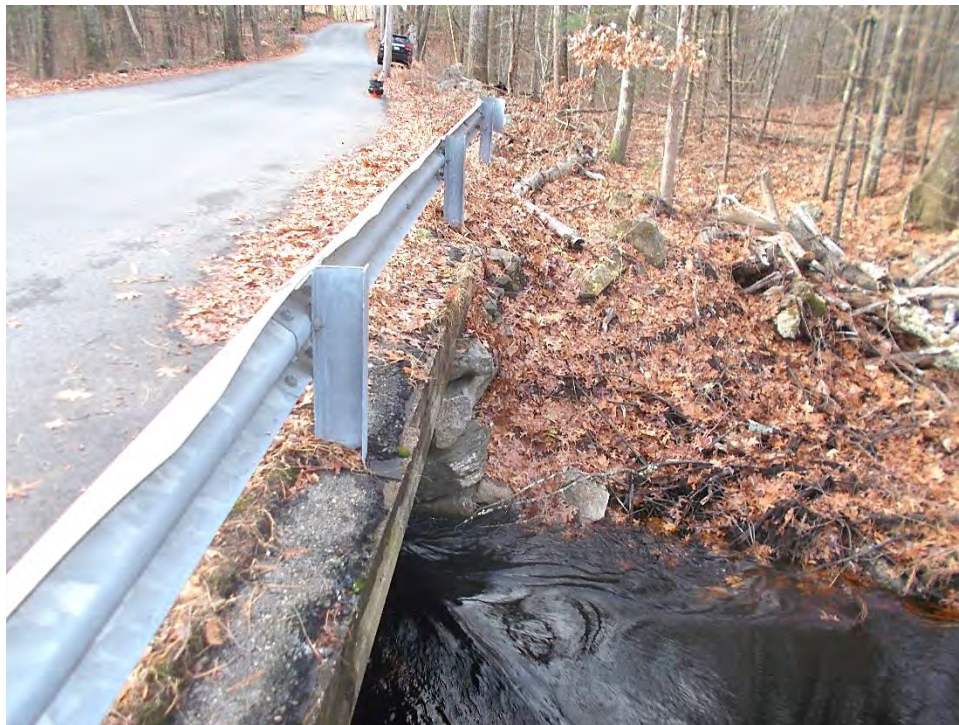
The guardrail traveling the bridge is a steel W-beam guardrail embedded into the concrete slab. Both guardrails are non-standard. The approach guardrail is loose and can be moved with foot pressure (Figure 27).

**Figure 27: Typical guardrail over bridge (looking south) – B-19-018**

<b>Brookview Road over Fish Brook (B-19-018)</b>	
<b>Cost Estimate</b>	
<b>Construction Costs</b>	\$146,500
<b>Safety Improvements (guardrail replacement)</b>	\$90,000
<b>Maintenance (substructure/embankment repairs)</b>	\$56,500
<b>Engineering Cost (survey, design, permitting, const. oversight)</b>	\$65,000
<b>Total</b>	<b>\$211,500</b>

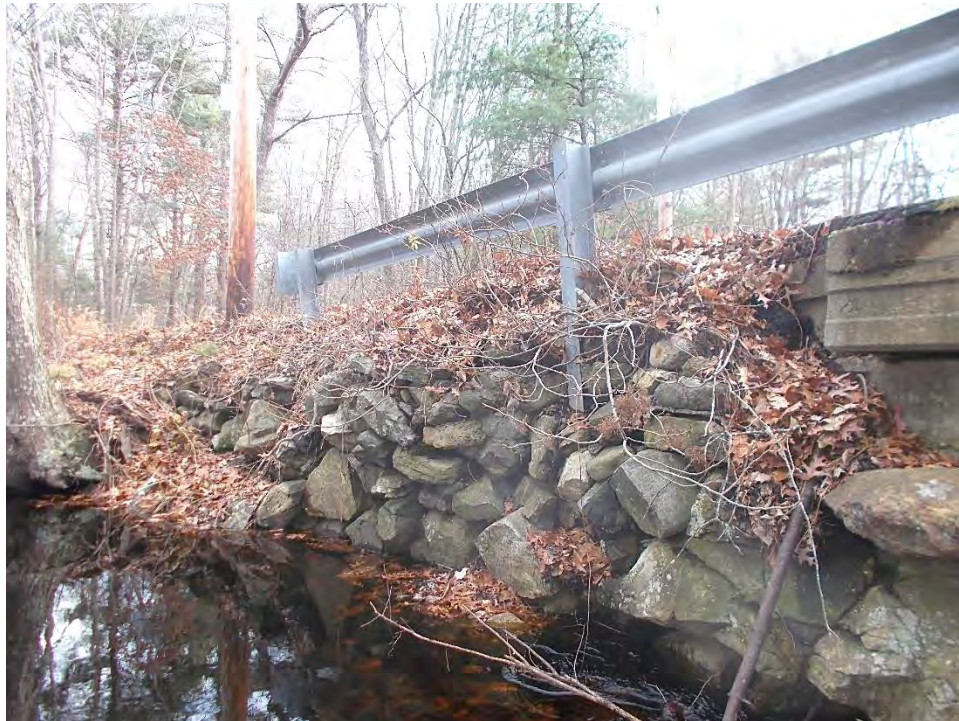
The abutments and U-wingwalls consist of dry-laid stones with evidence of concrete repairs on both breastwalls. The repairs are irregular in nature and are bulged to form around stones. The U-wingwalls are irregular with multiple areas of fill spilling through stones. There are voids present between all dry-laid stones up to ~3" deep at abutments. The northwest wingwall is bulging ~2' out of plane (Figure 28). There is undermining at the northwest breastwall/wingwall measuring ~ (18" deep by 7' long). From foot probing, there appears to be multiple areas of scour present along both abutments. The Fish Brook is traveling with moderate velocity and the stream appears to get deeper as you move downstream.

**Figure 28: Northwest wingwall bulging out of plane – B-19-018**

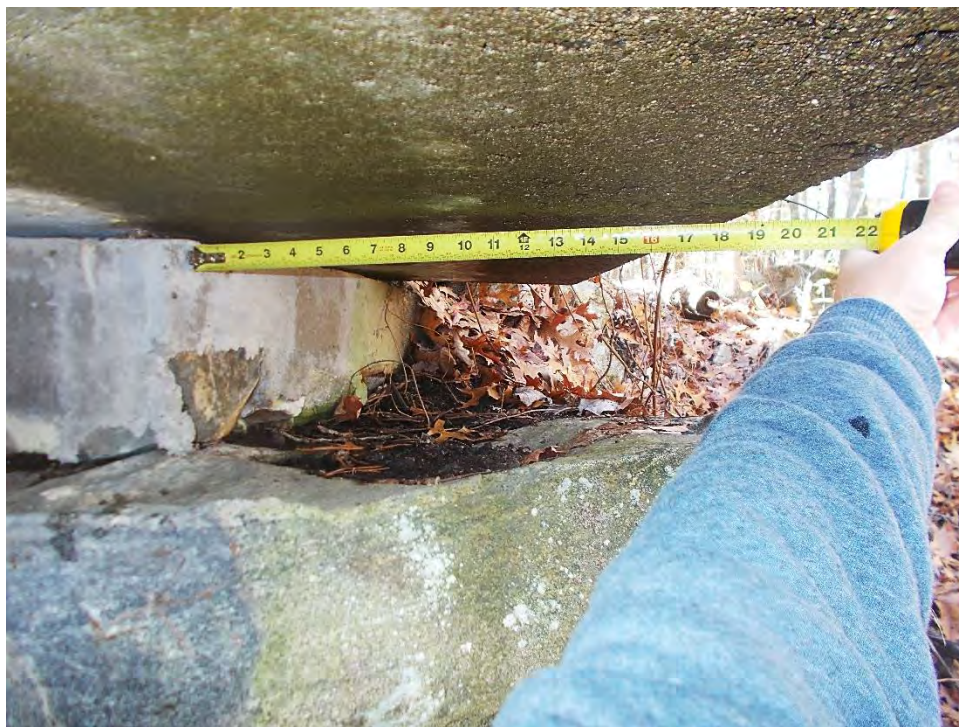
There is debris build-up in the upstream (west) channel ~ (7' long by 2' tall by 2' wide) consisting of sticks, leaves, brush, etc. Generally, the underside of the beams is sound, and each beam is ~5' wide. The two fascia beams overhang the abutments at all four corners (up to ~20") (Figure 29). There is minor longitudinal cracking and delamination throughout the underside of the beams.

**Figure 29: Beam overhang at north abutment – B-19-018**

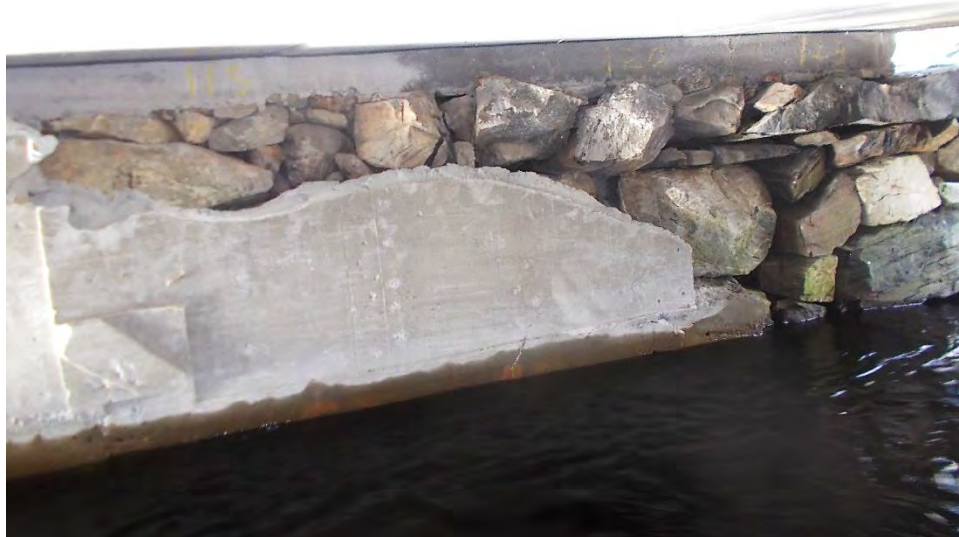
The special member inspections were required due to an undermining failure at the north and south breastwalls (Figures 30 & 31). These deficiencies were repaired shortly after the 2019 and 2020 special member inspections performed by MassDOT.

**Figure 30: Typical breastwall undermining repair – B-19-018**

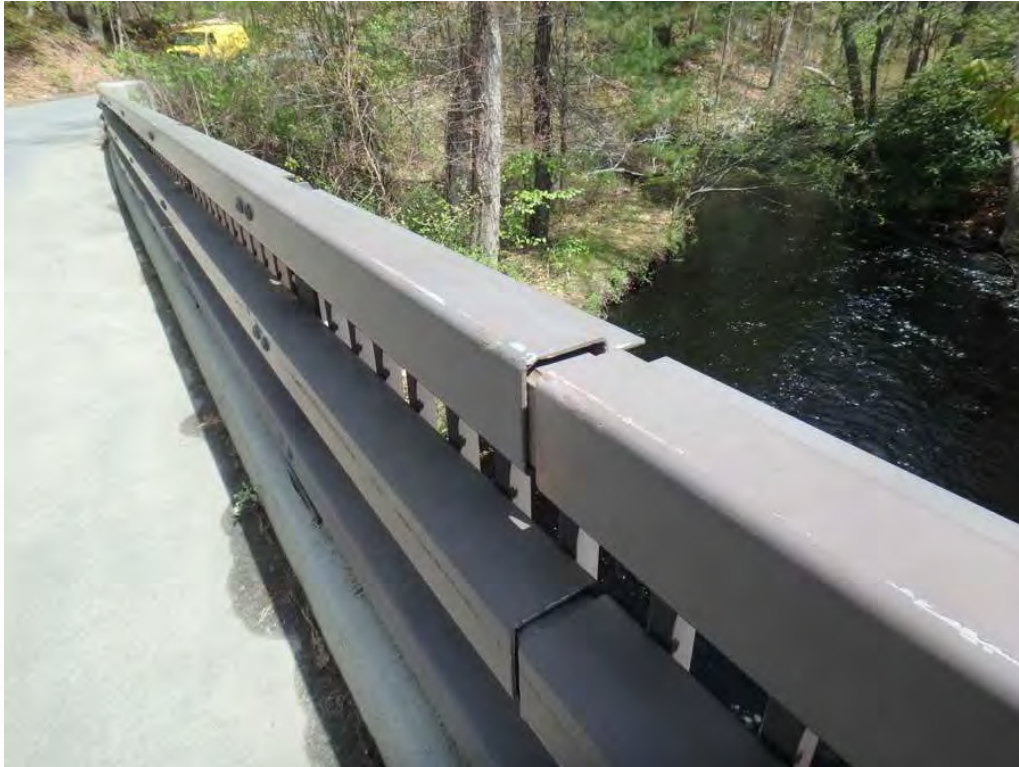
**Photo 3:** East bridge railing has minor scrapes (typical at the west bridge railing).

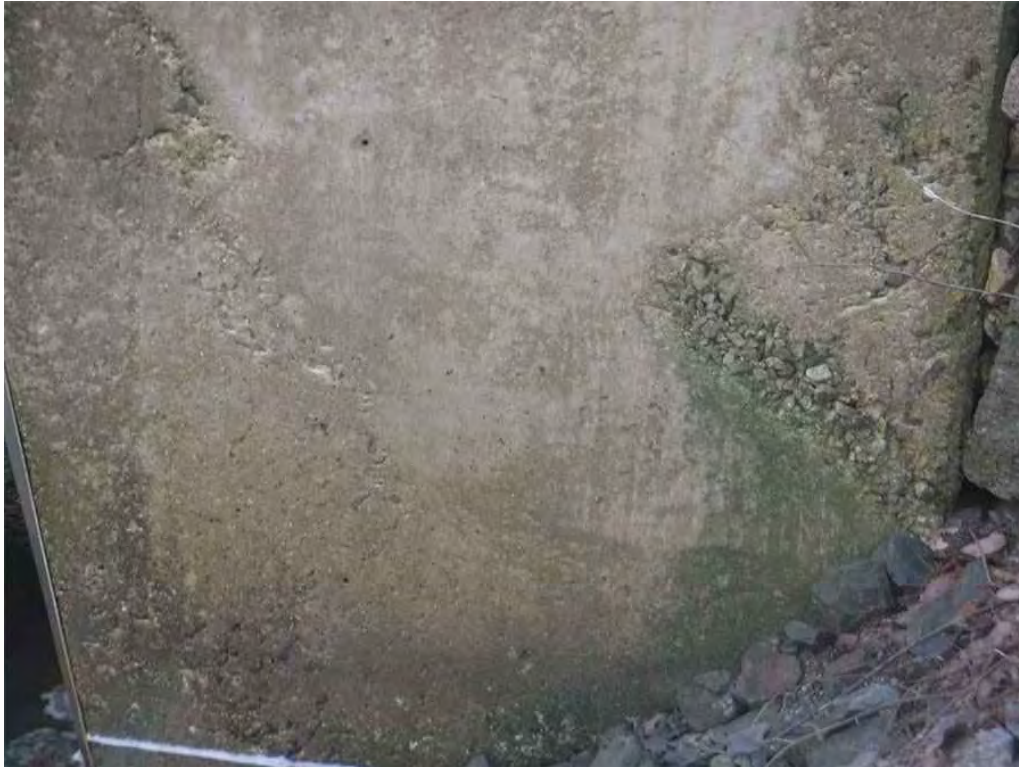
**Photo 3: Moderate Scaling to the North Headwall at the West End of the Culvert**

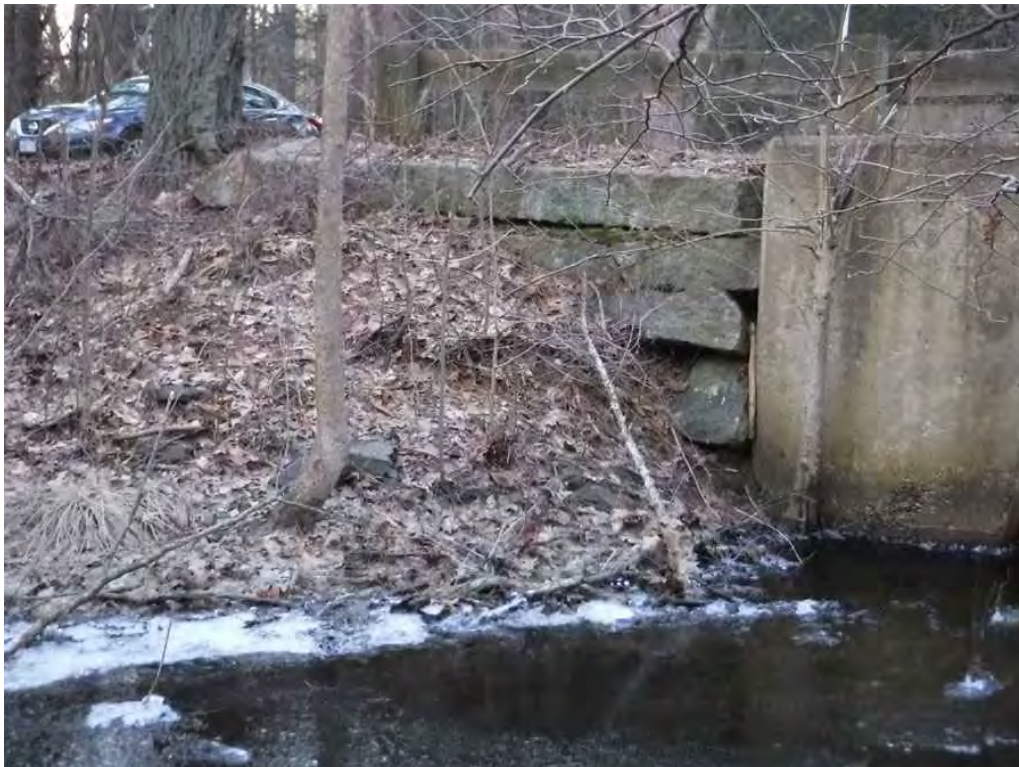
**Photo 4: Bottom Stone at the Northeast Wingwall Dislodged and Falling Out**

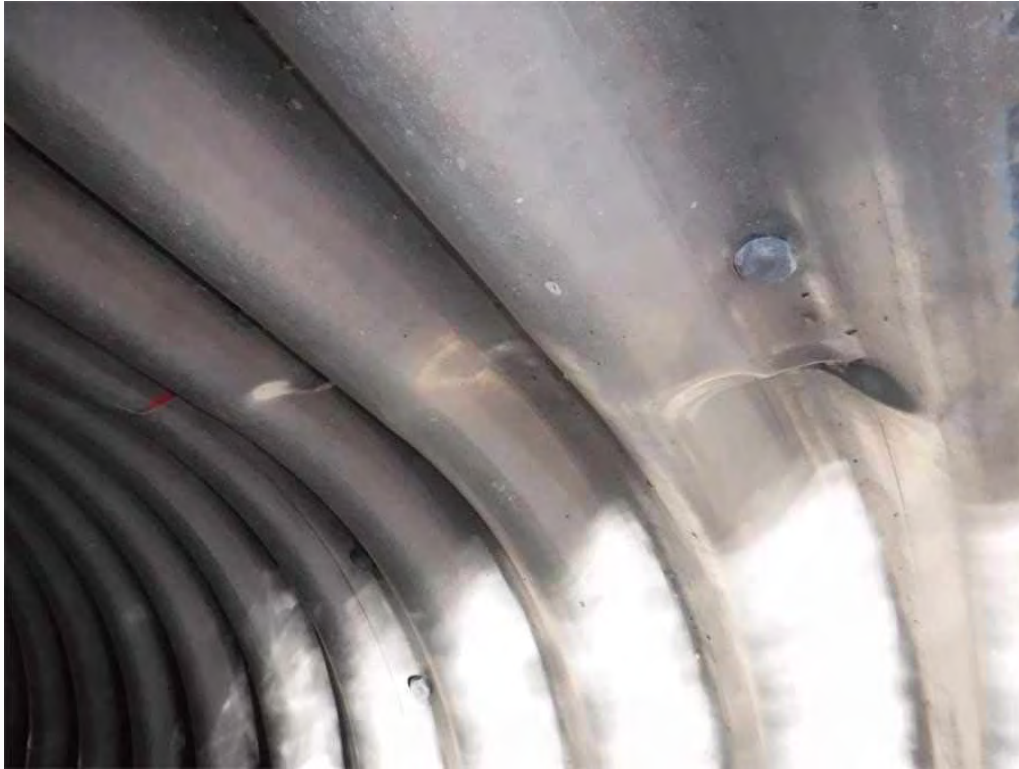
There is a 5'-0" long x 2" deep deformation (dent) starting 10' from the south headwall and 2' east of the crown (**see Photo 5**). There is minor surface corrosion along the water-line for the entire length of the aluminum barrel and the bottom two bolts at the splices exhibit light rust.

**Photo 5: Barrel 1, 5'-0" Long Deformation Starting 10' away from the South Headwall and 2' East of the Crown**

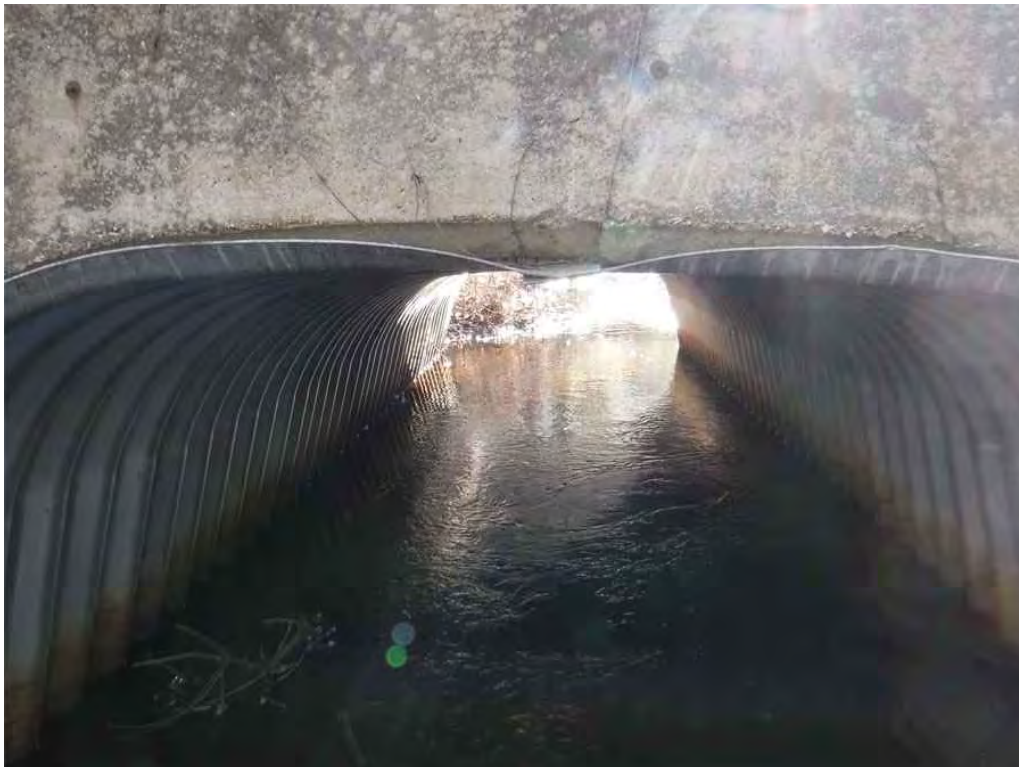
There is a minor dent at the crown of the barrel at the north headwall (**see Photo 6**). The aluminum at the floor of the barrel at the north end of the culvert is bent up 6" high, exposing the crushed stone under the culvert to potential scour (**see Photo 7**). There is minor surface corrosion along the water-line for the entire length of the barrel (**see Photo 8**).

**Photo 6: Barrel 2, Dent at the Crown of the Barrel at the North Headwall**

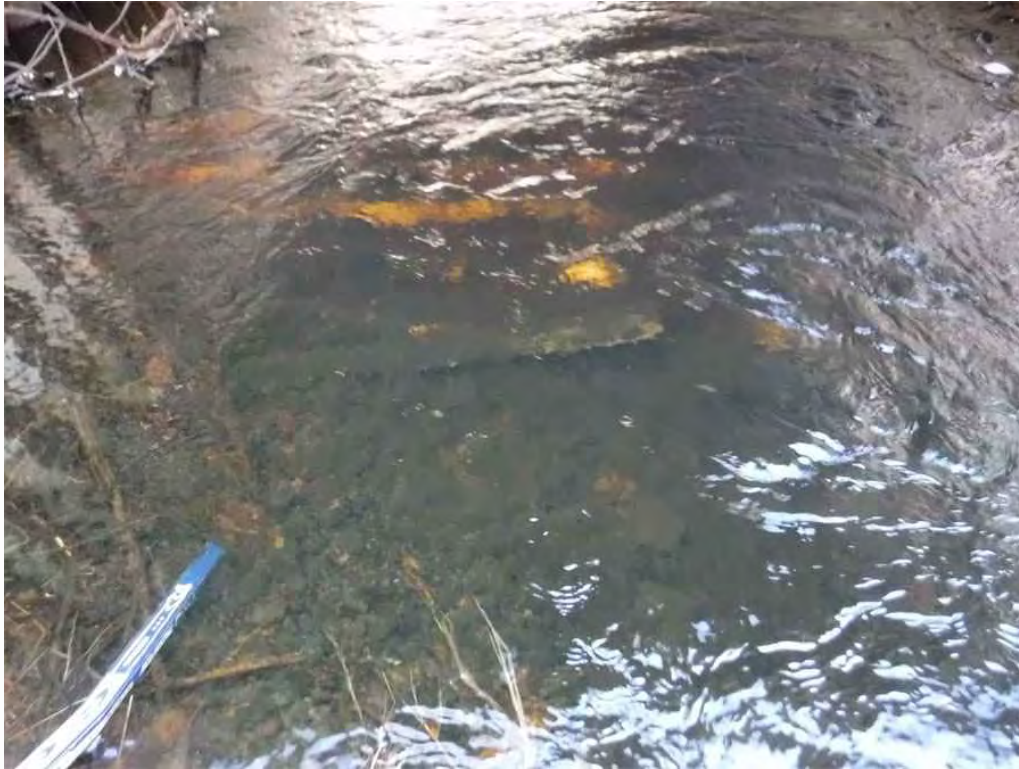
**Photo 7: Barrel 2, Aluminum Bent up 6" High at the Floor of the Barrel at the North End of the Culvert**
