# Boxford Culvert & Bridge Asset Management

Prepared for: **Boxford DPW**  
7B Spofford Road  
Boxford, MA 01921

Prepared by: **TEC, Inc.**  
146 Dascomb Road  
Andover, MA 01810

July 26, 2021

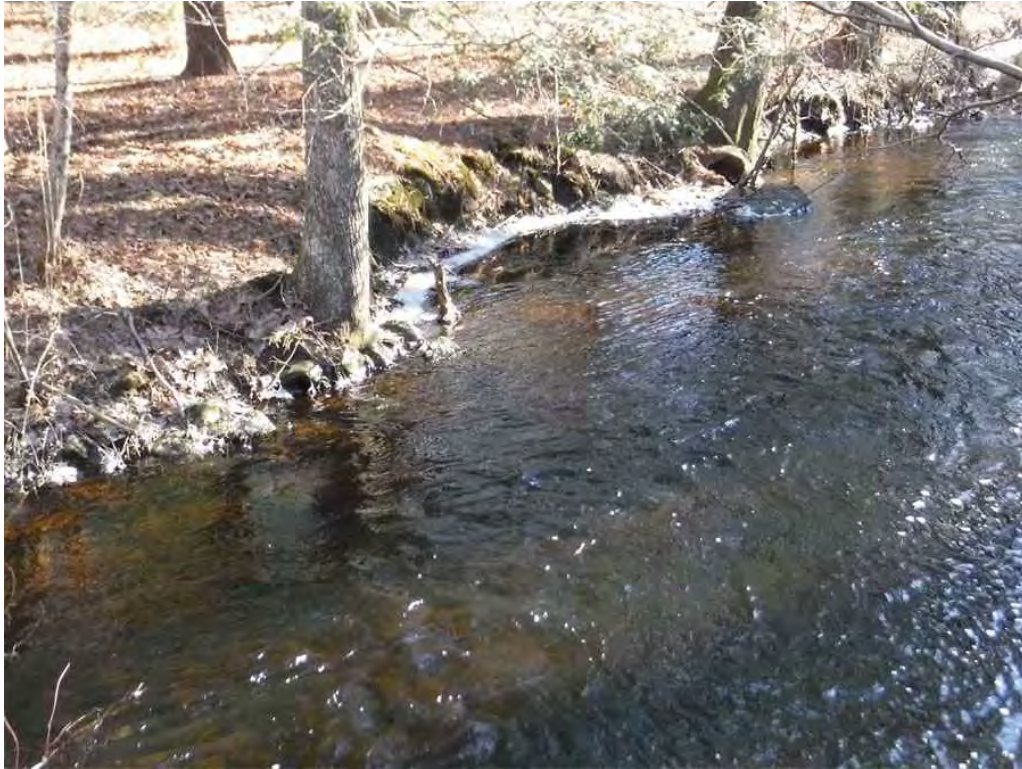
- Photo 8 : Barrel 2, Typical Surface Corrosion along the Waterline
- Photo 9 : Minor Erosion, Exposed Roots, and Trees Tilting Towards the Water at the Southeast Embankment

**Photo 9: Minor Erosion, Exposed Roots, and Trees Tilting Towards the Water at the Southeast Embankment**

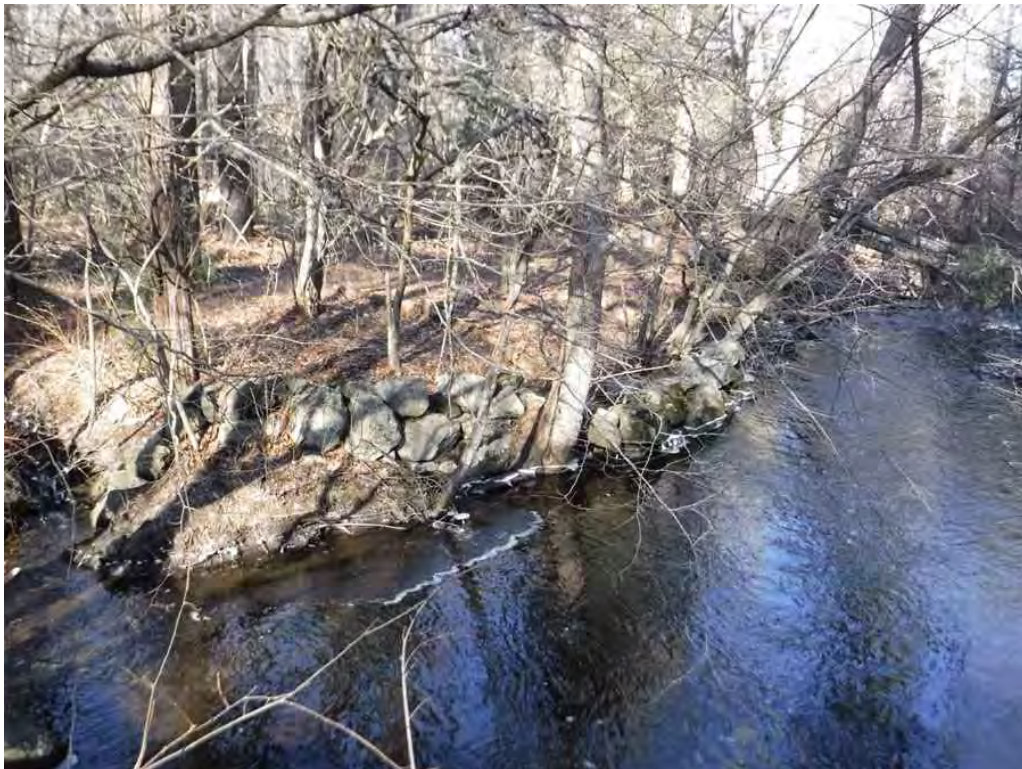
- Photo 10 : Trees Tilting Towards the Water Displacing the Northwest Stone Embankment
- Photo 11 : Barrel 2, 2'-0" High Buildup of Branches, Leaves, and Brush Starting from the South End of the Culvert and Extending Three-Quarters the Length of the Barrel

**Photo 10: Trees Tilting Towards the Water Displacing the Northwest Stone Embankment**

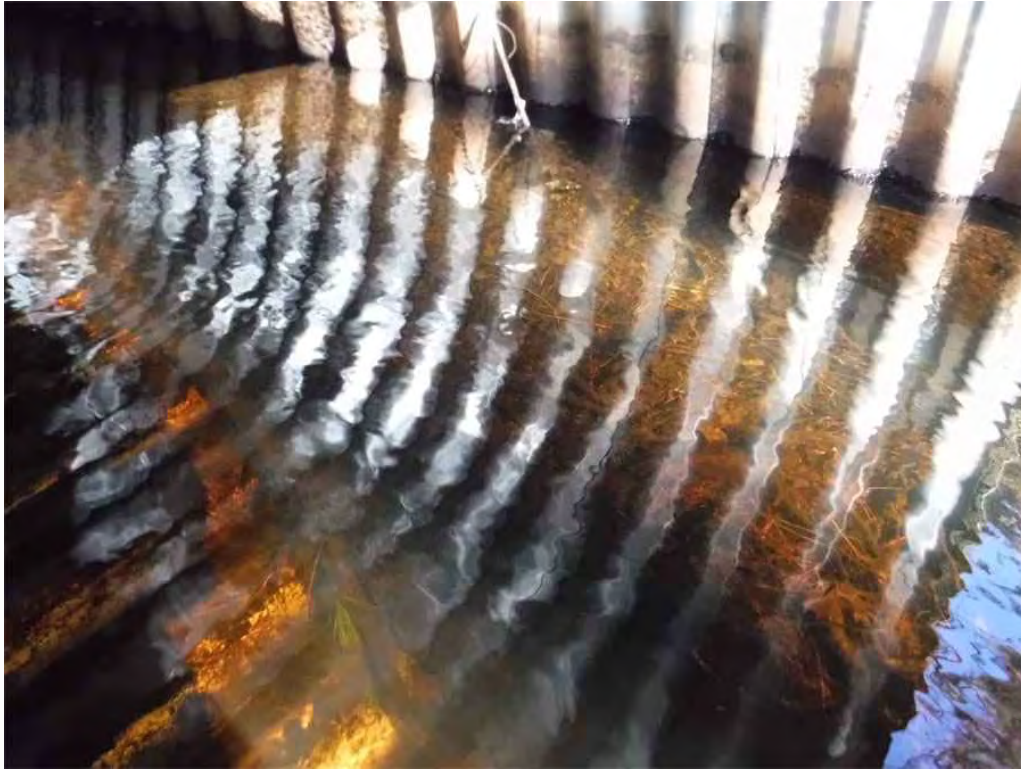
Barrel 2 has a buildup of branches, leaves, and brush 2'-0" high starting from the south end of the culvert and extending three-quarters the length of the barrel (**see Photo 11**).

**Photo 11: Barrel 2, 2'-0" High Buildup of Branches, Leaves, and Brush Starting from the South End of the Culvert and Extending Three-Quarters the Length of the Barrel**

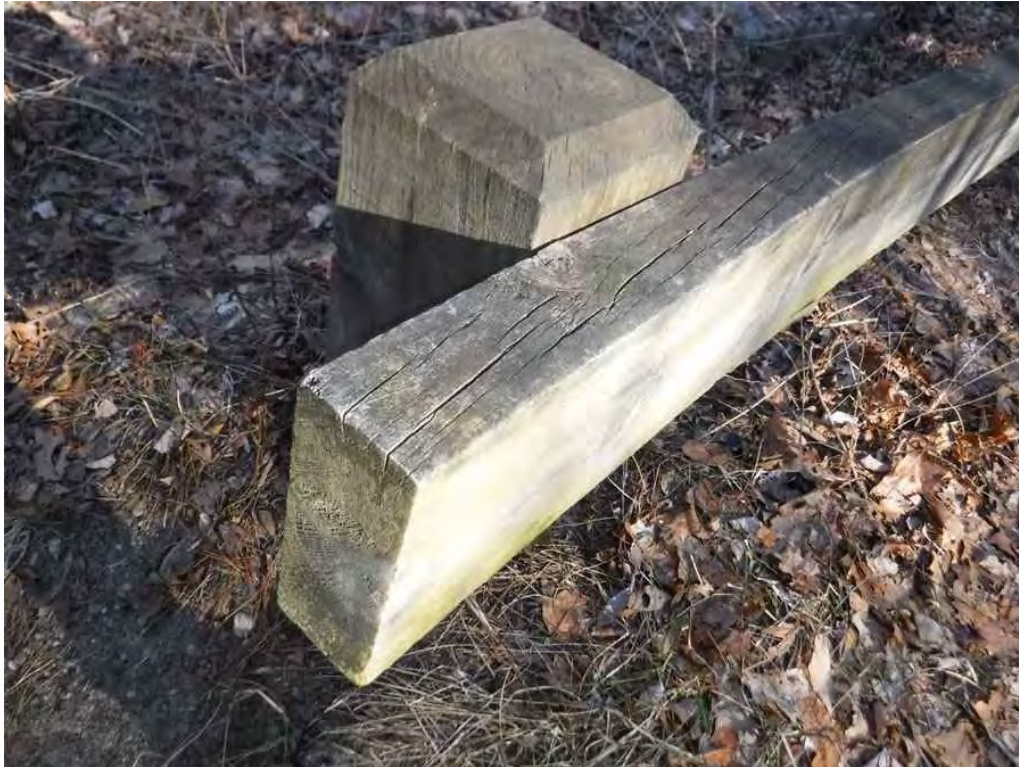
Both bridge rails consist of a timber beam mounted to timber posts. Both timber beams exhibit minor checking of the wood (**see Photo 13**).

- Photo 12 : Heavy Map Cracking in the Westbound (North) Lane at the West Approach
- Photo 13 : Bridge Railing, Minor Checking to the Upper Portion of the Timber Beams

**Photo 13: Bridge Railing, Minor Checking to the Upper Portion of the Timber Beams**

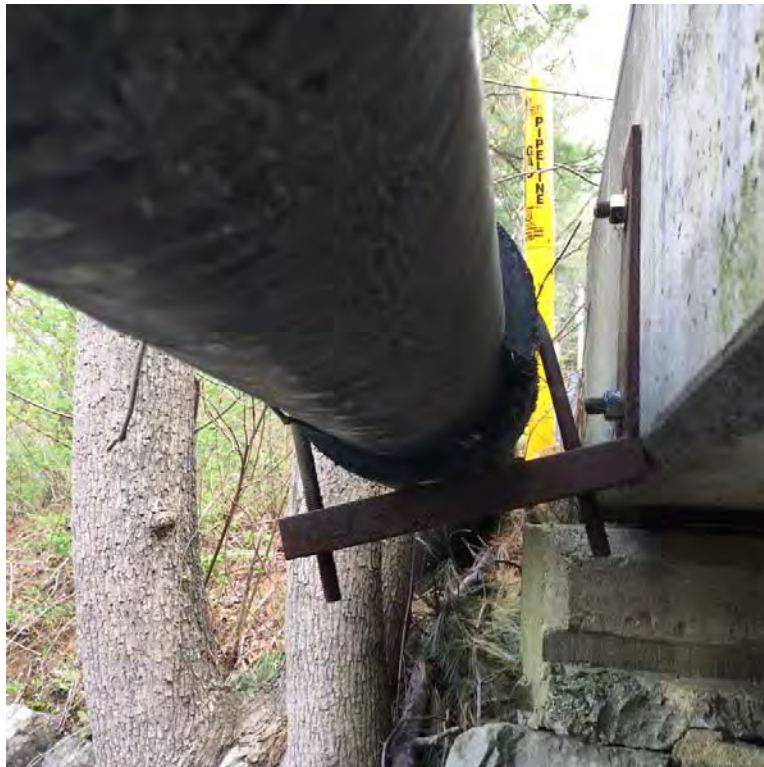
**Photo 2:** The utility bracket at the North fascia beam near the east end is bent downwards. Also note the large tree growing adjacent to the bridge at the northeast embankment.

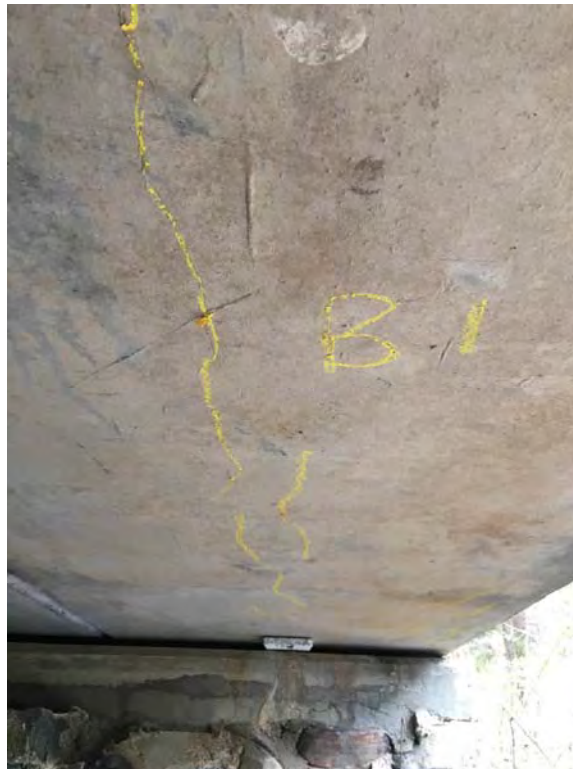
-Beam 1 has a longitudinal hairline crack at the center of the beam that extends from east end to the mid span. (**Photo 6**).

**Photo 6:** Longitudinal hairline crack at the center of the beam 1 that extends from east end to the mid span. (Looking east).

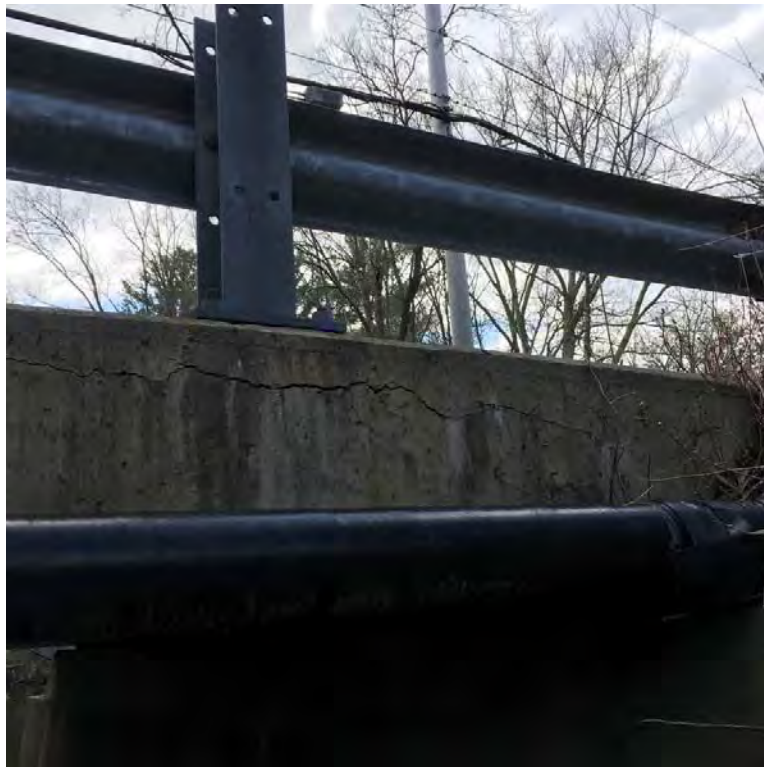
**Photo 10:** 1/4" wide horizontal crack near the top of the north fascia (the north side of beam 6) and typical vertical hairline cracking with minor efflorescence along the face.

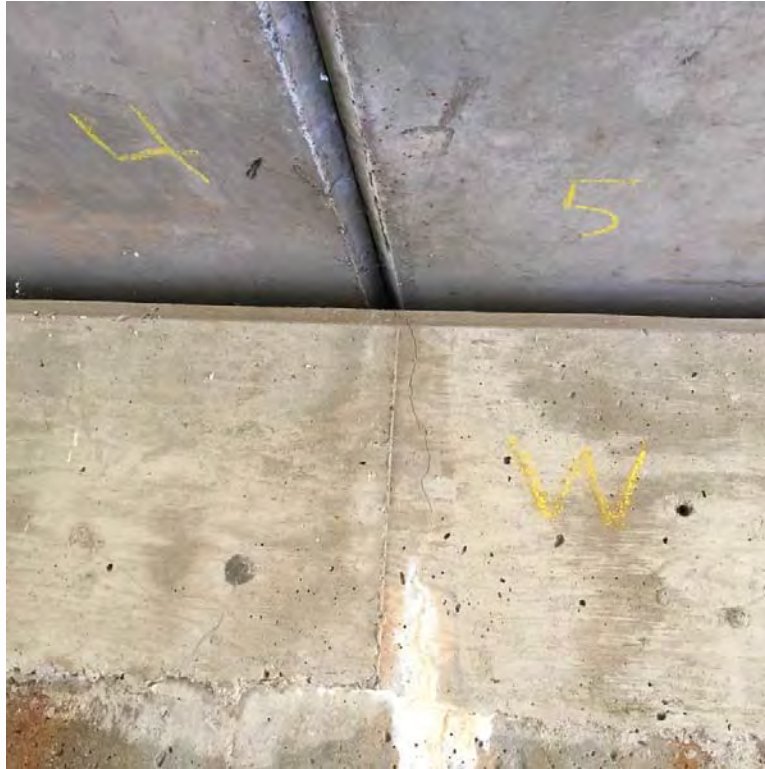
Photo 11 : Vertical crack, up to 1/8" wide x full height with moderate efflorescence under the joint between beam 4 and beam 5 on the west bridge seat.

**Photo 11:** Vertical crack, up to 1/8" wide x full height with moderate efflorescence under the joint between beam 4 and beam 5 on the west bridge seat.

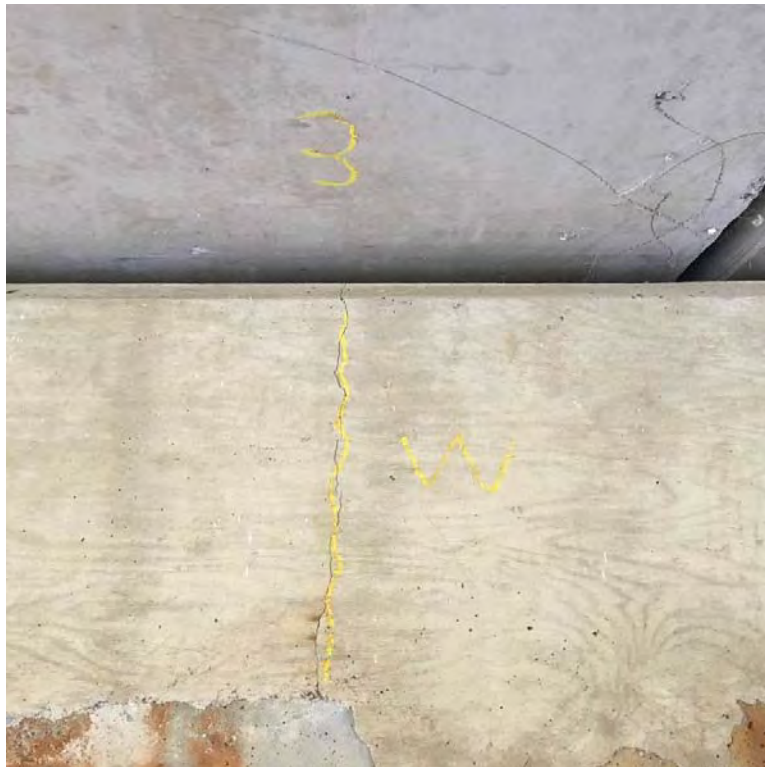
**Photo 12:** Vertical crack on the west bridge seat, 1/8" wide x full height under beam 3.

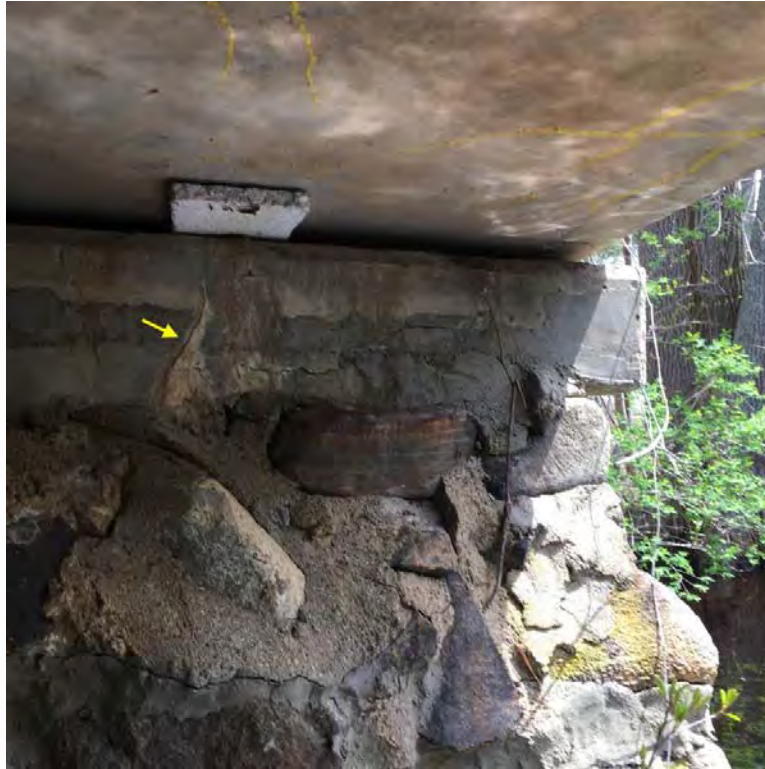
Photo 13 : Vertical crack on the east bridge seat, 1/8" wide x full height with moderate efflorescence under beam 1.

**Photo 13:** Vertical crack on the east bridge seat, 1/8" wide x full height with moderate efflorescence under beam 1.

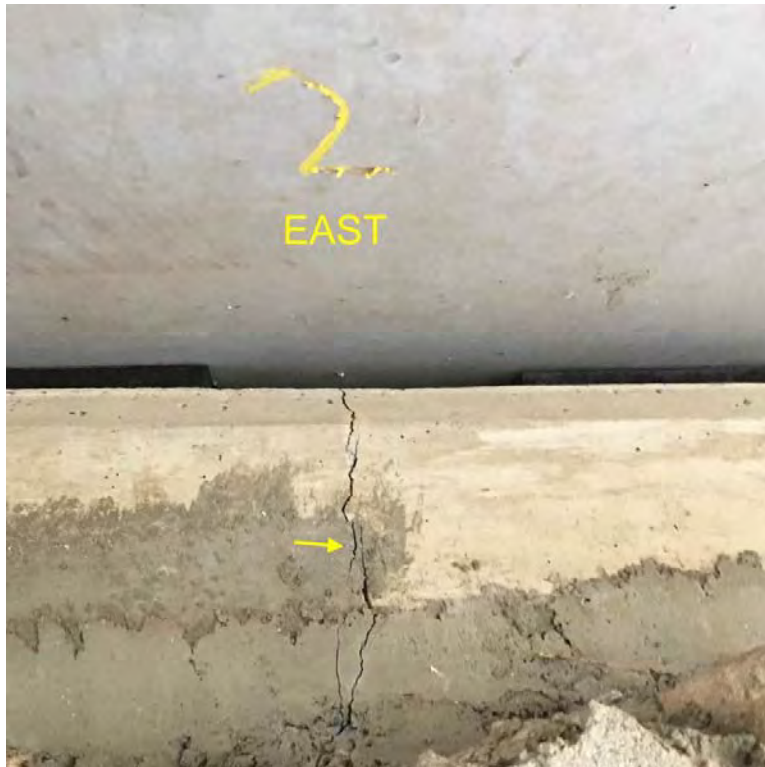
Photo 14 : Vertical crack on the east bridge seat, up to 1/4" wide x full height with under beam 2.

**Photo 14:** Vertical crack on the east bridge seat, up to 1/4" wide x full height with under beam 2.

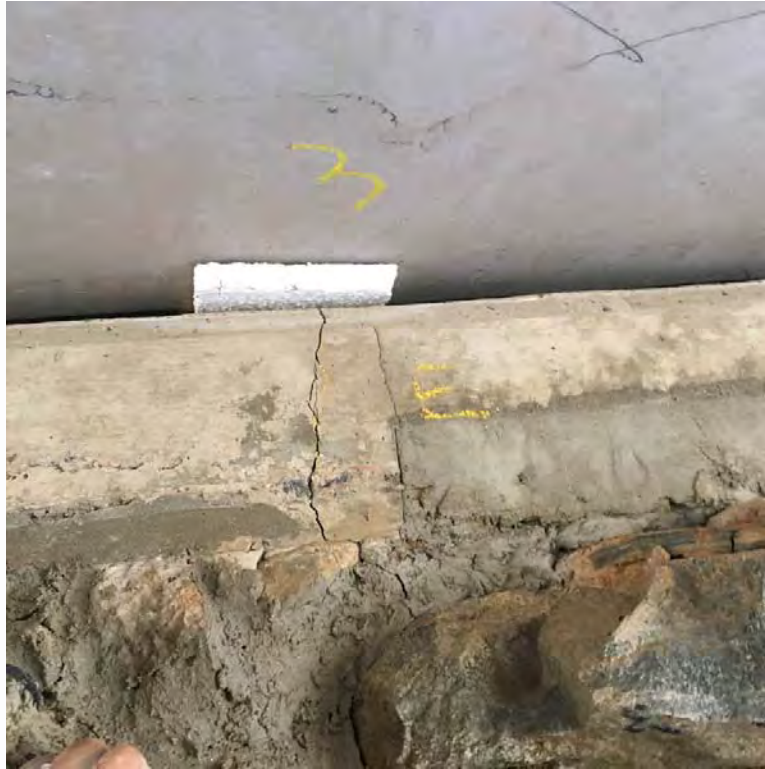
Photo 15 : Two vertical crack on the east bridge seat, up to 1/4" wide x full height with under beam 3.

**Photo 15:** Two vertical crack on the east bridge seat, up to 1/4" wide x full height with under beam 3.

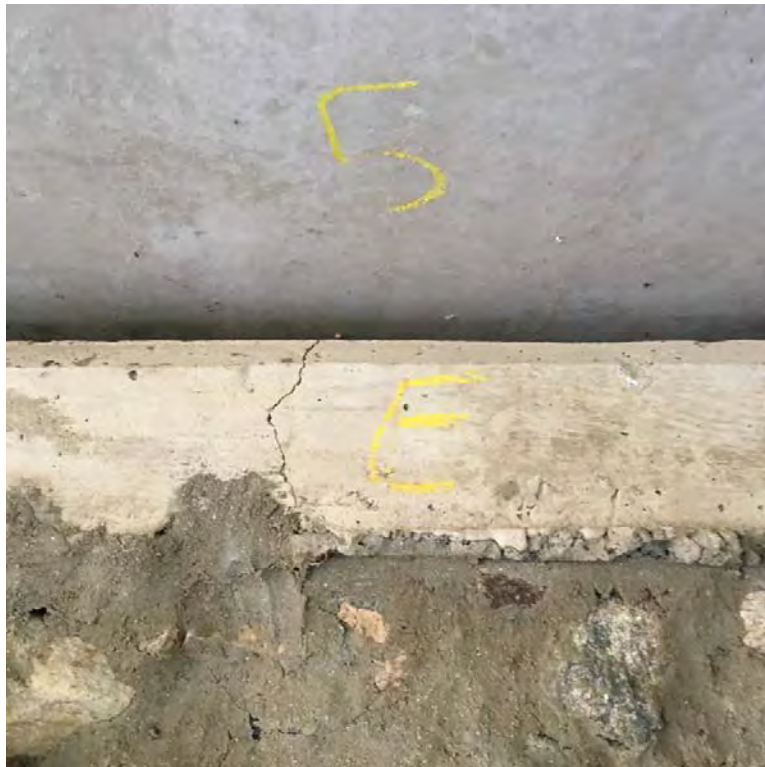
Photo 16 : Vertical crack on the east bridge seat, up to 1/4" wide x full height with under beam 5.

**Photo 16:** Vertical crack on the east bridge seat, up to 1/4" wide x full height with under beam 5.

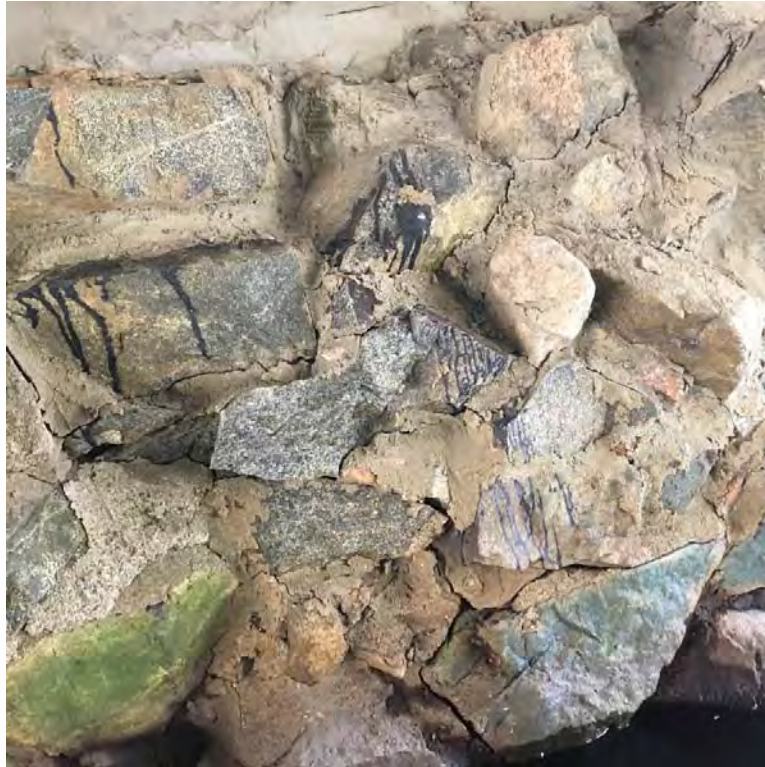
There is typical cracking in the mortar between the stones along the west breastwall. **(Photo 17)**.

Photo 17 : Typical cracking in the mortar between the stones along the west breastwall.

**Photo 17:** Typical cracking in the mortar between the stones along the west breastwall.

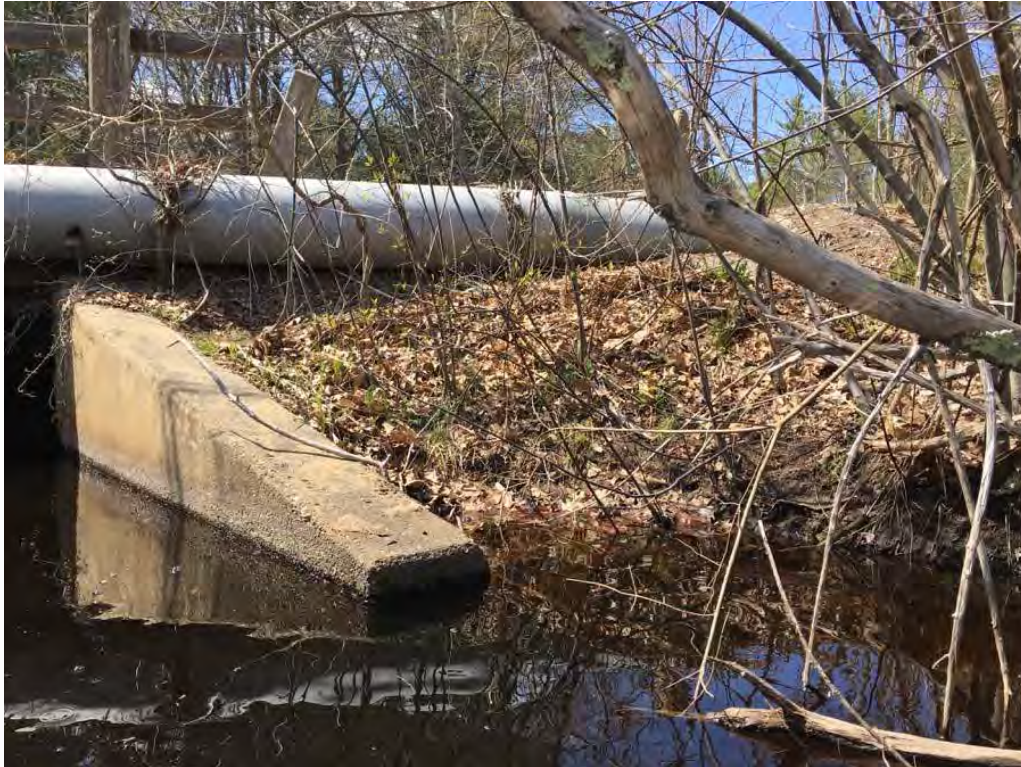
**Photo 11: Minor erosion behind the northeast wingwall.**

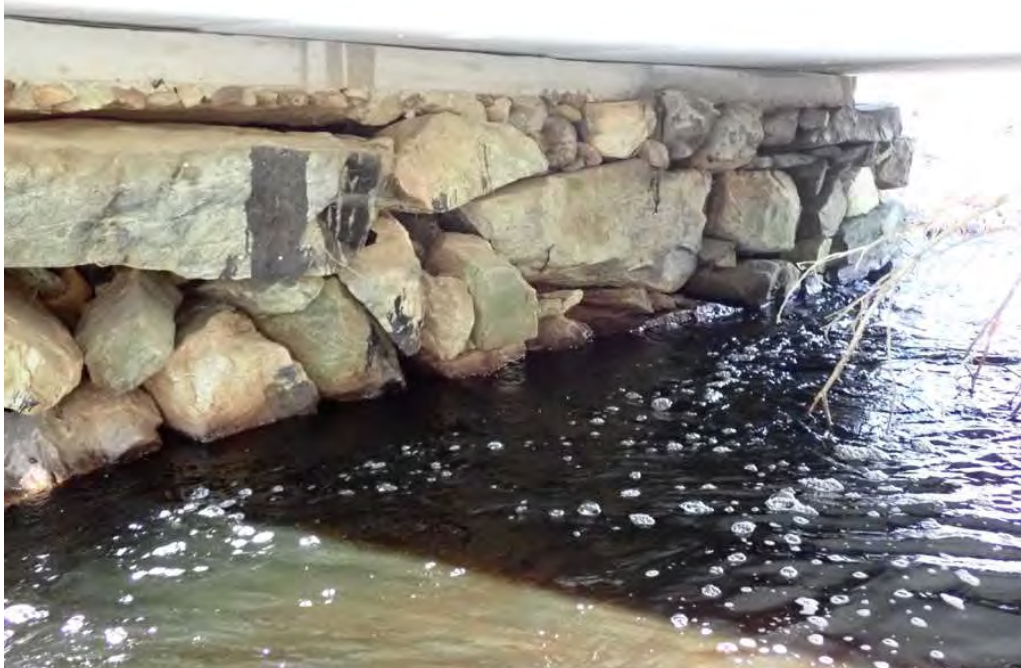
**Photo 4:** South breastwall, typical voids and displaced stones.

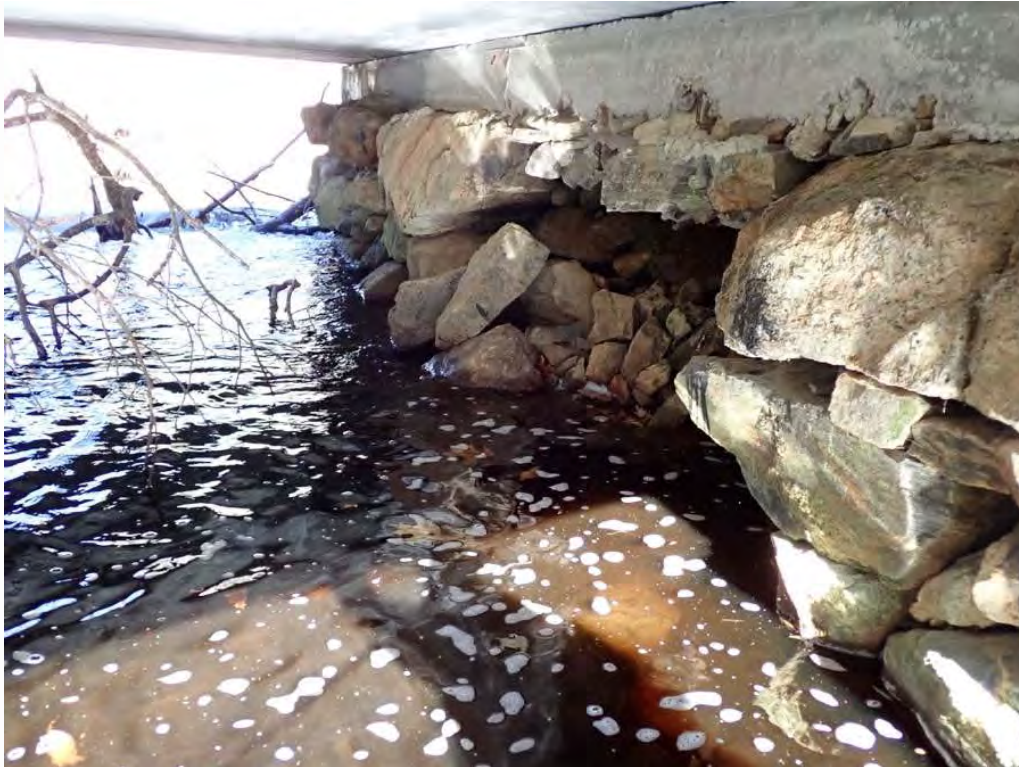
**Photo 5:** North breastwall, typical voids and displaced stones.

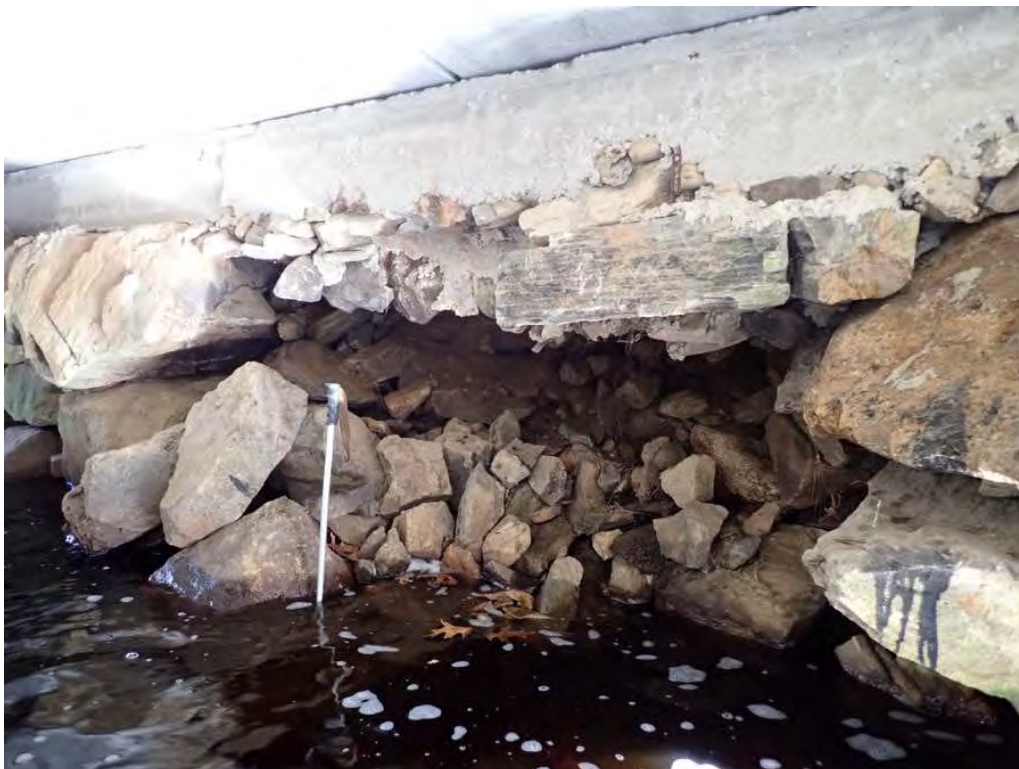
**Photo 6:** North breastwall, washout area starting at 4'-10" from the east edge of the concrete cap.

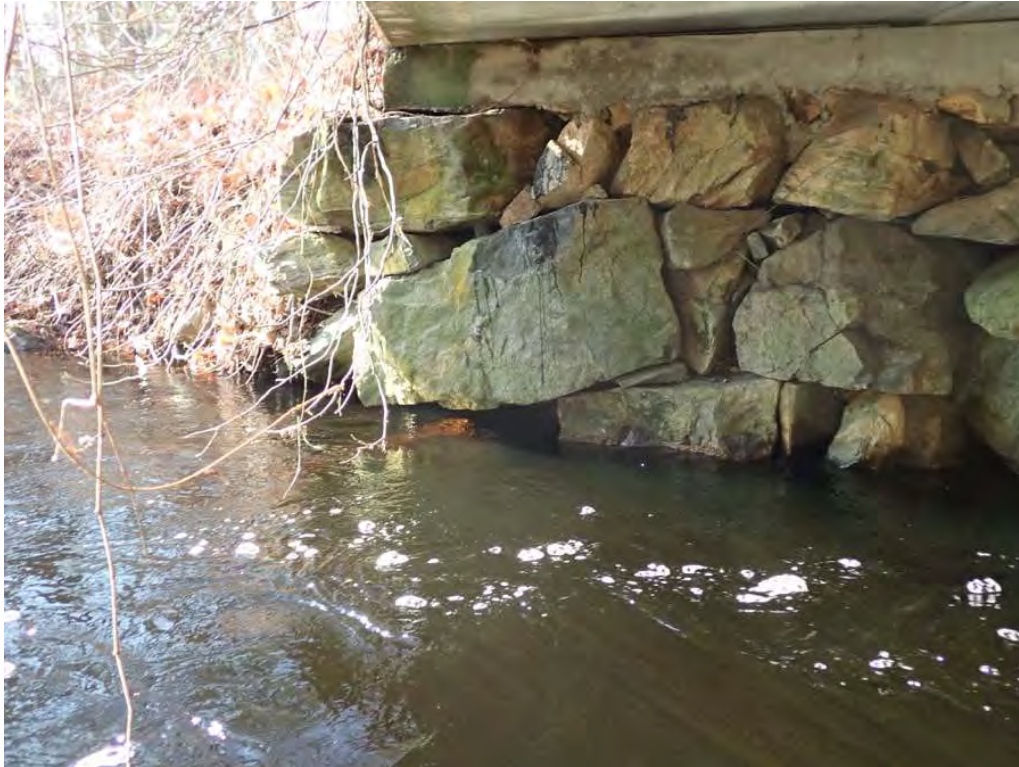
**Photo 9: South breastwall, undermined stone at the east edge.**

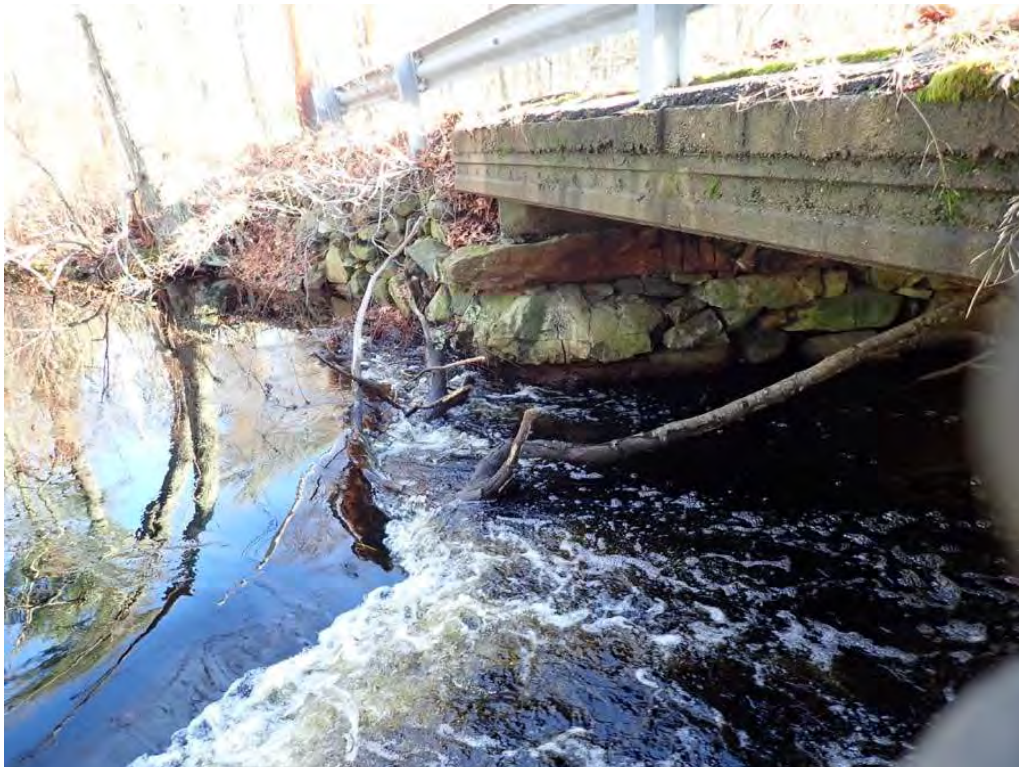
**Photo 10: Typical debris throughout channel; view at west elevation.**

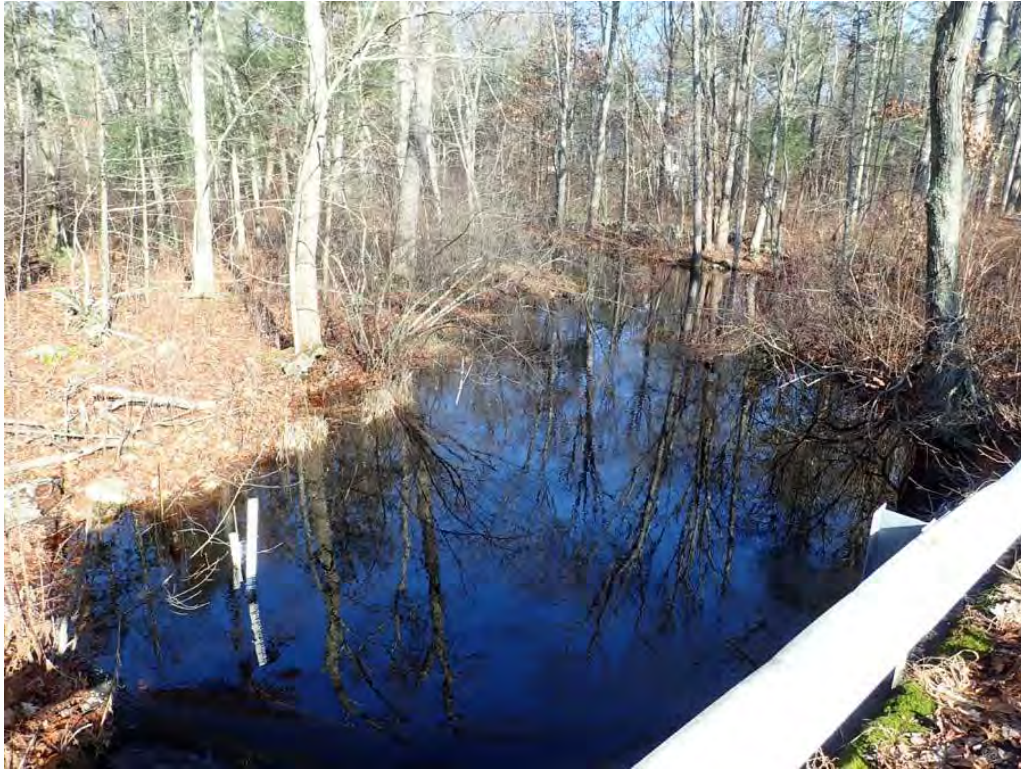
**Photo 11: Typical debris throughout channel; upstream.**

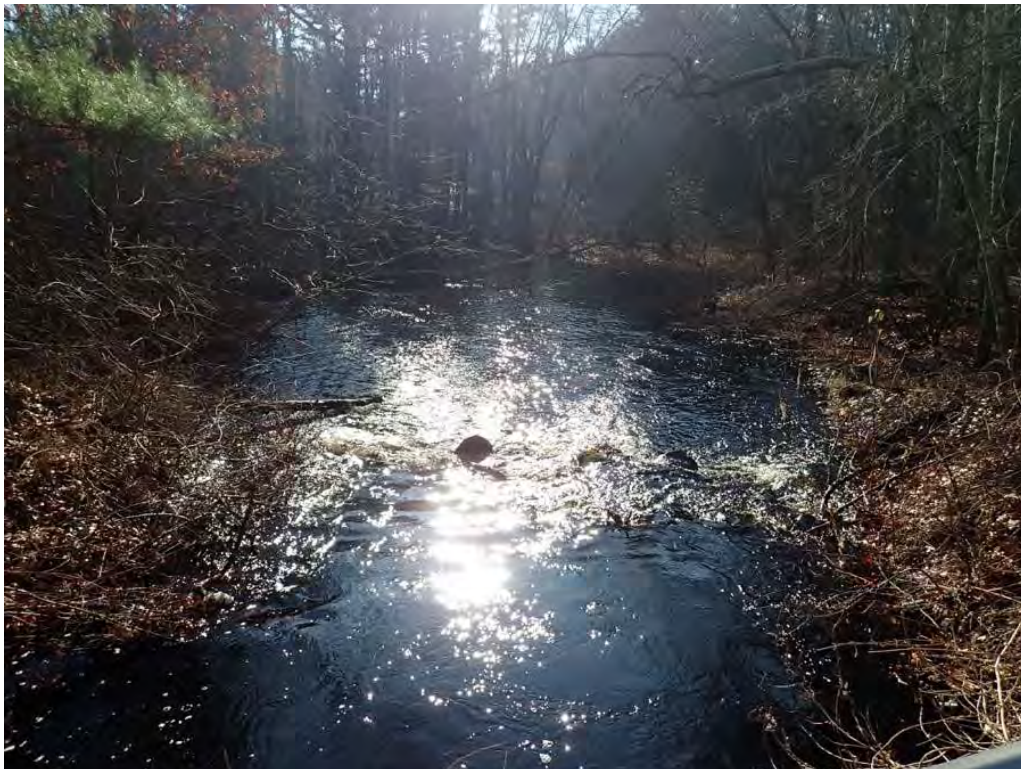
**Photo 12: Typical debris throughout channel; downstream.**
