EXTERIOR WALL/WINDOW EVALUATION AT
BOXFORD TOWN HALL/LIBRARY
7 Spofford Road
Boxford, Massachusetts 01921

April 10, 2018

**EXTERIOR WALL/WINDOW EVALUATION AT
BOXFORD TOWN HALL/LIBRARY
7 Spofford Road
Boxford, Massachusetts**

**Exterior Wall/Window Evaluation at the
Boxford Town Hall/Library
Boxford, Massachusetts
Gale JN 833440**

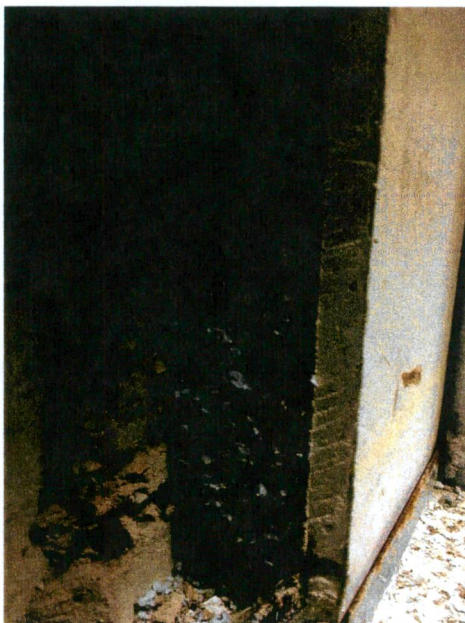
1. The typical wall construction of the building was observed to be a steel framed building with light gauge metal stud walls, over which an exterior grade gypsum sheathing board was attached. The exterior gypsum sheathing is Georgia-Pacific Gypsum Corporation DensGlass Gold (DensGold) with six-inch strips of Carlisle self-adhered membrane (SA membrane) installed over the seams. Outboard of the DensGold is 2-inch extruded polystyrene insulation board (XPS), an open cavity varying between 1" and 2-1/2", and brick veneer/precast concrete elements. The brick and precast were secured to the backup stud wall with masonry or stone ties. The metal studs are not insulated, and painted gypsum sheathing is installed on the interior of the studs.

Figure 6: View of the typical wall construction from the interior with precast concrete exterior cladding.

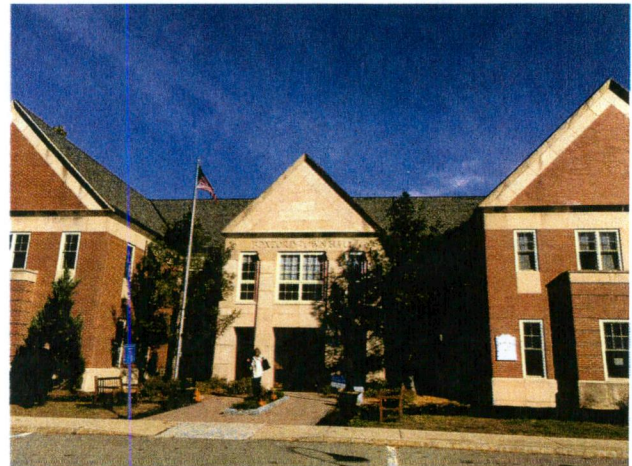
4. Precast concrete units are utilized at the roof eave, roof rake, second floor window sills, base of the foundation, and at the front entrance locations.

Figure 7: Precast concrete cladding is utilized at the front entrance of the building, at the rake and eave lines of the roof, second-floor window sills, and at the foundation level.

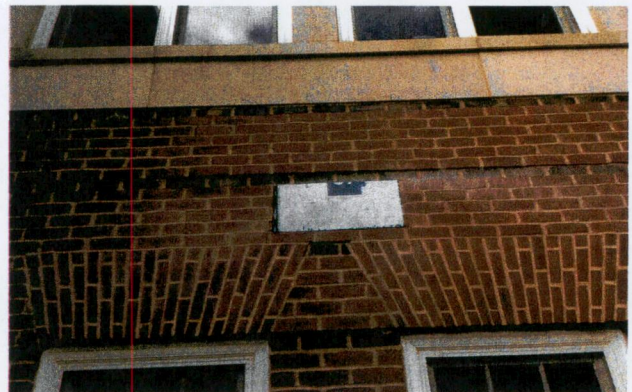
9. The brick mortar joints appeared to be in good condition with minimal deteriorated joints observed.
10. RILEM tube tests were performed at five (5) locations; two (2) brick types and three (3) mortar locations, including head and bed joints. The RILEM test concluded that the porosity of the mortar and brick meets industry standards.
11. Jack arches are installed in the brick masonry above the first-floor windows.

Figure 12: Jack arches are installed above the first-floor windows.

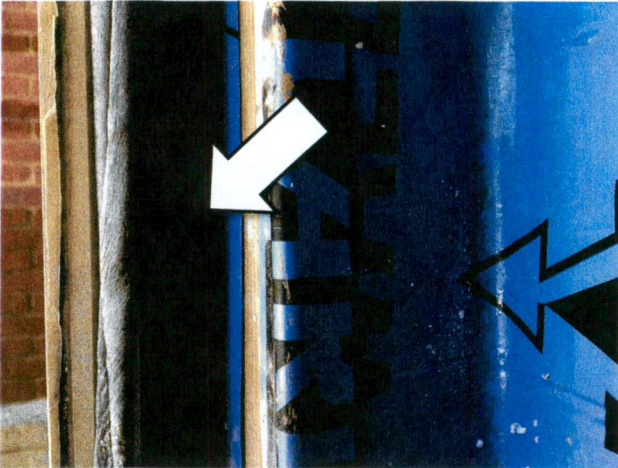
35. Double-hung vinyl clad wood windows are installed throughout the building. The windows appear to be in good condition and appear to operate well with no issues reported. Windows are secured to wood substrates at the jambs using 2-inch wide clips, spaced approximately 16-inches on center.

Figure 21: 2-inch clips are used to secure the windows to the wood blocking.

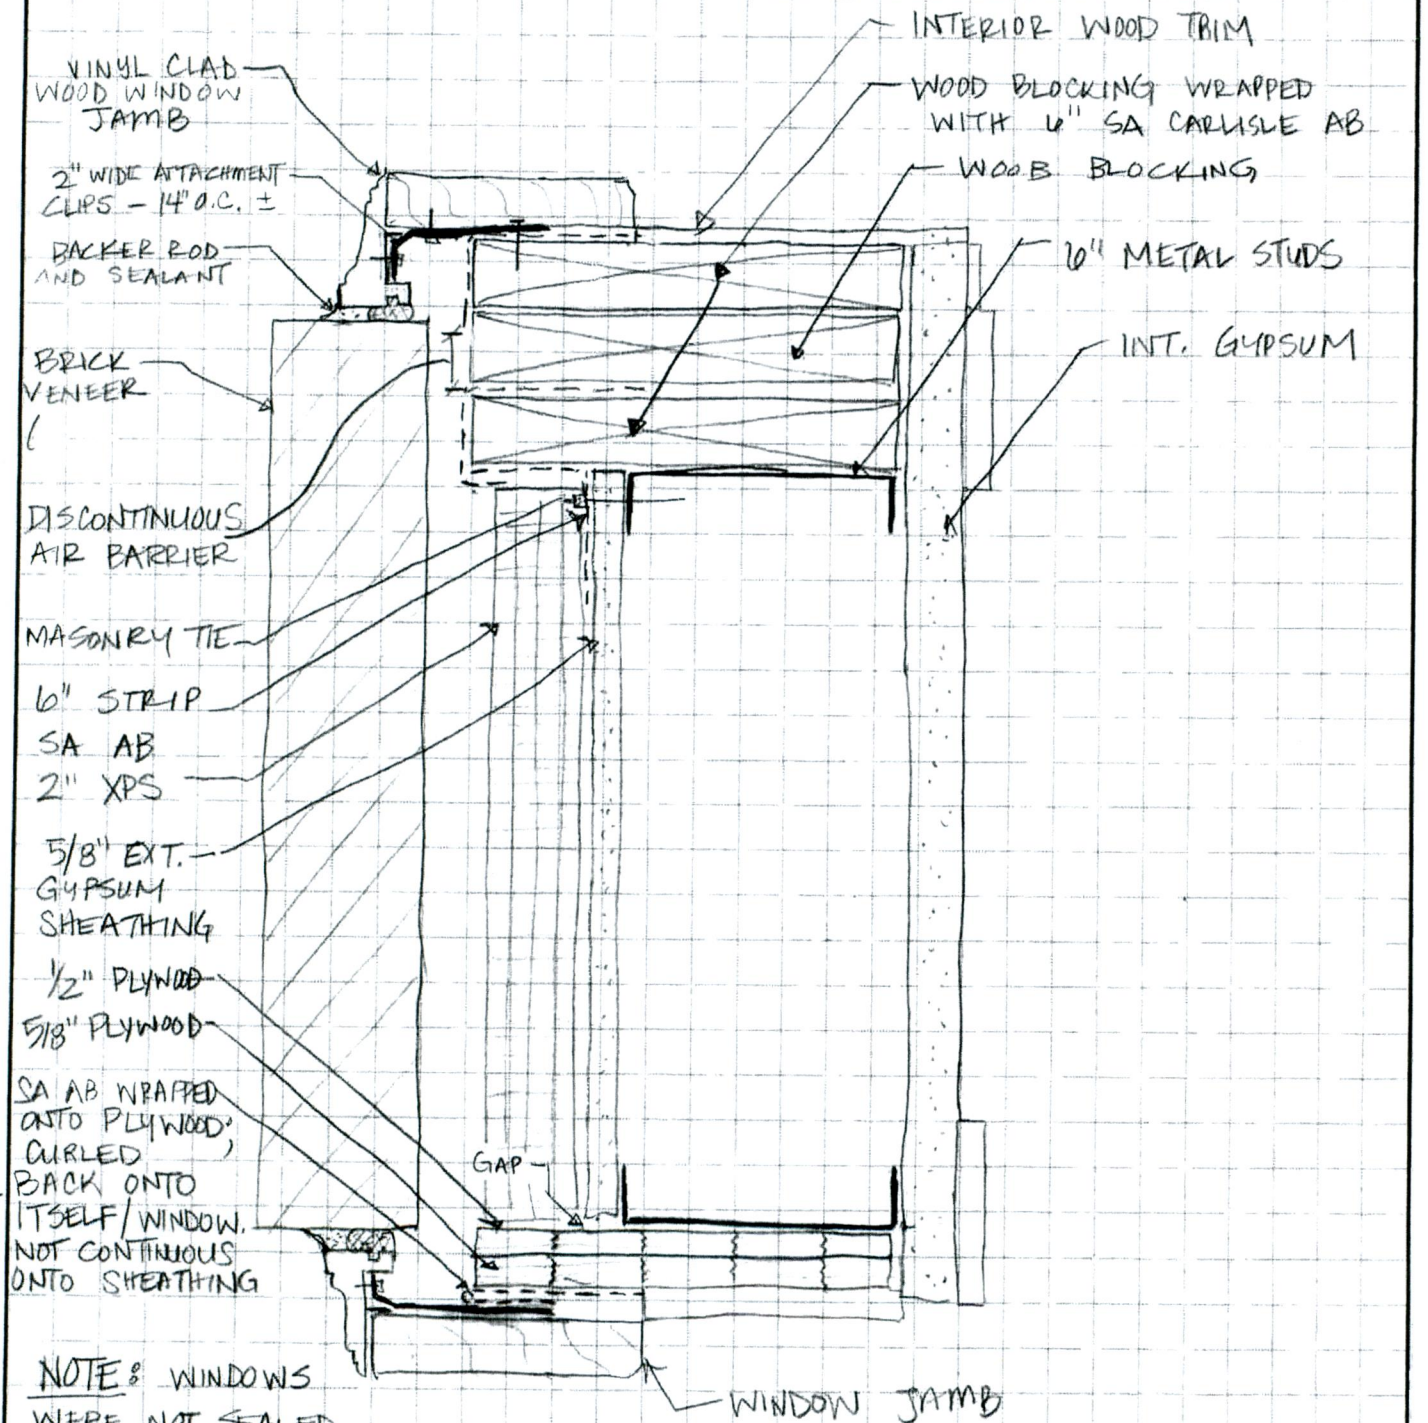
TEST CUT #1 - FRONT ELEVATION WINDOW JAMBS

L70 COURSES TALL BY 2 1/2 COURSES WIDE REMOVED

NOTE: WINDOWS
WERE NOT SEALED
TO AB.

NOTE: ONE (1) HORIZ. JOINT IN EXT. GYP. SHEATHING OBSERVED TO BE
TAPED WITH CARLISLE SA AB

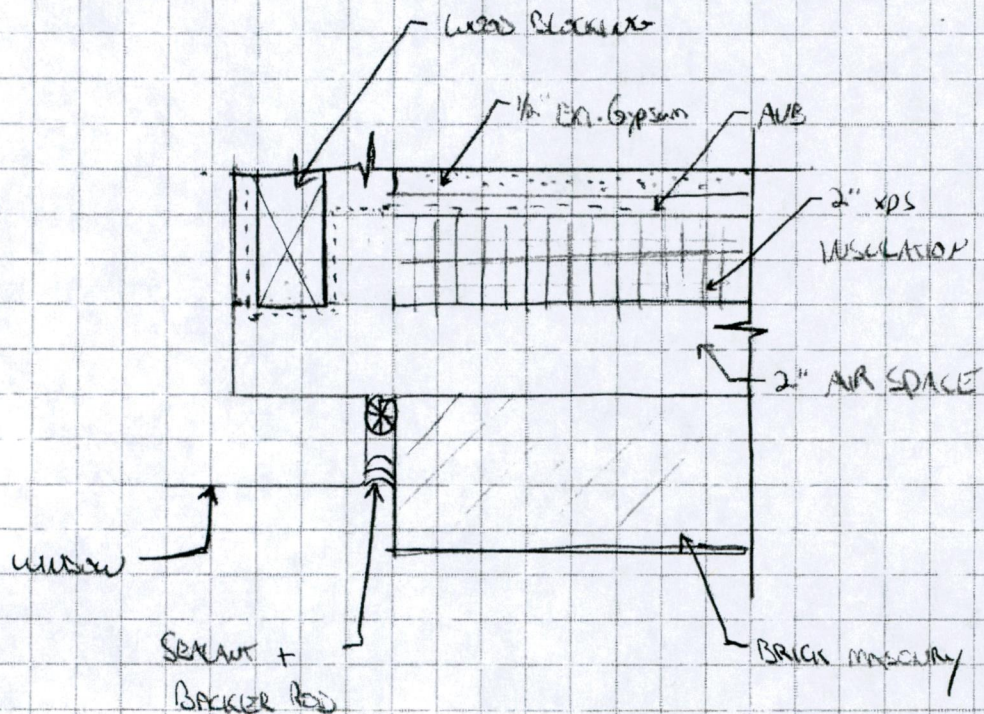
TEST Cut # 2

- Air Barrier Extends into Gypsum 6"
- INSULATION IS CAMP
- ICE RUNS DOWN FACADE OVER TEST CUT

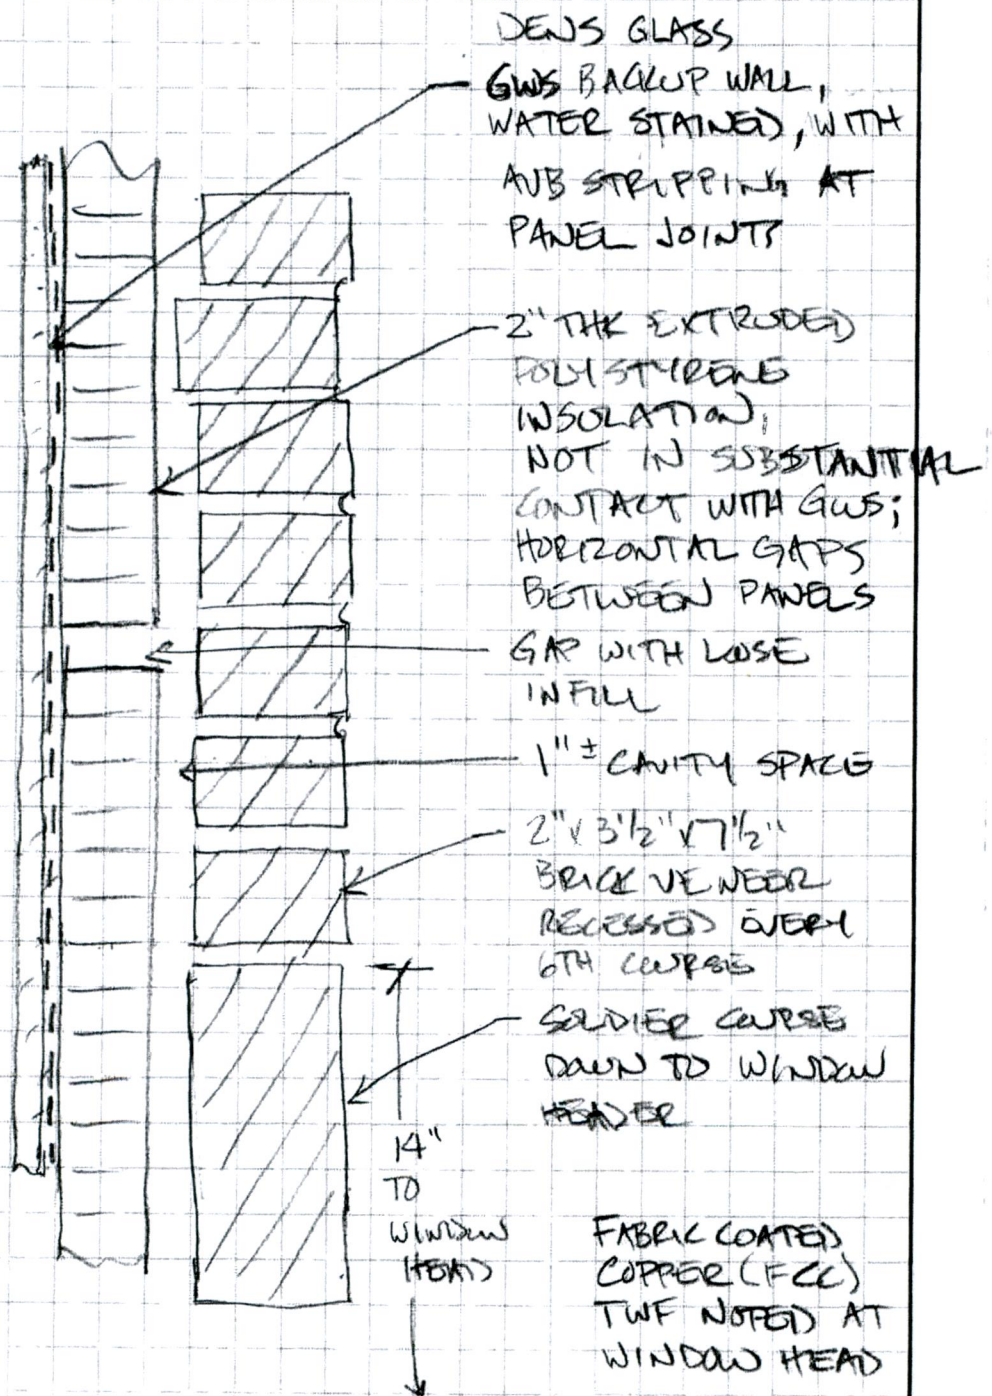
T.C. #3 : FIELD OF WALL BETWEEN 2ND FLR PRECAST
AND 1ST FLR WINDOW HEADER - SOUTH ELEV.

- XPS INSULATION NAILED TO Gypsum
- NO AUB
- MATERIALS ARE DRY
- INSULATION IS LOOSE IN SOME LOCATIONS
- ICE TRAVELING DOWN FACADE

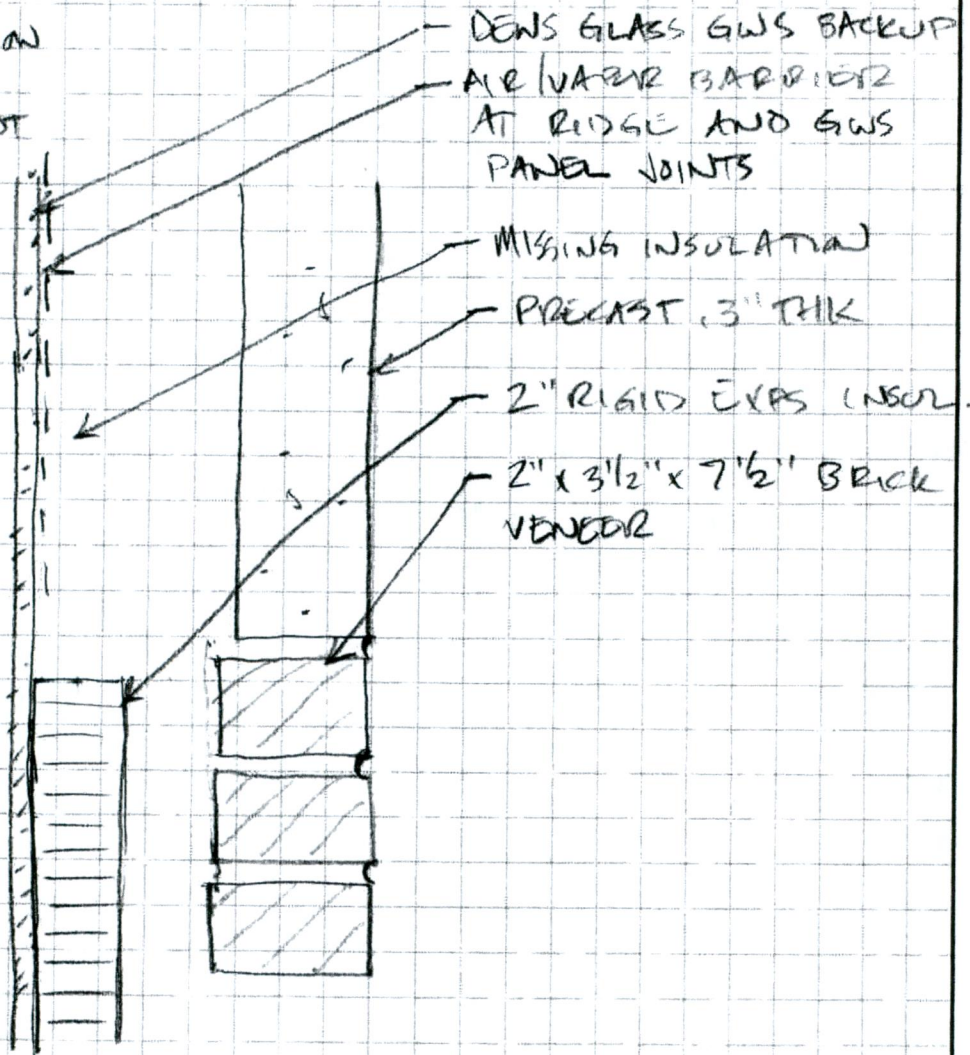
TEST CUT #5: RIDGE :- NORTH ELEVATION

NOTE: RIGID INSULATION
VISIBLE AT TOP OF
PRECAST - COULD NOT
VERIFY AFB TIE-IN
TO ROOF.

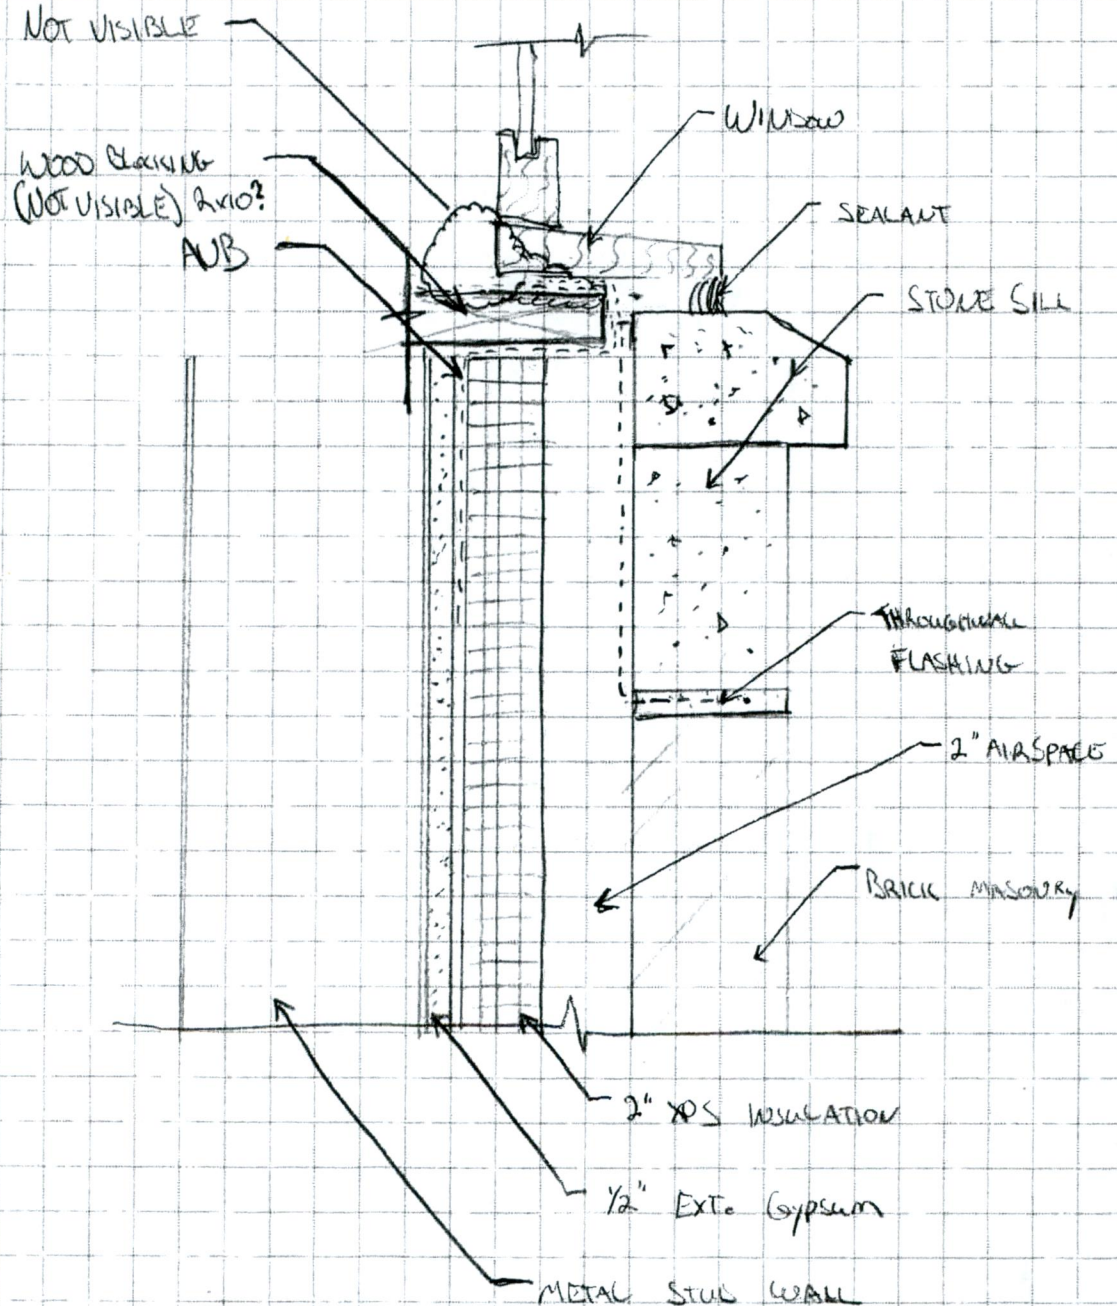
SCALE 3" = 1'-0"**TEST CUT #6 - Below Stone Sill of Meeting Room**

- INSULATION APPEARS LOOSE
- CONCRETE SILL DETERIORATED
- COPPER FLASHING THROUGHOUT FLASHING

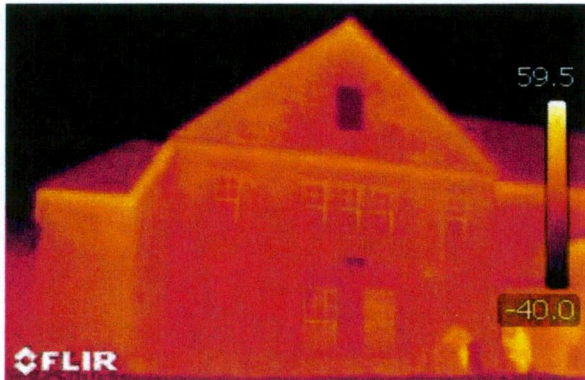
- In the field of the wall at gable elevations Refer to Figure 21.

Figure 9: Exterior thermographic image shows warm air exfiltration at multiple exterior wall locations.

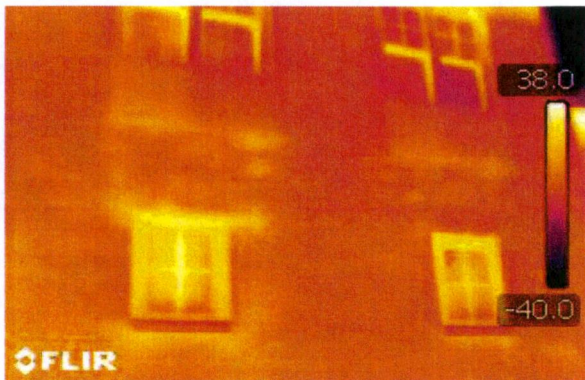
- In the field of the wall between the 1st and 2nd floor windows (at approximate floor line locations), and around windows. Refer to Figure 22.

Figure 10: Exterior thermographic image shows warm air exfiltration in the field of the wall between 1st and 2nd floor windows and around the windows.

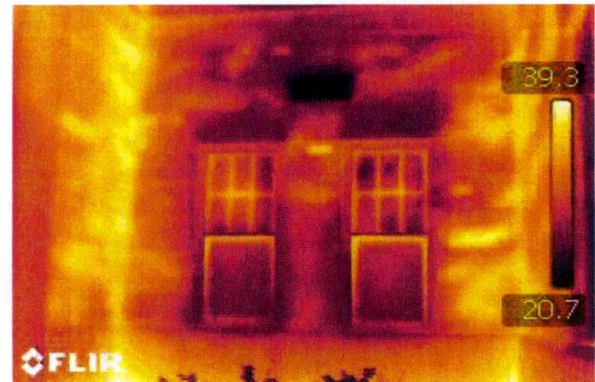
- At inside corners Refer to Figure 24.

Figure 11: Exterior thermographic image shows warm air exfiltration at inside corners of the exterior wall.
